UNITED STATES  
DEPARTMENT OF THE INTERIOR  
BUREAU OF RECLAMATION

Laboratory Report No. 6  
Hydraulic Laboratory  
Compiled by: J. E. Warnock

Subject: Diversion of river through west cofferdam area -  
Grand Coulee Dam - Columbia Basin Project.

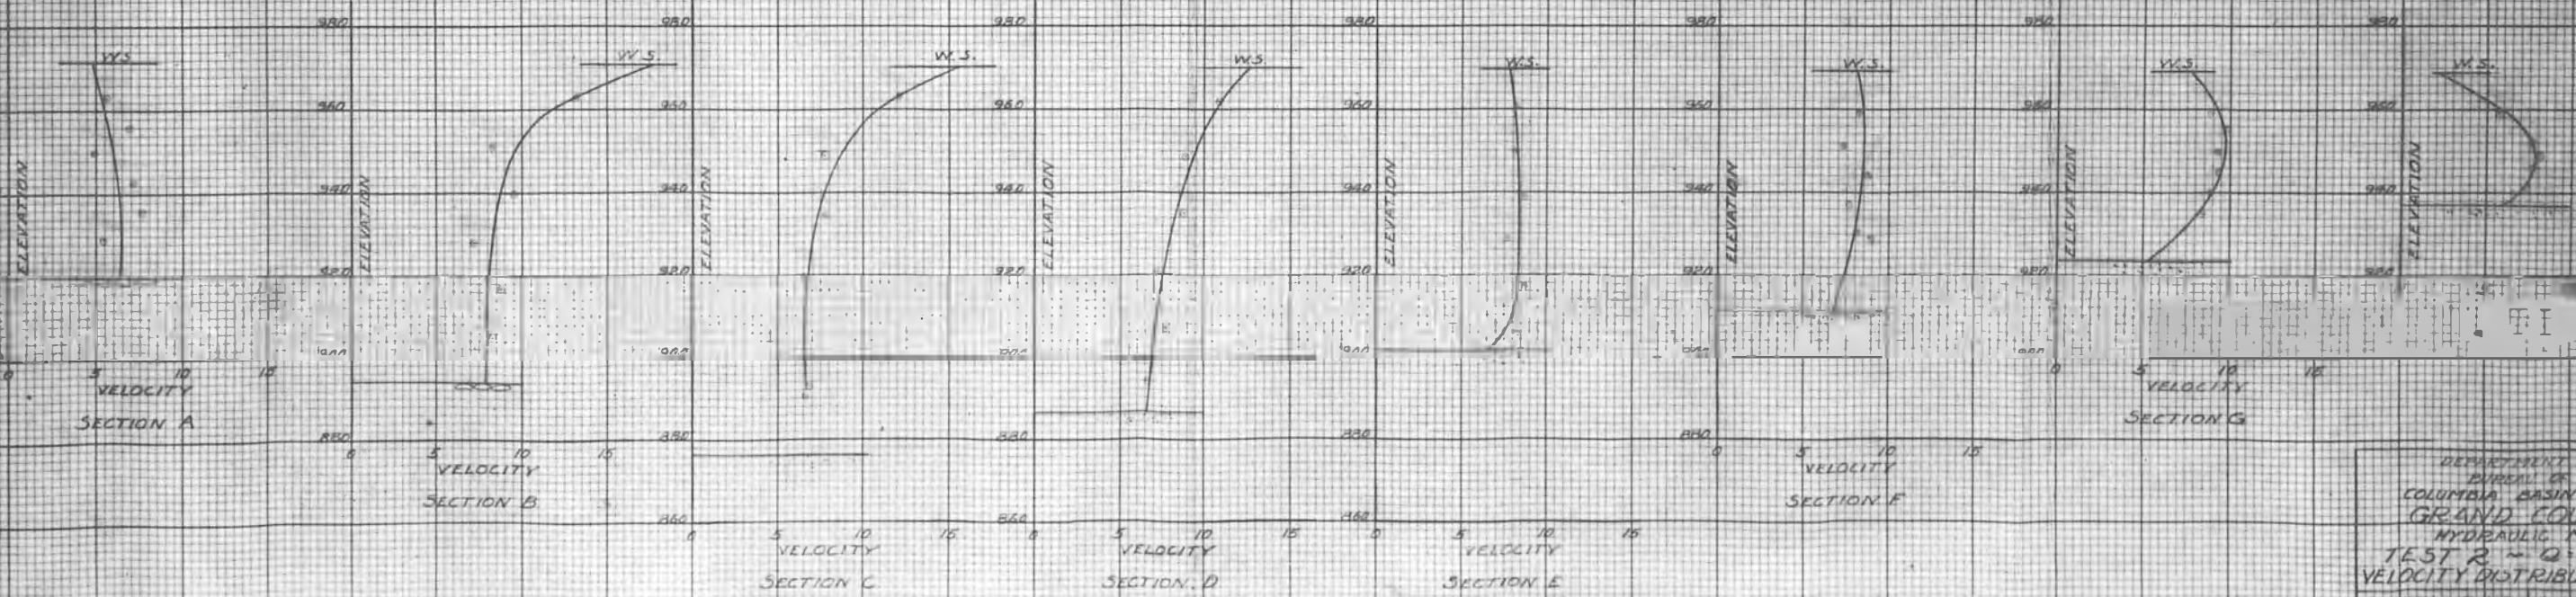
FIGURE 9

PROTOTYPE ISOVELS AT SECTION 1

NOTE: ELEVATION IS IN FEET  
 ALL MEASUREMENTS ARE IN FEET  
 SECOND PROTOTYPE  
 SEE FIGURE 1 FOR LOCATION OF SECTION 1

PROTOTYPE VELOCITIES AT VARIOUS VERTICALS

DEPARTMENT OF THE INTERIOR  
 BUREAU OF RECLAMATION  
 COLUMBIA BASIN PROJECT - WASHINGTON  
 GRAND COULEE DIVERSION  
 HYDRAULIC MODEL STUDIES  
 TEST 2 - Q = 300,000 - 1:120 MODEL  
 VELOCITY DISTRIBUTION AT SECTION 1  
 DRAWN BY G. SUBMITTED  
 TRACED RECOMMENDED  
 CHECKED APPROVED  
 JUNE 5, 1968 R. E. COLLINS, COLD, 3446

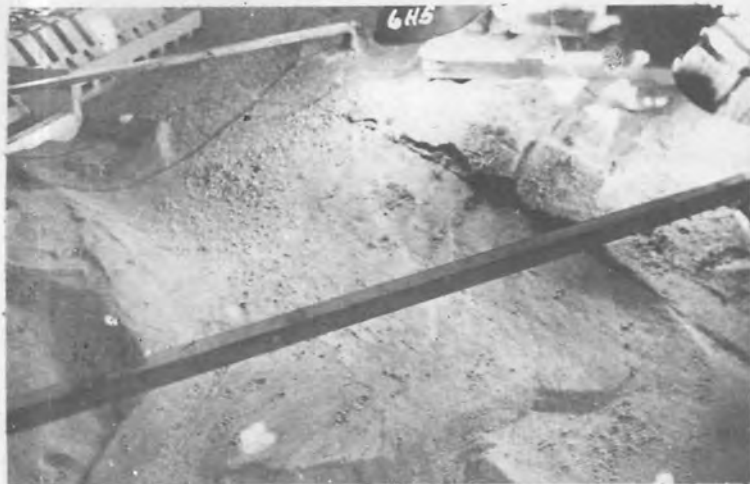
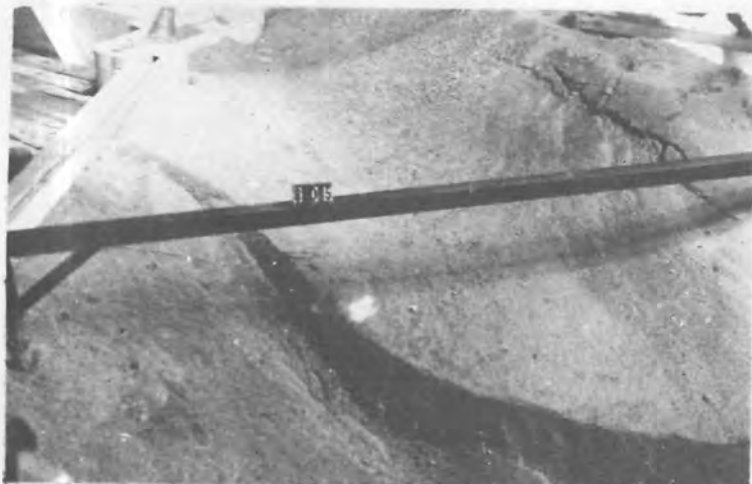
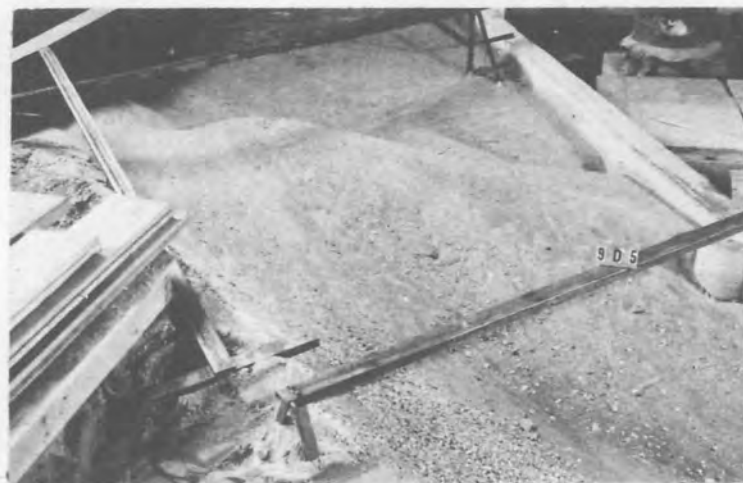
PLATE I

GRAND COULÉE DIVERSION MODEL  
Scale Ratio 1:120

Erosion below Dam after a Discharge of 500,000 Second-feet.

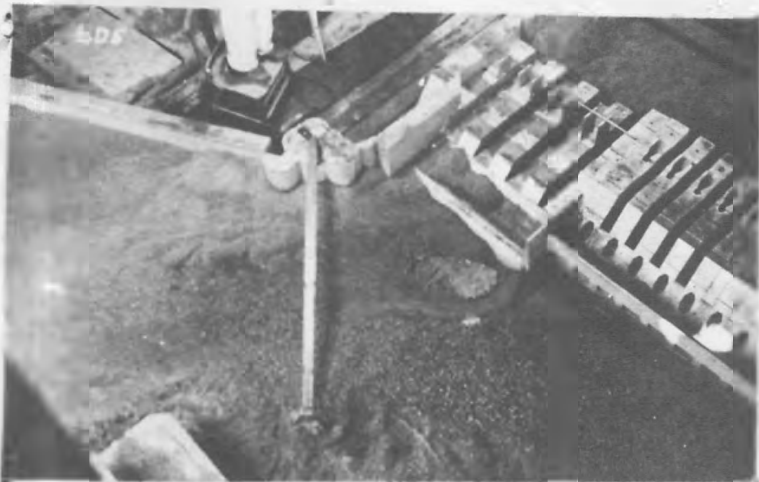
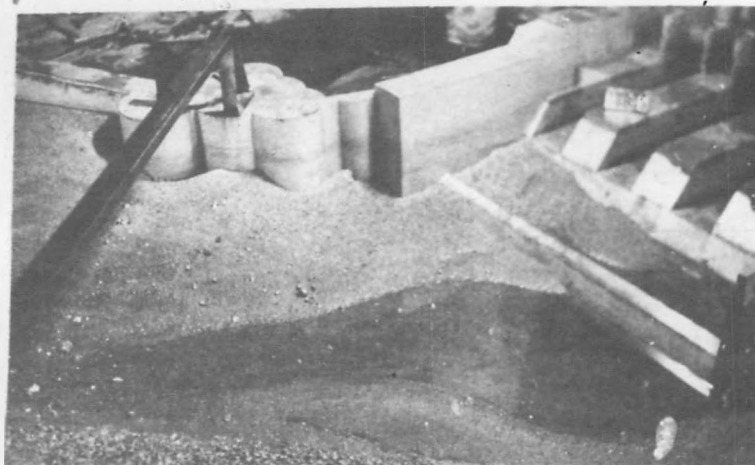
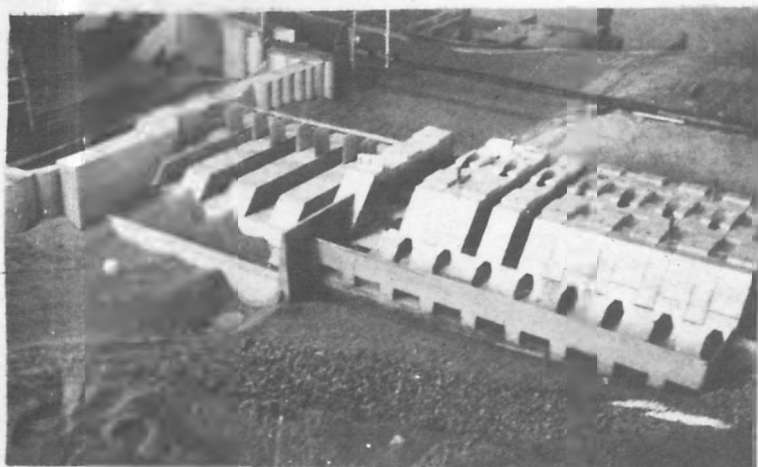
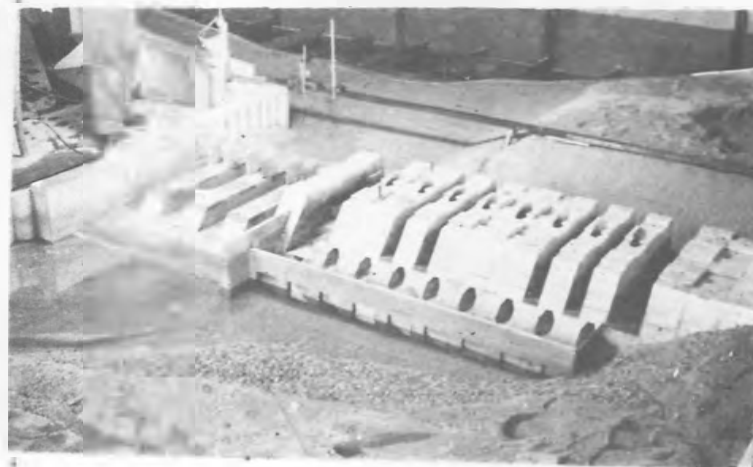
Erosion below Dam after a Discharge of 500,000 Second-feet.

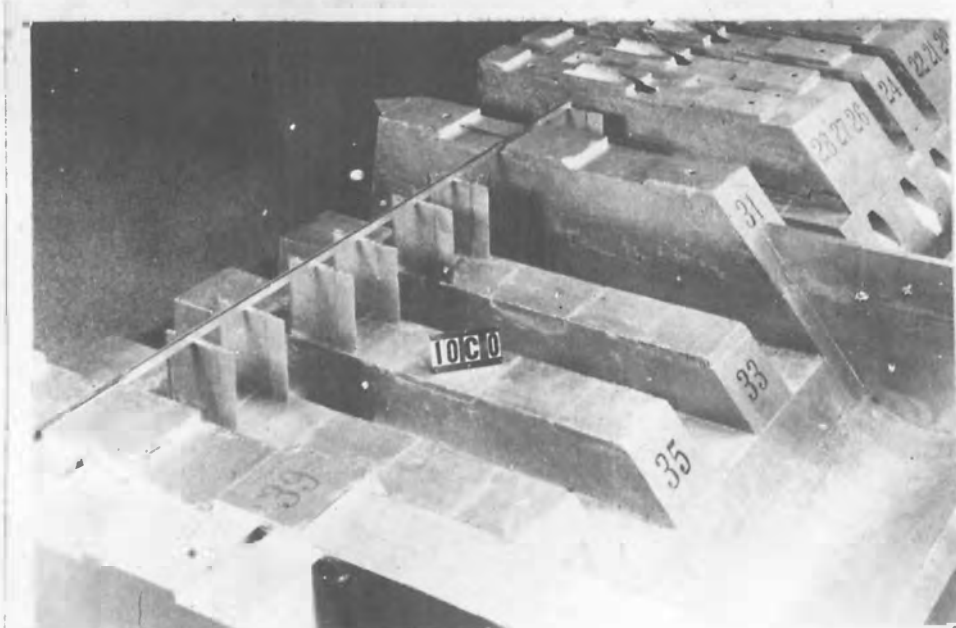
PLATE IV

GRAND COULEE DIVERSION MODEL  
Scale Ratio 1:120 Test 10

Flow through openings over blocks 13, 15, 17, 23, 25, 29, 30 and 32 to 38 inclusive. Each of these blocks except No. 30 level on top. Cribs upstream from blocks 31 and 39. Streamlined trestle bents in place.

Looking Upstream from Right Bank

Close up of Spillway Section  
Showing Trestle Bents.

Condition of River Bed before Test.

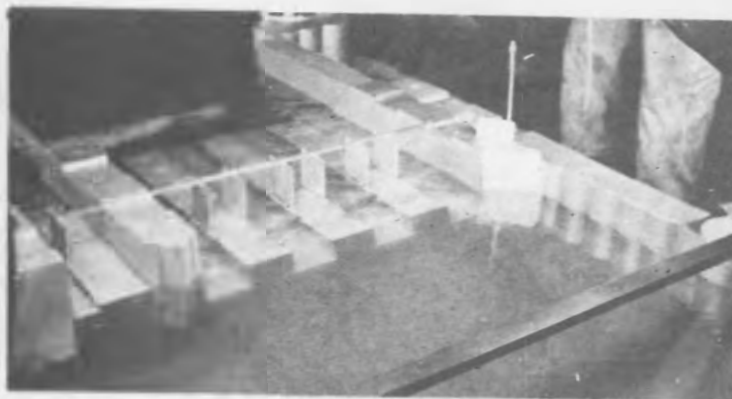
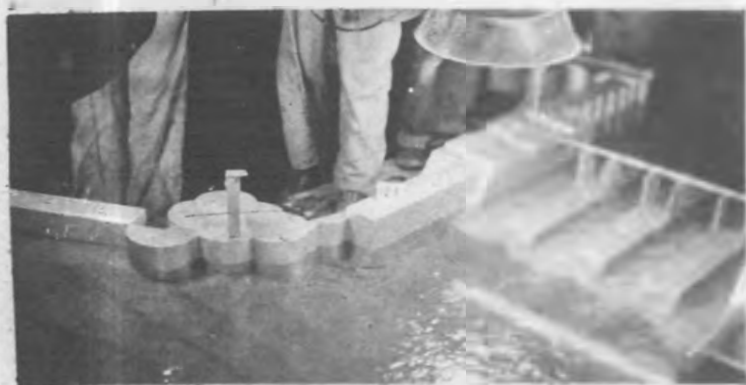
Discharge 200,000 Second-feet.

Flow Conditions during Diversion of the River  
through Left Powerhouse and Spillway Sections.

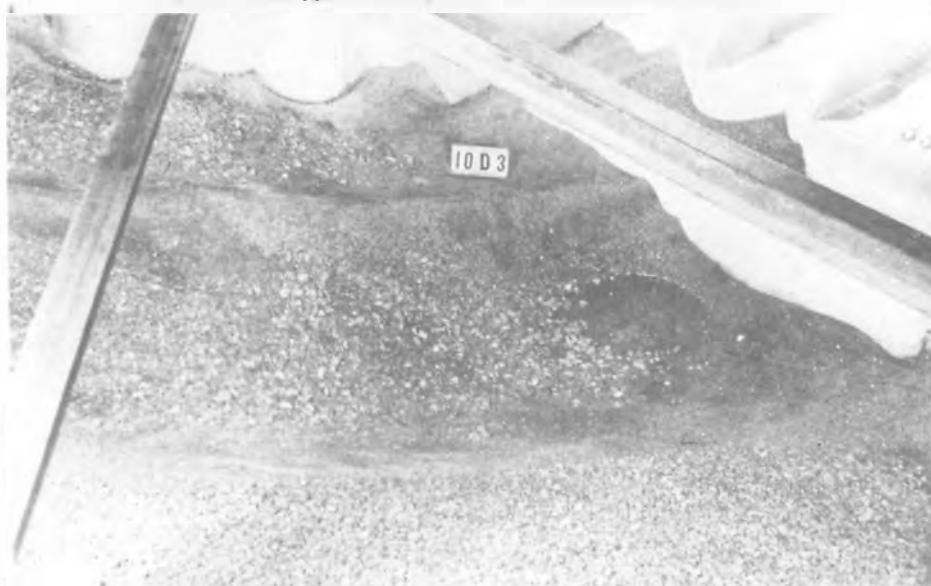
Below Bucket of Spillway Section

Erosion below Dam after a Discharge of 300,000 Second-feet.

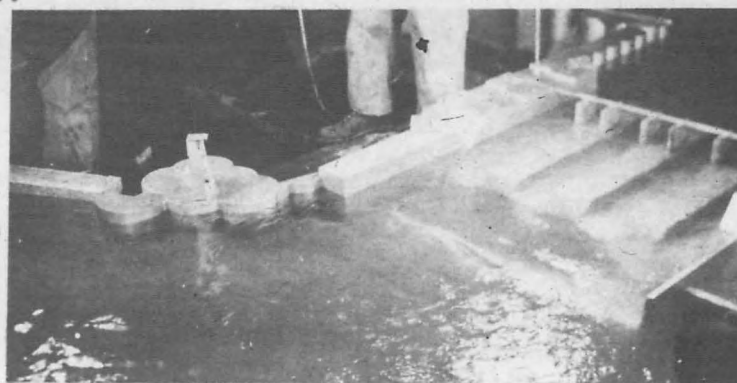
Discharge of 400,000 Second-feet.

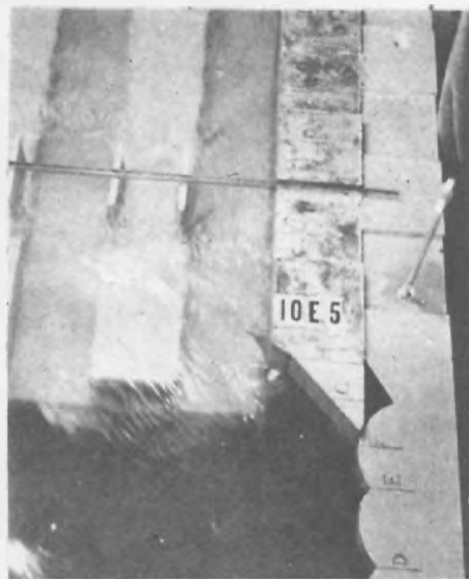
Wooden Crib at Upstream End of Block 39 - Discharge 500,000 Second-feet.

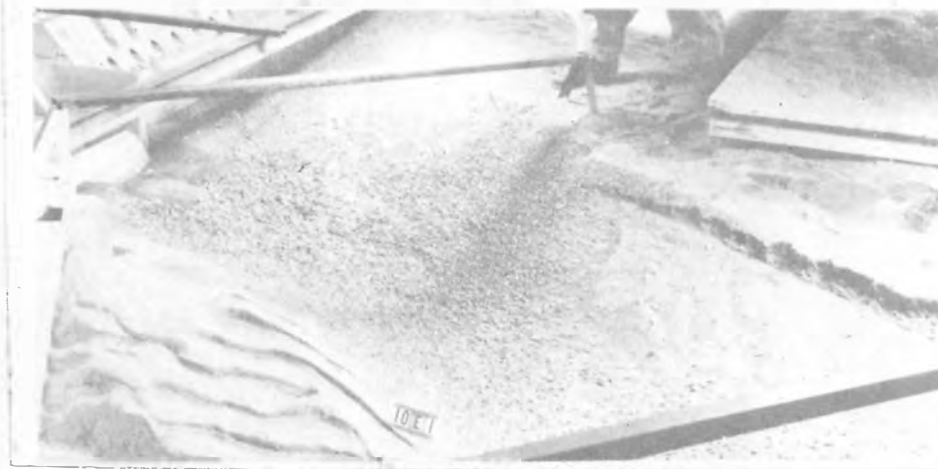
River Channel below Dam and Left Bank below Riprap.

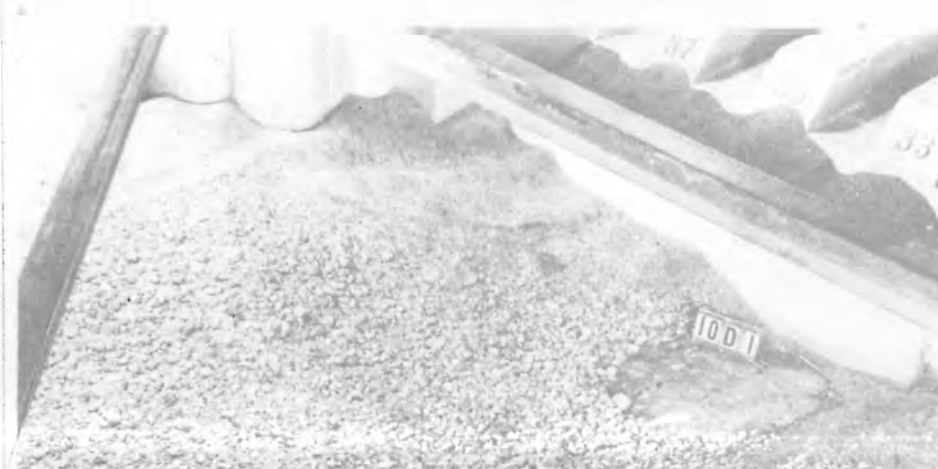
Downstream from Overflow Section  
Erosion after a Discharge of 500,000 Second-feet.

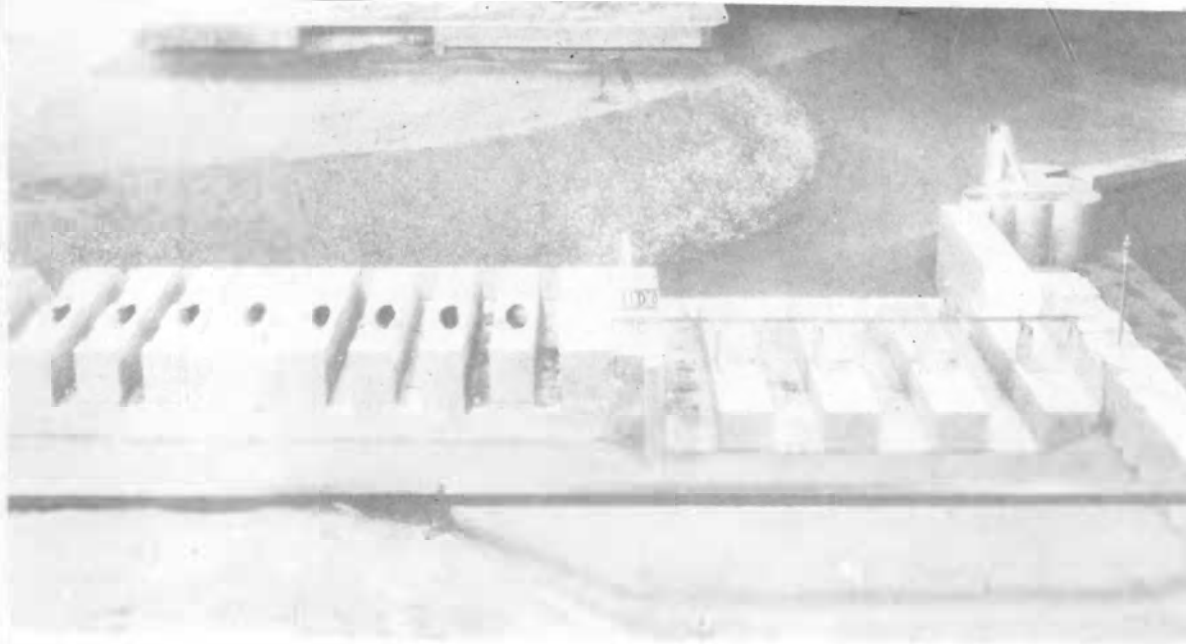
Upstream Side of Dam.

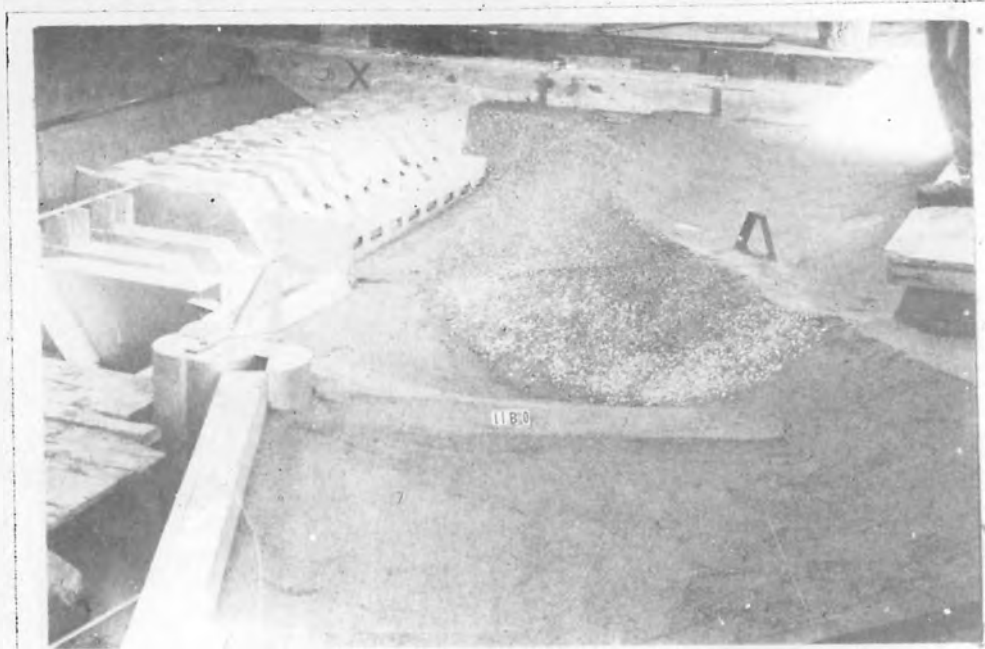
Flow through openings over blocks 13, 15, 17, 23, 25, 27, 29 and 32 to 39 inclusive. Each of these blocks level on top. Pier upstream from block 31. Streamlined trestle bents in place.

Looking Upstream from Right Bank.

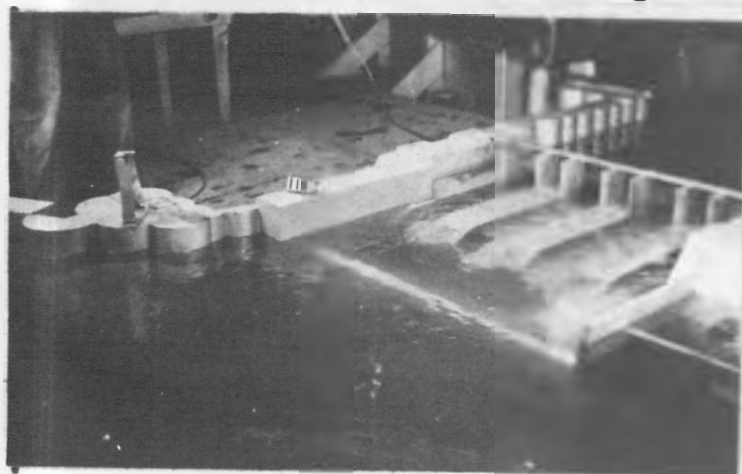
Discharge 200,000 Second-feet.

Flow Conditions during Diversion of the River  
through Left Powerhouse and Spillway Sections.

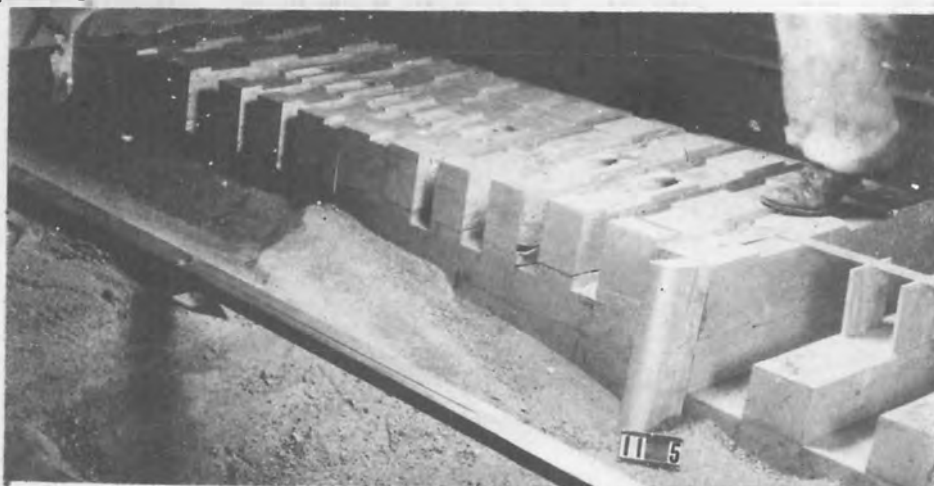
Flow through openings over blocks 13, 15, 17, 23, 25, 27, 29 and 32 to 39 inclusive. Each of these blocks level on top. Pier upstream from block 31. Streamlined trestle bents in place.

Upstream Side of Dam.

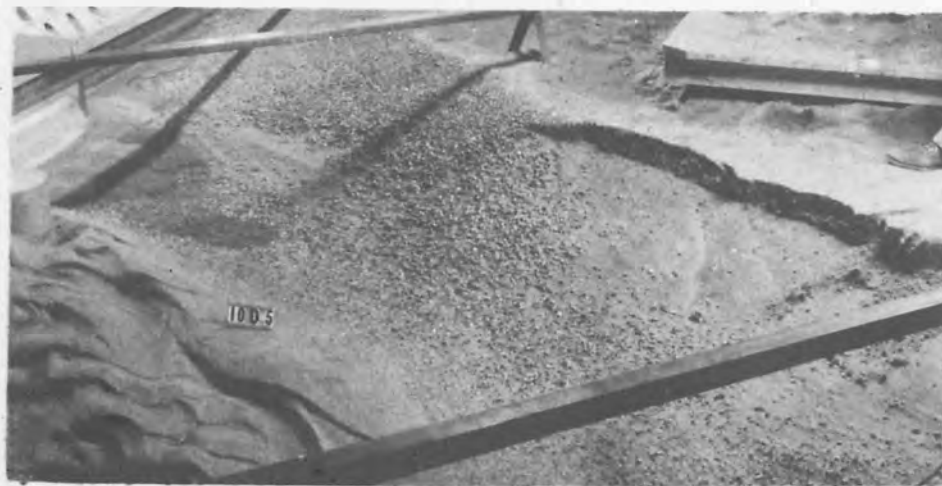
Left Bank below Riprap and River Channel below Dam.
