MORMON FLAT DAM

HYDRAULIC MODEL STUDIES
FOR THE
SPILIWAY DESIGN

HYDRAULIC MACHINERY LABORATORY
REPORT NO. HM-10

Subject: Hydraulic model studies for the redesign of the spill-way for Mormon Flat Dam, Salt River project, Arizona.

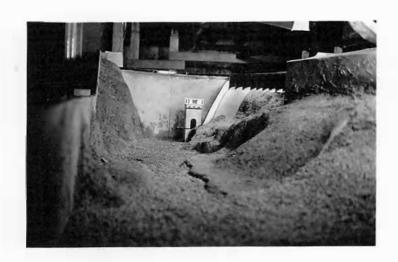
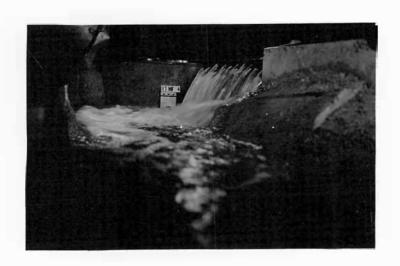
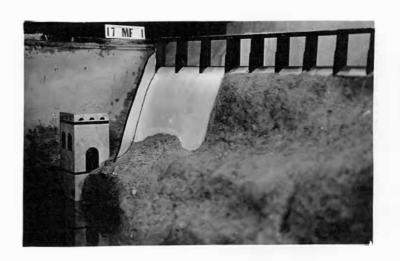
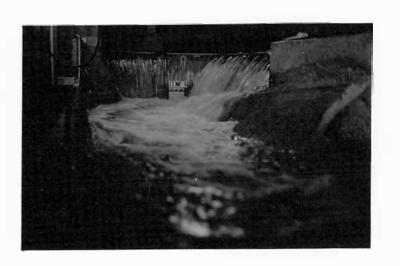
DAM AND SPILLWAY

DISCHARGE 80,000 SEC.-FT.

SPILLWAY

DISCHARGE 150,000 SEC.-FT.

- 6. Effect of various buckets and auxiliary dam. Various types and combinations of buckets were tried on the original ogee spillway to reduce the erosion and splash in the river below. None of the buckets tried was entirely satisfactory. An auxiliary dam was proposed for installation, about 1,500 feet downstream from the large dam, to control the tail water for the spillway and the powerhouse. In the tests of the buckets, it was found that the auxiliary dam was of little or no benefit in checking erosion and dissipating energy of the spillway discharge. Plate 1 shows the model of original structure before alterations were made.

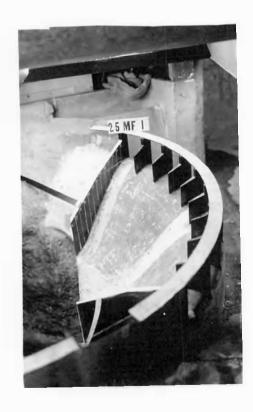
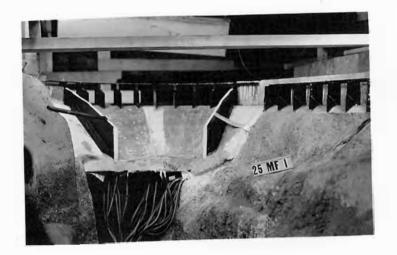
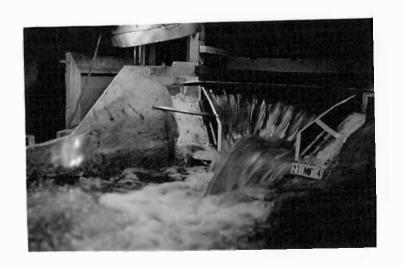
FROM LEFT SIDE

NO FLOW, LOOKING UPSTREAM

DISCHARGE 150,000 SEC,-FT.

Plate II shows the best development of the model. This is also shown in figure 2.

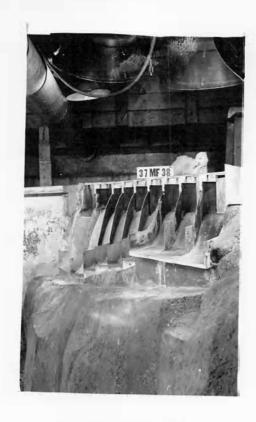
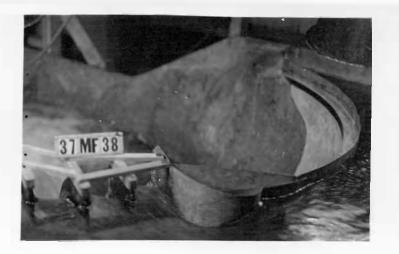
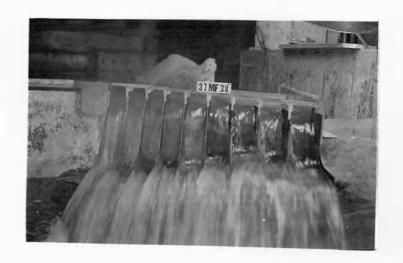
LOOKING UPSTREAM

DISCHARGE 150,000 SEC.- FT.

DISCHARGE 150,000 SEC.-FT.

The aprons and buckets conducted the flood water quite smoothly over the readway. Buckets 1 to 6 were given sufficient pitch to throw the floodwater over the readway into the tailrace. Aprons 7 to 9 were cantilevered over the readway to insure against the erosion of the read. Plate 3 shows the model in operation.

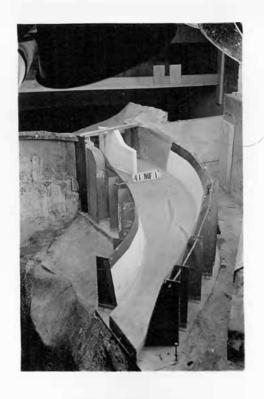
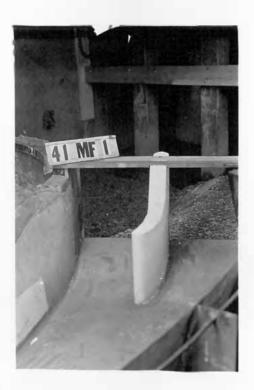
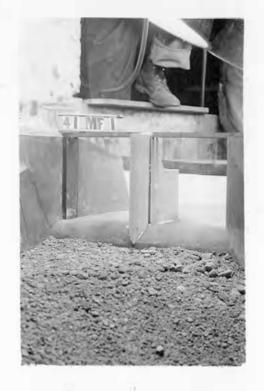
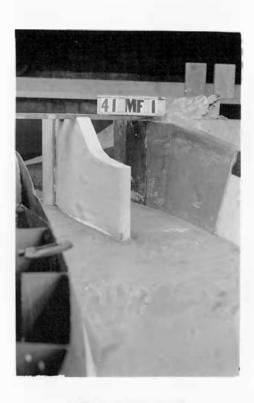
LOOKING UPSTREAM

FROM RIGHT SIDE

LOOKING DOWNSTREAM

FROM LEFT SIDE

TAPERED SPILLWAY FINAL DESIGN

All of the revisions described in the foregoing paragraphs are incorporated in the recommended design, the model drawing of which is shown in figure 6. Plates 4 and 5 show the recommended design as developed in the model. Figures 8 and 9 are the prototype plans of the final design, developed from the recommended design.

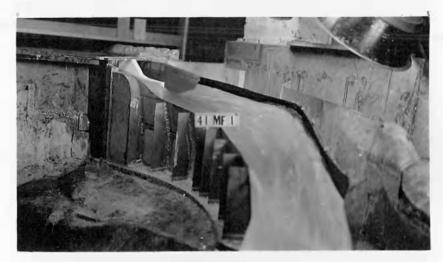
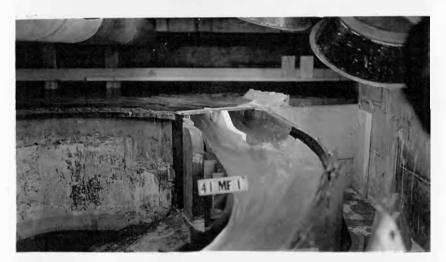
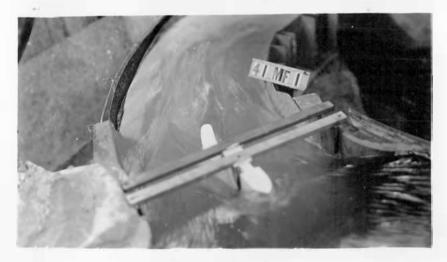
LOOKING UPSTREAM

LOOKING DOWNSTREAM

TAPERED SPILLWAY FINAL DESIGN

DISCHARGE 150,000 SEC.-FT.

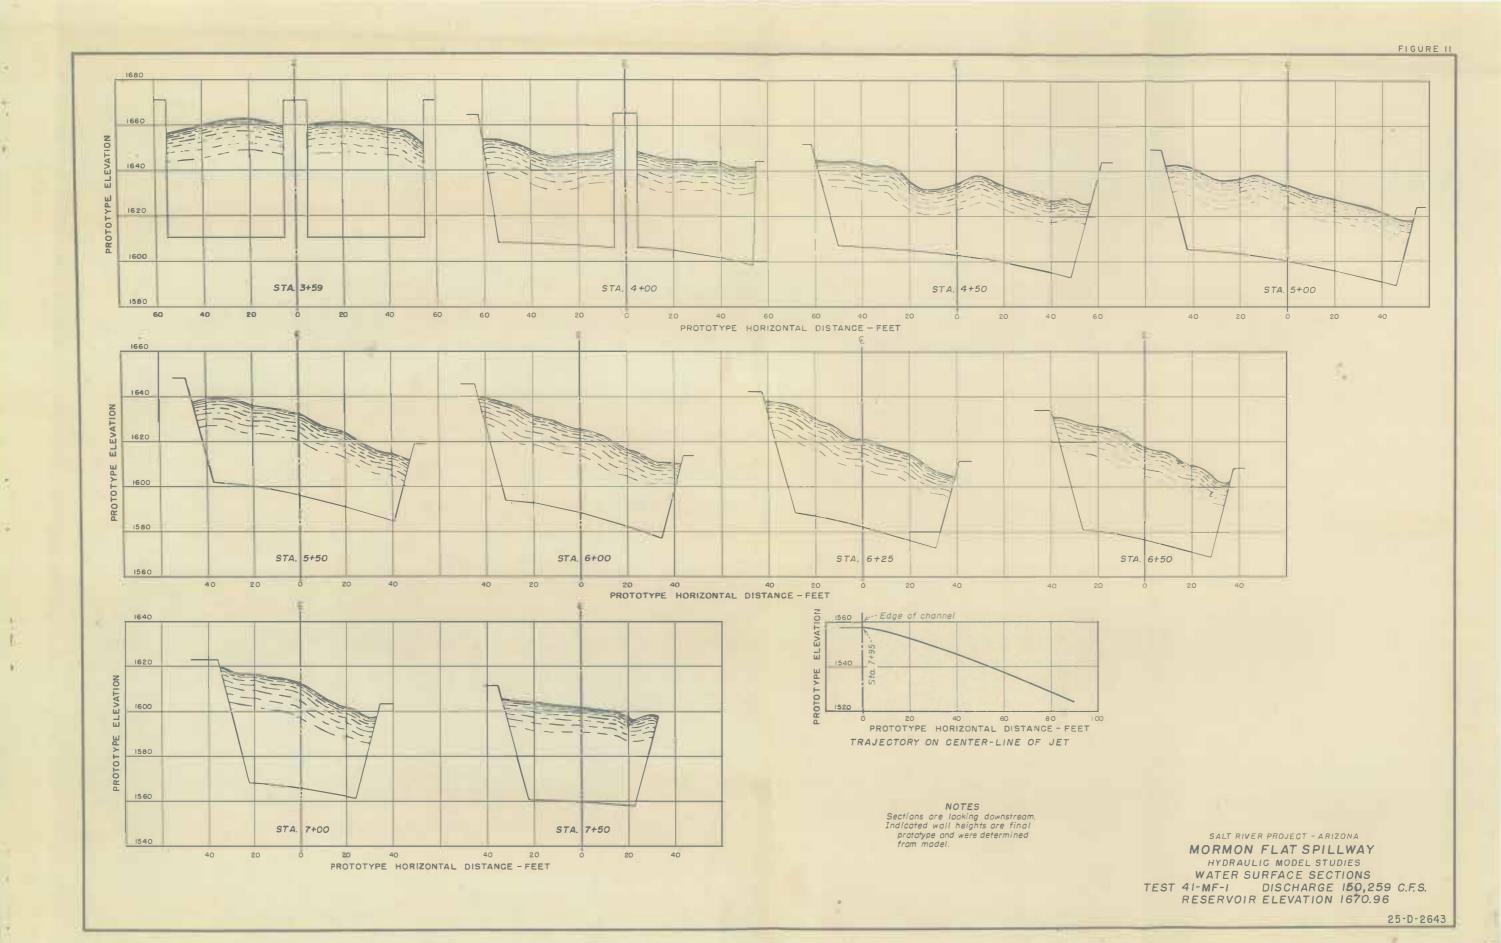
11. Water surface measurements. Water surface sections of the discharge of 150,259 cubic feet per second in the final design are shown in figure 11.
