* UNITED STATES *Warnock* *
* DEPARTMENT OF THE INTERIOR (9) *
* BUREAU OF RECLAMATION *
*
* MEMORANDUM TO CHIEF DESIGNING ENGINEER *
*
* SUBJECT: PROGRESS REPORT ON MODEL *
* STUDIES AT MONTROSE, COLORADO OF THE *
* IMPERIAL DAM AND DESILTING WORKS *
* ALL-AMERICAN CANAL *
*
* By *
* C. W. Thomas, J. E. Warnock, C. P. Vetter *
*
* Montrose, Colorado *
* July 25, 1936 *

From: Board of Consulting Engineers on the All-American Canal
To: R. F. Walter, Chief Engineer
Subject: Report on Special Features of the Discharge Structures for the Dam.

ALL-AMERICAN CANAL HEADWORKS

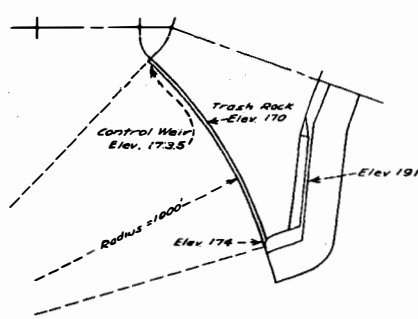
Layout Number	Drawing	Position of River	Elev. of Weir	Length of Run	Remarks on Conditions
22

Right	185.0	3 hrs.	<p>Bad flow conditions around end of dike with excessive drop in head and bad whirl. Flow through trashrack and to roller gates is at angle and not well distributed. Silt bar inside of trashrack and in front of sluiceway at approximate elevation 178. Channels below roller gates badly silted. Tendency for small channel to form around bar and approach sluiceway from left. Weir completely buried in bar. Results unsatisfactory.</p>
23

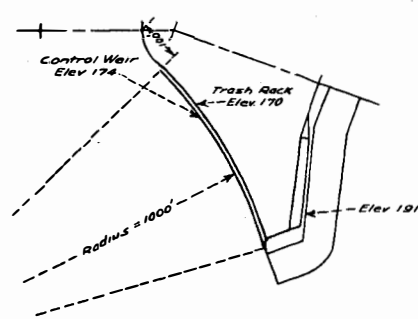
Right	184.0	6 hrs.	<p>Concentration of flow around end of dike. Flow through trashrack and entrance to roller gates not good. Inside of trashrack and channels below roller gates badly silted channel out around to left caused high head over dam. Scour bad around nose of dike. Results very unsatisfactory.</p>
24

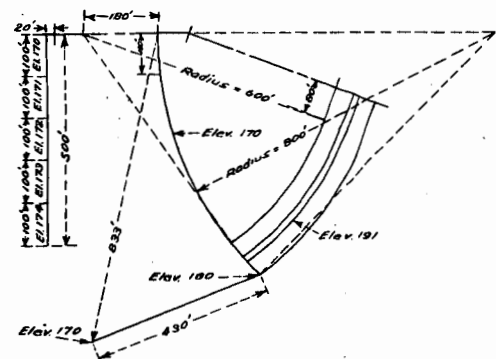
Right	181.0	7 hrs.	<p>Flow conditions good. Slow whirl inside of trashrack but not of severe proportion channel along trashrack and outside over left carry most of flow passing sluiceway. No silt inside of trashrack or in channels below roller gates. Good channel outside of trashrack. Channel around and over left weir. Considerable silt in front of sluiceway. Sluicing operation very satisfactory. General results fairly satisfactory.</p>

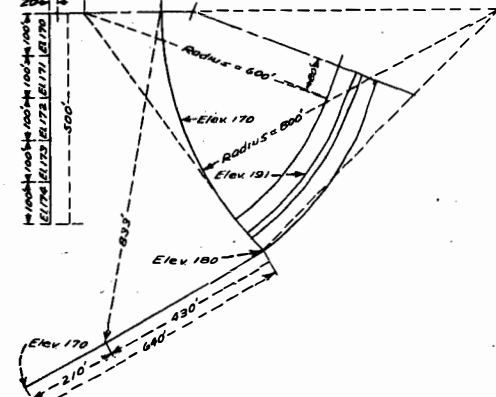
25

Right	180.0	6 hrs.	<p>Dike forced water out over right weir then around over left weir across trashrack. Water enters roller gates from directly in front considerable silt outside of trashrack in front of sluiceway and very little inside of trashrack. Left weir was not as effective as when flow was from right. Sluicing operation gave favorable results. Slots effective in sluicing. General results fairly satisfactory.</p>

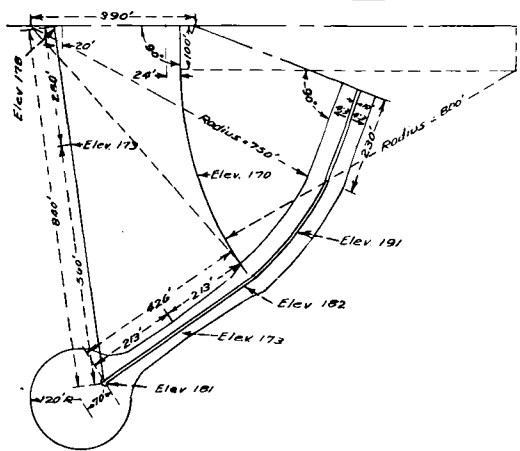
Center Left Right	179.5 161.5 182.0	6 hrs. 6 hrs. 5 1/2 hrs.	<p>1. Flow through trashrack and entrance to roller gates good. Flow divides at junction of straight weirs, approximately 1/3 of flow to right and remainder to left. Silt bar close to sluiceway. Some silt inside of trashrack. Channel along left weir from sluiceway to low point in weir. Small clear space below right weir downstream from low point.</p> <p>2. Flow through trashrack and entrance to roller gates good. Upstream end of left weir above water but remainder was very effective. Silt bar not as large as with flow from center. Some silt inside of trashrack and inside channels below roller gates.</p> <p>3. Flow through trashrack and approach to intakes good. Left weir effective for 300 feet upstream from sluiceway. Right weir effective for 200 feet upstream from nose of dike. Large silt bar in front of sluiceway and considerable silt inside of trashrack but very little in channels below roller gates. Sluicing period satisfactory for all three runs. Results generally satisfactory.</p>

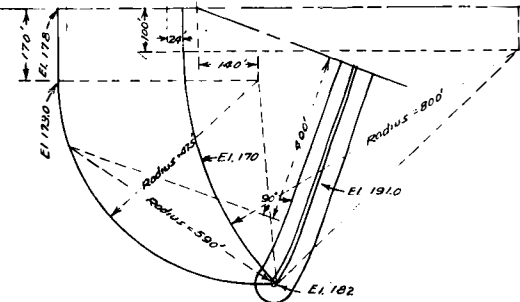
35

Right	183	6 hrs.	<p>Flow conditions thru trashrack and to roller gates fair. End of right weir next to dike effective for a distance of 320 feet from nose of dike. Flow is mostly outside of weir and approaches sluiceway over 200 feet of left weir next to dam. Large silt bar formed in front of sluiceway and considerable bar inside of trashrack. Sluicing period only partially effective. Results unsatisfactory.</p>
36

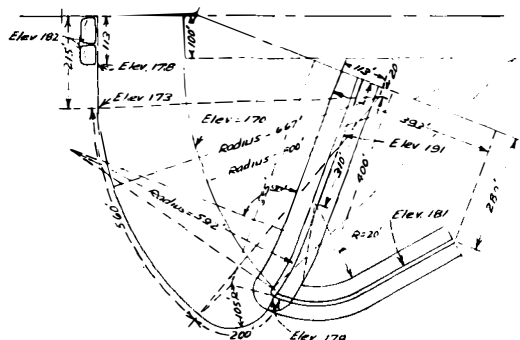
Left Right	161 161	6 hrs. 6 hrs.	<p>1. Flow through trashrack and entrance to roller gates good. Left portion of weir very effective. After the run there was no silt inside of the trashrack or in the channels below the roller gates and only a very small amount inside of the weir. No sluicing period. Results very good for this position of river.</p> <p>2. Flow through trashrack and entrance to roller gates fair. Current around nose of dike and along right portion of weir. Standing wave over right section of weir and over extreme left end. After run there was some silt inside of the trashrack and some in the inlet channels below the roller gates. A large bar formed in the channel between the trashrack and weir. If trashrack had not been so fine, probably more silt would have entered it and approached the roller gates. Results unsatisfactory for this position of river.</p>

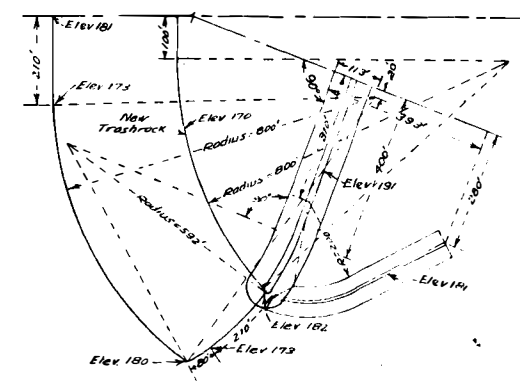
37

Right	161	6 hrs.	<p>Flow through trashrack and entrance to roller gates fair. Weir action satisfactory. Large silt bar deposited outside of trashrack but did not extend thru trashrack. The finer trashrack installed for this test became partially choked and probably obstructed the advance of the silt bar. Sluicing period only partially effective. Results not entirely satisfactory.</p>

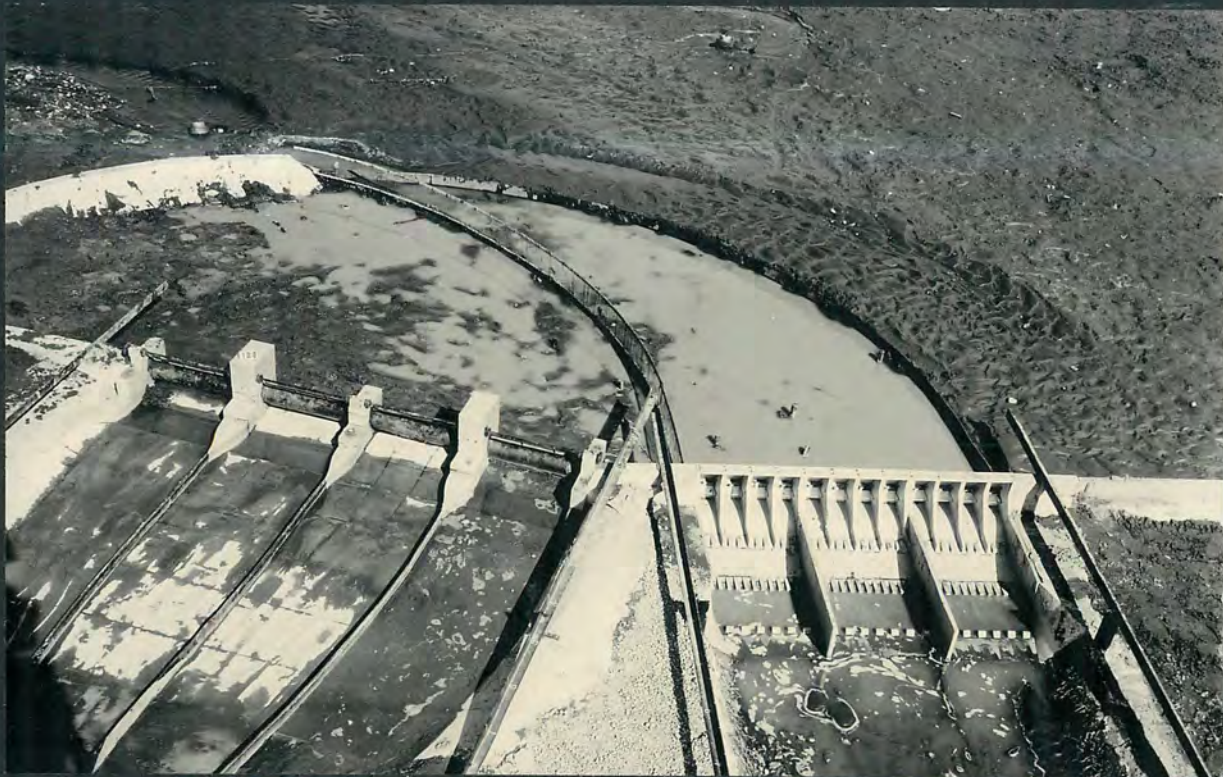
Layout No. 1 - Trashrack in position B

11. It soon became evident that some sort of skinning weir was essential for obtaining the desired distribution of flow to the trashrack, and efforts were therefore concentrated on determining the most efficient shape and elevation of the weir in relation to the trashrack. Altogether 38 layouts were tested, several with the flow approaching from different directions. 25 of these layouts are listed with comments in the attached table. Prints of layouts 25 to 35 inclusive are shown on attached prints. For all layouts up to and including Number 35, and also number 37, three units of the sluiceway (12 gates) were utilized for the disposal of surplus flow. For layouts 36 and 38 only two units (8 gates) were utilized and somewhat better flow conditions and silt control were obtained in this manner. In all cases better results were obtained when the flow approached from the left than when it approached from the right. Photographs of the following typical layouts are attached hereto, Numbers 1, 2, 6, 12, 19, 22 and 30

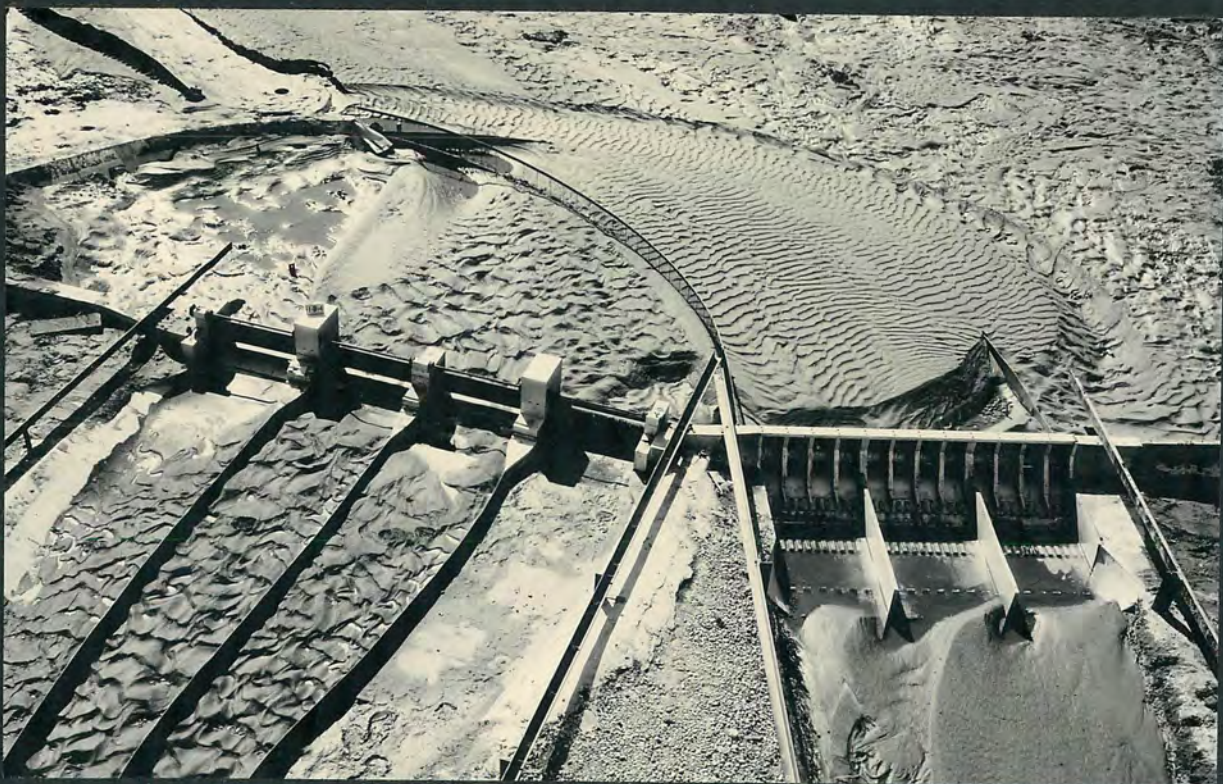
Layout No. 1 - Trashrack in position B - Silt
deposit after 6-hour run with river from right
Intake $Q = 10,000$ Sluiceway $Q = 14,000$

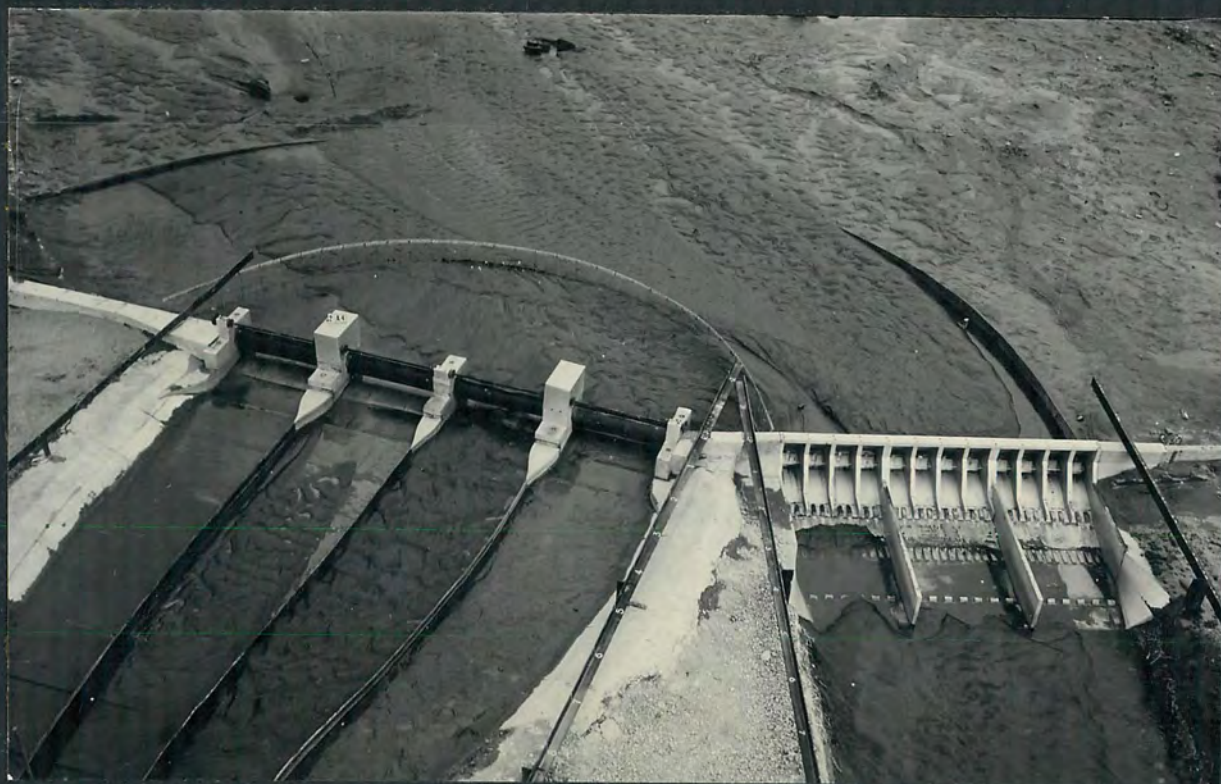
Layout No. 2 - Trashrack in position A - Silt
deposit after 6-hour run with river from right -
Intake Q - 10,000 Sluiceway Q - 14,000

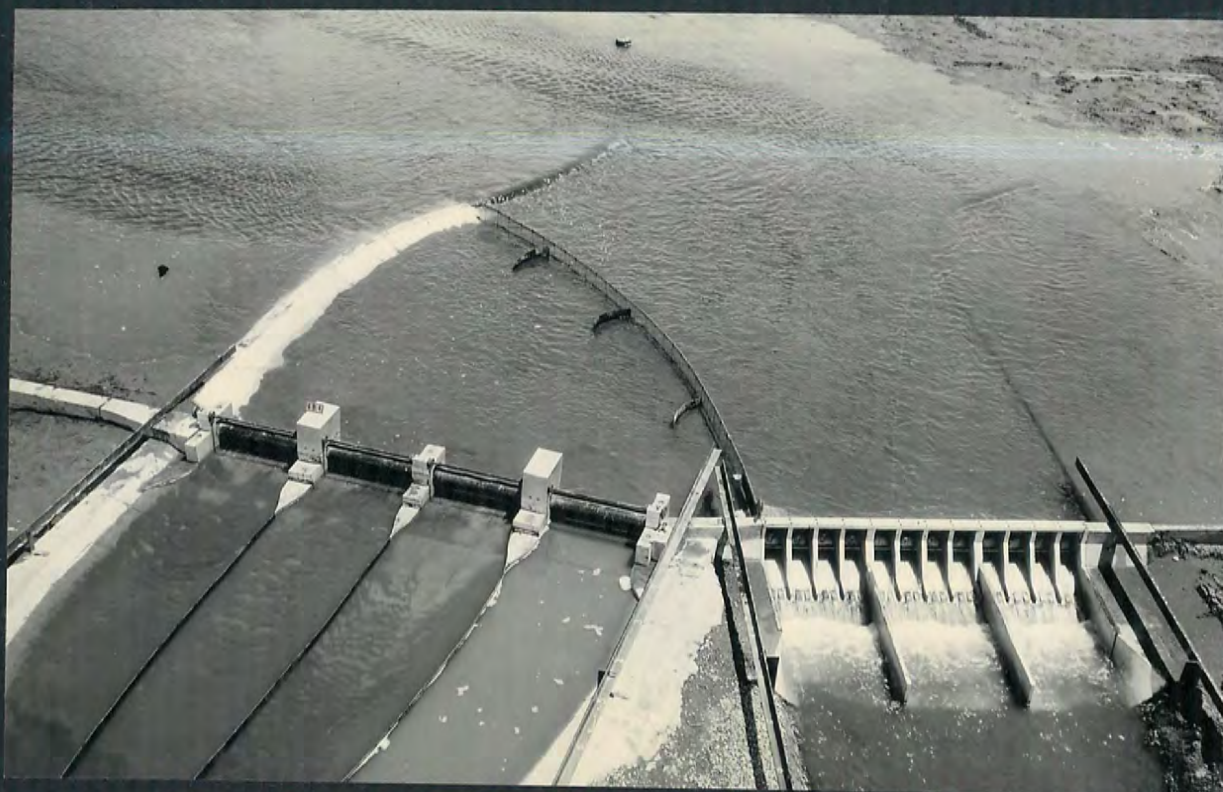
Layout No. 6 - Flow conditions with river from right -
Intake $Q = 10,000$ Sluiceway $Q = 1,000$

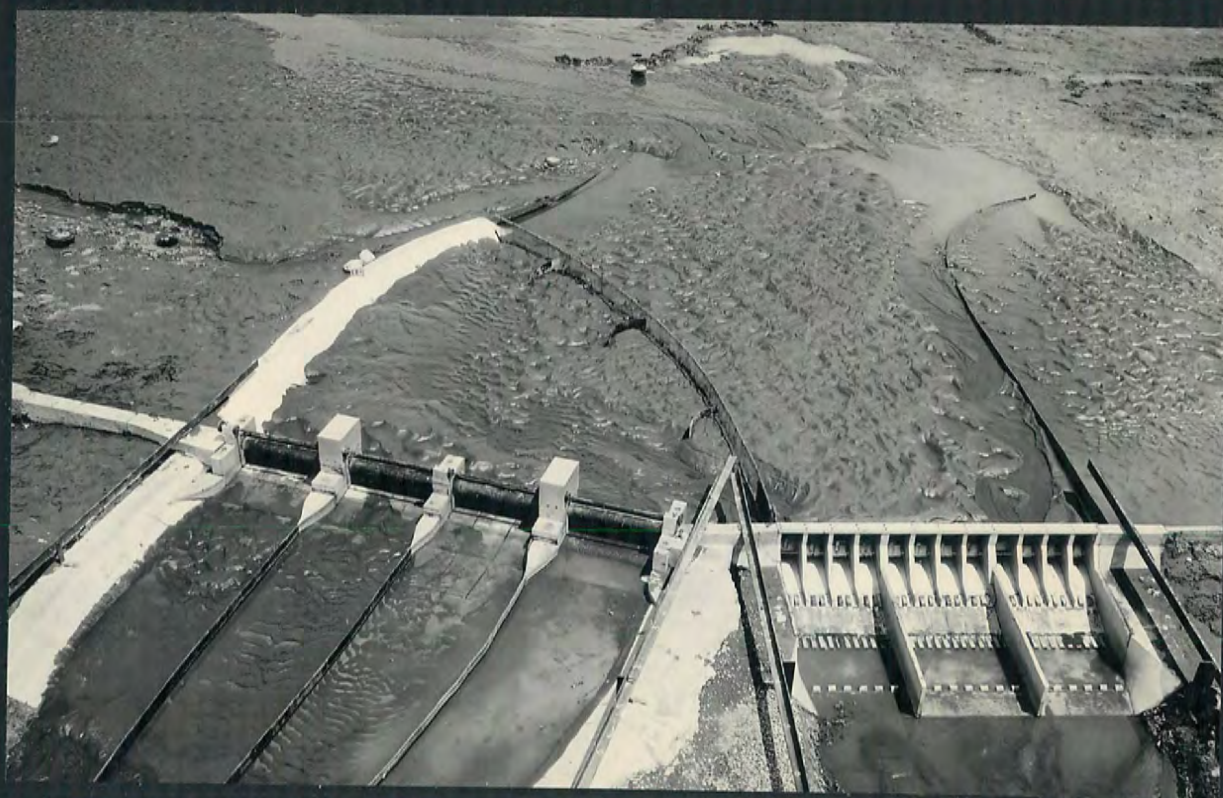
Layout No. 7 - Silt deposit after $1\frac{1}{2}$ -hour run with river from right
Intake $Q = 10,000$ Sluiceway $Q = 14,000$

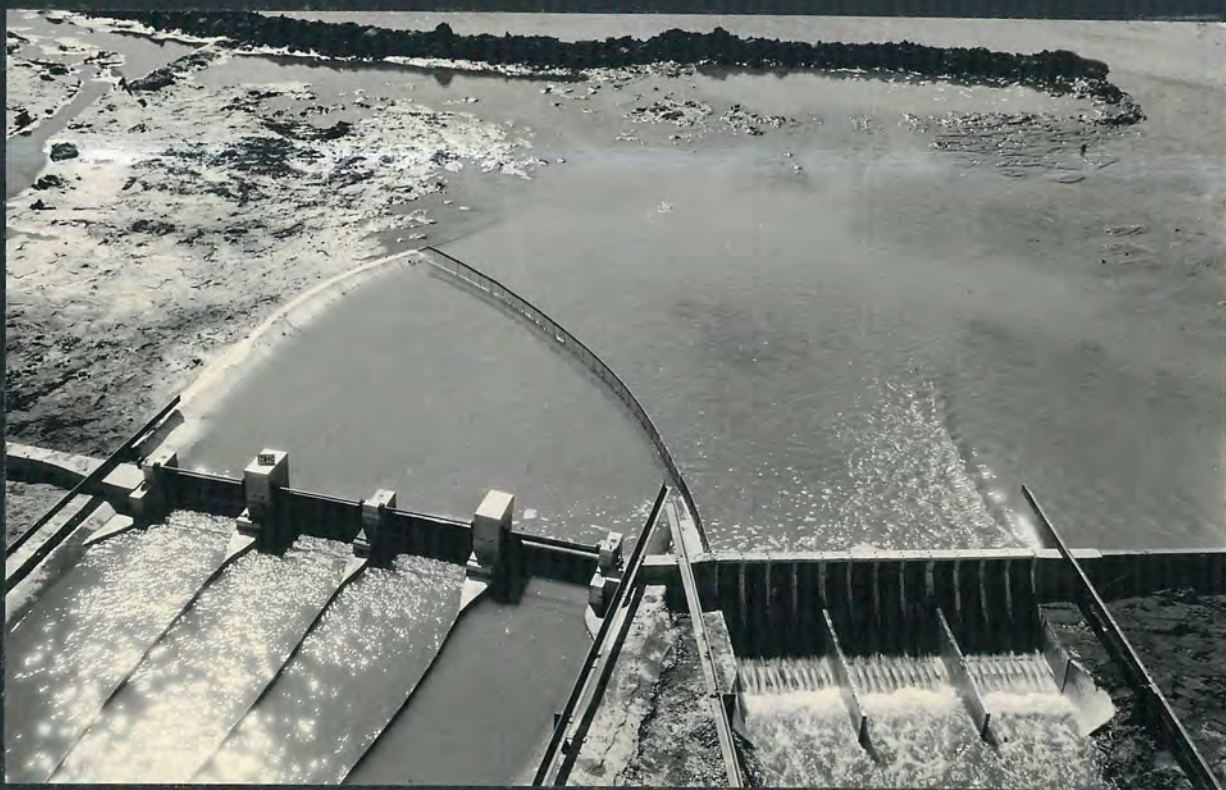
Layout No. 12 - Flow conditions with river from left
Intake $Q = 10,000$ Sluiceway $Q = 14,000$

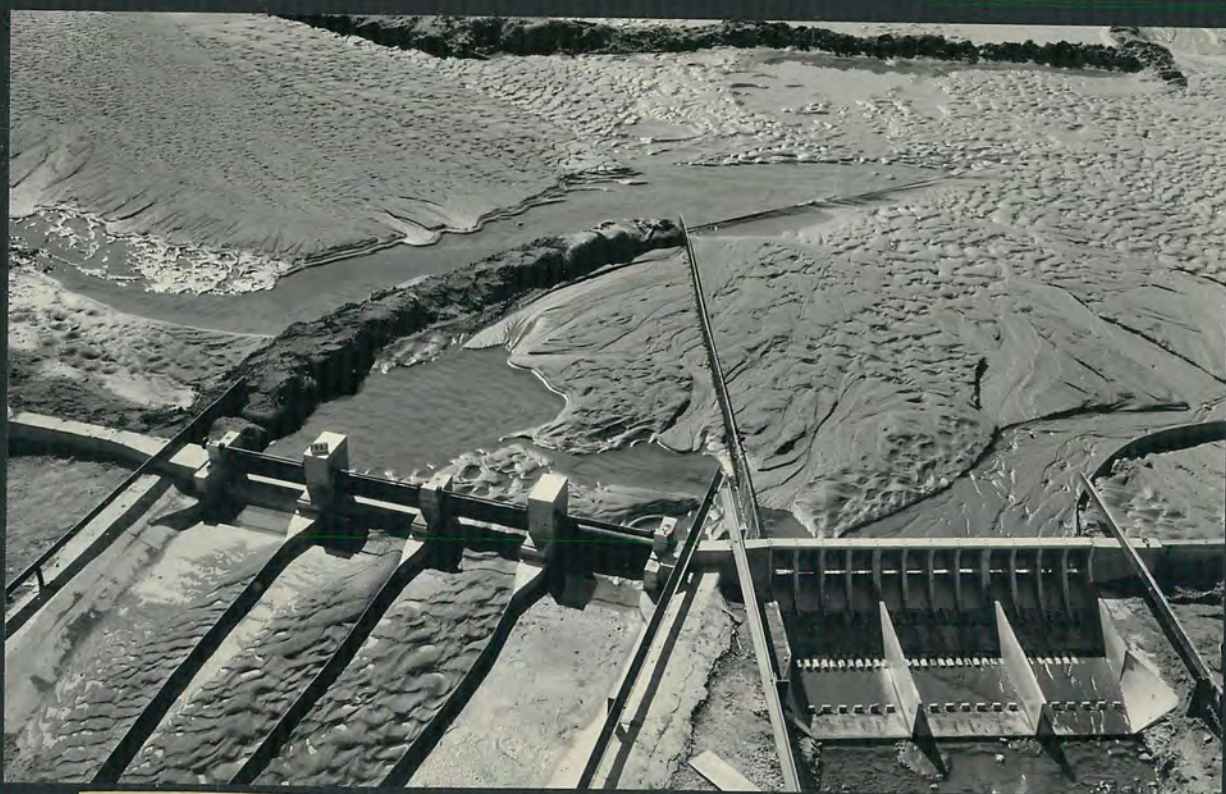
Layout No. 19 - Silt deposit after 6-hour run with river from right
 Intake $Q - 10,000$ Sluiceway $Q - 14,000$

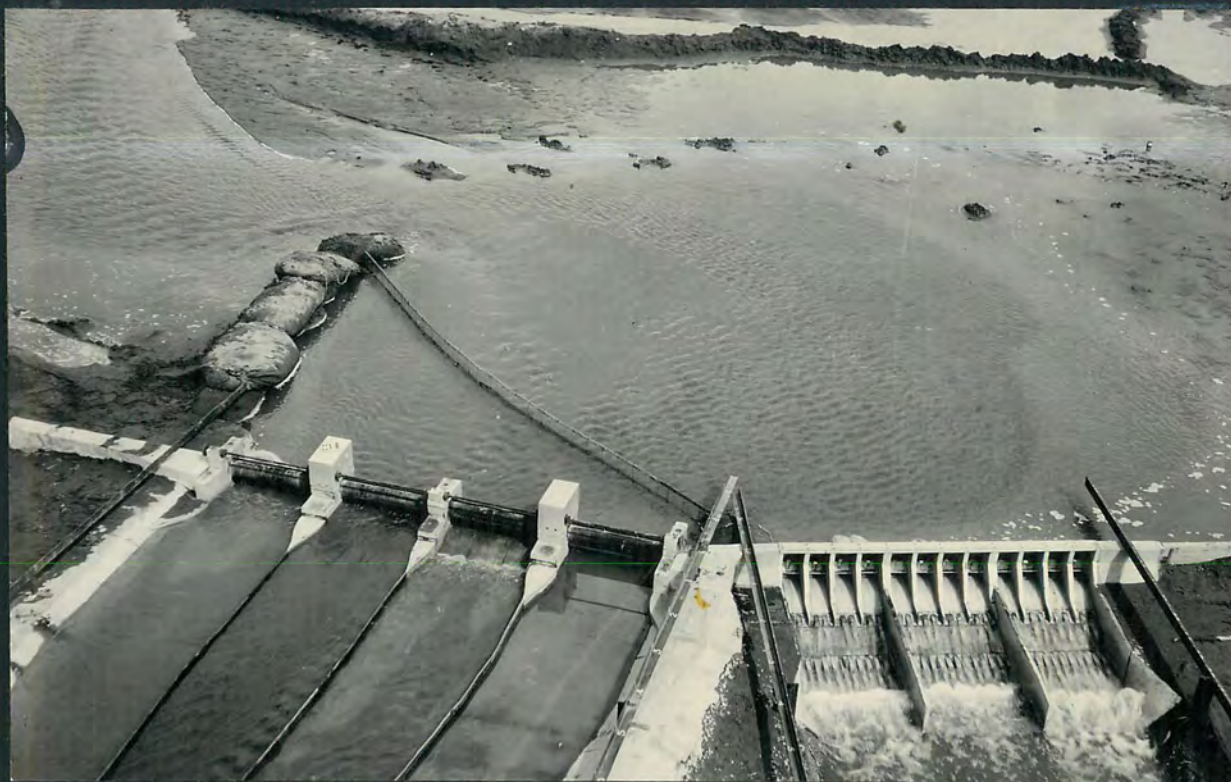
Layout No. 22 - Flow conditions with river from right
Intake $Q = 10,000$ Sluiceway $Q = 14,000$

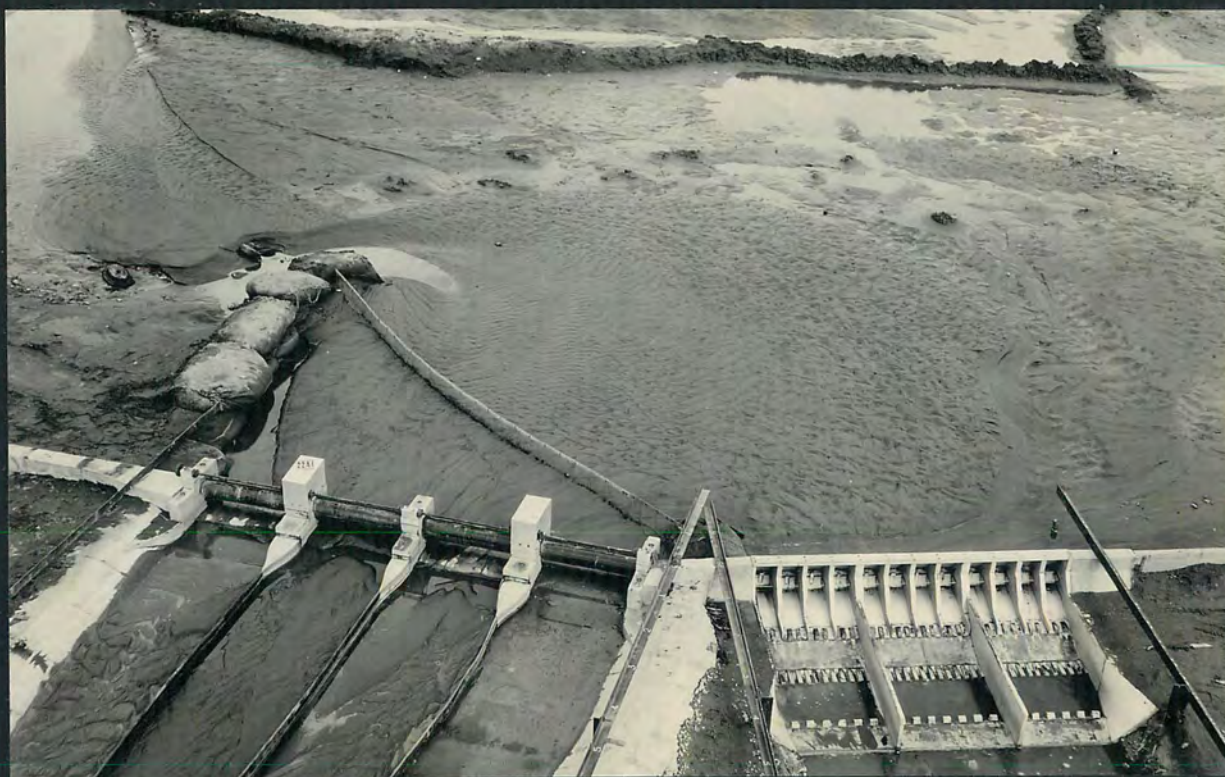
Layout No. 22 - Silt deposit after 3-hour run with river from right
Intake $Q = 10,000$ Sluiceway $Q = 14,000$

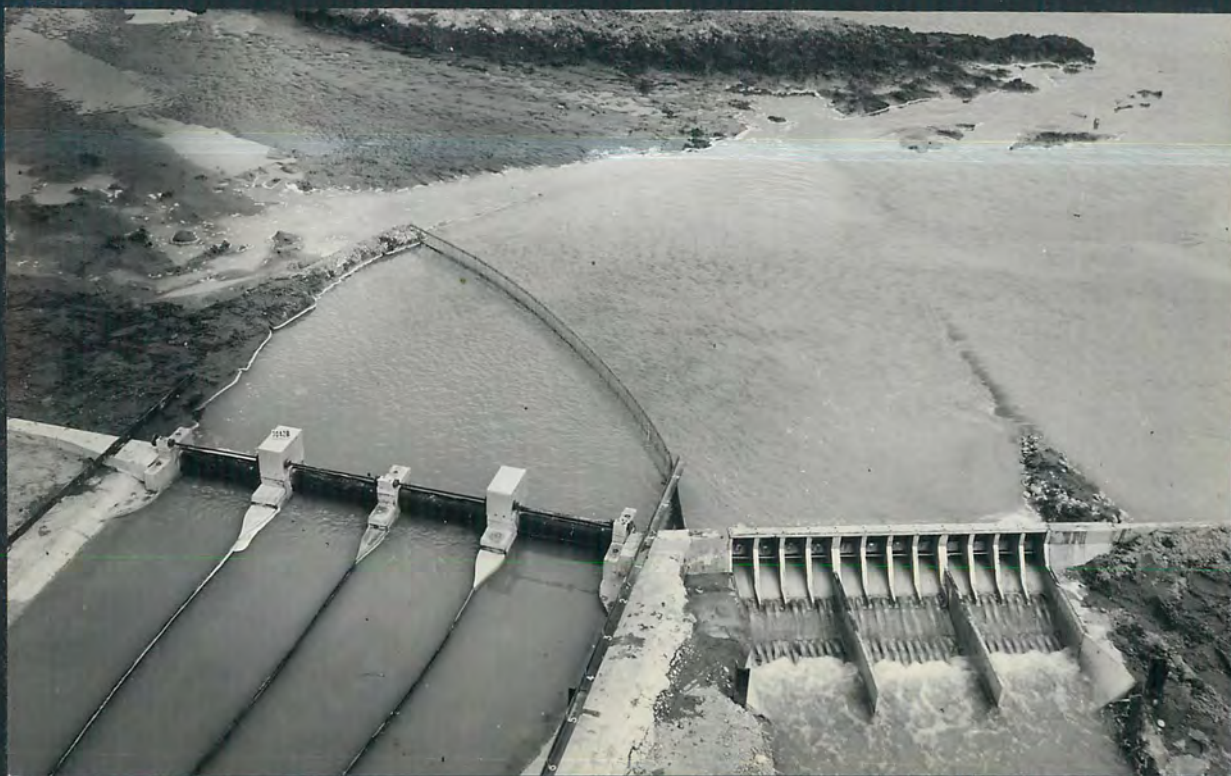
Layout No. 30 - Flow conditions with river from left
Intake $Q = 10,000$ Sluiceway $Q = 14,000$
