COMMON ERRORS IN MEASUREMENT OF
IRRIGATION WATER

Charles W. Thomas, Hydraulic Engineer
Bureau of Reclamation
United States Department of the Interior
Denver, Colorado

This paper was presented in part
to the Irrigation and Drainage
Conference, Irrigation and
Drainage Division, ASCE, Denver,
Colorado, September 8-10, 1955

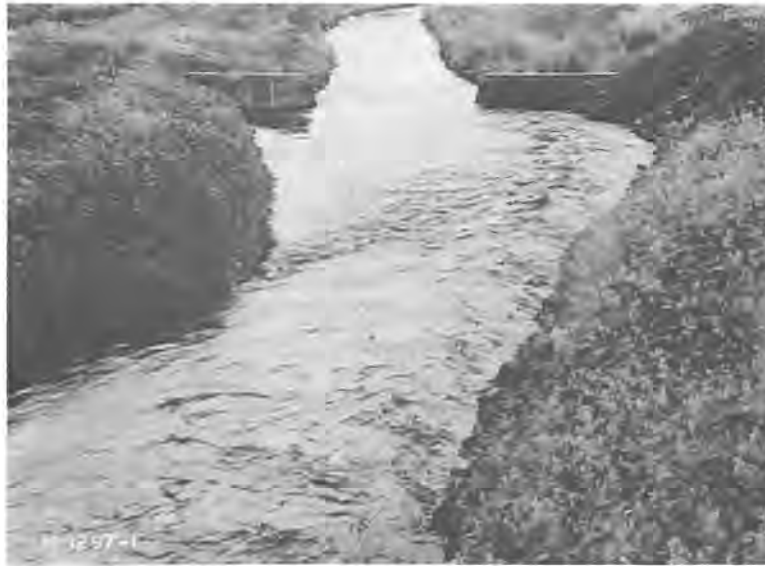
Numerous instances have been noted in the field where weirs have been placed in channels having relatively high gradients. It is very difficult to hold a properly proportioned weir pool under these conditions

and obtain smooth flow through the weir notch. Obviously, the increased velocity of approach and turbulence will cause errors in measurement. Channel curvature and consequently poor velocity distribution over the weir crest will also cause excessive errors which are not easily evaluated. Laboratory experiments have shown that the extreme difference in discharge over a weir for a

constant head, but with the upstream velocity distribution varied, amounted to 26 percent. A weir with very poor approach conditions is shown in the photograph above.

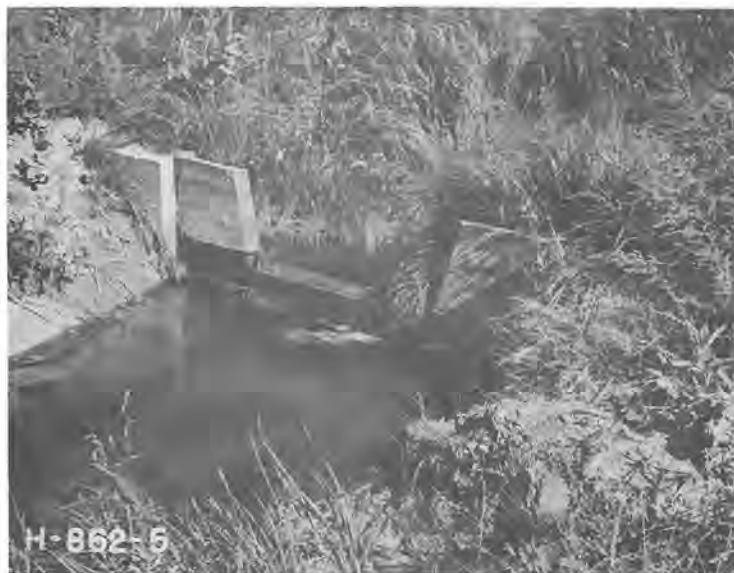
Obstructions in the measuring section cause errors proportionate to the magnitude of such an obstruction. In irrigation systems float-

ing detritus, weeds, moss, etc., may obstruct the water passage, as shown in the photograph at left. Frequent and close inspection accompanied by remedial measures will relieve this condition.

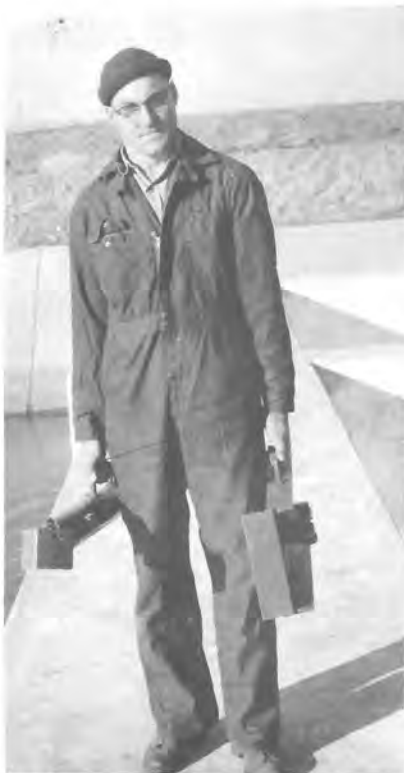
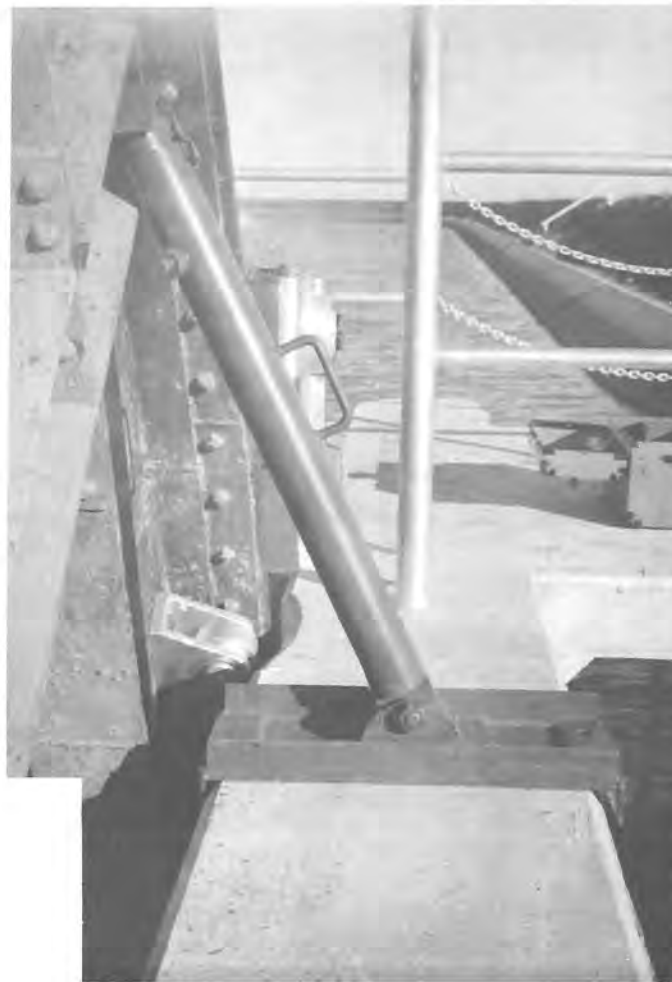
In addition to the photographs of the jack above, a sketch of the parts is shown on the following page. Two jacks are used, one on each side of the gate, during the cable replacement.

In changing the hoist cables of the radial check gates on the Delta-Mendota Canal of the Central Valley Project, it is necessary to secure the gate in an open position while the old cables are removed, and the new ones installed. Since the cables must be changed when there is water in the canal, this can be a slow and also hazardous undertaking using the previous method of putting a sling and chains around the operating deck to support the gate. A special jack built by Robert H. Vouch, Tracy Operations Field Branch, is light, and makes it possible to do the work required in a much easier, safer, and less costly manner.

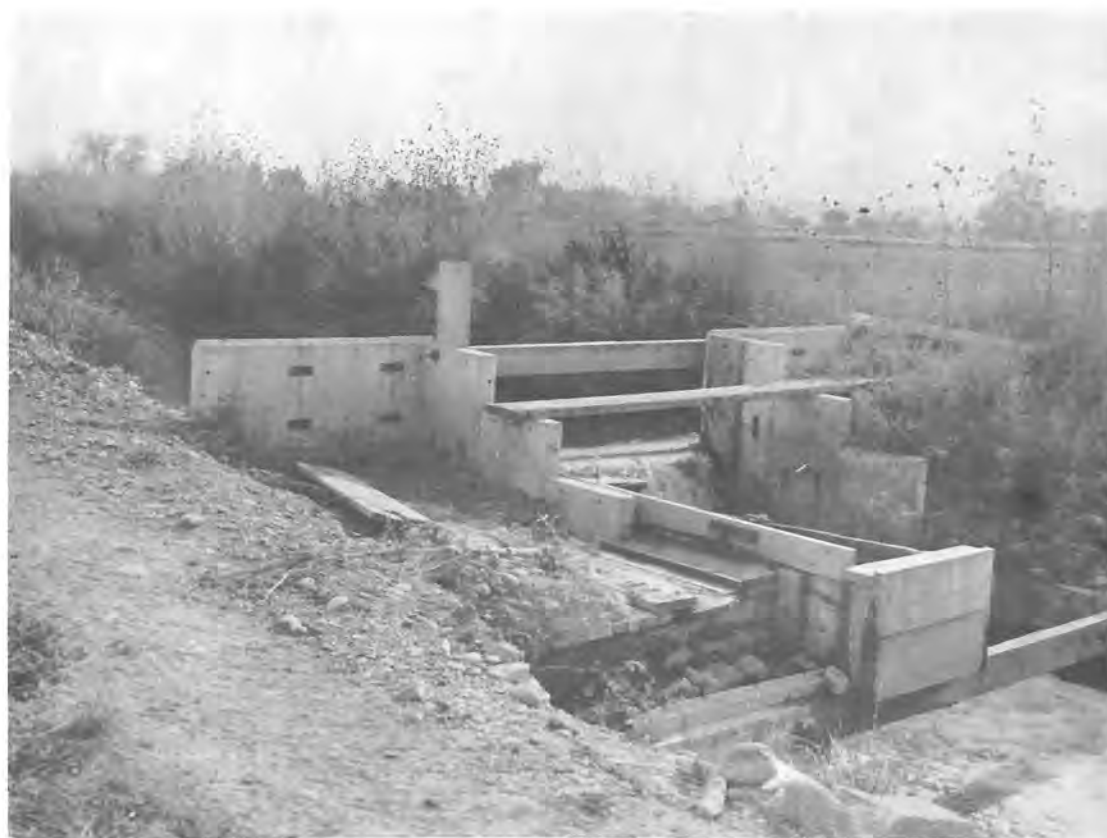
One of the major problems on operating projects in many areas is the inability to perform the concrete work for minor water control structures during the frost free period of the year. The use of precast concrete blocks to build minor structures, instead of placing concrete on the job, affords many conveniences, as well as a saving in construction costs, especially when the jobs are located in a remote area. The Uncompahgre Project in western Colorado has utilized precast concrete blocks in the replacement of minor structures since 1954. Typical of a drop structure constructed with the blocks is that shown below.

The first structure using precast concrete blocks was constructed in 1954; since that time an additional 25 structures have been completed. Jesse R. Thompson, now retired, former Manager of the Project for the Uncompahgre Water Users' Association, Montrose, Colorado, designed a set of forms to precast 2' x 2' x 4" and 1' x 2' x 4" concrete blocks to be used in the construction of drops, chutes, headwalls, and other minor water control structures. A drop of 6 feet, in a 4-foot wide channel with the structure 10 feet long can be placed with the

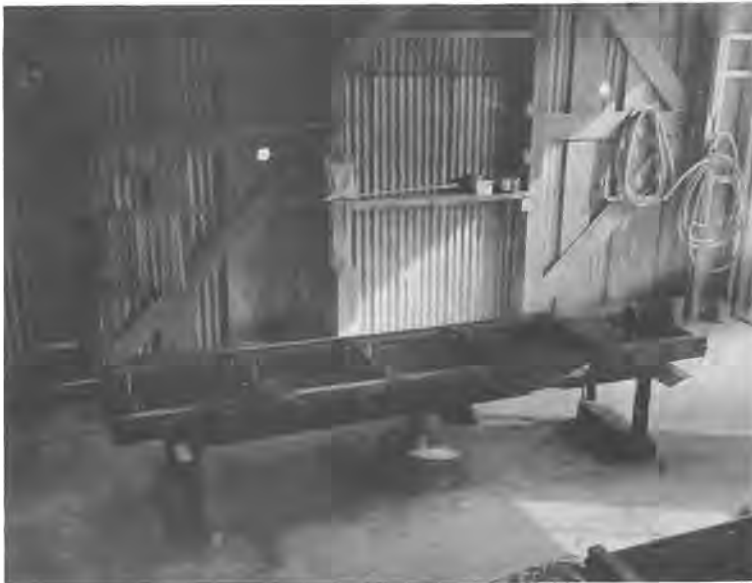
Only two men are required to fabricate and stockpile the prefabricated blocks. The forms are bolted to permanent trestles at about average waist height, as shown in the photograph below, for convenience in assembling the forms, troweling the concrete, and moving the finished blocks from the forms to the stockpile.

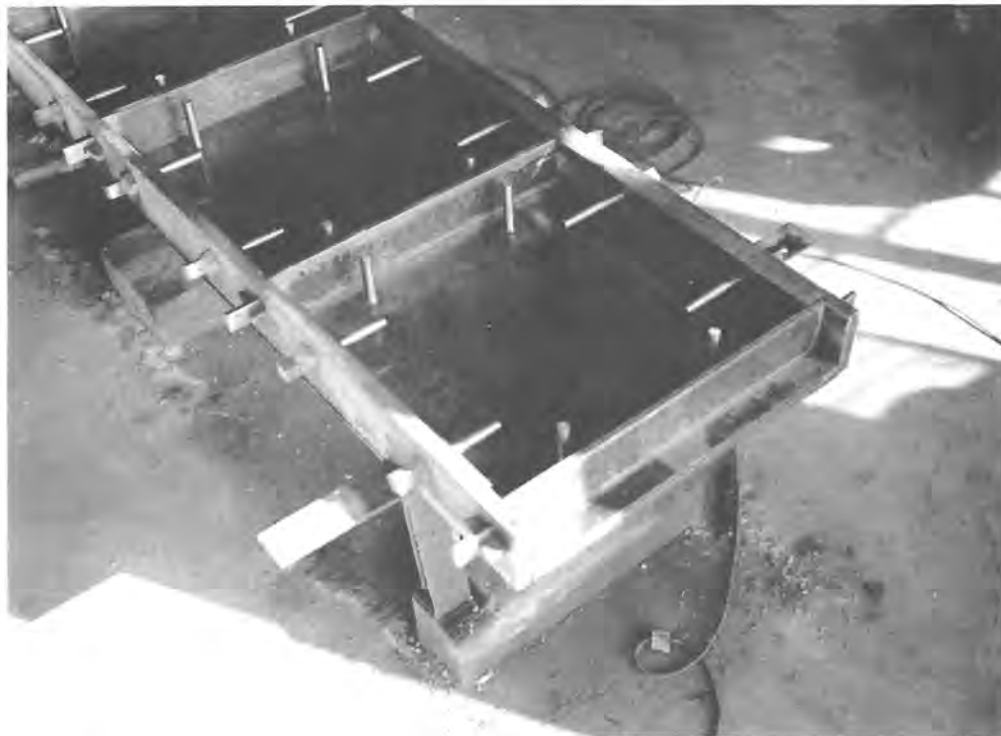
A close-up view of one of the forms is shown below. A bar bending machine, set up in the building, is used to bend the reinforcing bars, and to make U-bolts as needed.

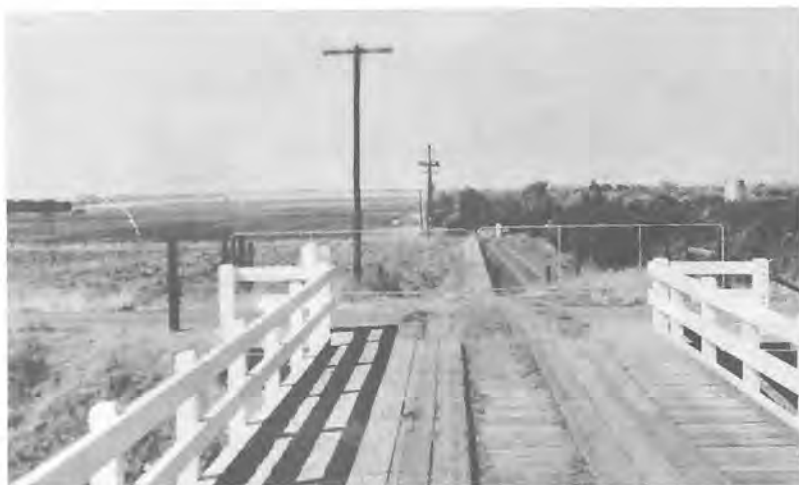
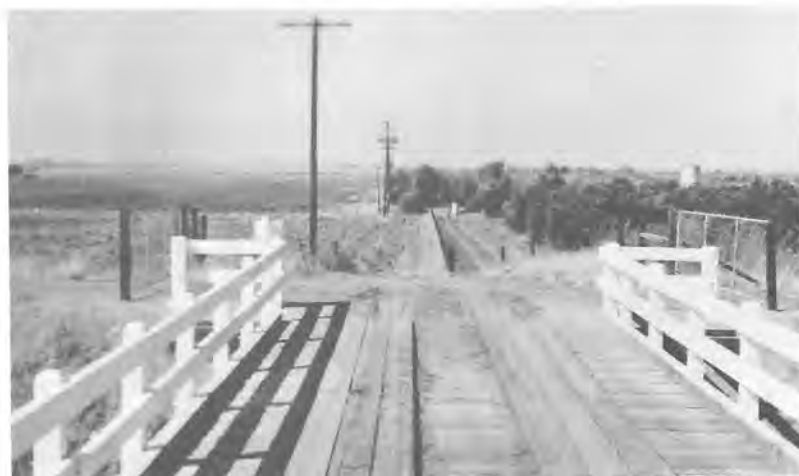
Where a bridge is used for transferring cattle across the Friant-Kern Canal, Central Valley Project, California, use is being made of 16-foot metal farm gates instead of constructing or replacing cattleguards. The gates serve a dual purpose. The large double gates shown in the first photograph below can be opened and swung into position shown in

the lower photograph to close off the canal roadway leaving an open runway for the cattle to cross the canal bridge.

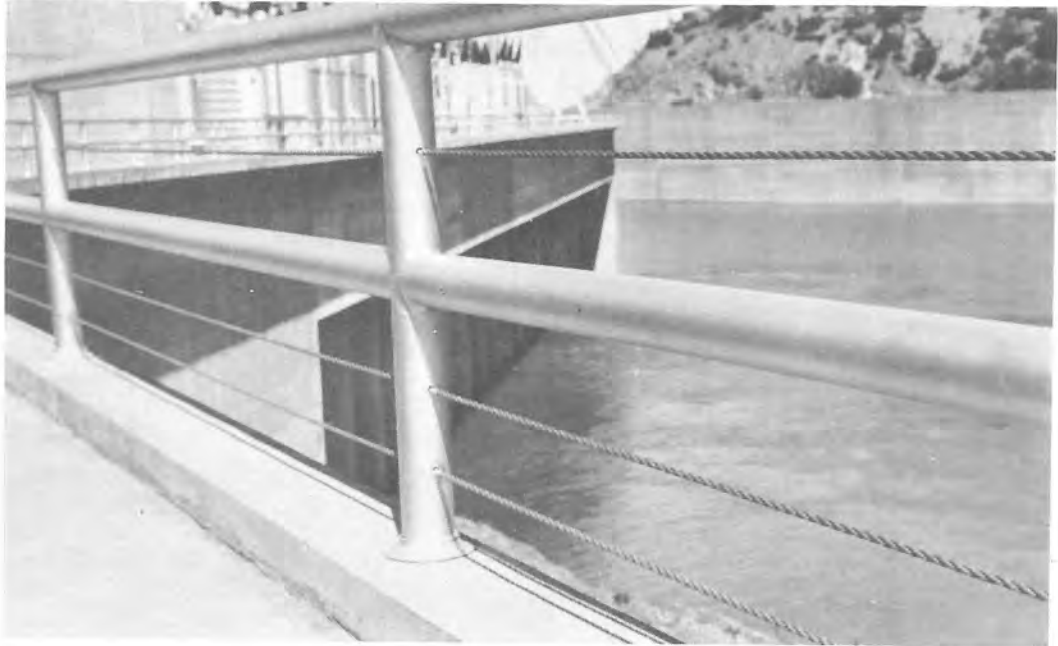
Galvanized cables have been added to the guardrails in the vicinity of the Shasta Power Plant, Central Valley Project, California, as shown below, to provide additional protection to visitors, particularly small children. The additional protection afforded by the cables is quickly and easily obtained where guardrail posts of the type shown are in existence.
