A PAPER PRESENTED
AT
THE ASCE-PORTLAND CONVENTION
PORTLAND, OREGON
JUNE 23-27, 1958

**LABORATORY STUDY TO DETERMINE
COVER BLANKET FOR KENNEWICK
MAIN CANAL, WASHINGTON**

by
Enos J. Carlson
Supervising Hydraulic Engineer

Division of Engineering Laboratories
Bureau of Reclamation
Denver, Colorado

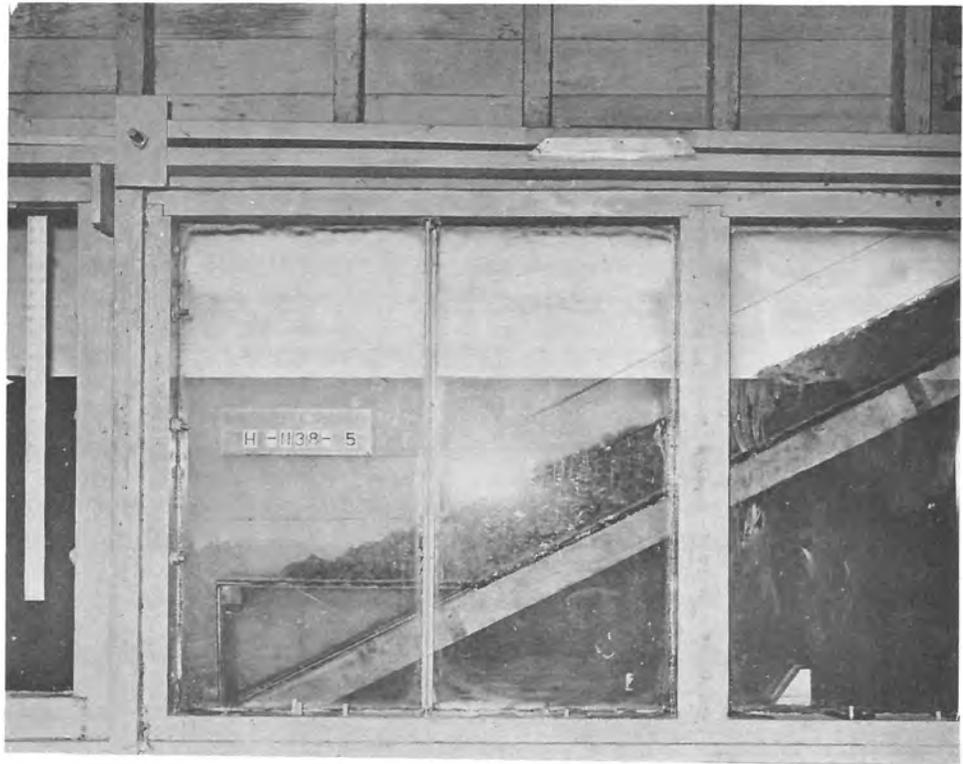
(a) Model prepared for Test 1

Yakima Project - Washington
KENNEWICK MAIN CANAL
TEST 1 (GRAVEL MOISTENED AND WELL MIXED)
Model study

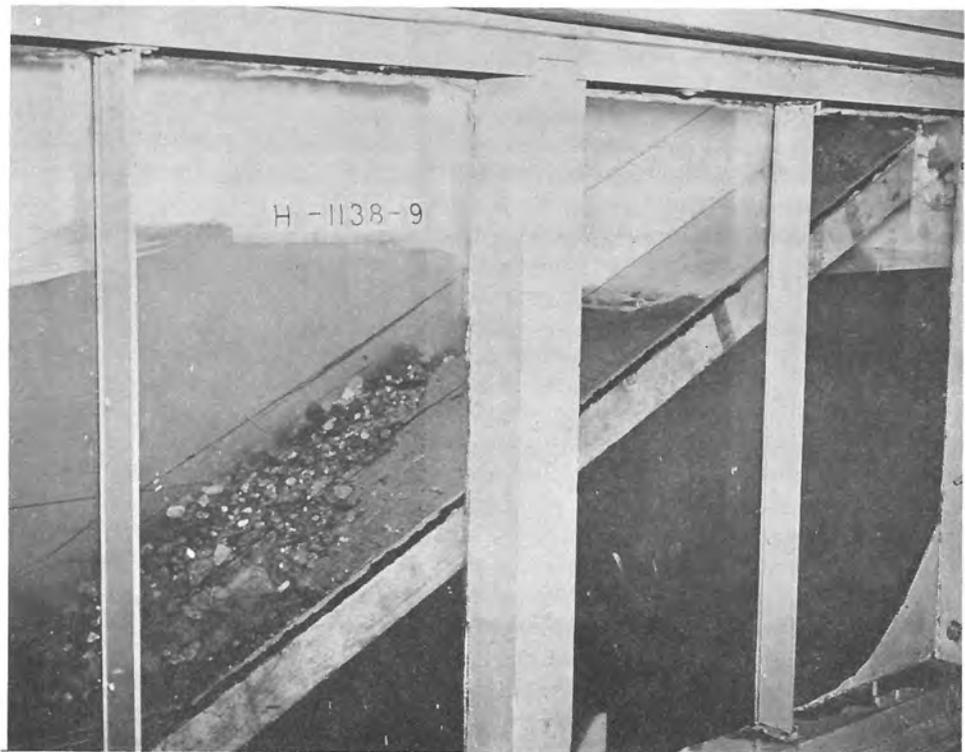
(b) Slope failure after 45 minutes of operation at 32 waves per minute - wave height 0.32 ft.

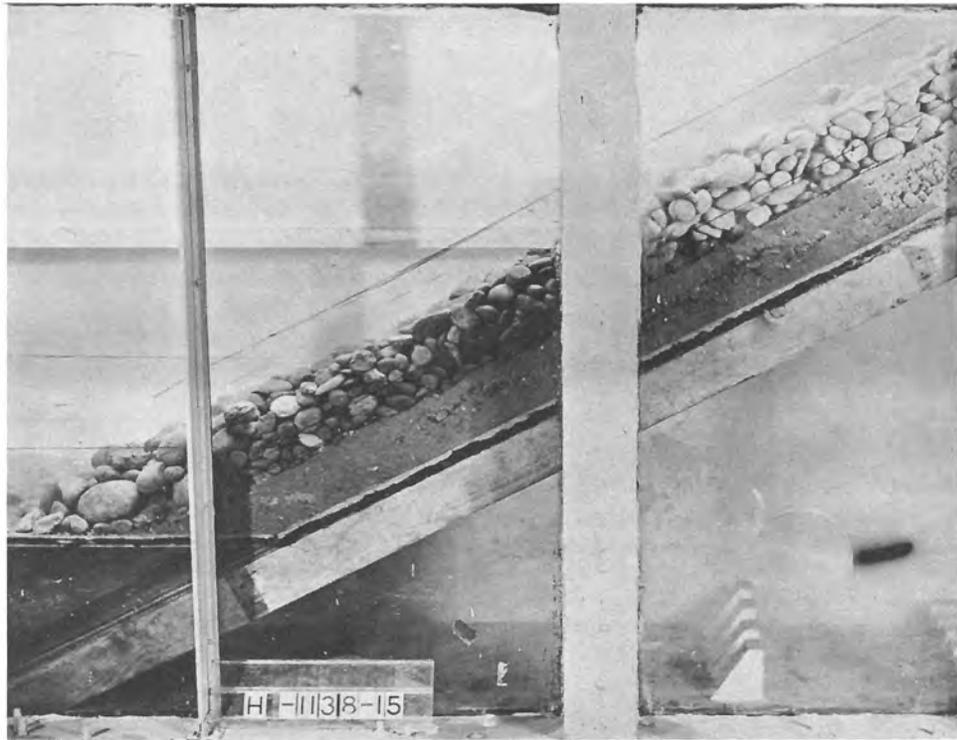
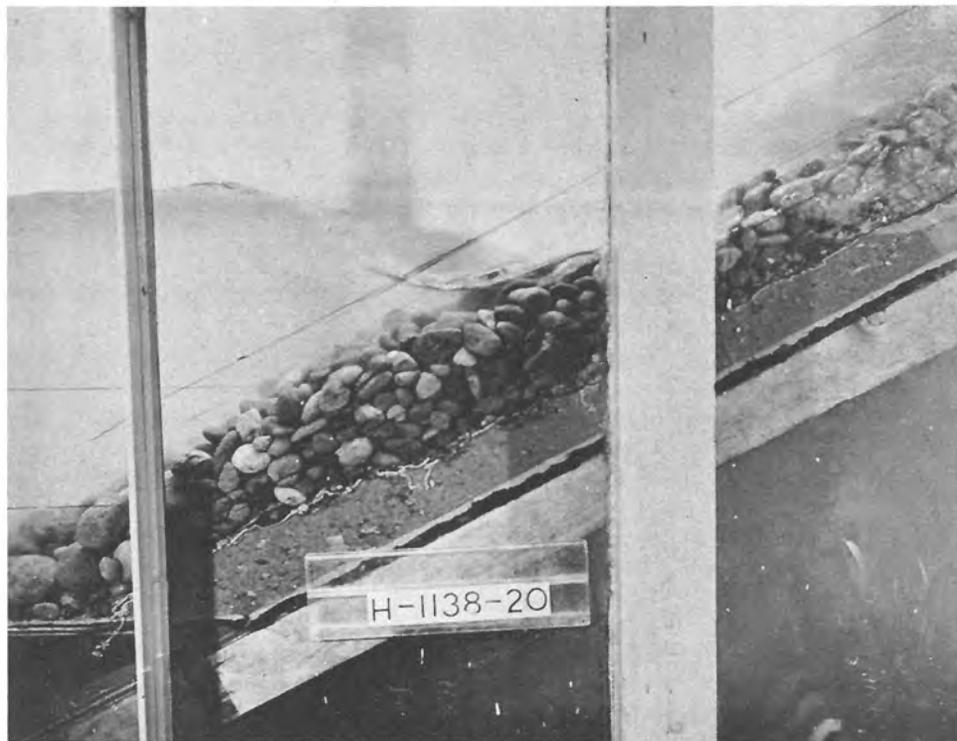
Figure 10

(a) Ready for operation

(b) After 23 hours of operation at 42 waves per minute--wave height 0.43 ft.

Yakima Project - Washington
KENNEWICK MAIN CANAL
TEST 2 (GRAVEL SEPARATED ON 3/4-INCH SCREEN)
Model study

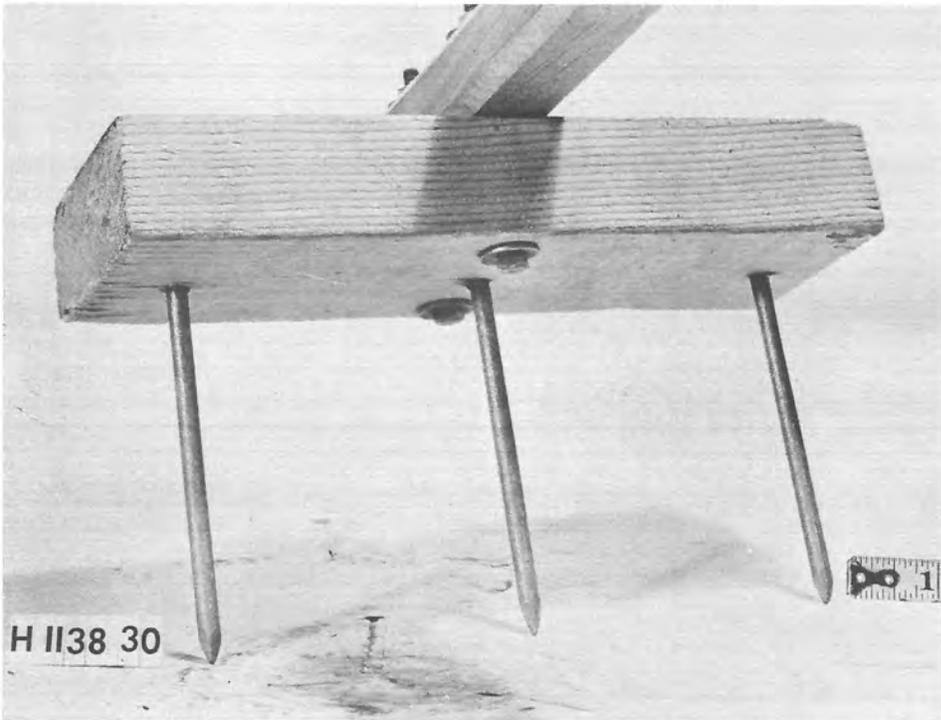
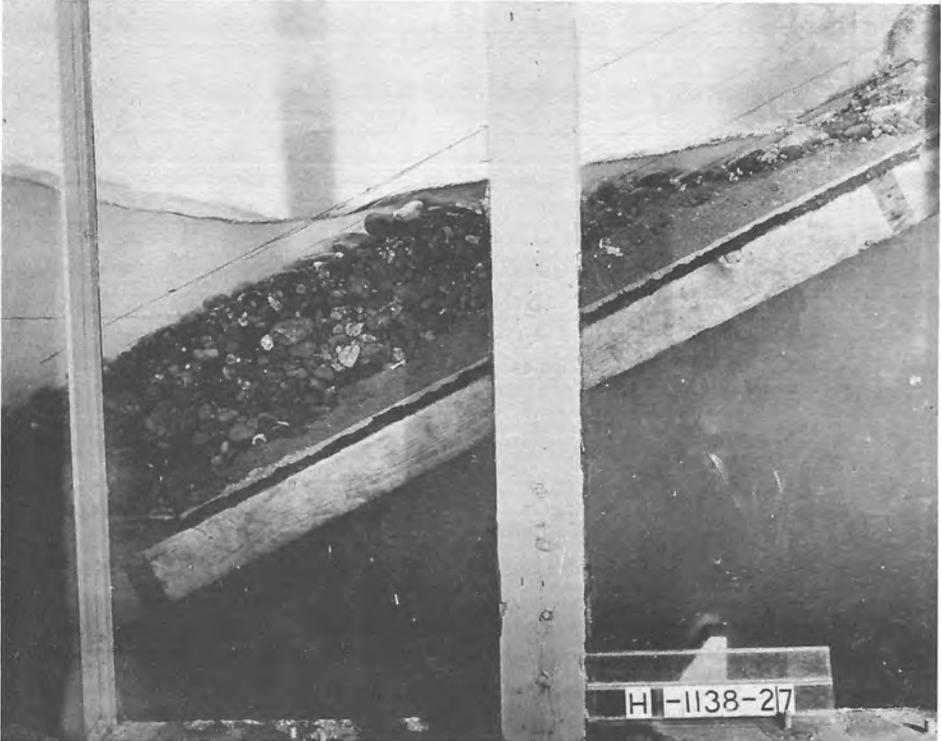
(a) Rake used in Test 3

(b) After 19 hours of operation at 42 waves per minute--wave height 0.43 ft.

Yakima Project - Washington
KENNEWICK MAIN CANAL
TEST 3 (GRAVEL PLACED DRY AND RAKED)
Model study

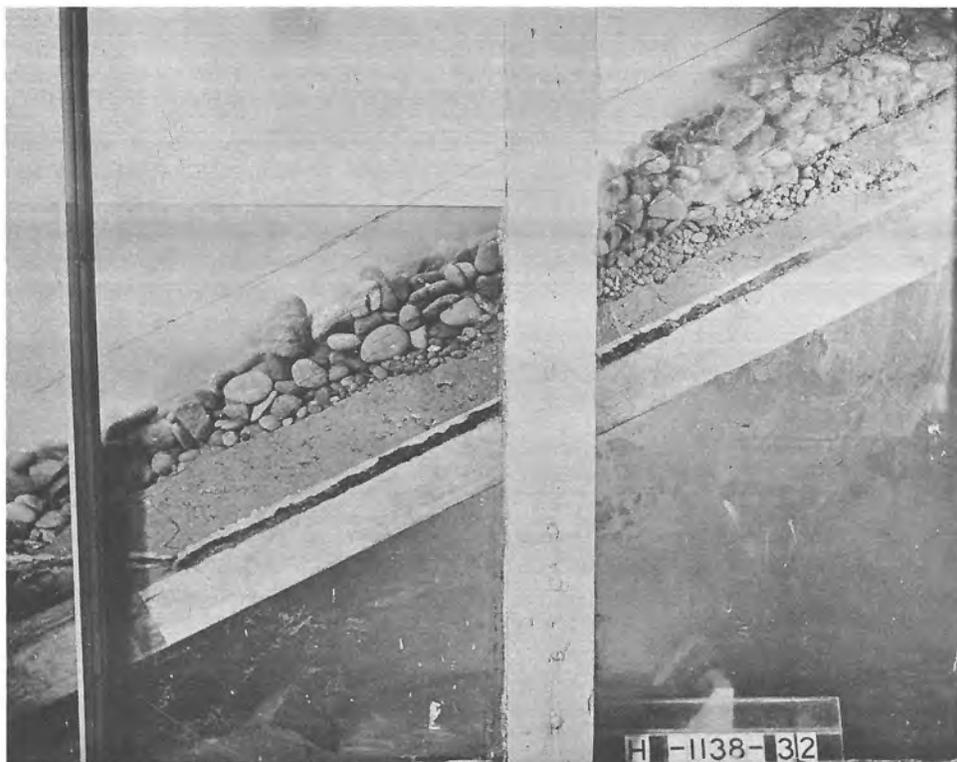
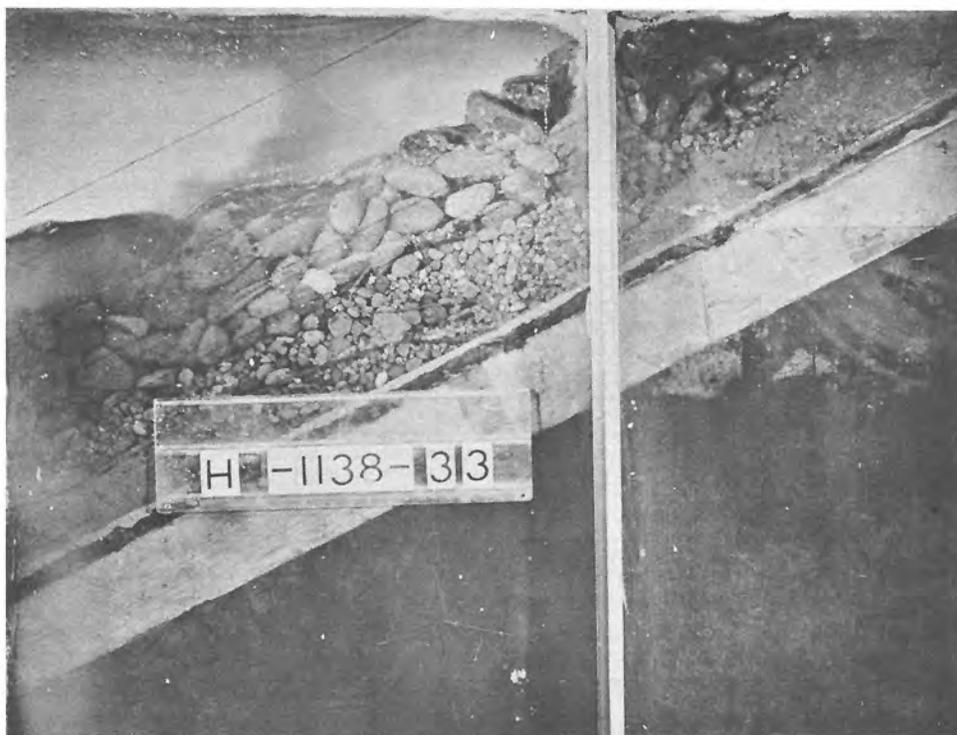
Figure 12

(a) After 45 minutes of operation--
2.7 ft. depth--42 waves per
minute--wave height 0.43 ft.

(b) After 20 more minutes of
operation--3.2 ft. depth--
42 waves per minute--
wave height 0.5 ft.

Yakima Project - Washington
KENNEWICK MAIN CANAL
TEST 4 (GRAVEL SEPARATED ON 1-INCH SCREEN)
Model study

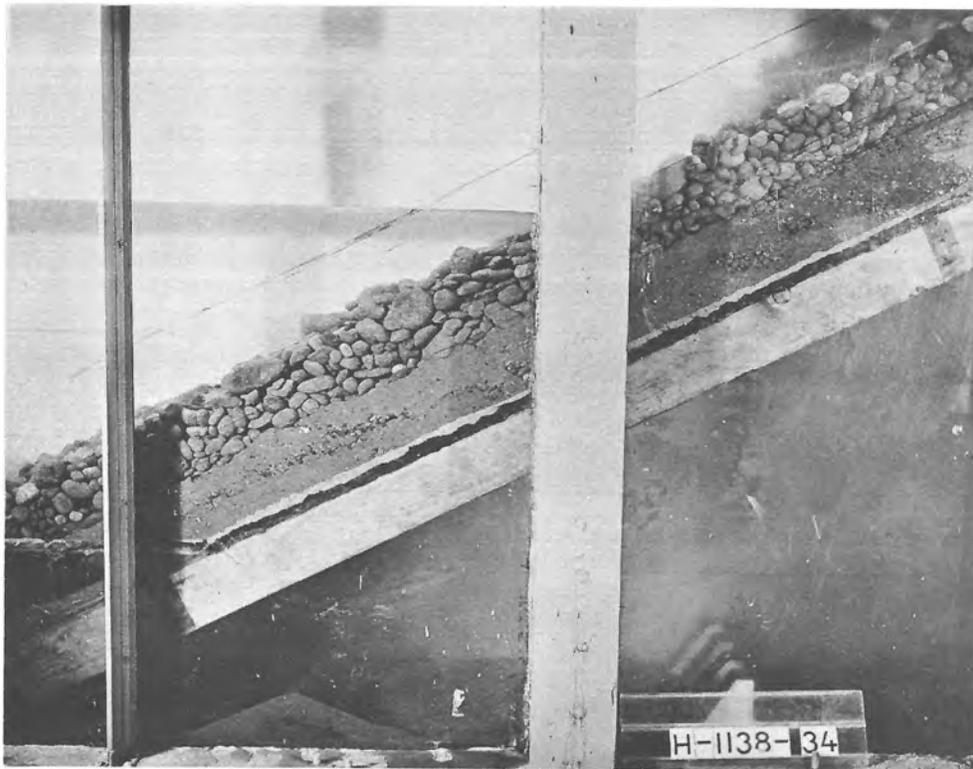
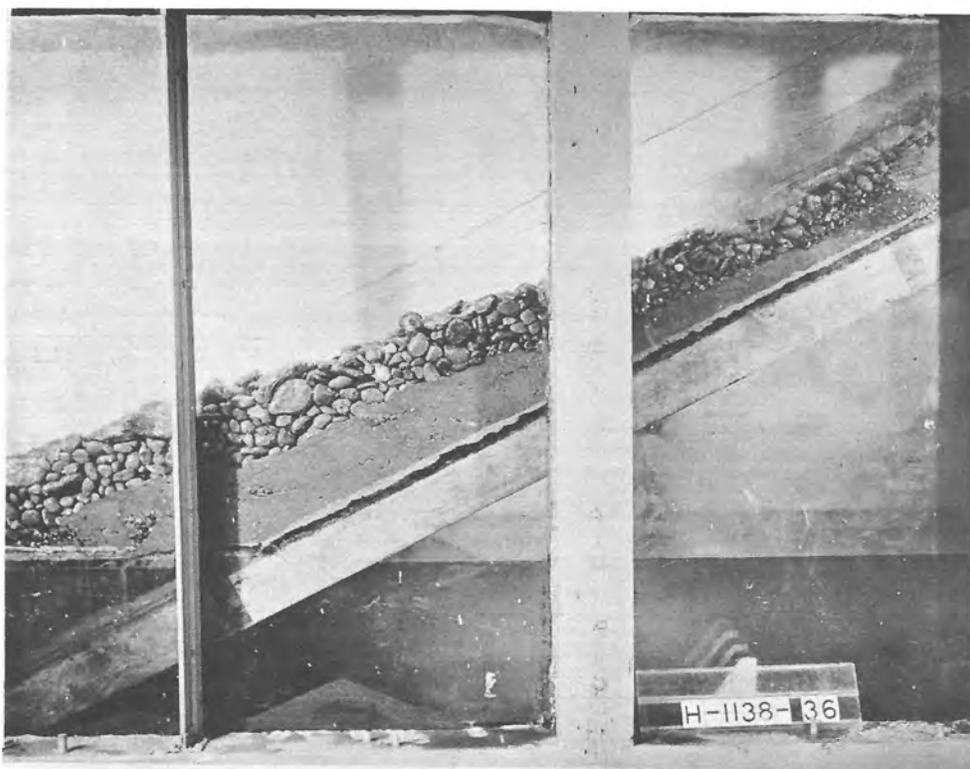
Figure 14

(a) Ready for operation

(b) Slippage that occurred immediately after test started

Yakima Project - Washington
KENNEWICK MAIN CANAL
TEST 5 (GRAVEL SEPARATED ON 1/2-INCH SCREEN)
Model study

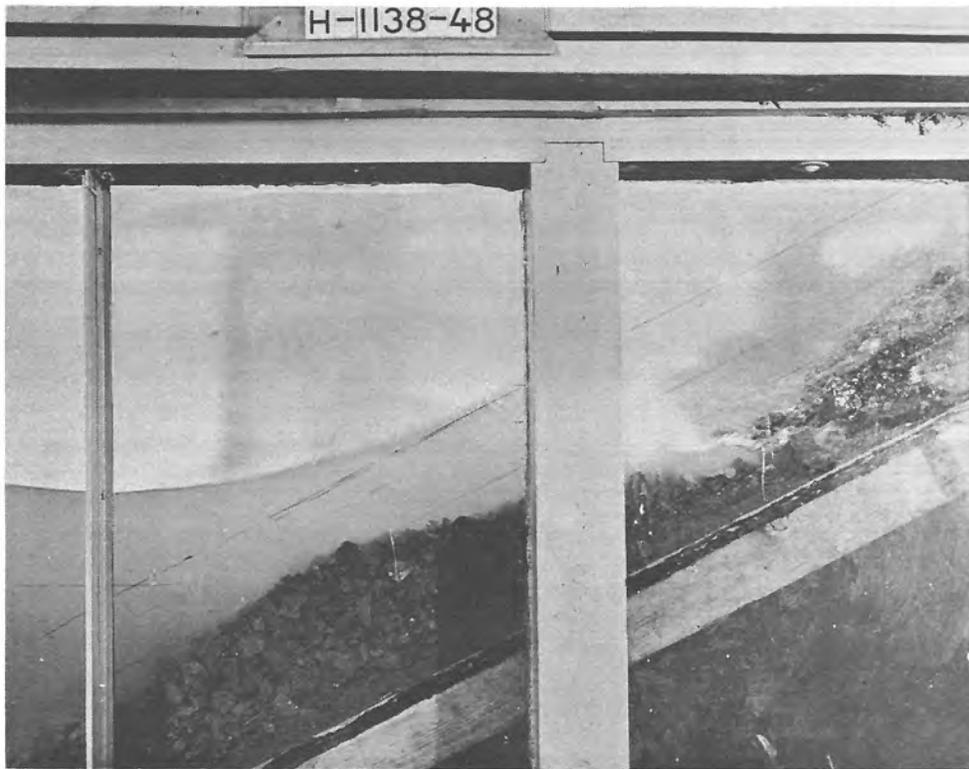
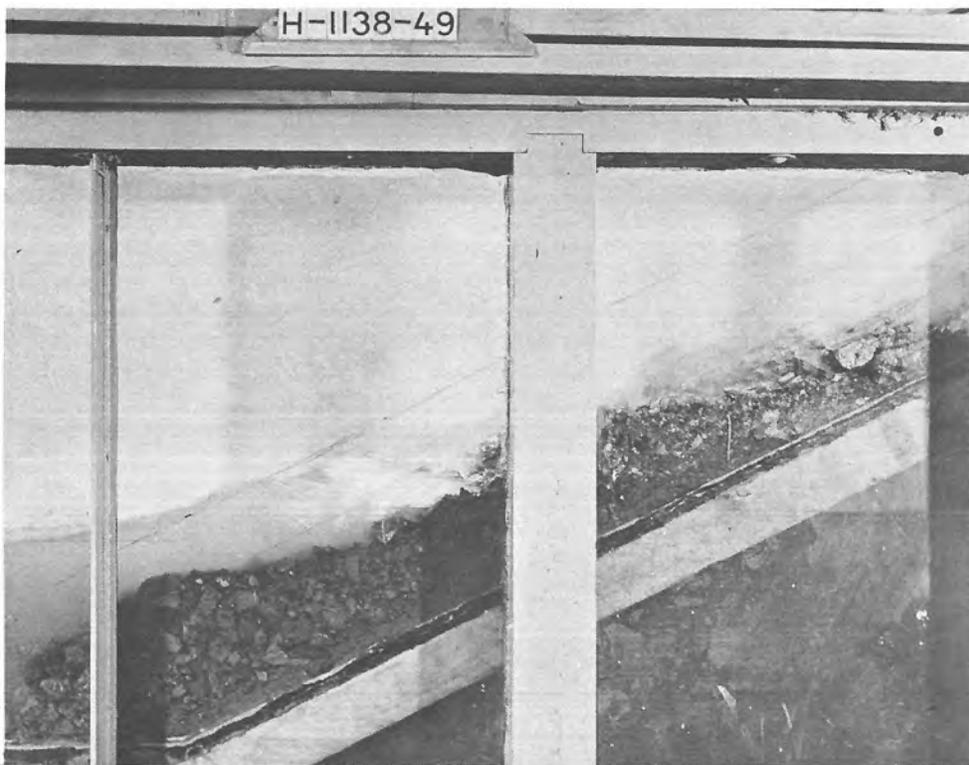
Figure 16

(a) After 3 hours operation at various wave heights and frequencies

(b) After 5 hours operation with various waves and depths

Yakima Project - Washington
KENNEWICK MAIN CANAL
TEST 10 (TALUS MOISTENED AND WELL MIXED)
Model study

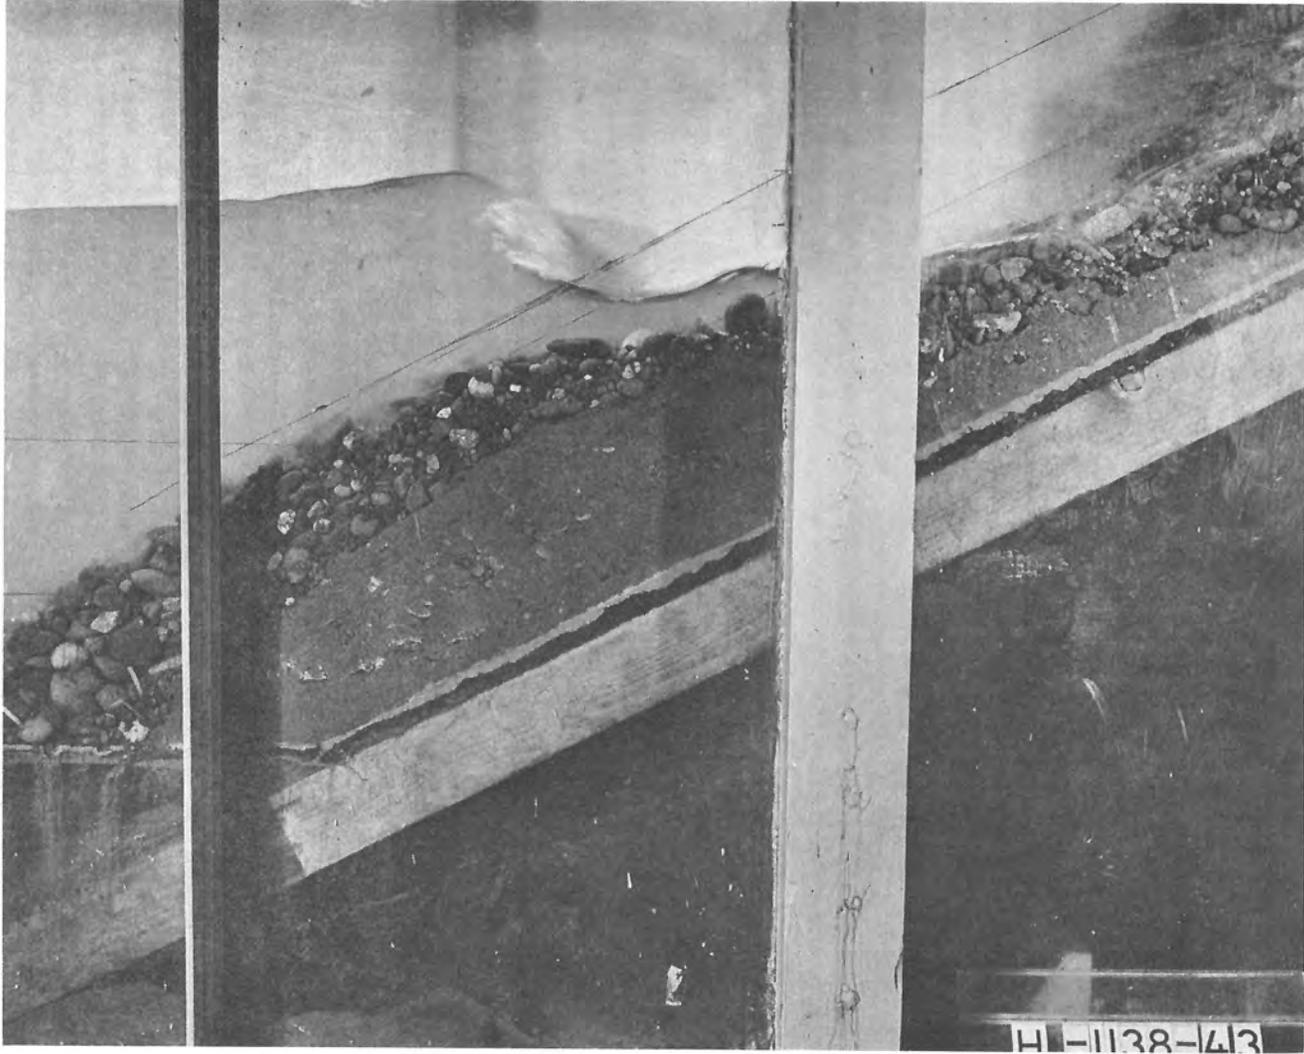
Yakima Project - Washington
KENNEWICK MAIN CANAL
TEST 8 - AFTER 5 HOURS OF OPERATION
Model study

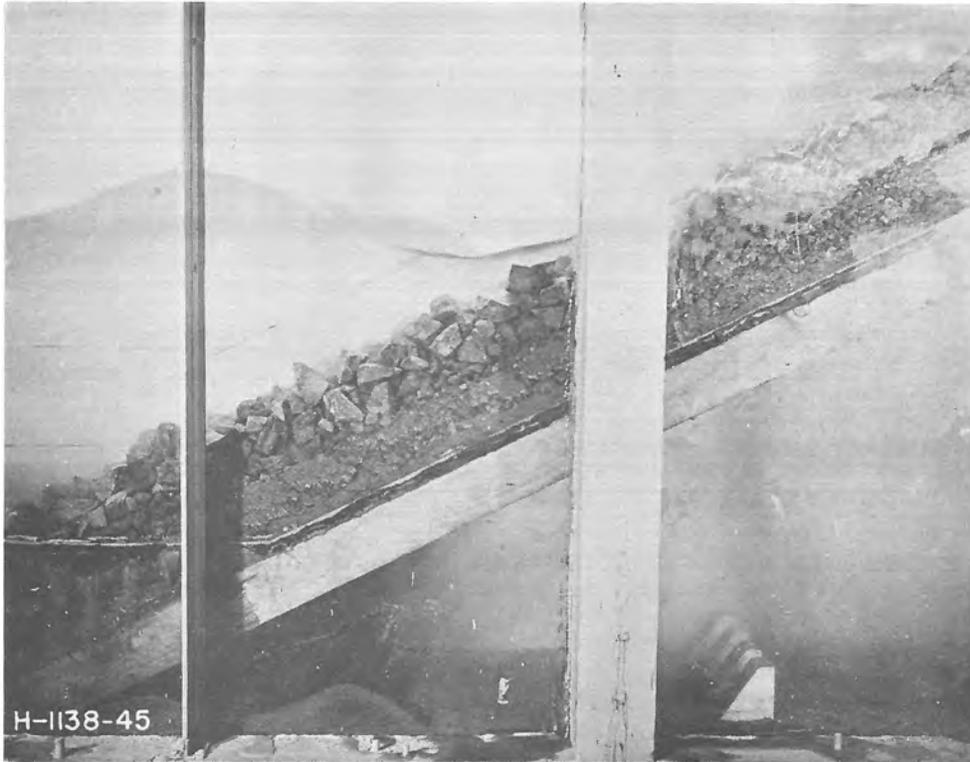
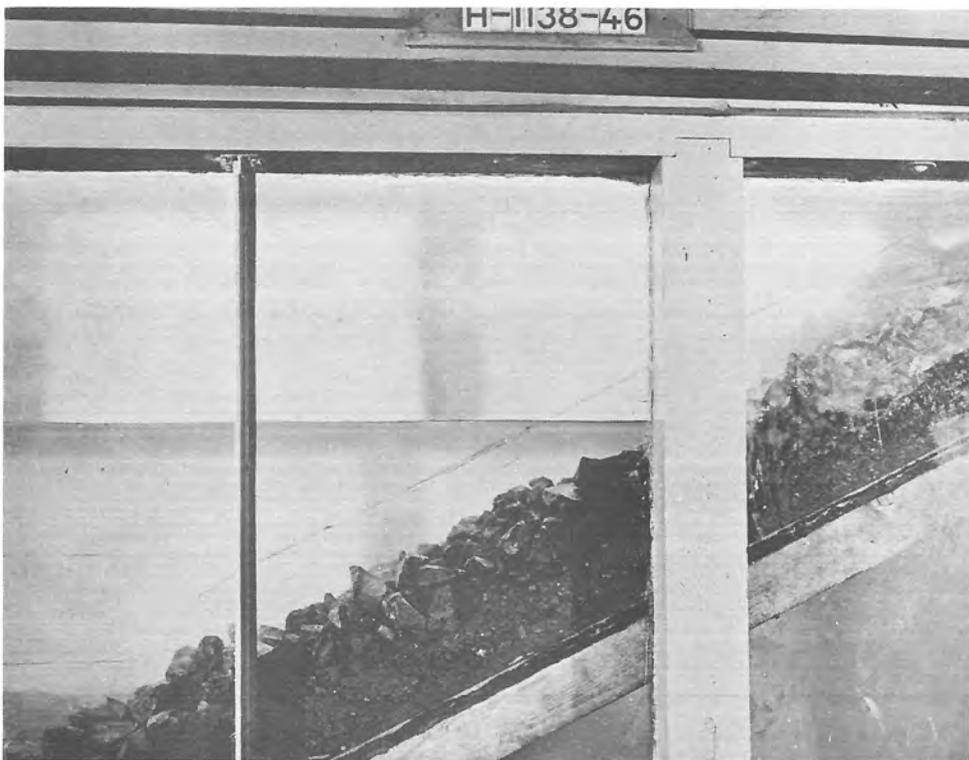
Figure 20

(a) A 0.5 ft. wave approaching the 2:1 slope

(b) Slope after 5 hours of operation at varying wave heights and frequencies

Yakima Project - Washington
KENNEWICK MAIN CANAL
TEST 9 (RECOMMENDED COVER -
TALUS SEPARATED ON 3/4-INCH SCREEN)
Model study

The 0.5-foot wave approaching the slope may be seen in the photograph, Figure 20a. At 68 waves per minute, the surface material was still relatively stable. There was a little movement of the fine material in the lower layer; however, this movement in the lower layer appeared to stop after about 2 hours of operation. The model was operated at 68 waves per minute for approximately 5 hours. The photograph, shown in Figure 20b, gives the condition of the slope at the end of the 5-hour period. A comparison of Figures 15b and 20b shows very little change in the appearance of the material.

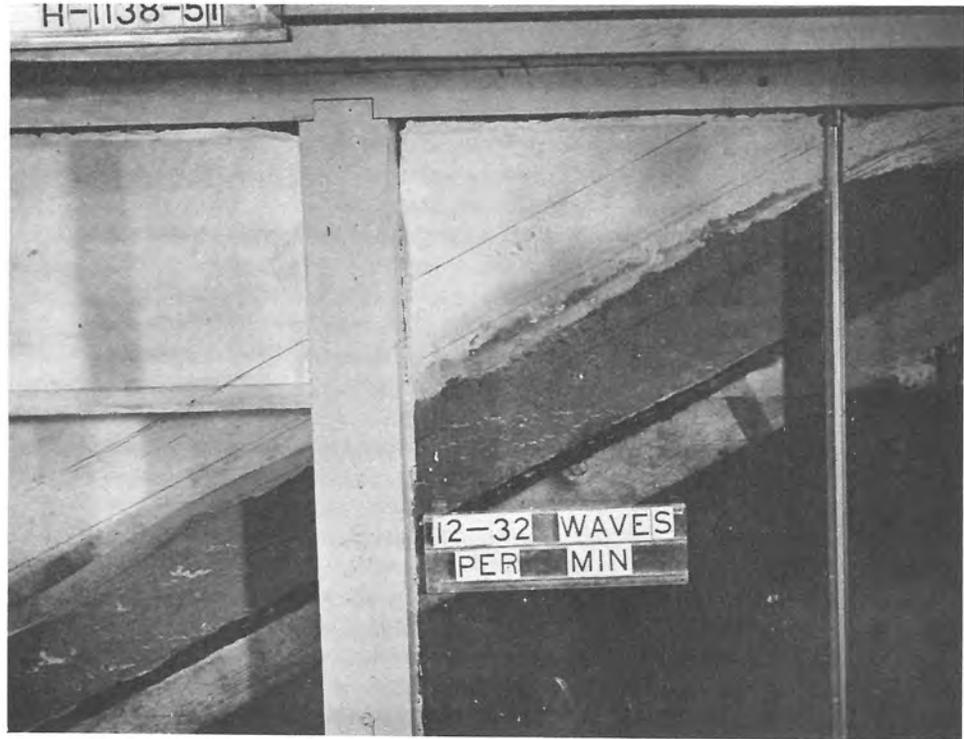
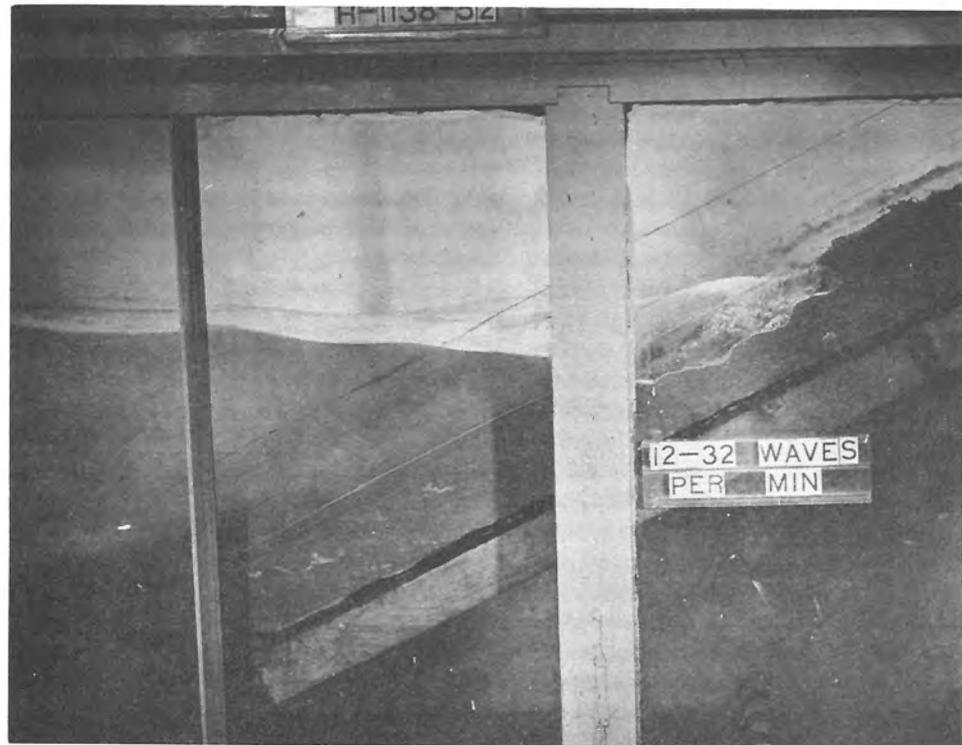
(a) Ready for operation

(b) Two minutes after operation started at 2.7 ft. depth and 32 waves per minute--wave height 0.26 ft.

Yakima Project - Washington
KENNEWICK MAIN CANAL
TEST 12 (FINE BASE MATERIAL)
Model study

The water was raised slowly in the flume to a depth of 2.7 feet, Figure 21a. There was some settlement of the material on the slope, and near the water surface, cracks could be observed. The wave machine was started and operated at 32 waves per minute. The wave height varied from 0.25 to 0.40 foot as the material washed down the slope. During this operation, complete failure of the base material slope occurred. Immediately on starting the wave machine, the earth material began to fail. The photograph taken 2 minutes after operation started may be seen in Figure 21b. The density current of fine material flowed down the slope to the bottom of the flume. After 12 minutes of operation, the 2:1 slope was completely exposed. The model was operated for 1 hour, after which it was turned off and slowly drained. The fine base material assumed an approximately level position, as shown in Figure 22a.

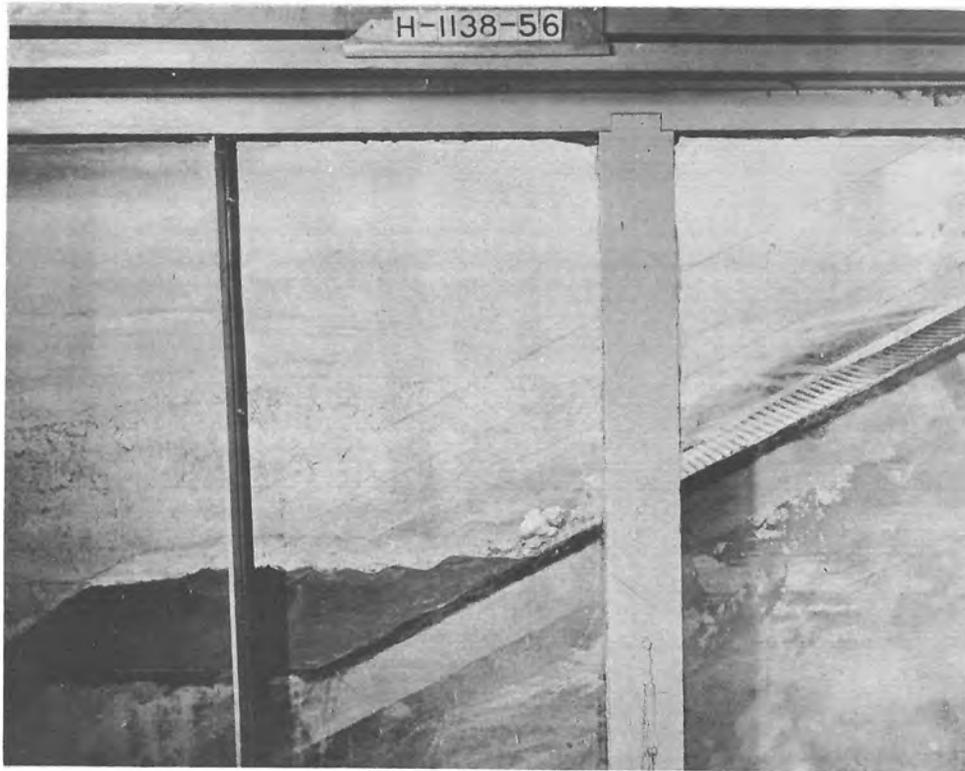
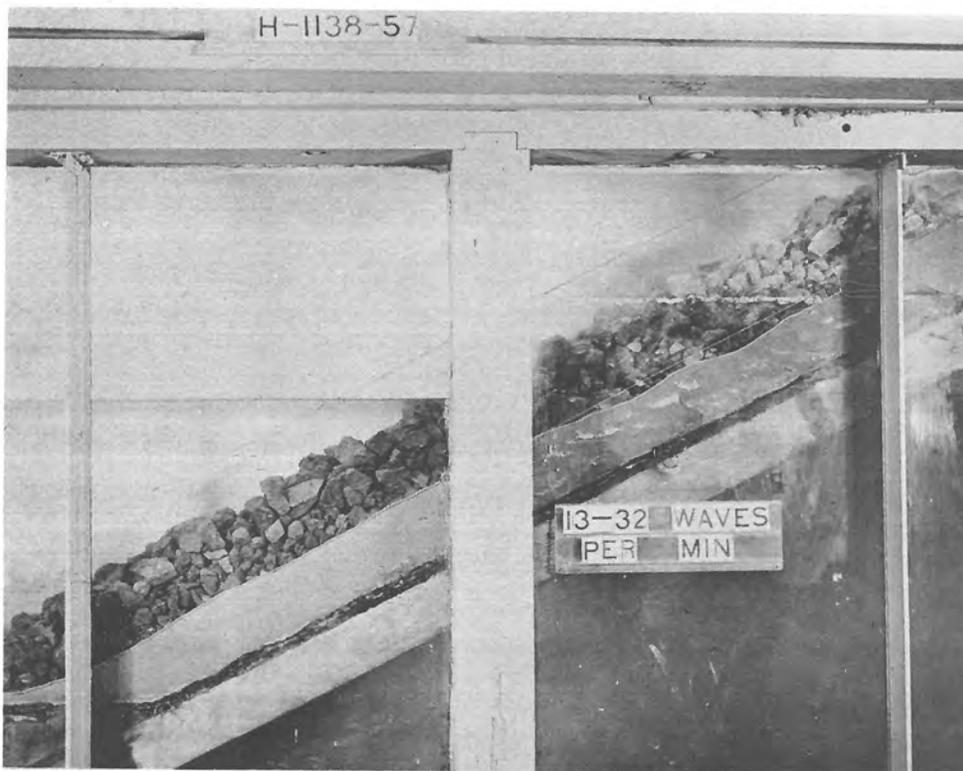
Figure 22

(a) Test 12--after 1 hour of operation
at 2.7 ft. depth--32 waves per
minute--wave height 0.26 ft.

(b) Test 13--ready for operation.
Base material covered with
plus 1/2-inch talus

Yakima Project - Washington
KENNEWICK MAIN CANAL
TESTS 12 and 13
Model study

thin layers with a wooden tamper. The talus material was dumped on the compacted base material, simulating the way that it would possibly be placed in the field, Figure 22b. The model was slowly filled to a depth of 2.7 feet, and the wave machine was started at 32 waves per minute, giving a wave height of 0.32 foot.

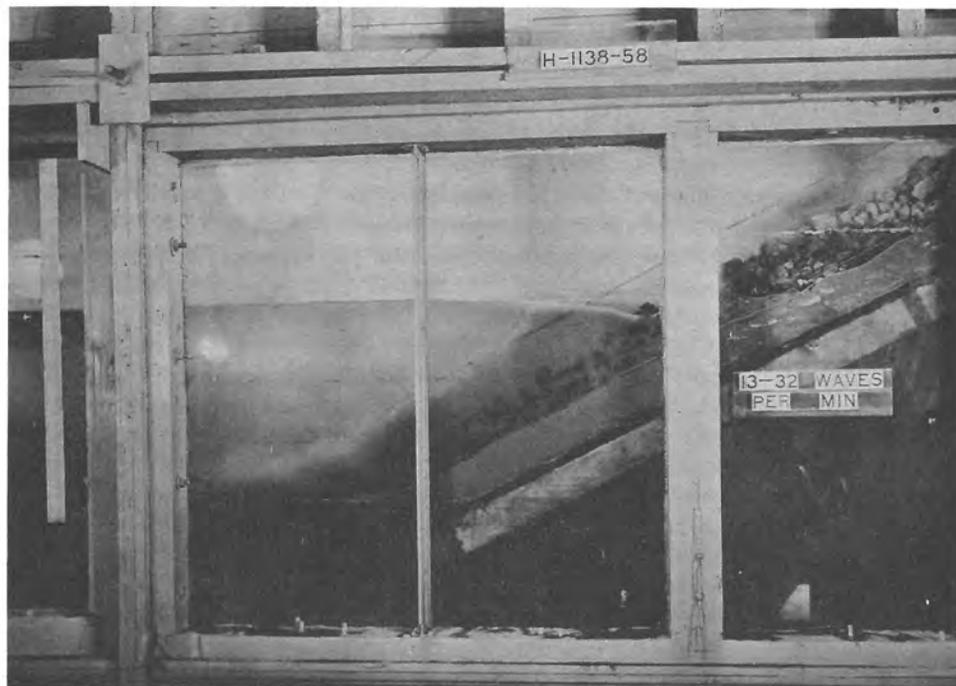
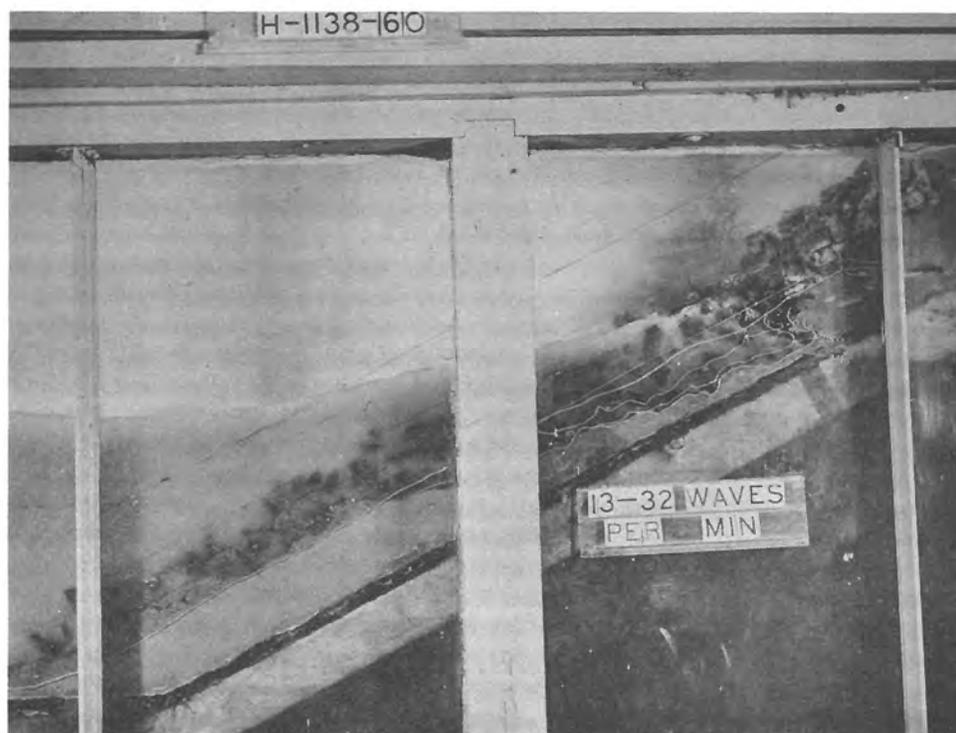
(a) After 7 minutes of operation at 32 waves per minute--depth 2.7 ft. --wave height 0.26 ft.

(b) After 90 minutes of operation at 32 and 42 waves per minute leaching of base material progressed as shown by lines on the photograph

Yakima Project - Washington
 KENNEWICK MAIN CANAL
 TEST 13 (BASE MATERIAL AND
 PLUS 1/2-INCH TALUS MATERIAL)
 Model study

A photograph taken 90 minutes after operation started, shows the base material had washed within approximately 1/2 inch of the board slope (Figure 23b). The model was operated an additional 17-1/2 hours at 42 waves per minute. During this time, the upper part of the slope failed completely. The finer material was completely washed from beneath the talus cover. The photograph showing this failure may be seen in Figure 24a.

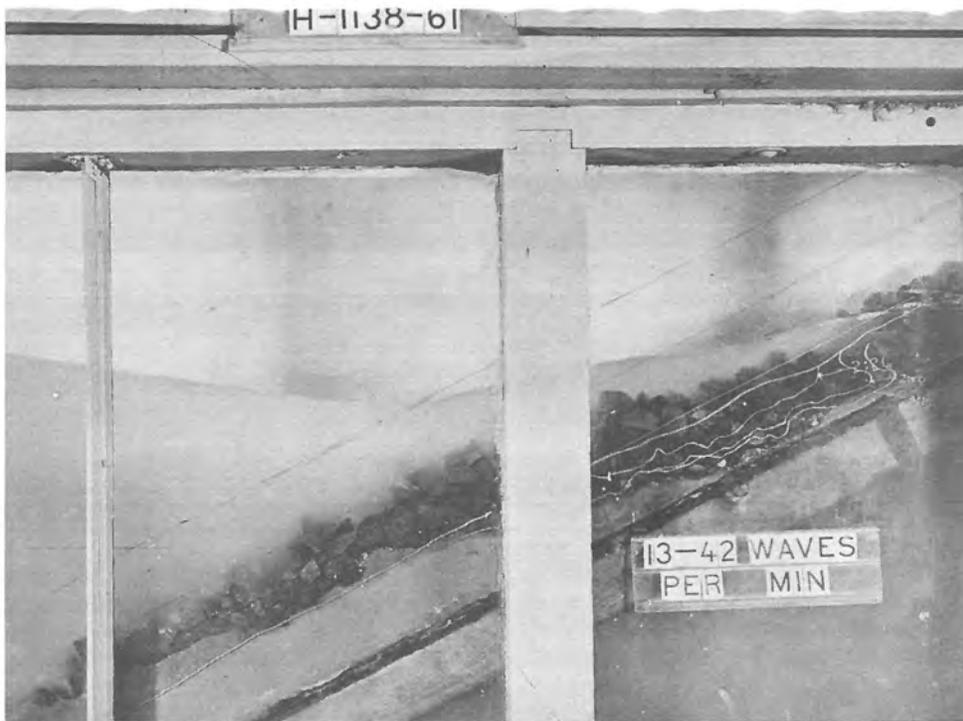
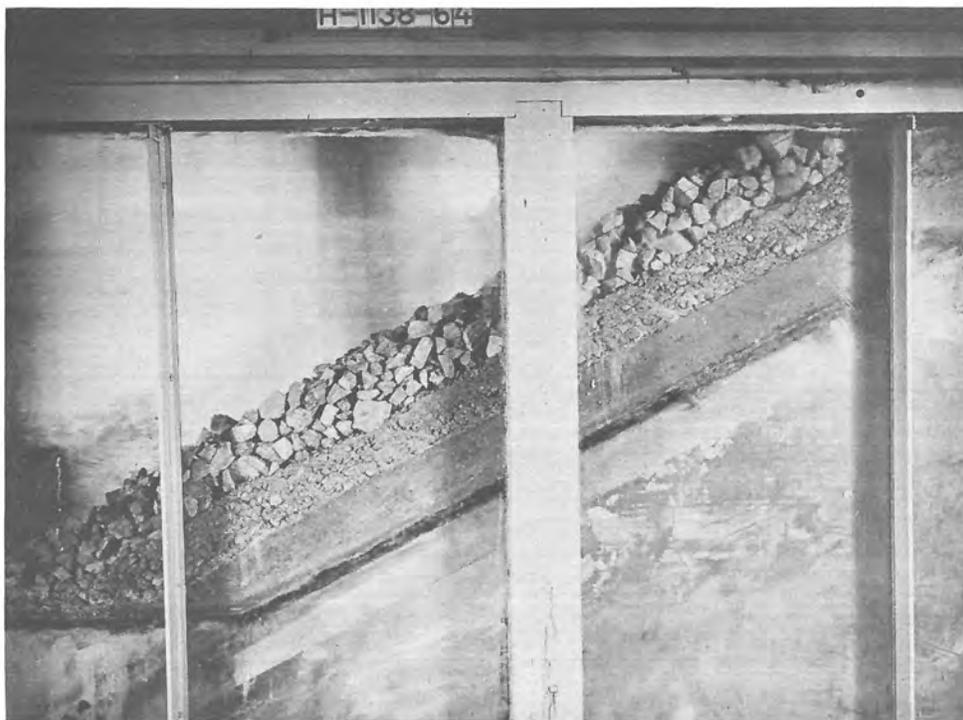
Figure 24

(a) Test 13--after the model was left running all night at 42 waves per minute. Base material completely leached out in area near water surface

(b) Test 14--ready for operation. Base material covered with talus separated on 3/4-inch screen - recommended cover

Yakima Project - Washington
KENNEWICK MAIN CANAL
TESTS 13 and 14
Model study

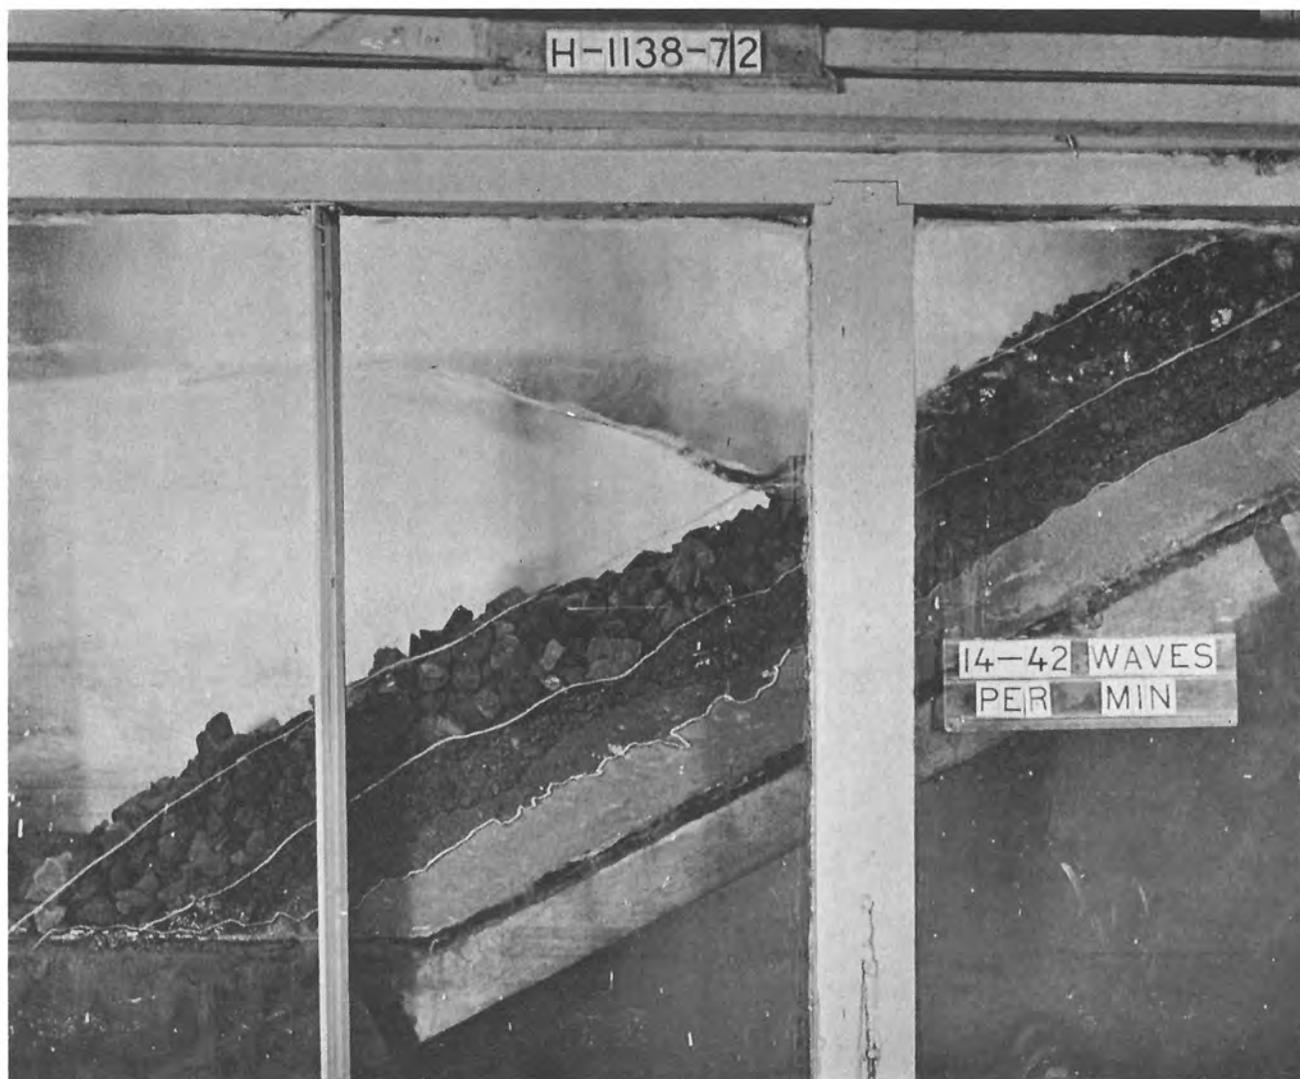
Yakima Project - Washington
KENNEWICK MAIN CANAL
TEST 14 (RECOMMENDED COVER) AFTER 28 HOURS OF OPERATION
AT 42 WAVES PER MINUTE--2.7 FT. DEPTH--WAVE HEIGHT 0.43 FT.
Model study

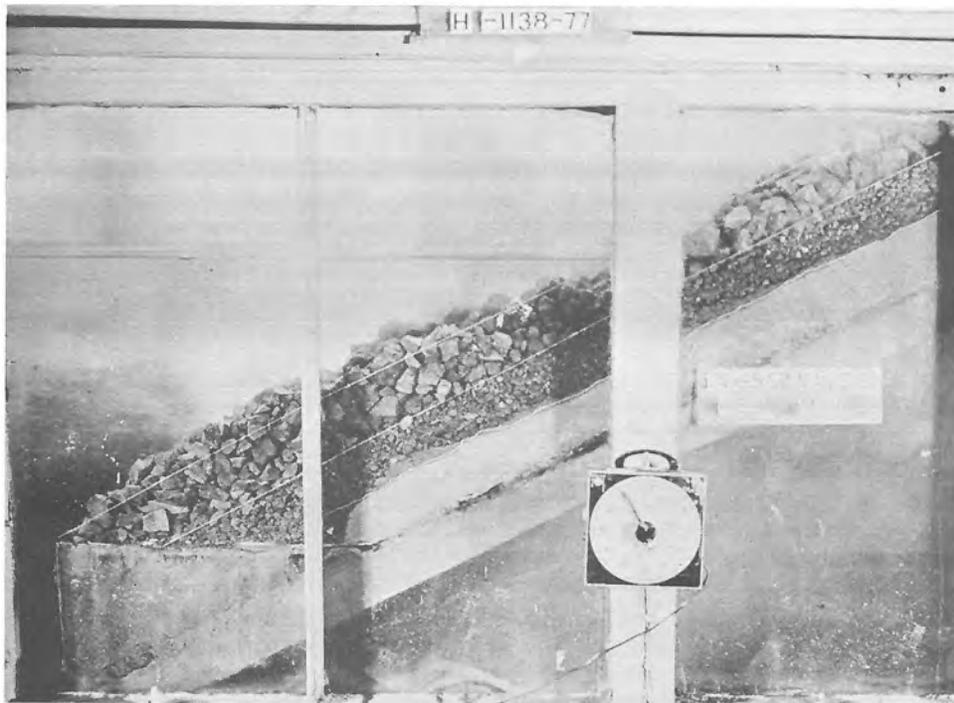
Figure 26

(a) After 128 hours of operation at various depths, wave heights and frequencies

Yakima Project - Washington
KENNEWICK MAIN CANAL
TEST 14 (RECOMMENDED COVER)
Model study

As may be seen from a study of Figure 26a, the material withstood the operation very well. At the frequency of 51 waves per minute, there was some movement of the surface material. During the complete test, the talus material below 3/4-inch in size was very stable, and no leaching of the fine base material was observed. The waves of 22 per minute frequency ran up and down the slope from maximum to minimum, a distance of 2.2 feet. The 0.6-foot high waves at 22 waves per minute resulted in the most damaging condition where leaching action was concerned. However, no leaching of the base material occurred.

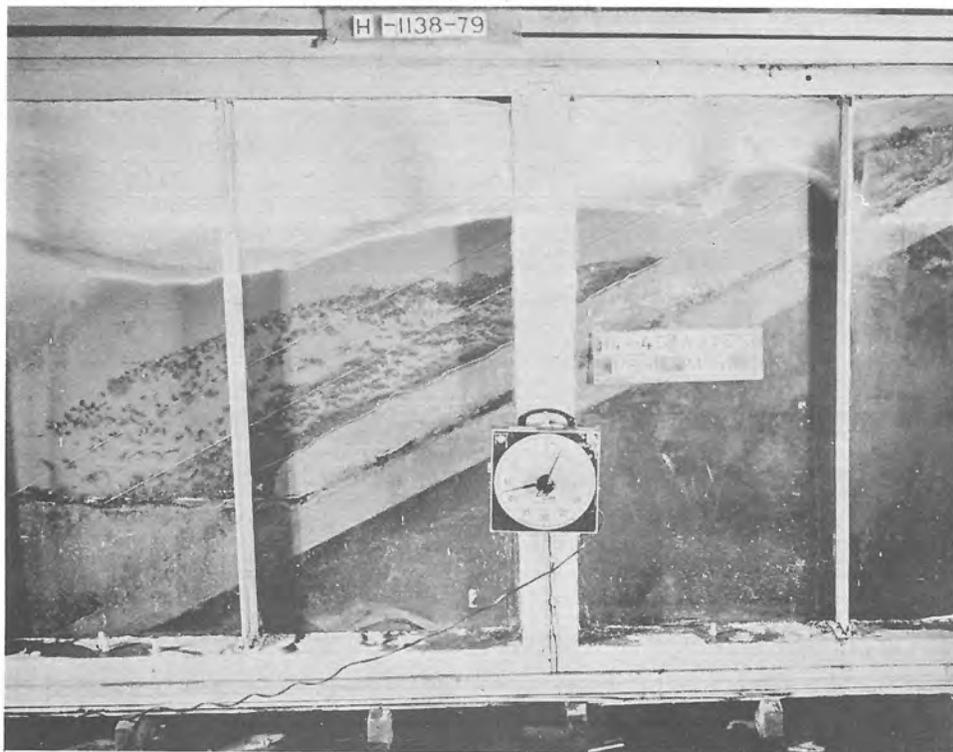
(b) Failure of slope from waves 0.75 ft. high and 45 per minute--approximately 12 minutes after final test started

The section was operated to failure after the above test, the water surface was raised to a depth of 3.03 feet, and the wave machine set for 45 waves per minute, with a resulting wave height of 0.75 foot. For this condition, the material failed. Failure started on the surface and progressed to the bed material. Total failure occurred in 12 minutes, as may be seen from the photograph of Figure 26b. The large waves were large enough to wash the larger gravel particles off the slope, exposing the finer gravel and eventually the fine base material.
