HYDRAULIC MODEL STUDY OF THE CHANDLER FISH SCREEN, WASHINGTON

PERRY L. JOHNSON

Subject: Model Study for Chandler Canal Fish Screen Structure - Yakima

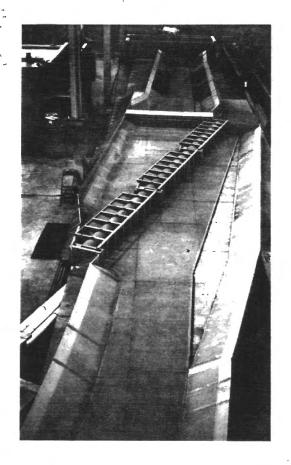
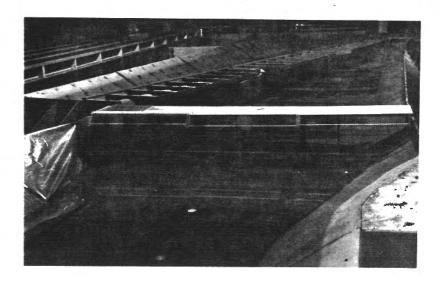
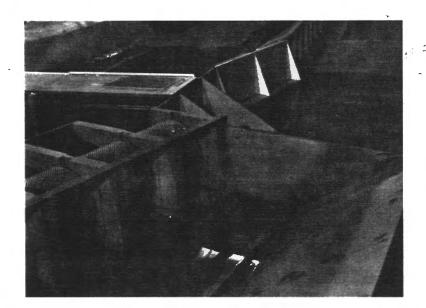
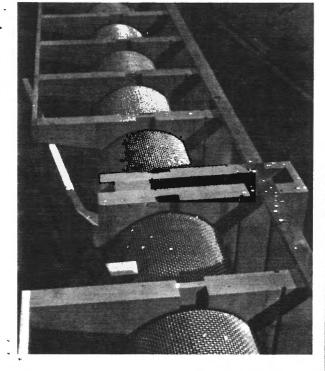
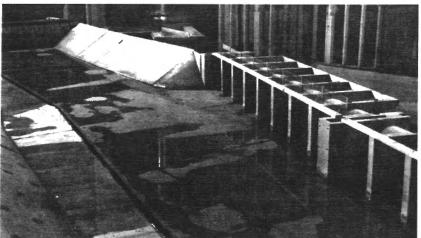
Figure 2. - The 1:12 scale model.

To evaluate and refine the flow patterns approaching, through, and exiting the structure a 1 to 12 scale physical hydraulic model was built (figure 2). The model included a 700-ft-long reach of canal which contained the new drum screen, trashrack, and fish bypass structures. The model included approximately 350 ft of approach canal to the trashracks and 100 ft of exit canal downstream of the end of the structure. Flow was supplied to the model using the laboratory pump and piping system. Discharges were measured using Venturi meters. Velocities were measured using electromagnetic and propeller type current meters. Both documentation photographs and video tape were taken.

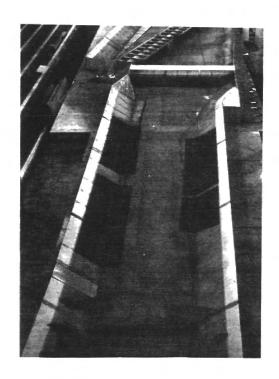
Figure 3. - Expanded metal lath flow resistance.

(figure 3) was used in the model to create selective resistance which modified the model flow distribution. By forcing the model distribution to match the field it was assured that the model was a true representation.

As a first step, the approach flow distribution in the model was adjusted and confirmed by comparison to field velocity data collected at station 41+70 for a discharge of 1,244 $\rm ft^3/s$. The field data were collected by the Yakima Project Office specifically for this study. Expanded metal lath

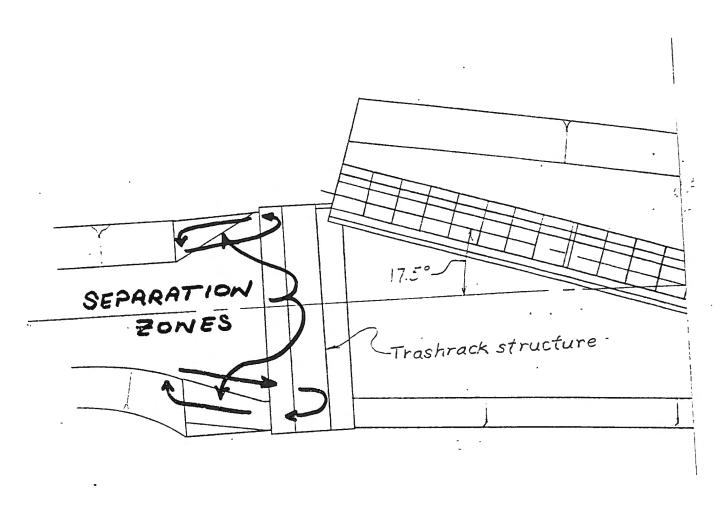
Figure 4. - Expansion-transition separations.

The flow patterns and flow distribution for the initial design were then observed. Because the maximum discharge of 1,500 ft 3 /s was recognized to be critical with respect to eddy formation, flow distribution, and velocity magnitudes, all observations and data were taken at that discharge. Separation or eddy zones were observed on both sides of the channel at the expansion transitions upstream of the trashrack structure (figure 4). On the left side (looking downstream) the flow re-attaches prior to the drum screen structure. Thus no reverse flow through the drum screens resulted. The right bank eddy did not significantly effect the flow through the drum screens but it did represent a generally undesirable flow condition.

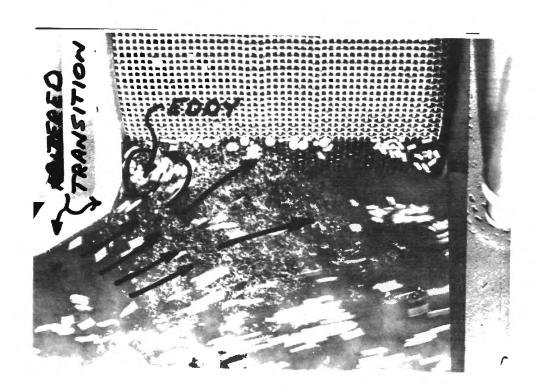
Figure 5. - Flow separation behind bypass intake.

Separation or eddy zones were also observed in front of the drum screens immediately downstream of the two intermediate bypass intakes (figure 5). The original bypass intake design included a mitered transition between the guide wall and the main screen structure which yielded a trailing separation. The influence of this separation, either in the form of reverse flow through or increased angle of flow impingement on the following drum, extended about half way down the drum (figure 5).

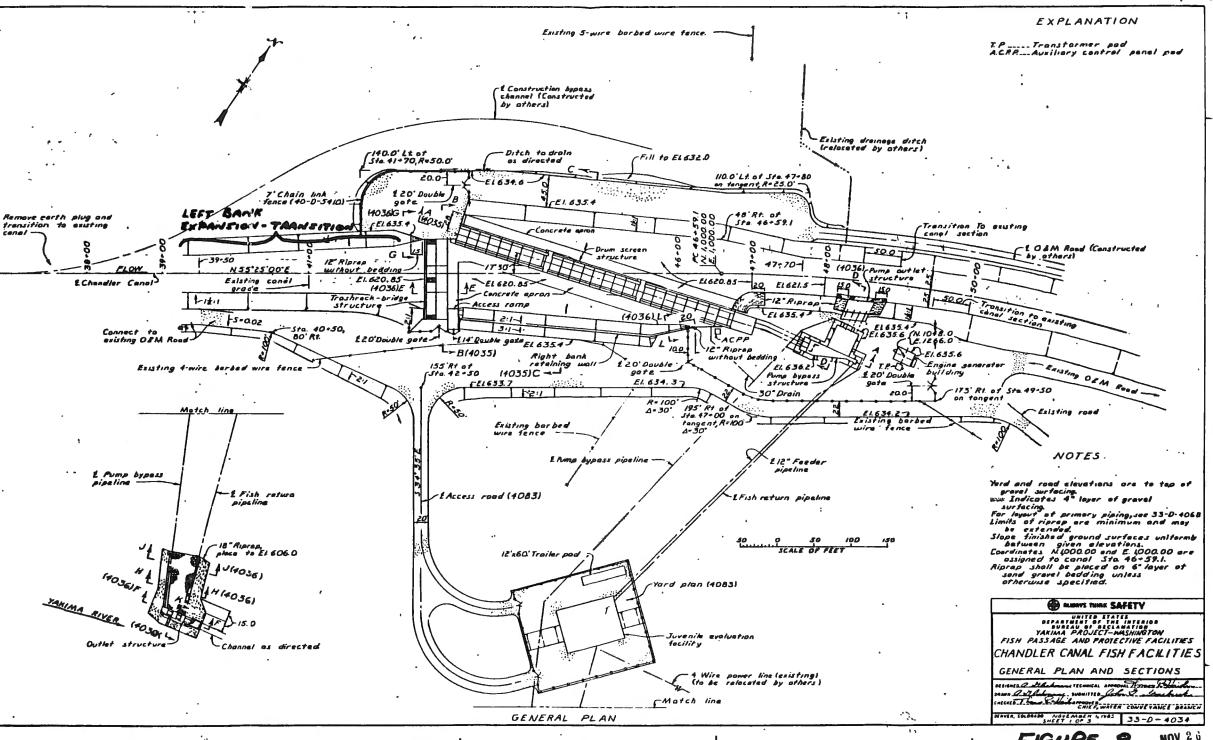
FIGURE 8 NOV 2 d

Although stoplogging at the trashracks appeared to have some promise it was felt that modification of the approach channel alignment with modification of the canal section containing the screen structure was a cleaner approach to the problem. Consequently, various realignments and transitions in the approach channel were tested. It was concluded that to significantly modify the approach flow distribution a fairly long modification was required. An initial effort which increased the length of the left bank expansion-transition from 40 ft to 80 ft was found to have little influence on the flow distribution at the screen. Increasing the length of the left bank expansion-transition to 250 ft (figure 8) significantly increased the discharge to the first three drums. In addition, studies indicated that continuity (velocity = discharge/crosssectional area) significantly influenced flow distribution along the structure. Consequently, to maintain a uniform flow distribution it was desirable to maintain a constant channel cross-sectional area over the length of the screen structure. Therefore, the exit channel behind the drums was widened to reduce velocities at the lower end of the screen structure. This arrangement with a 250-ft-long approach channel expansiontransition and with an enlarged exit channel (figure 8) was tested and found to yield a good velocity distribution.

In summary, it appears that the structure configuration as shown in figure 8 yields satisfactory flow conditions either with or without stoplogging at the trashrack structure. If it is considered desirable or necessary to increase flows to the first drums, stoplogging at the trashrack structure may be used.

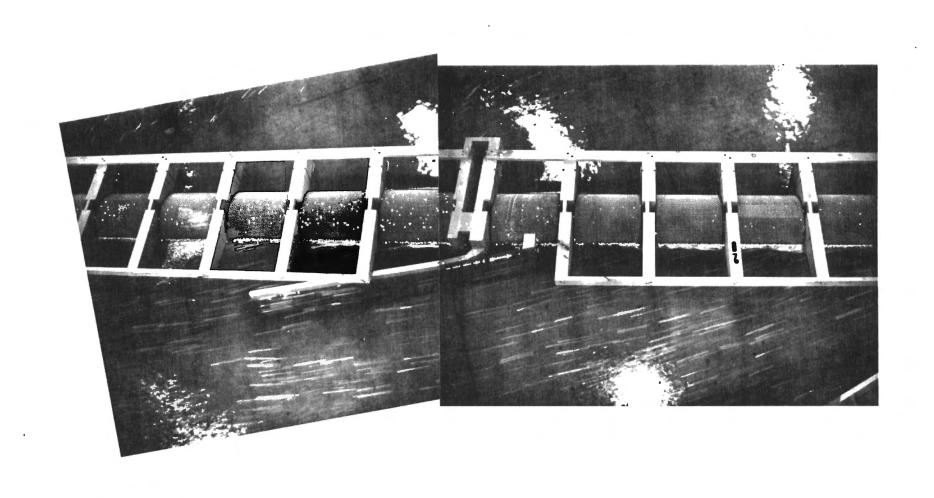
Figure 9. - Time lapse photograph of flow past modified bypass intake with guidewalls positioned at 12° to the structure.

In addition, the localized influences of the bypass intakes were addressed. The guidewalls were realigned at the 12° angle and the back sides of the guide walls were extended, with only a slight break, to an intersection with the screens (figure 9). The extension of the walls required an additional 6-ft displacement of the downstream screen at each of the intermediate bypass intakes (a 12-ft total increase in structure length). The extension and realignment of the guidewalls, however, eliminated a majority of the separation zone behind the intake and created a much improved flow across the trailing screens (figure 9).

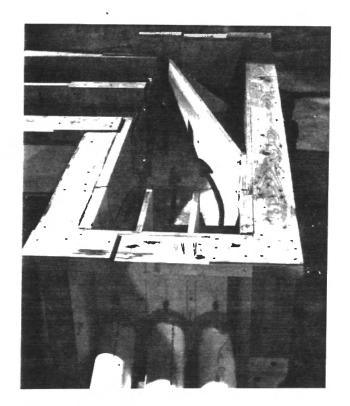
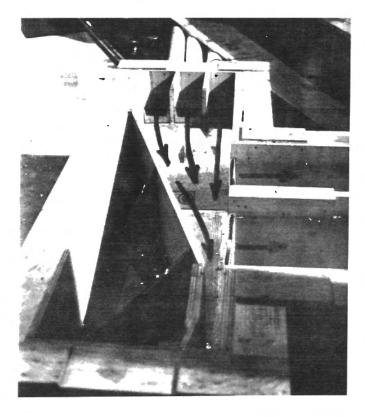
Figure 17. - Model of pumpback-bypass structure.

With completion of testing of the main drum screen structure efforts were directed at evaluating and refining flow conditions through the pumpback bypass structure. The pumpback bypass structure (figure 16) is used to concentrate the diverted fish in a reduced discharge and return a portion of the bypass flow back to the canal. Figures 17 and 18 show the dry and operating model. The discharge withdrawn at each bypass intake of the drum screen structure is a function of the intake cross-sectional area (a 2-ft-wide vertical slot running the full water column depth) and the required intake velocity of 2 ft/s. With a 11.0-ft water depth at the drum screens, the resulting required discharge per bypass is 44.0 ft 3 /s. The total bypass discharge for all three intakes is thus 132 ft 3 /s. Because of demands on the canal discharge, 132 ft 3 /s represents an unacceptably large return discharge to the river. Consequently, the pumpback bypass structure is required.

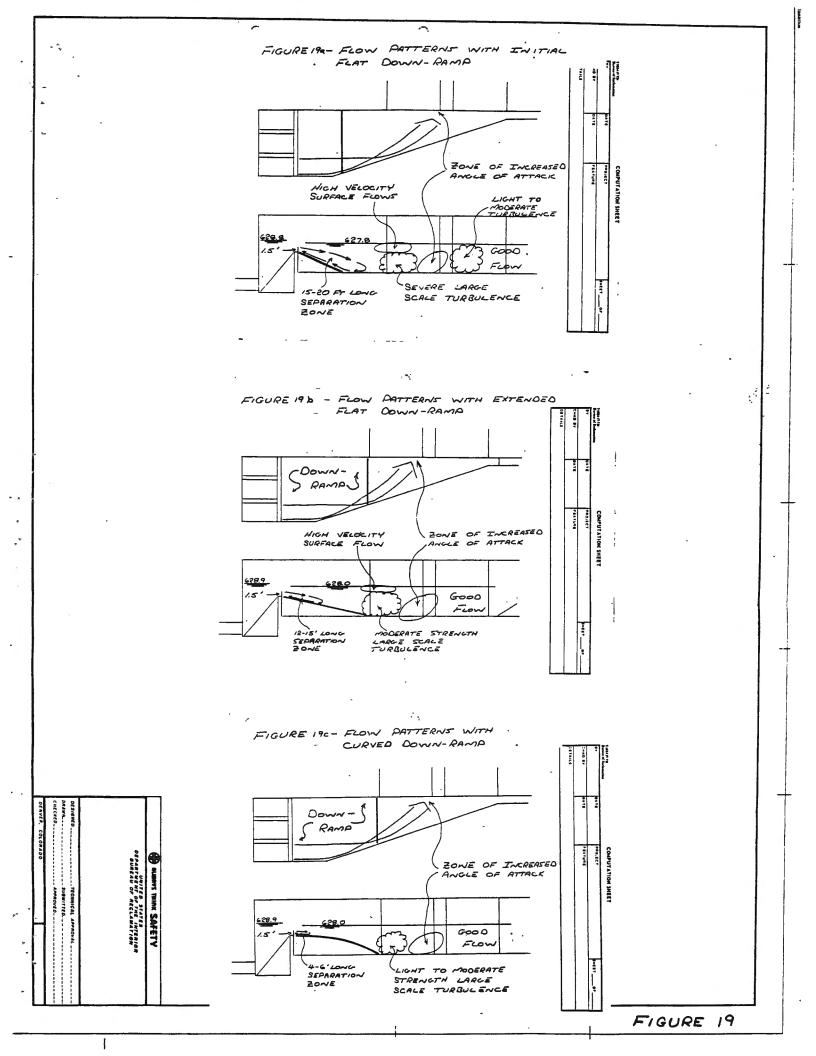
| | ~ . | | | |
|---|---|---|---|---|
| FIGORE 21 | T FT4044 TY I SCREEN I DOWN - | PAMPA | TST ACROSTST | TRAVELING MOED FEAT |

Three down-ramp designs studied in the model, with resulting flow patterns, are shown in figure 19. More detailed flow patterns for the three ramps are shown in figures 20, 21, and 22. Note that the short down-ramp (figures 19a and 20) was ineffective in both elimination of the separation zone and minimization of large scale turbulence. The longer flat ramp (figures 19b and 21) showed improved performance, although an eddy zone and large scale turbulence were still present. The down-ramp with an included vertical curve (figures 19c and 22) yielded the best performance. The eddy zone was eliminated and the ramp functioned as an effective diffuser minimizing large scale turbulence along the traveling screen faces.
