PAP-651

**FINAL REPORT ON THE HYDRAULIC MODEL STUDIES
KESWICK DAM STILLING BASIN MODIFICATIONS**

by
Kathleen H. Frizell

Final Report on the Hydraulic Model Studies - Keswick Dam Stilling Basin Modifications

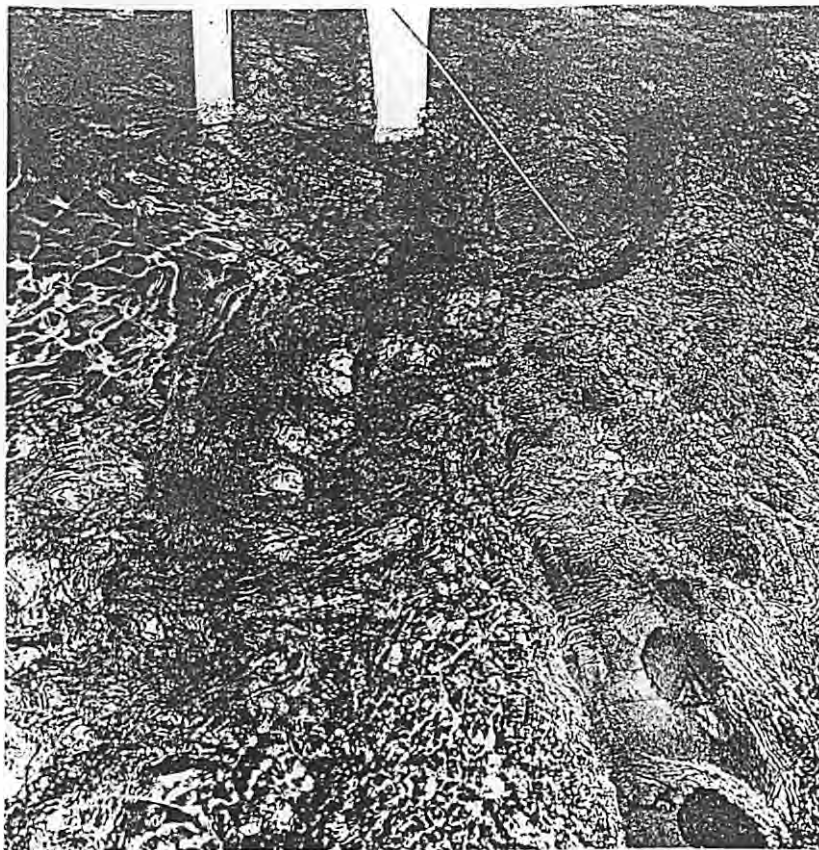
Channel A, the curved channel, directs a jet across the river channel. The area adjacent to the fishtrap is essentially unaffected by the channel and flow along the rock bench downstream of the curved channel exit is very calm. Figure 3 shows the flow conditions with a total of 14,000 ft³/s, (TW = 498.25) with 9,000 ft³/s from the powerplant, 350 ft³/s from the fishtrap, and 4,650 ft³/s from the spillway. This flow condition is typical of all flows where the tailwater elevation in the river channel is below the elevation of the rock bench. As the tailwater increases, the velocity of the jet across the channel decreases, and eventually the jet disappears as the total release reaches 80,000 ft³/s. The measured velocities are given in table 1.

Figure 3. - Curved channel (A) exiting into the river channel downstream of the fishtrap, $Q = 14,000 \text{ ft}^3/\text{s}$ including $9,000 \text{ ft}^3/\text{s}$ from the powerplant.

With channel A excavated, the jet entering the river channel is less pronounced when compared to the jet from smaller spillway flows (figs. 3, 8). However, the jet is still strong enough to likely affect migrating fish when compared to the present condition (figs. 7, 8). With channel B excavated, the jet entering the river channel appears to be about the same as that at smaller spillway flows (figs. 4, 9) and of significantly greater magnitude when compared to no channel excavation (figs. 7, 9). This observation is also confirmed by the velocity data.

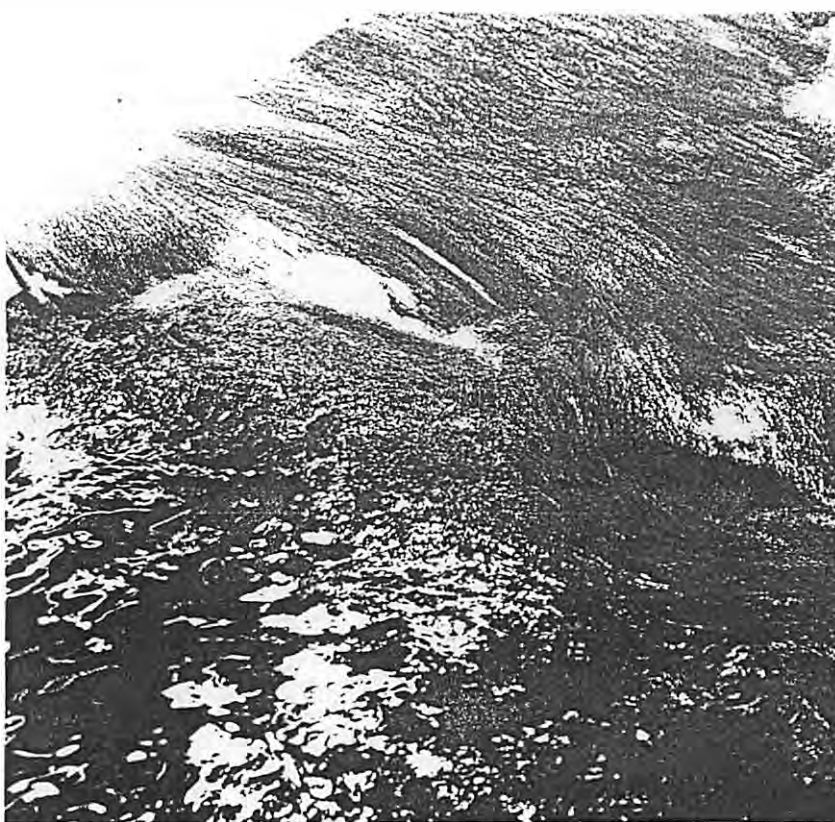
Figure 10. - Flow conditions through channel C, $Q = 22,500 \text{ ft}^3/\text{s}$ with no powerplant flow.

With either channel C or channel D excavated flow conditions in the river channel are acceptable (figs. 10 and 11). Both exit far downstream from the fishtrap entrance, thus limiting their affects on river channel and fishtrap flows. Channel C parallels the main flow over the rock bench and the velocity from the channel greatly decreases upon entering the river channel. Channel C produces similar flow conditions to the original condition in the river channel with no effect on the fishtrap entrance (figs. 7 and 10).

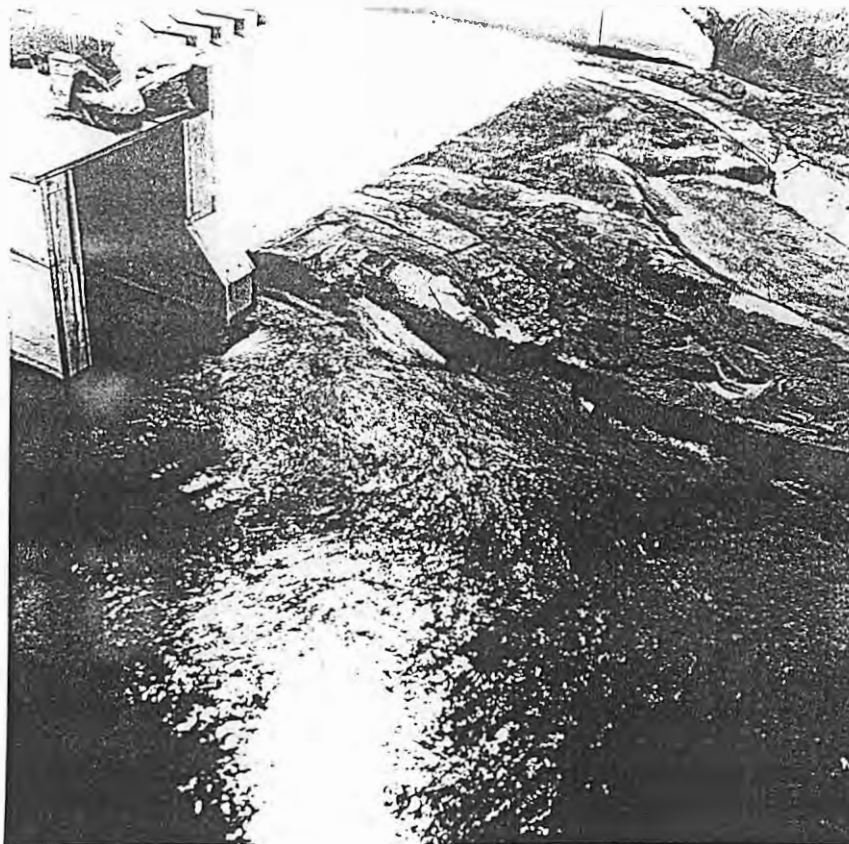
Observations of single gate operation were made for channel B only. At the time of this test, only channels A and B were being investigated and channel B was the preferred channel. Single gate operation was investigated for a discharge of $8,000 \text{ ft}^3/\text{s}$, with no powerplant flow and $350 \text{ ft}^3/\text{s}$ through the fishtrap. At this small discharge, the excavated channel carries a large portion of the flow. Only a small depth of flow exits the basin over the rock bench. As a result, when the far right gate (looking downstream) is open, the flow is directly in line with the channel producing a strong flow out the channel (fig. 12). The remaining flow recirculates (counterclockwise) in the basin and exits over the rock bench. When the far left gate is open, the flow from the gate is directed at the rock bench. Therefore, more flow passes over the rock bench and less flow passes through channel B. The flow still recirculates (clockwise this time) in the basin before exiting from the channel (fig. 13).

Figure 13. - Channel B with only the far left gate operating at 8,000 ft³/s with no powerplant flow.

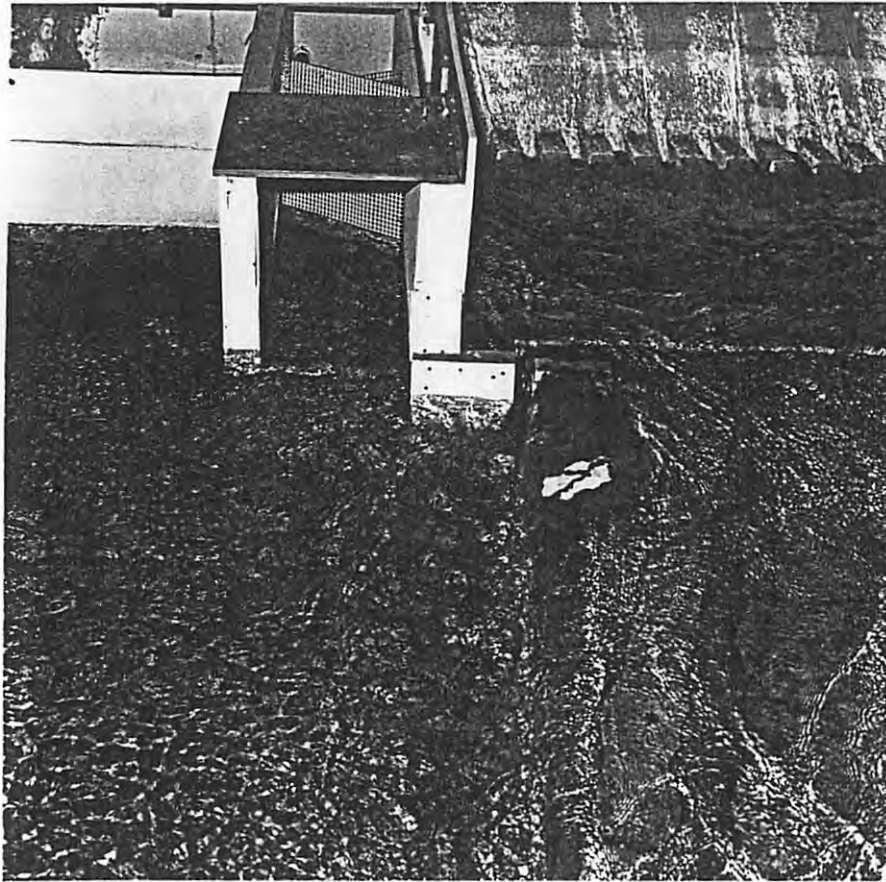
Figure A3. - The final serpentine fish escape channel shown operating with a total discharge of 14,000 ft³/s.
