DISSOLVED OXYGEN ENHANCEMENT ON THE PROVO RIVER

Tony L. Wahl¹ M. ASCE, Doug Young²

Abstract

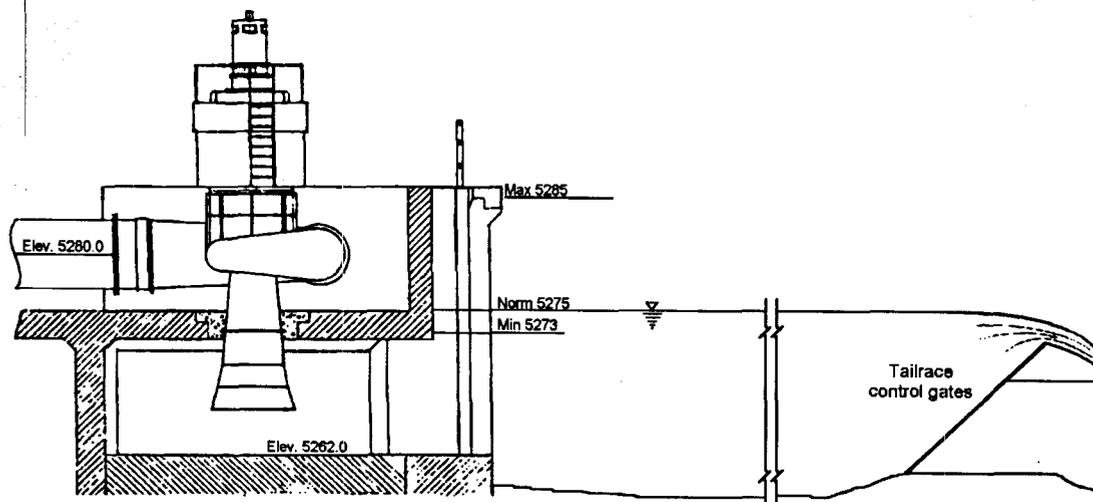
Figure 1. - Cross section through Deer Creek Powerplant showing turbine draft tube and tailrace configuration.

Deer Creek Powerplant, constructed in 1958, contains two Francis-type turbines rated at 2475 Kw each. Rated head and discharge for each turbine are 36.6 meters (120 ft) and 8.5 m³/s (300 ft³/s), respectively. Maximum head is 42.7 meters (140 ft). The draft tubes on both units are simple conical diffusers discharging into prismatic chambers leading to the tailrace (fig. 1). Water levels in the tailrace below the powerplant are controlled by an overflow gate structure consisting of three 4.57-meter (15-ft) wide flap gates. The powerplant is operated by the Provo River Water Users Association (PRWUA).

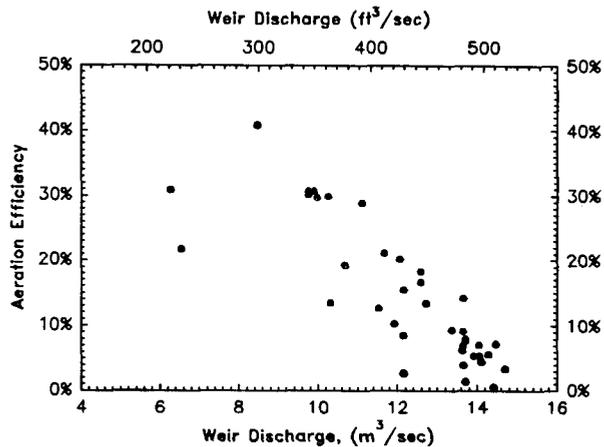
Figure 5. - Weir aeration efficiency versus discharge.

Weir Aeration. — The weir gates were raised for much of the summer, even prior to the start of turbine aeration, to maintain tailrace levels required for a diversion structure drawing water from the tailrace. Increases in DO concentration as high as 2 mg/L were achieved across the raised tailrace gates, with the largest DO increases occurring as the total powerplant discharge (and the unit discharge across the gates) decreased. Figure 5 shows the increase in aeration efficiency with decreasing dis-

charge. The height of the weir gates did not appear to have a significant effect on the aeration efficiency, although the gates were held at a constant height of 0.61 meters (2 ft) for most of the summer. In future efforts we may experiment further with different gate heights, since a significant power savings is possible if the gates can be partially lowered.
