## DISSOLVED OXYGEN ENHANCEMENT ON THE PROVO RIVER

Tony L. Wahl<sup>1</sup> M. ASCE, Doug Young<sup>2</sup>

### Abstract

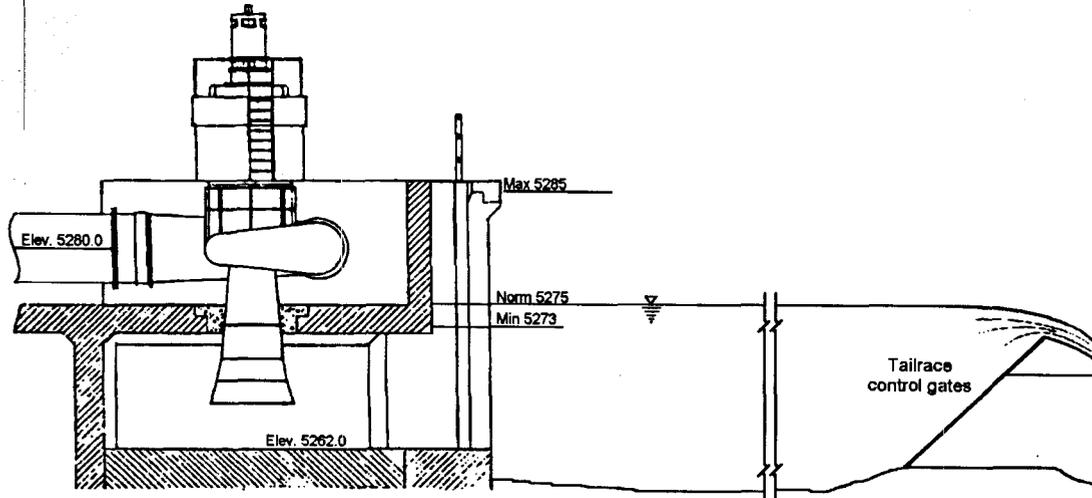
*Figure 1. - Cross section through Deer Creek Powerplant showing turbine draft tube and tailrace configuration.*

Deer Creek Powerplant, constructed in 1958, contains two Francis-type turbines rated at 2475 Kw each. Rated head and discharge for each turbine are 36.6 meters (120 ft) and 8.5 m<sup>3</sup>/s (300 ft<sup>3</sup>/s), respectively. Maximum head is 42.7 meters (140 ft). The draft tubes on both units are simple conical diffusers discharging into prismatic chambers leading to the tailrace (fig. 1). Water levels in the tailrace below the powerplant are controlled by an overflow gate structure consisting of three 4.57-meter (15-ft) wide flap gates. The powerplant is operated by the Provo River Water Users Association (PRWUA).

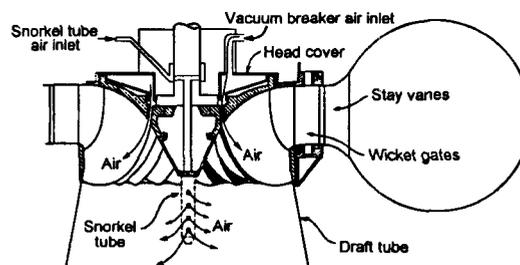
*Figure 2. - Air was injected into the turbines through the vacuum breaker system and through the snorkel tube.*

The reservoir was near maximum capacity at the time of the test. Air was injected through the vacuum breaker systems and through the snorkel tubes of each turbine unit (fig. 2) using air compressors. We

expected to get the greatest airflow through the vacuum breaker system due to the larger pipe diameter of the plumbing leading to the runner (5 cm on the vacuum breaker, versus 2.5 cm on the snorkel tube). DO concentrations were measured upstream of the turbines (on a line carrying cooling water from the penstock to the turbine bearings) and in the tailrace pool. We also tested the concept of raising the tailrace control gates to create a free overfall for additional aeration.

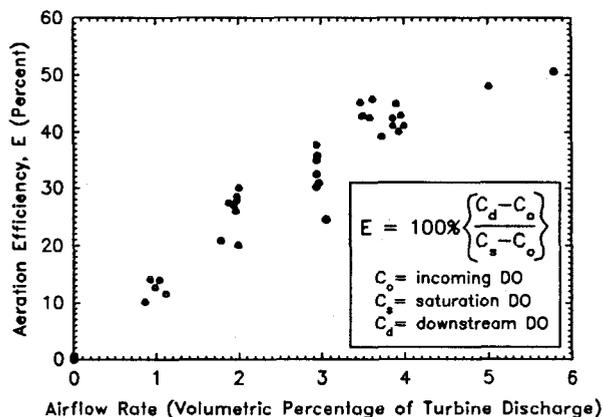
Figure 3. - Turbine aeration efficiency as a function of airflow rate.

Figure 3 shows the results of the turbine aeration portion of the tests. The DO increase is expressed in terms of aeration efficiency, that is the percentage increase in DO compared to the initial deficit from saturation. The airflow is expressed as a volumetric percentage of the water discharge through the turbines (air volume computed at standard temperature and pressure). For airflow rates up to about 4 percent, the aeration efficiency increased about 10 percent for each additional 1 percent air. At the time of the tests the incoming DO concentration was about 2 mg/L, and the saturation concentration at the water surface was about 9 mg/L, so a 40 percent aeration efficiency would correspond to a DO increase of about 2.8 mg/L, for a final concentration downstream of the turbines of 4.8 mg/L.

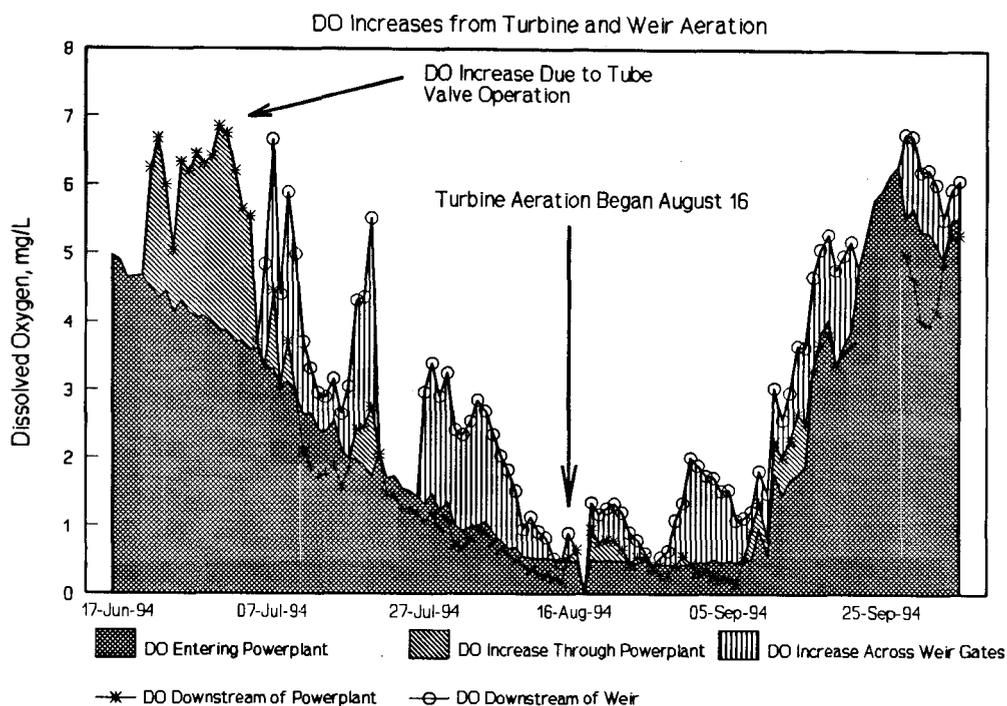
**Figure 4.** - DO concentration changes through Deer Creek Powerplant and over the tailrace weir gates (mean daily values). Operation of the tube valve outlet works produces extreme aeration of the tailrace basin. The reservoir turned over during the last two weeks of September.

Figure 4 shows the DO concentrations measured in the dam (upstream of the powerplant), downstream of the powerplant (just above the tailrace weir gates), and downstream of the tailrace weir gates. It should be noted that there are several periods of missing data for the sensors located downstream of the powerplant and downstream of the weir gates. There also are some periods in which the data are inconsistent; DO concentrations downstream of the powerplant are reported to be less than the DO at the dam (entering the powerplant). This is believed to be due to a faulty DO reading downstream of the powerplant.

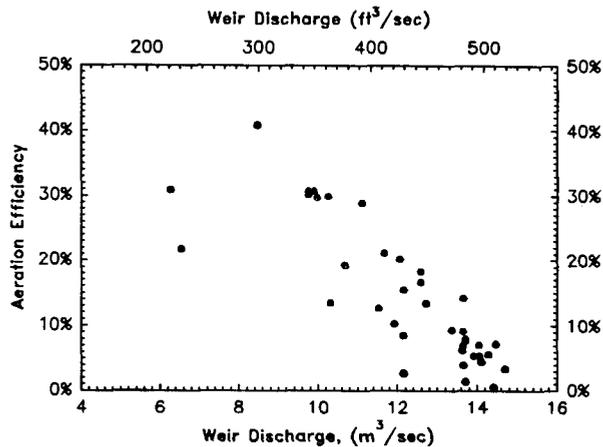
Figure 5. - Weir aeration efficiency versus discharge.

**Weir Aeration.** — The weir gates were raised for much of the summer, even prior to the start of turbine aeration, to maintain tailrace levels required for a diversion structure drawing water from the tailrace. Increases in DO concentration as high as 2 mg/L were achieved across the raised tailrace gates, with the largest DO increases occurring as the total powerplant discharge (and the unit discharge across the gates) decreased. Figure 5 shows the increase in aeration efficiency with decreasing dis-

charge. The height of the weir gates did not appear to have a significant effect on the aeration efficiency, although the gates were held at a constant height of 0.61 meters (2 ft) for most of the summer. In future efforts we may experiment further with different gate heights, since a significant power savings is possible if the gates can be partially lowered.
