# UPPER GILA RIVER FLUVIAL GEOMORPHOLOGY STUDY

CATALOG OF HISTORICAL CHANGES  
NEW MEXICO

US Department of the Interior  
Bureau of Reclamation

DECEMBER 20, 2002

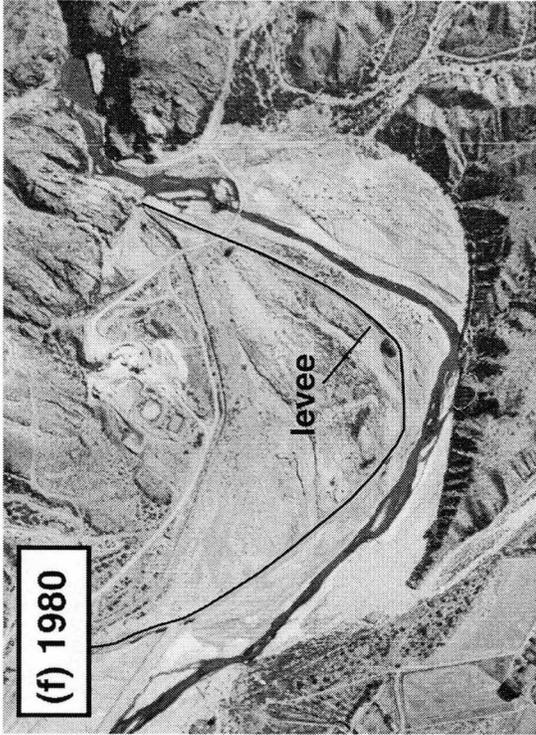
**Figure 12. Case Study (4): Upstream of Ash Creek.** (a) 1935. Relatively wide flood channel; active channel is positioned along right bank; (b) 1953. Active channel migration to left bank; multiple threads evident in point bar; (c) 1965. Channel narrowing due in part to levee construction along the right bank. The levee was breached by a flow between 1953 and 1965; (d) 1973. Channel widened; extensive sedimentation behind levee. Similar channel position to 1935; (e) 1975. Similar channel position and width to 1973; (f) 1980. Right bank point bar was modified by flood flows. Levees were repaired and reduced the flood channel width; (g) 1996. Damage to levee on right bank. Channel position is similar to 1953; (h) 2001. Similar channel position to 1996. Flow is from right to left in the aerial photos.

Case Study (4) is located between House Canyon and the mouth of Middle Box. Channel width from 1935 to 1953 was relatively large; from 1953 to 1965, the channel narrowed, at least in part due to an extensive levee constructed on the right bank (Figure 12). This levee was breached prior to 1965, possibly during the 1959 flood. The entire flood channel width as well as the area behind the levee had been recently inundated prior to the 1973 photography, presumably by the 1972 flood. Between 1975 and 1980 photography, floods had modified the majority of the point bar surface. New levees were built to replace the previous structures. The levee was a discontinuous feature by 1996 and must have been eroded following the floods of 1984 and the early to mid-1990's. The position of the active channel varies considerably in this reach; although the diversion at the mouth of the Middle Box may be a minor control on the position of the low flow channel as it enters Redrock Valley, it seems likely that in this reach the channel position is mainly controlled by the orientation of the channel at the mouth of the Middle Box and the bars that are deposited along the right side of the valley during high flows.

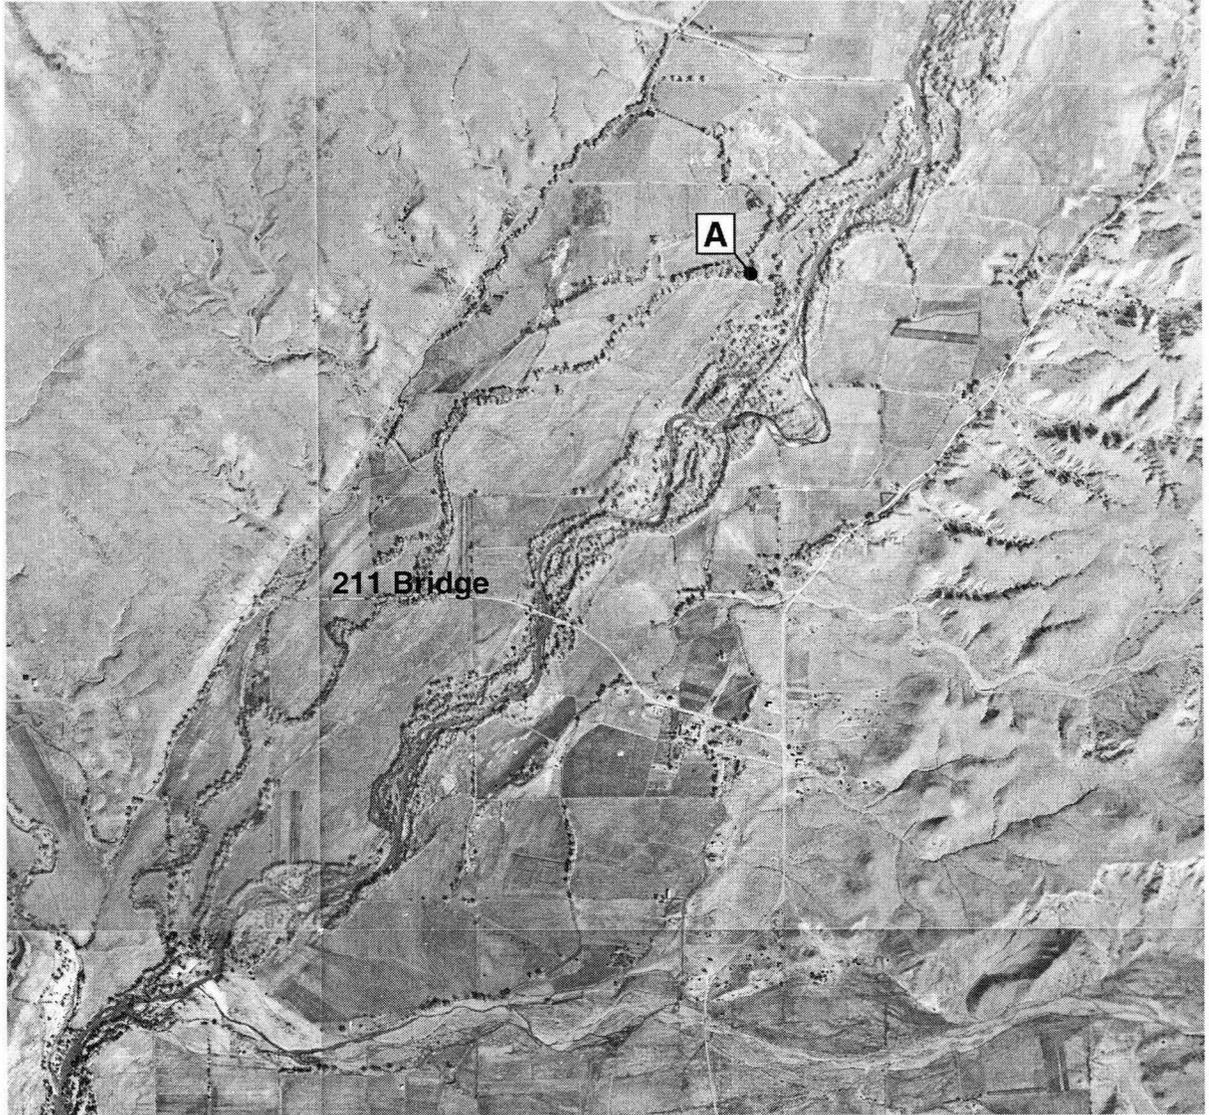
(a) 1935

**Figure 18. Case Study (8): Route 211 Bridge.** (a) 1935. Channel was wide with a sinuous active channel; (b) 1953. Channel was straightened and leveed, cutting off previous 1935 meanders (shown by arrows); (c) 1975. Channel widened through lateral erosion of some levees (shown by arrows); (d) 1980. Widened channel; levees had been replaced or repaired, cutting off some new sections of channel (arrow indicates an example of this scenario). Note the location of point A; (e) 1996. Eroded levees along the entire reach; new unprecedented channel positions had formed. Refer to point A and arrows for locations of major channel change; (f) 2001. Similar channel position to 1996. Flow is from top to bottom in the aerial photos.

The majority of channel changes in this reach occurred upstream of the Route 211 Bridge (Figure 18). The 1935 channel was relatively wide with a sinuous active channel and some small levees setback from the river along farmlands. The active channel, in contrast, was narrow. From 1935 to 1965, the channel was artificially straightened by levees, cutting off many previous channel bends. Major tributaries, such as Bear Creek, were also leveed during this period. 1975 photographs show eroded levees and a wider active channel. These effects are presumably from the 1972 flood. By 1980, new levees had been built following the 1978 flood; impacts from this flood can be seen in places where the post-1978 channel was cut off by the new levees. By 1996, a major change in channel width had occurred, eroding levees along the entire reach and forming new channel positions that were unprecedented in the historical record. The present (2001) channel is very similar compared to the 1996 channel.
