R-90-02

HYDRAULIC MODEL STUDY OF MC CLURE DAM EXISTING AND PROPOSED RCC STEPPED SPILLWAYS

February 1990

U.S. DEPARTMENT OF THE INTERIOR
Bureau of Reclamation
Denver Office
Research and Laboratory Services Division
Hydraulics Branch

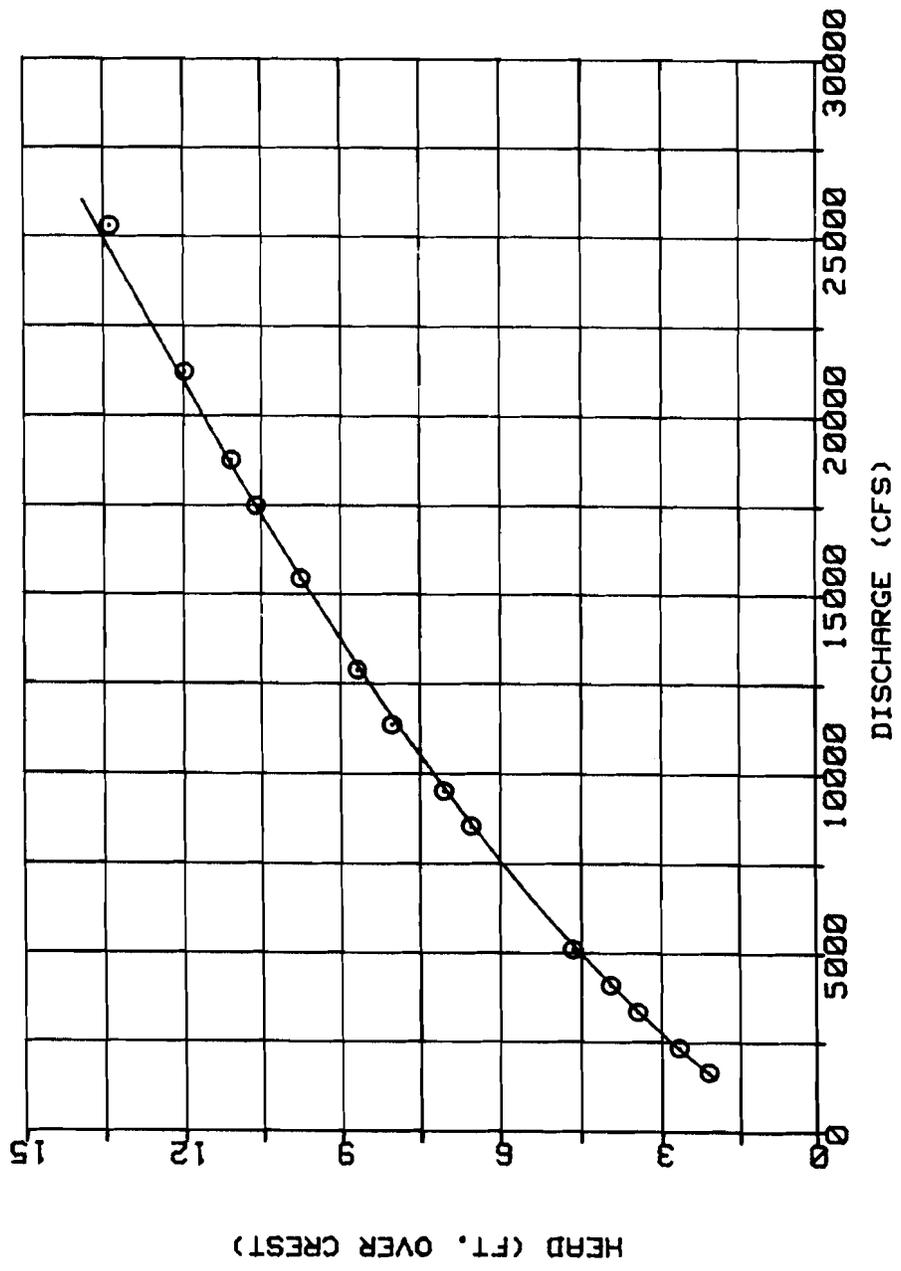
Figure 1. - Discharge rating curve for the RCC spillway.

A total discharge of 16,534 ft³/s was passed over the 167-foot-long RCC spillway crest at 10.26 feet of head, 0.24 foot below maximum water surface elevation 7890 (fig. 1). The discharge coefficient at design discharge was 3.01, typical of a broad crest. The head/discharge relationship is given by the equation:

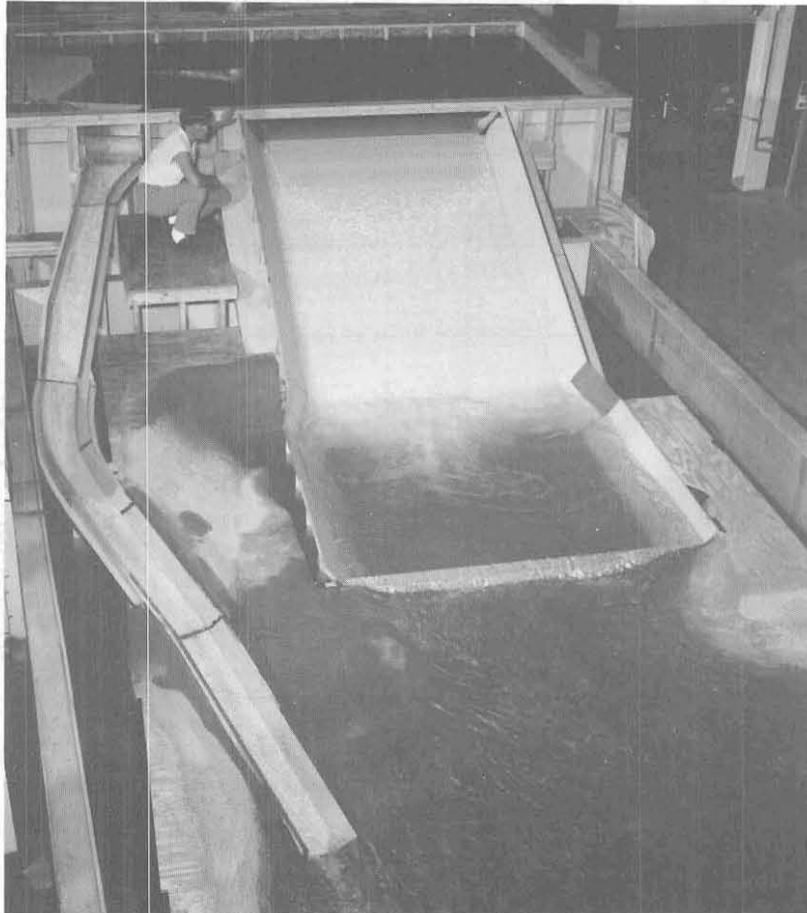
Figure 2. - 1:30 scale model of the initial design for the existing and RCC stepped spillways.

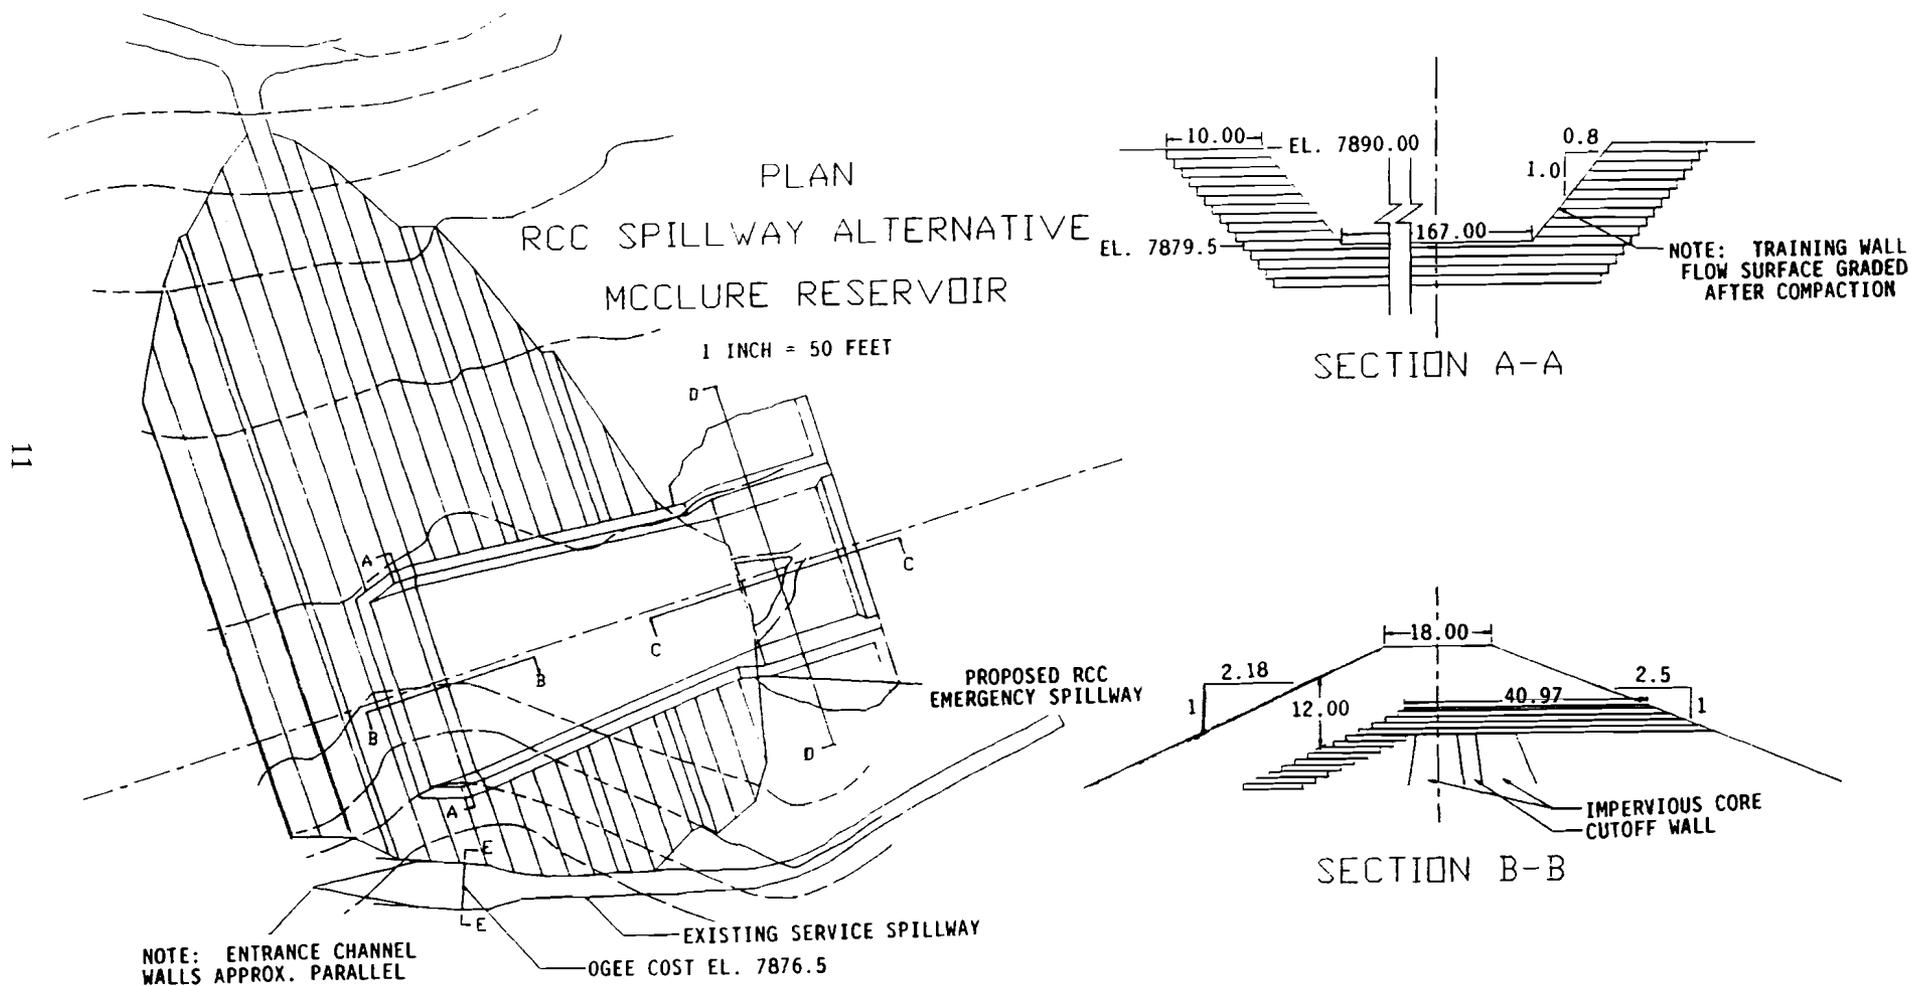
Figure 3. - Feasibility drawings of the RCC stepped spillway.

The 50-foot-wide stilling basin was investigated to determine its energy dissipation characteristics. The 131-foot-long basin was tested with and without the design end sill (fig. 3). The basin with the 17.7-foot-high end sill produced excellent energy dissipation for all flow rates under normal tailwater

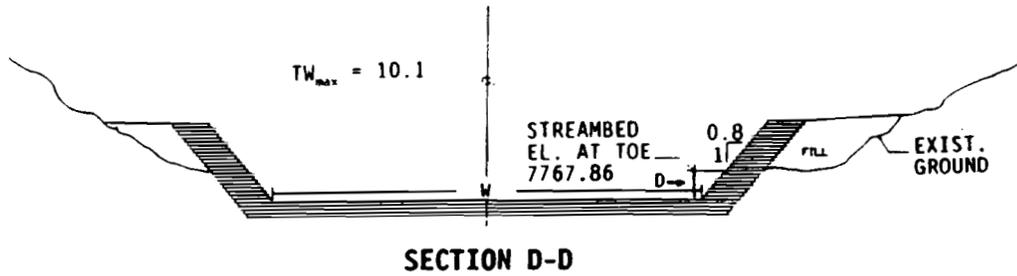
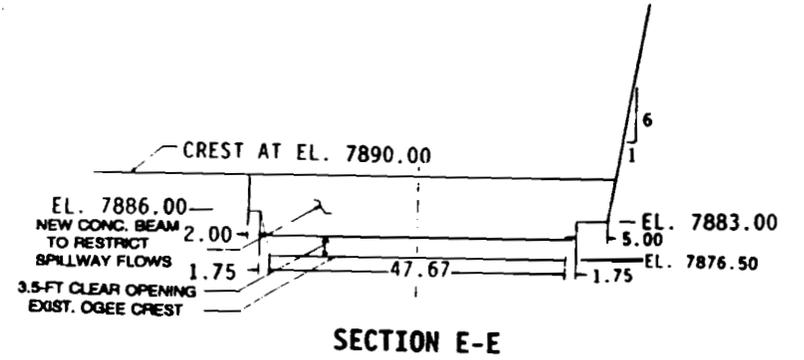
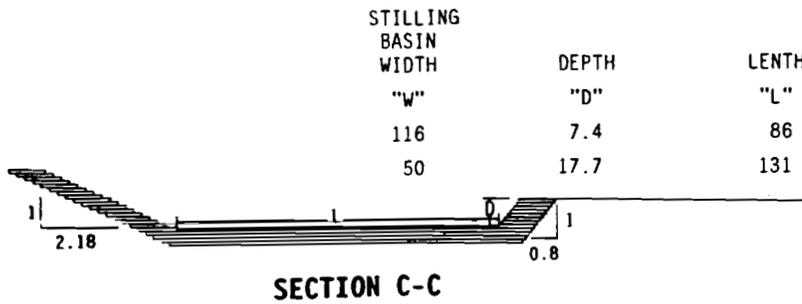
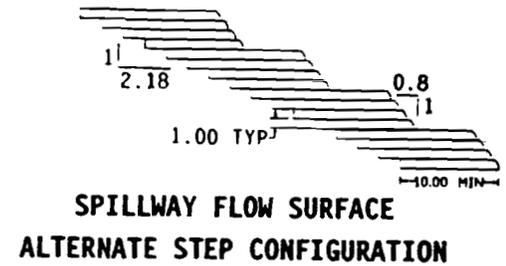
Figure 3. - Feasibility drawings of the RCC stepped spillway. - Continued

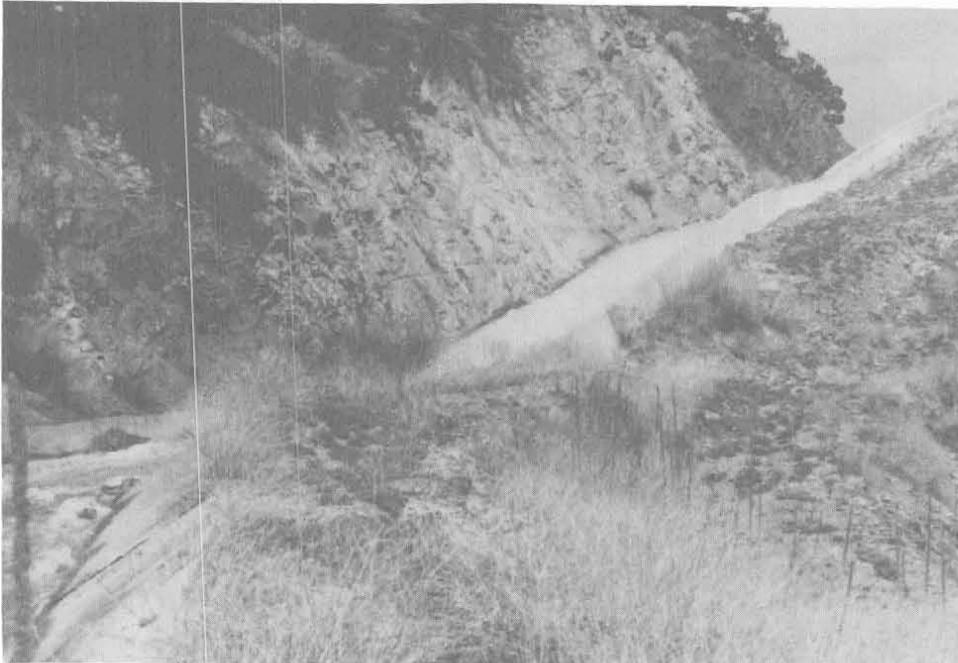
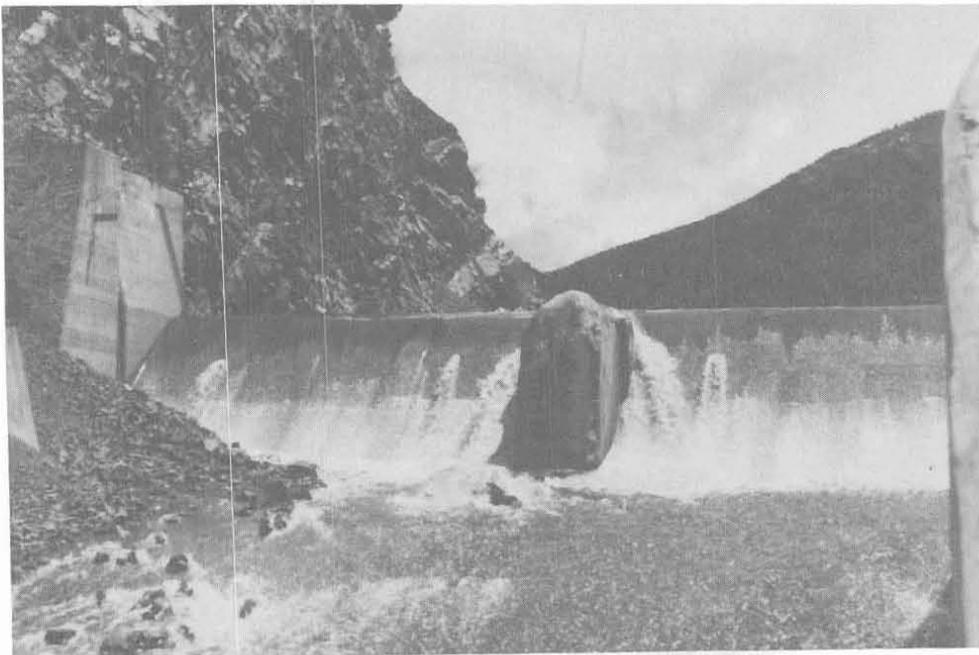
(a) Existing service spillway chute.

(b) Crest for existing service spillway.

Figure 4. - Existing service spillway. (Note: Center pier not included in model.)

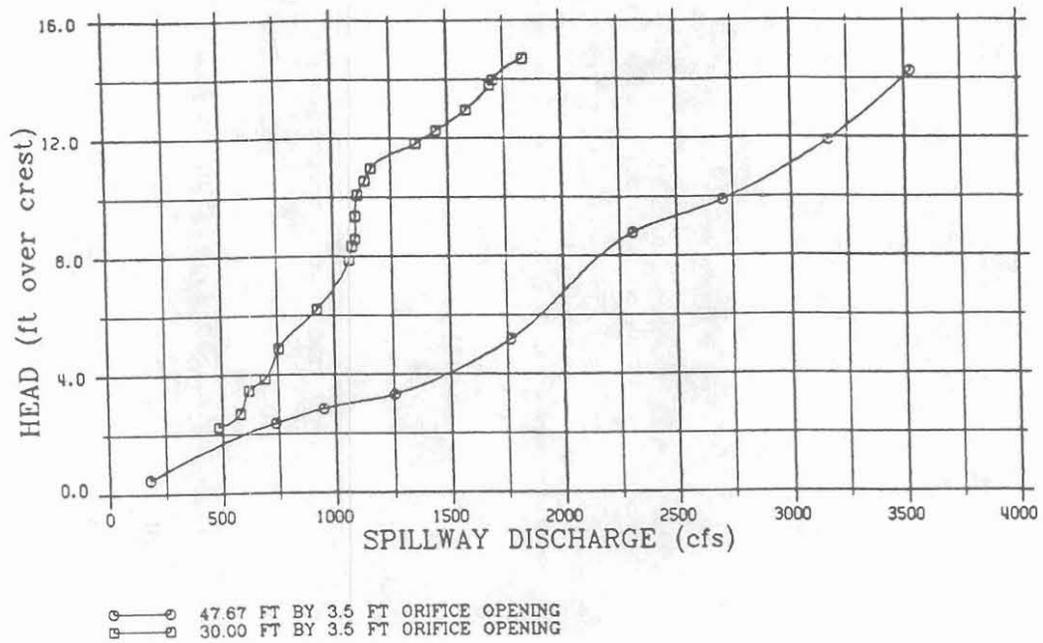
Figure 5. - Discharge rating curve for the existing spillway with an orifice constructed above the crest.

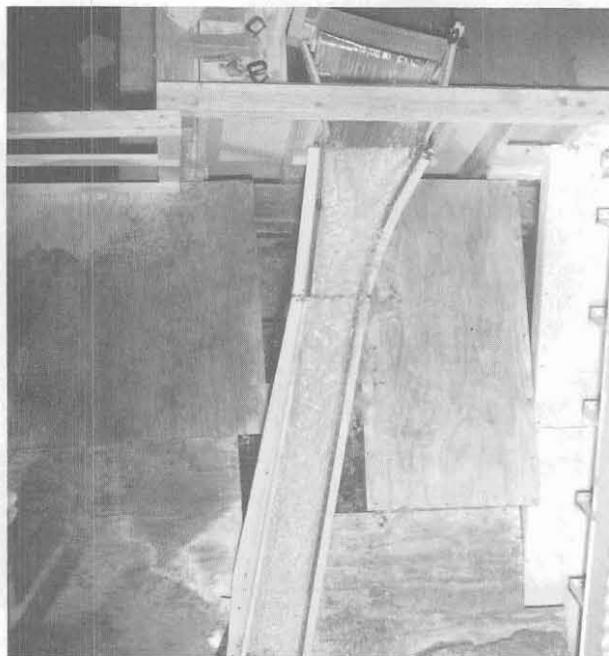
Figure 6. - Overtopping the left chute wall downstream of the crest for a discharge of 3,440 ft³/s through the 47.67- by 3.5-foot opening.

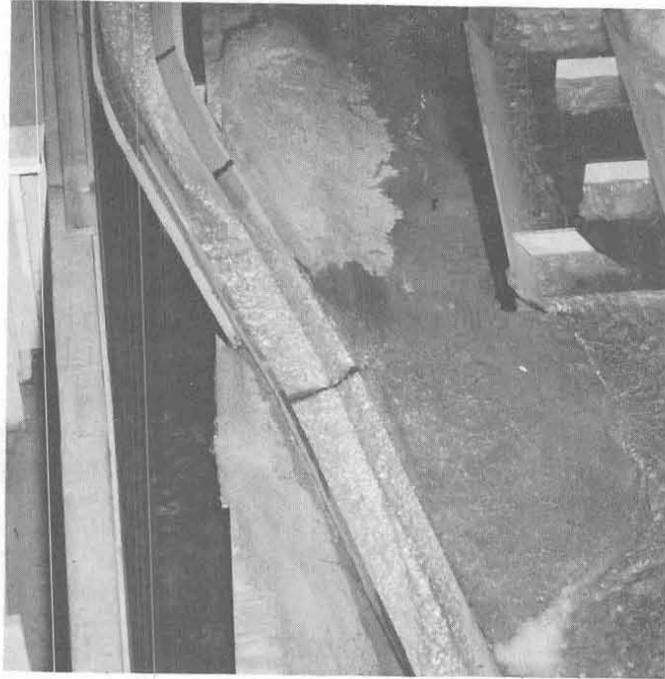
Figure 7. - Overtopping the left wall downstream of the horizontal bend for a discharge of $3,440 \text{ ft}^3/\text{s}$ through the 46.67- by 3.5-foot orifice.

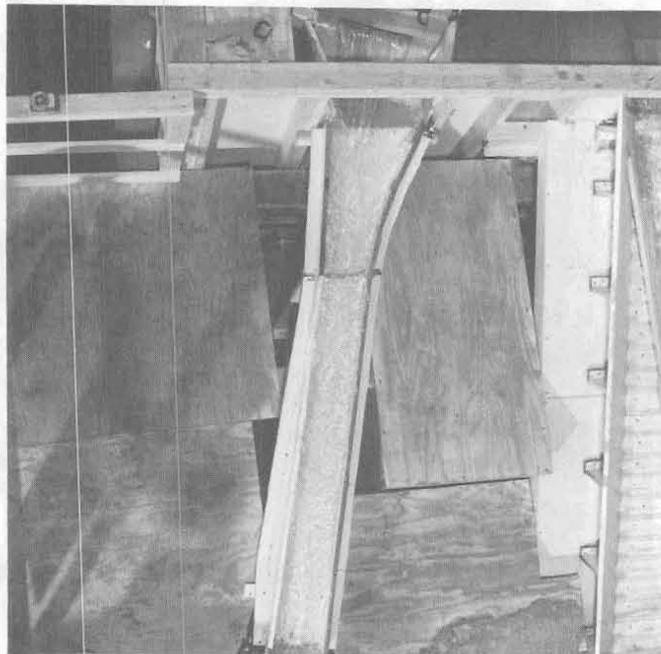
Figure 8. - Overtopping the left wall downstream of the crest (30- by 3.5-foot orifice).

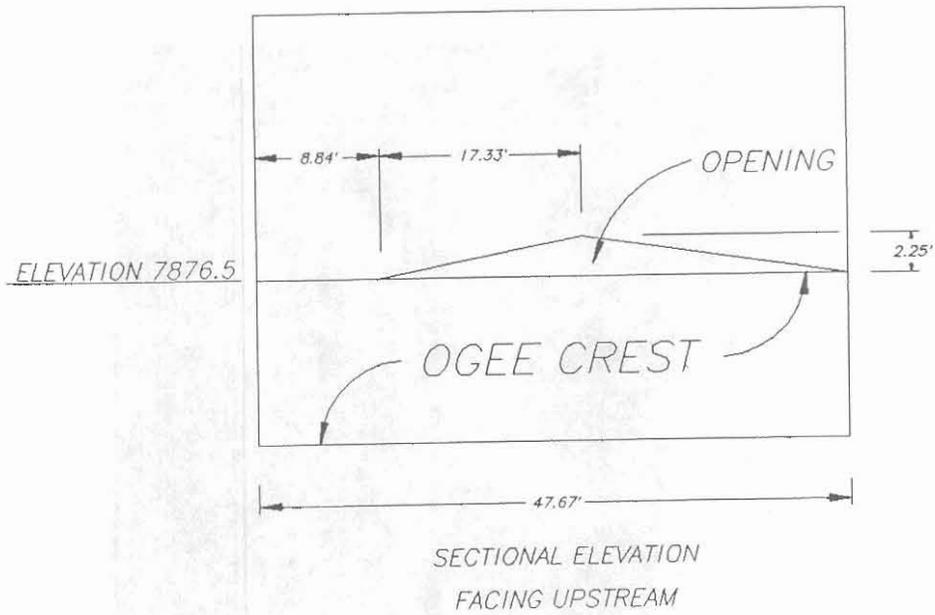
Figure 9. - Triangular orifice that successfully restricts chute discharge at maximum water surface.

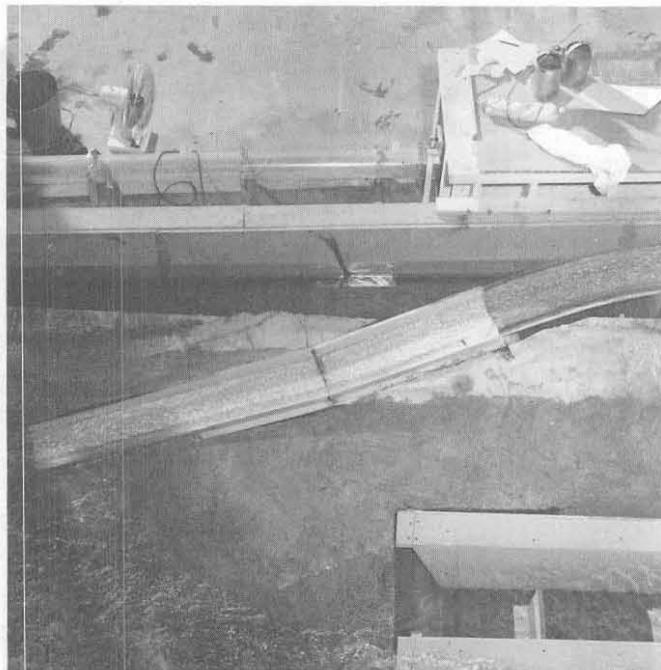
Figure 10. - Superelevation of the bend prevented overtopping of the left chute wall downstream.

Discharges greater than 1,100 ft³/s passed by the existing spillway, regardless of the crest geometry, caused the sloping left wall downstream of the horizontal bend to be overtopped. Superelevation was added at the bend by forming 75-foot transition spirals into and out of a 5-foot banked section in the center of the bend. Adding the superelevation prevented overtopping of the left wall downstream of the bend for the entire discharge range of the 30- by 3.5-foot rectangular orifice (fig. 10).

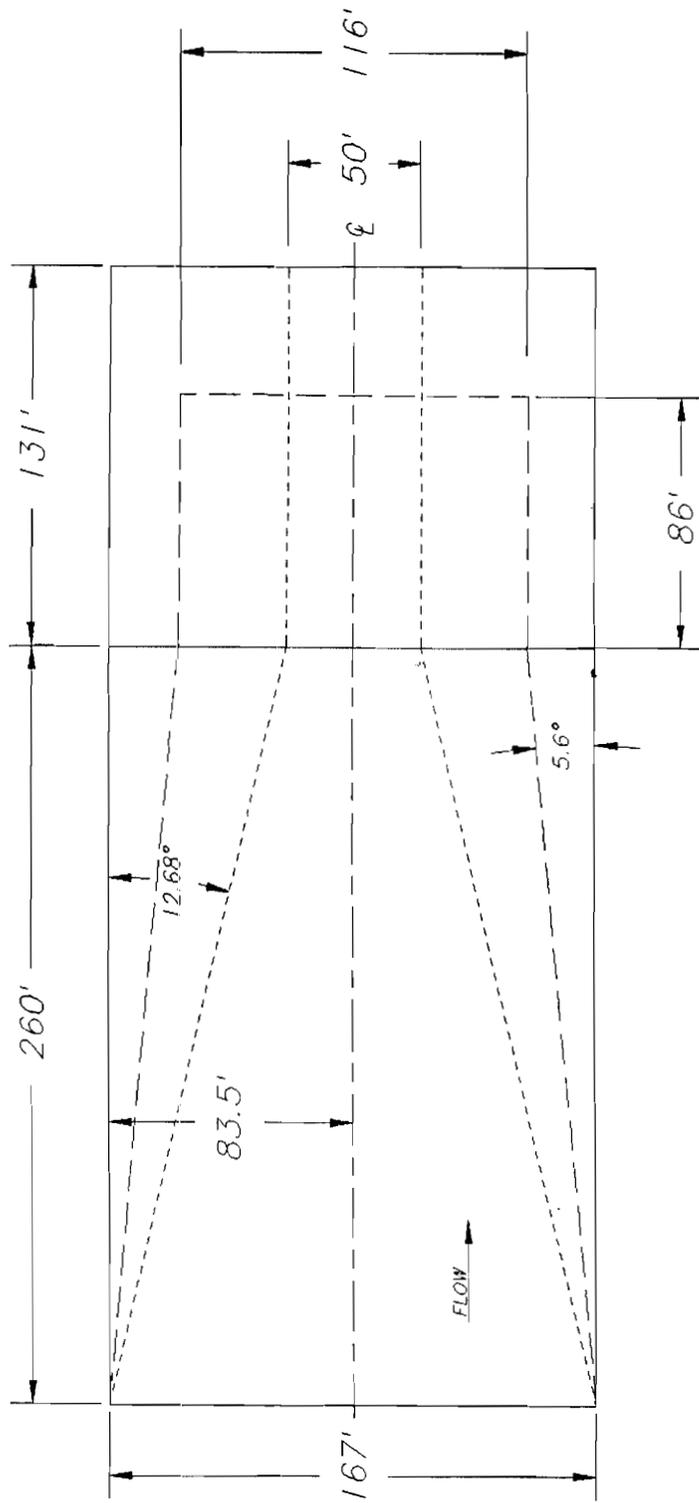
PLAN

(END SILL NOT SHOWN)

Figure 11. - Plan of the RCC spillway and stilling basin showing the wall convergences tested.

As a basis for comparison, the RCC spillway was tested first with parallel chute walls or no wall convergence (fig. 11). The methods used to evaluate the performance of the stepped spillway were

Initial tests were performed with 1-foot steps for the entire 167-foot spillway chute width or no convergence of the chute walls. Results from these tests indicated that investigation of converging spillway chute walls was applicable. The same tests were then completed for chute wall convergences that produced 116- and 50-foot widths at the toe of the dam (fig.11).

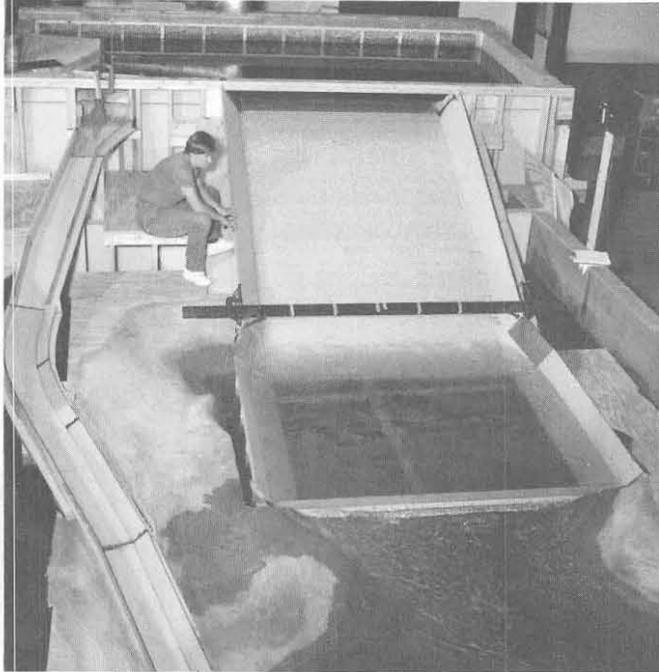
Figure 12. - Discharge of $5,000 \text{ ft}^3/\text{s}$ over the 1-foot-high stepped RCC spillway with no chute wall convergence.

Flow conditions in the spillway chute and stilling basin with no convergence of the walls were excellent. As expected, for small unit discharges, the flow became rough very near the spillway crest and remained rough down the full length of the chute with the jet entering the basin and breaking up before impinging on the floor (fig. 12). As the discharge increased, the jet traveled further down spillway chute before becoming rough; however, flow conditions remained excellent (fig. 13).

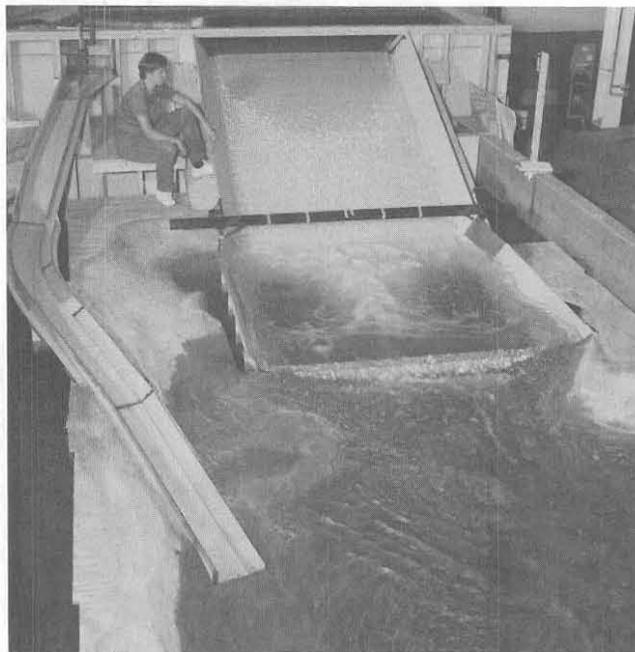
Figure 13. - Passage of design discharge over the 1-foot-high stepped RCC spillway.

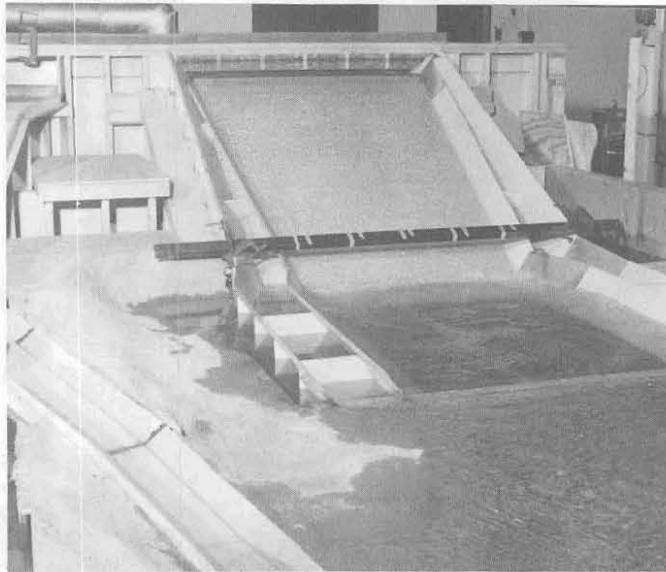
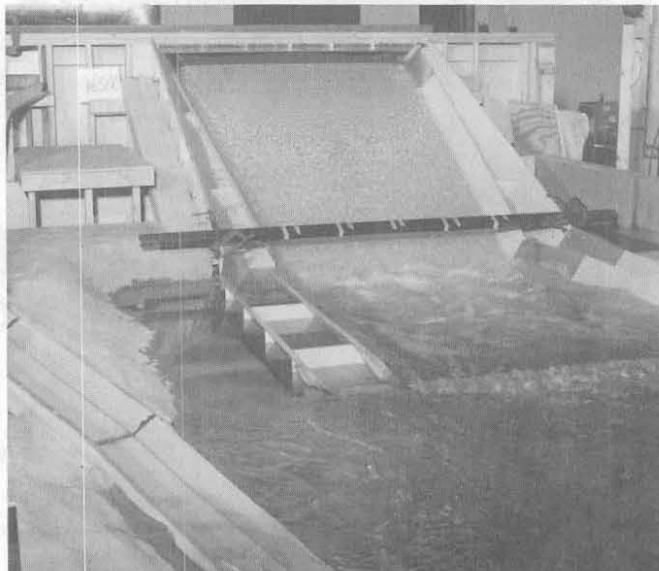
(a) $Q = 5,000 \text{ ft}^3/\text{s}$

(b) $Q = 16,534 \text{ ft}^3/\text{s}$

Figure 14. - RCC spillway with 1-foot steps and a 116-foot chute width at the dam toe.

The spillway chute walls were then modified to converge at 5.6° resulting in a 116-foot width at the dam toe. Flow conditions near the crest were identical to those with no wall convergence. Flow depths increased as the width decreased, particularly along the walls; however, no cross waves developed in the chute. Flow conditions were excellent throughout the chute and stilling basin indicating that the steps were still performing adequately (fig. 14).

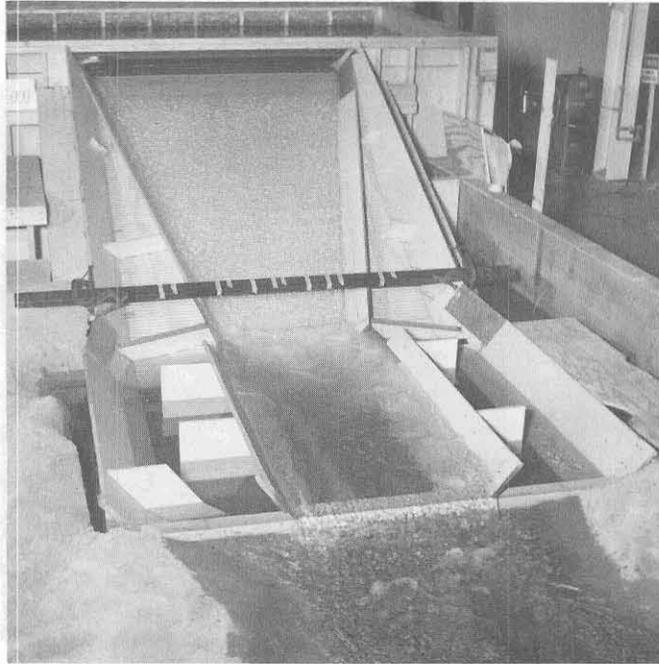
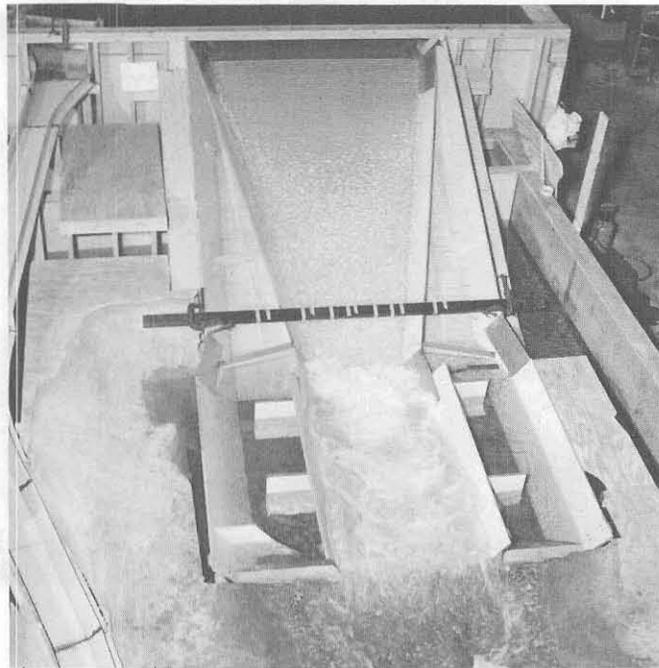
(a) $Q = 5,000 \text{ ft}^3/\text{s}$.

(b) $Q = 16,534 \text{ ft}^3/\text{s}$.

Figure 15. - RCC spillway with 1-foot steps and a 50-foot chute width at the dam toe.

The 12.68° wall convergence resulted in a 50-foot-wide basin at the dam toe. Flow conditions were excellent; however, flow depths were significantly increased. Fins rose up the side walls, but no cross waves were formed, probably due to the rough water surface created by the steps. The chute walls must contain a flow depth of 7 feet, measured from the downstream edge of the step normal to the slope. Figure 15 shows the spillway operating at 5,000 and 16,534 ft³/s with the chute converging to 50 feet at the dam toe.

The 4-foot steps were expected to dissipate substantially more energy than the 1-foot steps, although the velocity measurements did not so indicate. Comparing the stilling basin action with that of the 1-foot steps indicated that, with the 4-foot steps, the jump had moved slightly upstream and the flow exiting the basin appeared calmer (figs. 15 and 17).

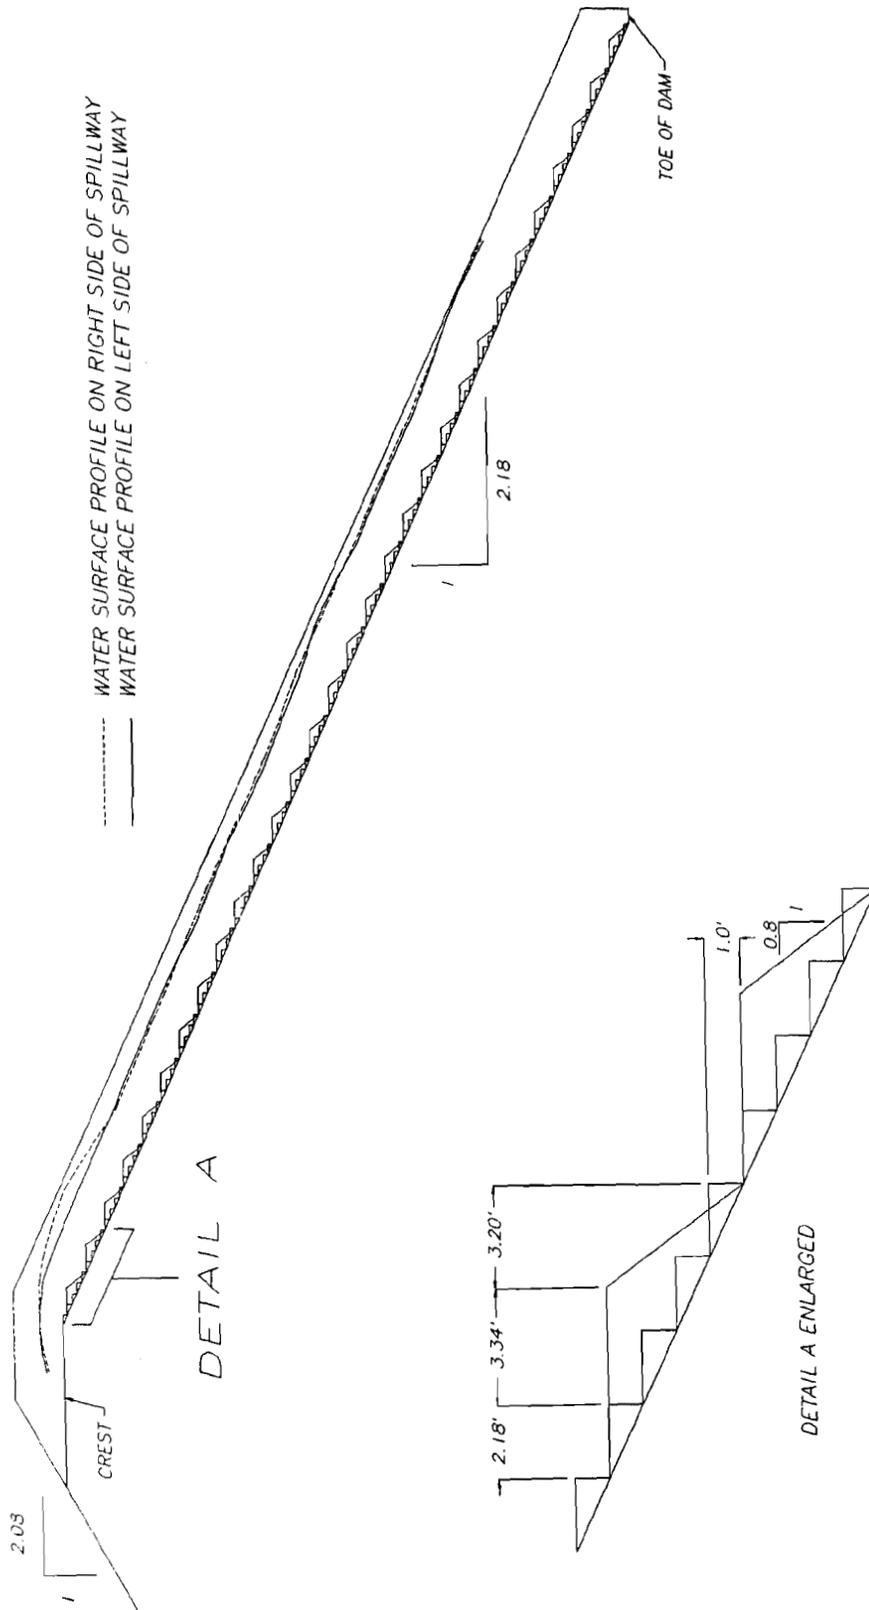
Figure 16. - Step geometry and chute water surface profiles for 4-foot steps.

The 4-foot steps were added to the model on top of the 1-foot steps, beginning 1 foot below the broad crest, for the entire width of the chute (fig. 16). Tests were conducted only for the convergence to a 50-foot width at the dam toe based upon the results from tests with the 1-foot steps. The 4-foot steps were tested to determine if the greater step height would increase the energy dissipation characteristics of the spillway.

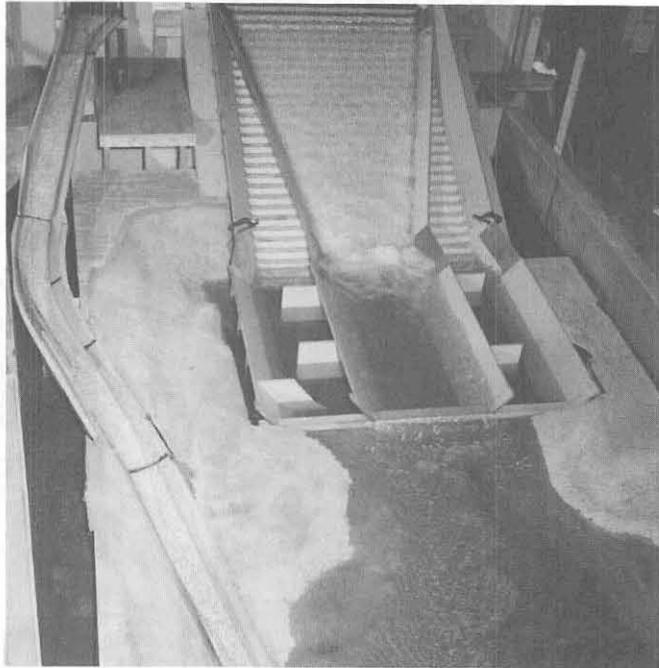
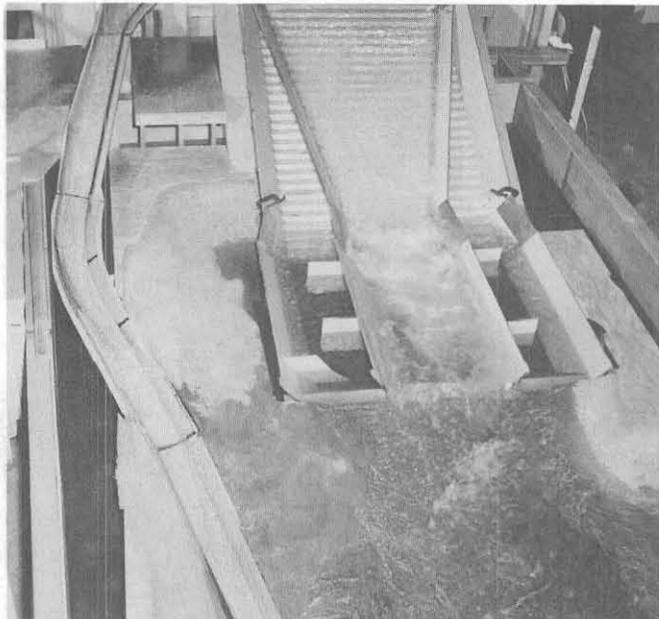
(a) $Q = 5,000 \text{ ft}^3/\text{s}$.

(b) $Q = 16,534 \text{ ft}^3/\text{s}$.

Figure 17. - RCC spillway with 4-foot steps and a 50-foot chute width at the dam toe.

Observation of the flow on the stepped face indicated a rougher flow closer to the crest (fig. 17). This was shown by "white water" or a rough water surface that continued until the jet entered the basin. The rougher water surface created a greater flow depth throughout the chute than with the 1-foot steps. Figure 16 shows the water surface profiles along the right and left chute walls for 4-foot steps. At the design discharge, a maximum flow depth of 8.5 feet, measured from the edge of the steps normal to the slope, was contained by the training walls.

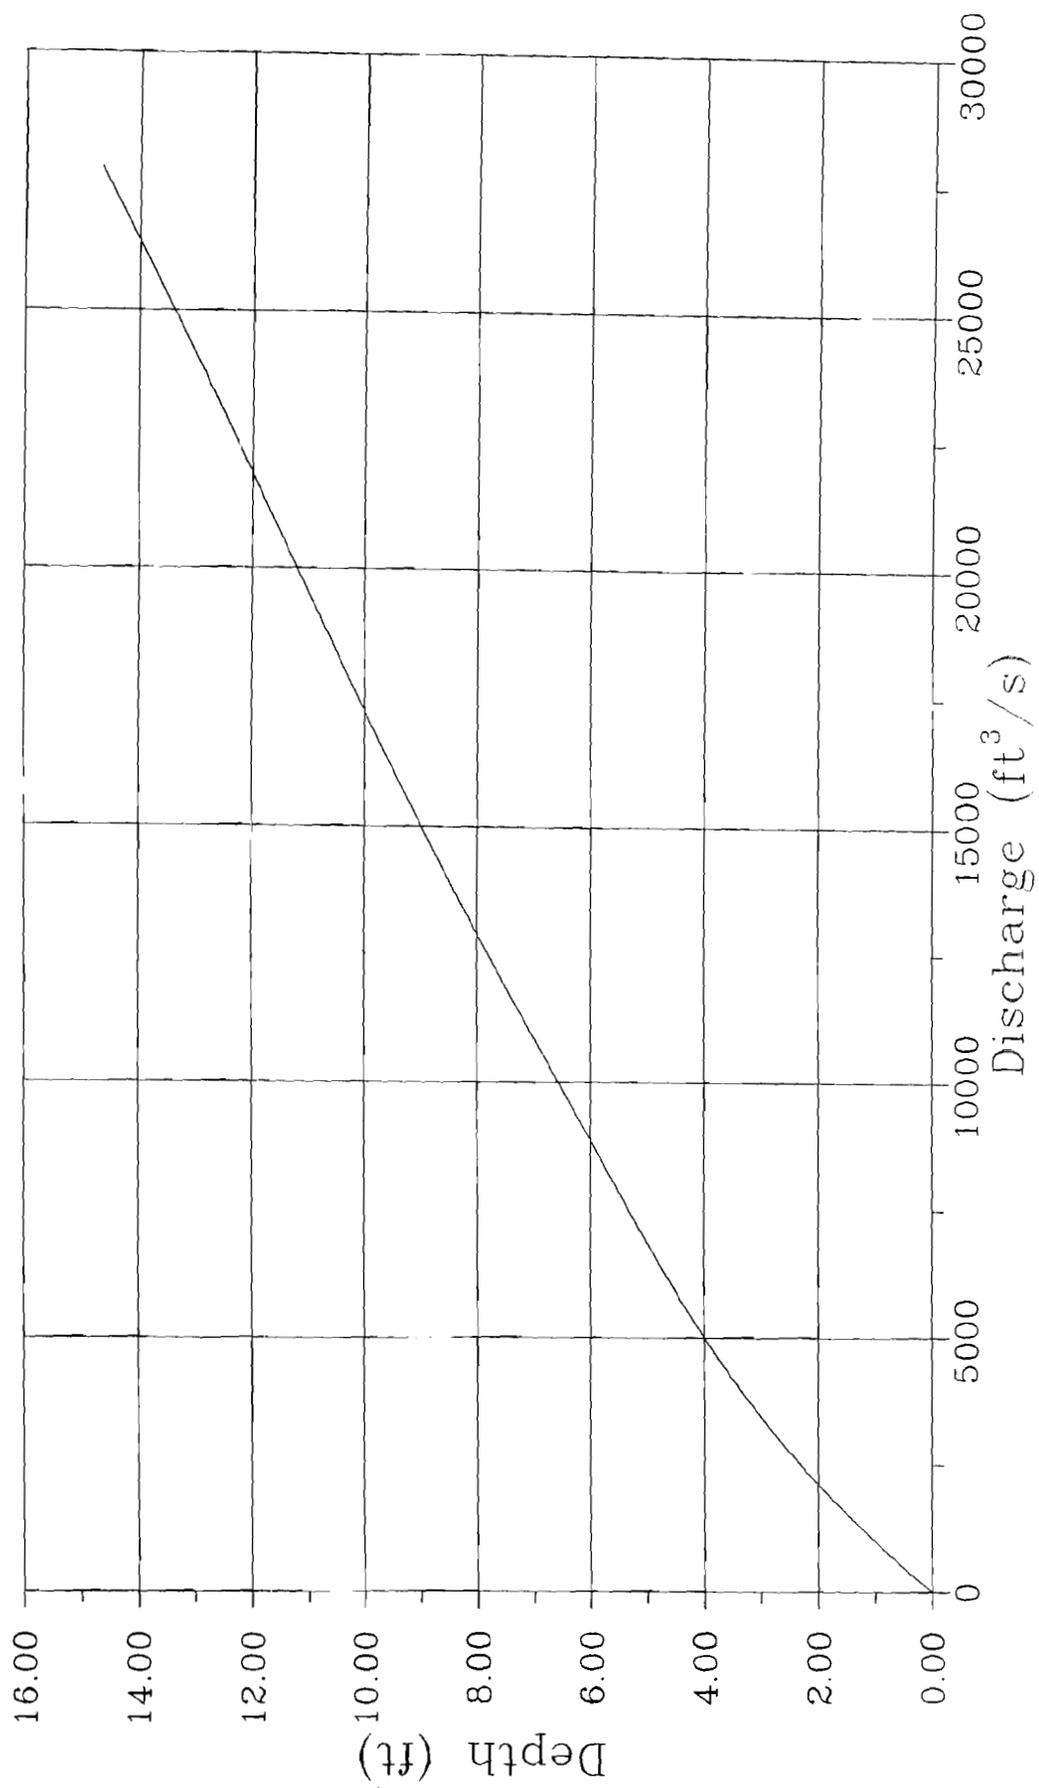
Figure 18. - Tailwater rating curve.

elevations. Tailwater elevations were referenced to a streambed elevation of 7767.86 feet. This gives a tailwater elevation of 11.0 feet at design discharge (fig. 18).
