TR-2016-02

Travel to Grand Coulee Third Powerplant for strain gauge tests on unit G21 stator spring system

Date(s) of Travel: June 5 – 10, 2016

TRAVEL REPORT

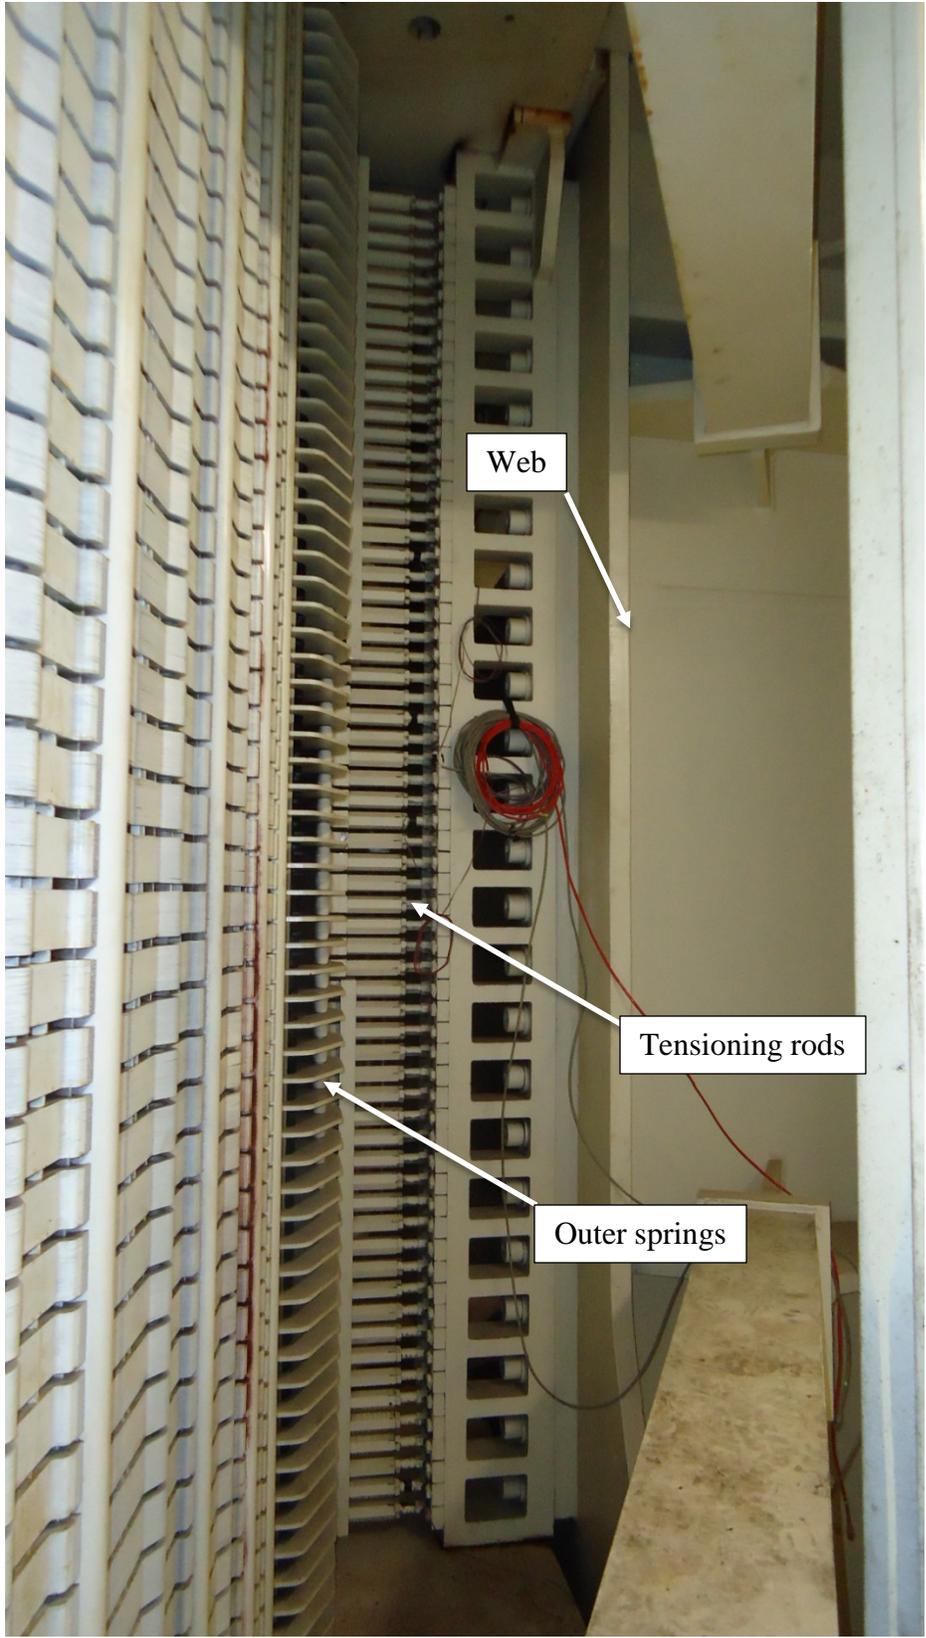
Figure 1 Overview photo of G21 stator tensioning & spring system

The spring and tensioning system for the G21 stator includes 15 large steel columns, known as webs which are placed evenly around the outside diameter of the stator. Each web contains 64 tensioning rods and springs that work in a system to properly secure the stator during operation (Figure 1). Strain gauges were installed on 4 different tensioning rods (Figure 2) from each web. Webs 2, 5, 8, 11, and 14 also contained strain gauges on the left and right sides of one outer spring and adjacent tensioning rod (Figure 3). A total of 70 strain gauges were installed. All gauges were installed in a quarter-bridge configuration and were aligned to measure strain in the axial direction. Gauges were purchased from Omega Engineering Inc and contained 3-wires, 3-mm grid size, and 350 ohm resistance.

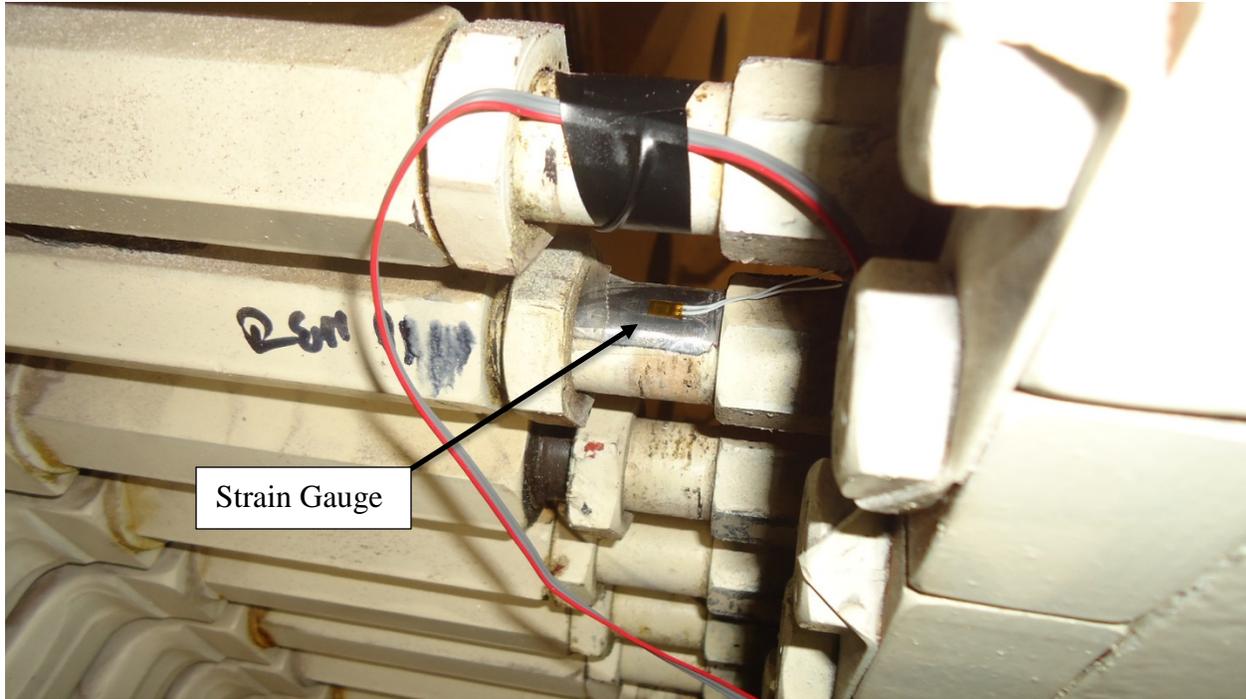
Figure 2. Axially-oriented strain gauge installed on tensioning rod.

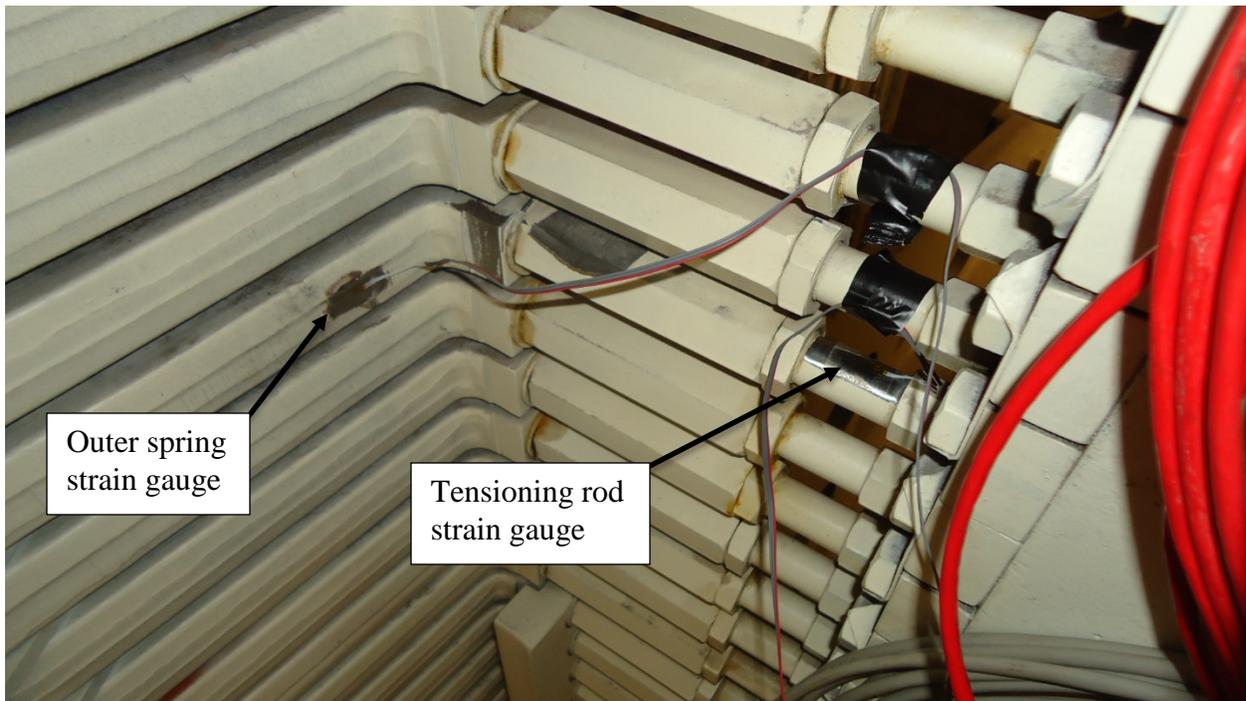
Figure 3. Strain gauges installed on the left side of an outer spring (gauge also installed on right side but not visible in the photo) and tensioning rod.

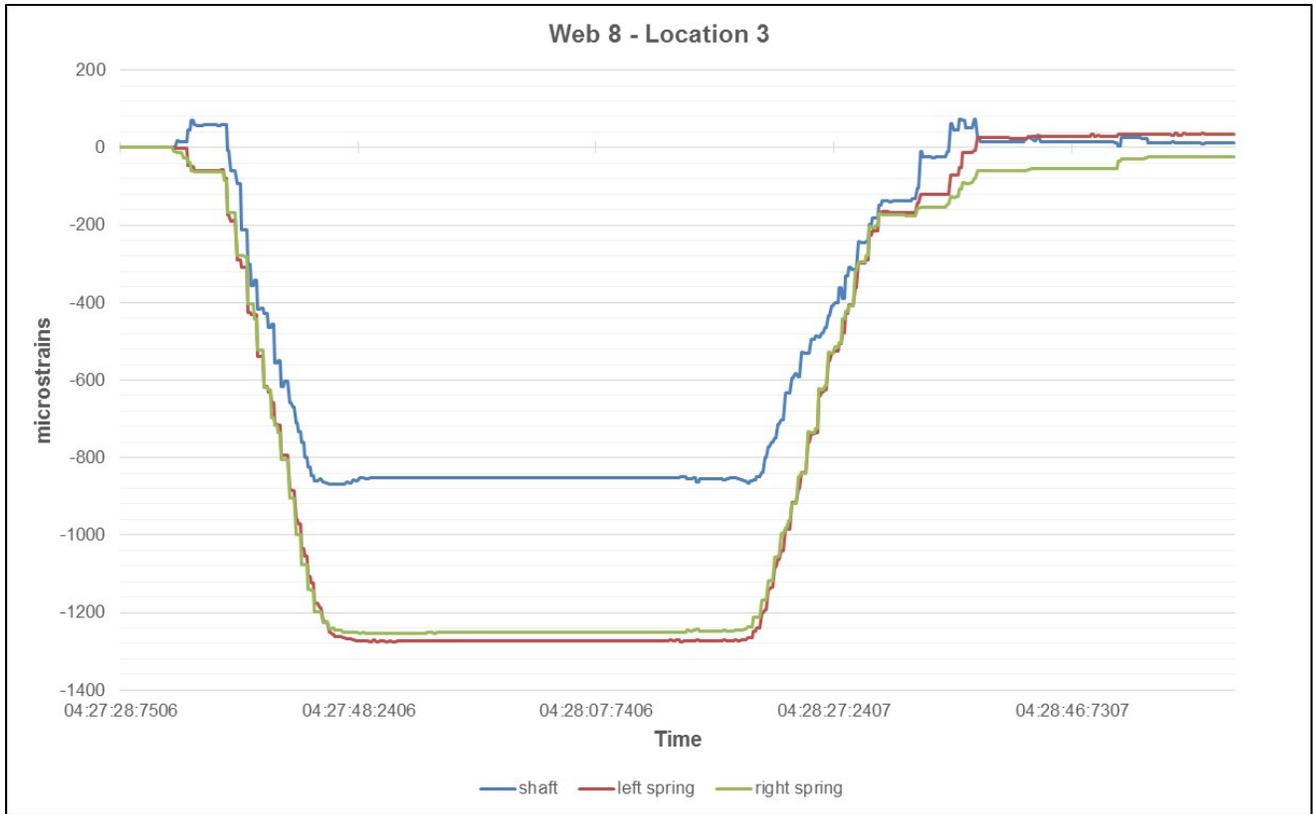
Figure 4. Example of test data for location 3 of web 8 which included two gauges on the outer spring and one on the tensioning rod.

Testing included manually loosening the block bolts behind the tensioning rod and then re-tightening the bolts to the recommended torque. Before each test the strain gauges were zeroed in the existing condition under tension. Strain data were then acquired as the tensioning rod went from tension, to zero strain, and then back to tension (the cycle appears as zero strain, followed by compression and then a return near zero strain, see Figure 3). All test data were collected with a Micro Measurements D4 conditioner data acquisition unit at a rate of 8 samples/second.
