# RECLAMATION

Technical Memorandum No. 8540-2017-047

## Coal Tar Enamel Repair Guide

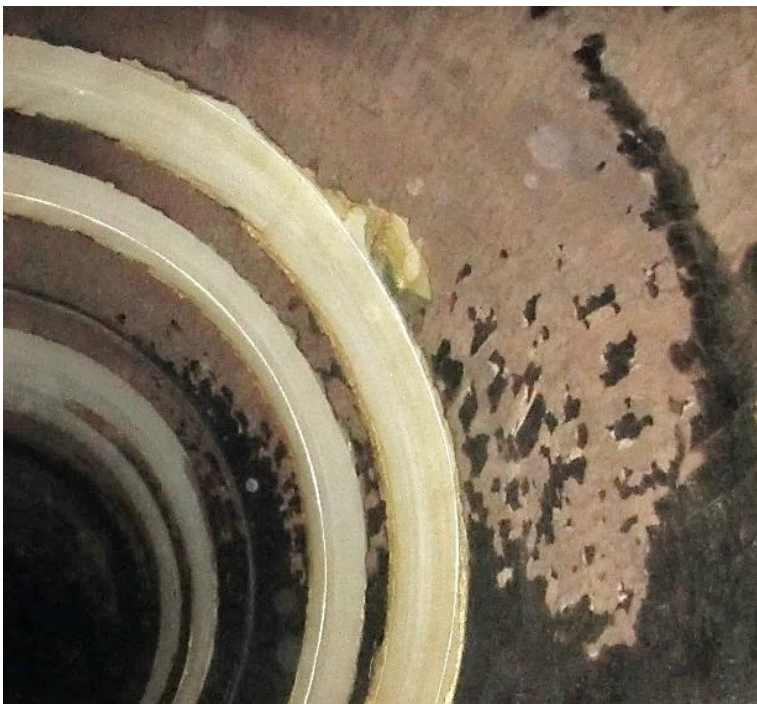
**Figure 2. Coal tar enamel lined discharge tube showing badly degraded enamel in the pipe crown and several bands of spot repairs at Unit 6, Grand Coulee Keys Pump/Generator Plant. Photo taken in the above ground section, which is subjected to fluctuating temperatures.**

Spot repair techniques can be very effective in extending the service life of a structure if the lining is generally in good condition. If the surrounding coal tar enamel is not in good condition, spot repairs may not be recommended. Figure 2, taken at Grand Coulee Keys Pump/Generator Plant, shows a coal tar enamel lined discharge tube with badly degraded enamel in the pipe crown and several bands of spot repairs.

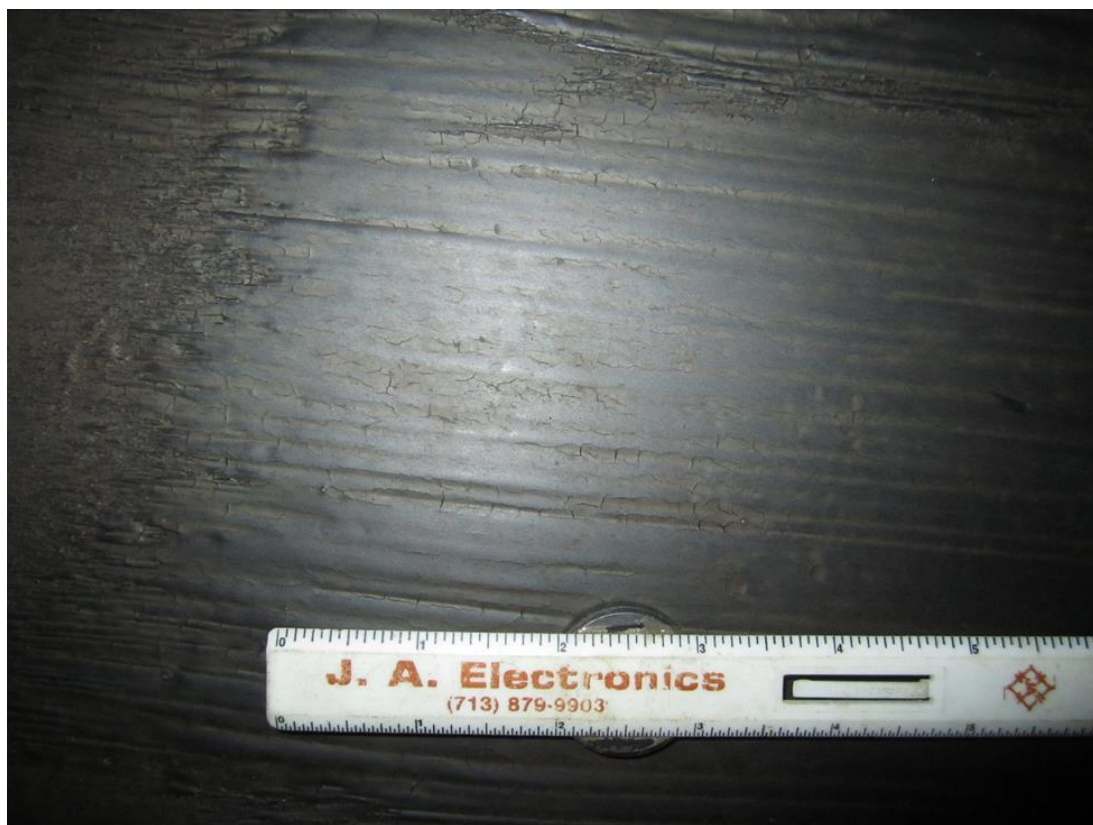
**Figure 4. Early stages of cracking that are visible only on the coating’s surface and do not penetrate down to the substrate.**

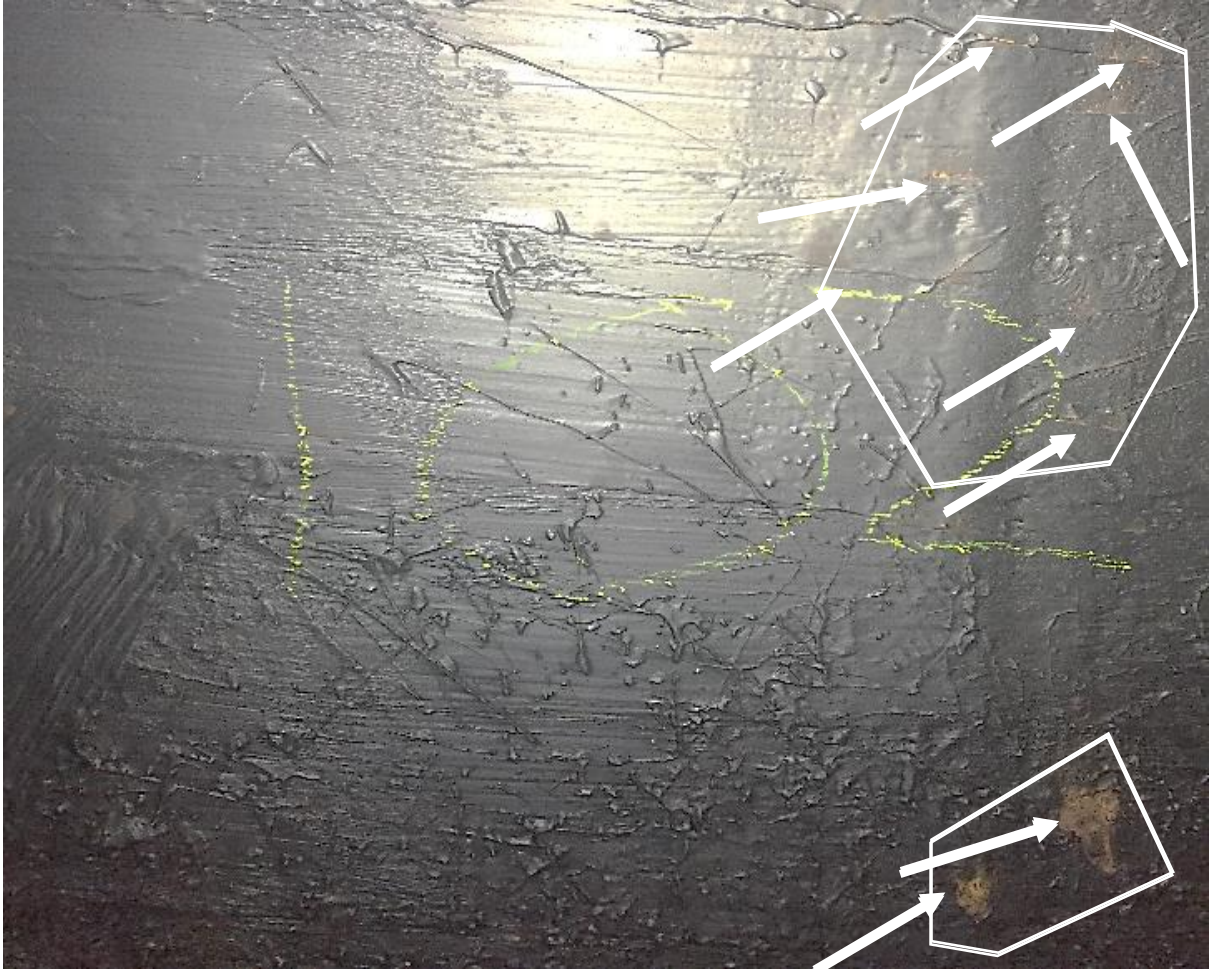
**Figure 5.** Areas selected for spot repair should be outlined to correct all defects, while preserving as much coal tar enamel as possible.

Someone will have to identify and label every spot repair that is to be completed for the contractor to conduct the work. Figure 5 shows an example of a repair area where the coating is in good condition, with arrows pointing out the minor coating cracks and corrosion. In this particular example, the corroding defects are grouped together, resulting in two spot repair areas, rather than repairing each individual damaged area. In order to conduct successful spot repairs, the surrounding enamel has to be in excellent condition to form a transition with the new coating material. This example demonstrates minimizing the repair area, while salvaging as much coal tar enamel as possible.

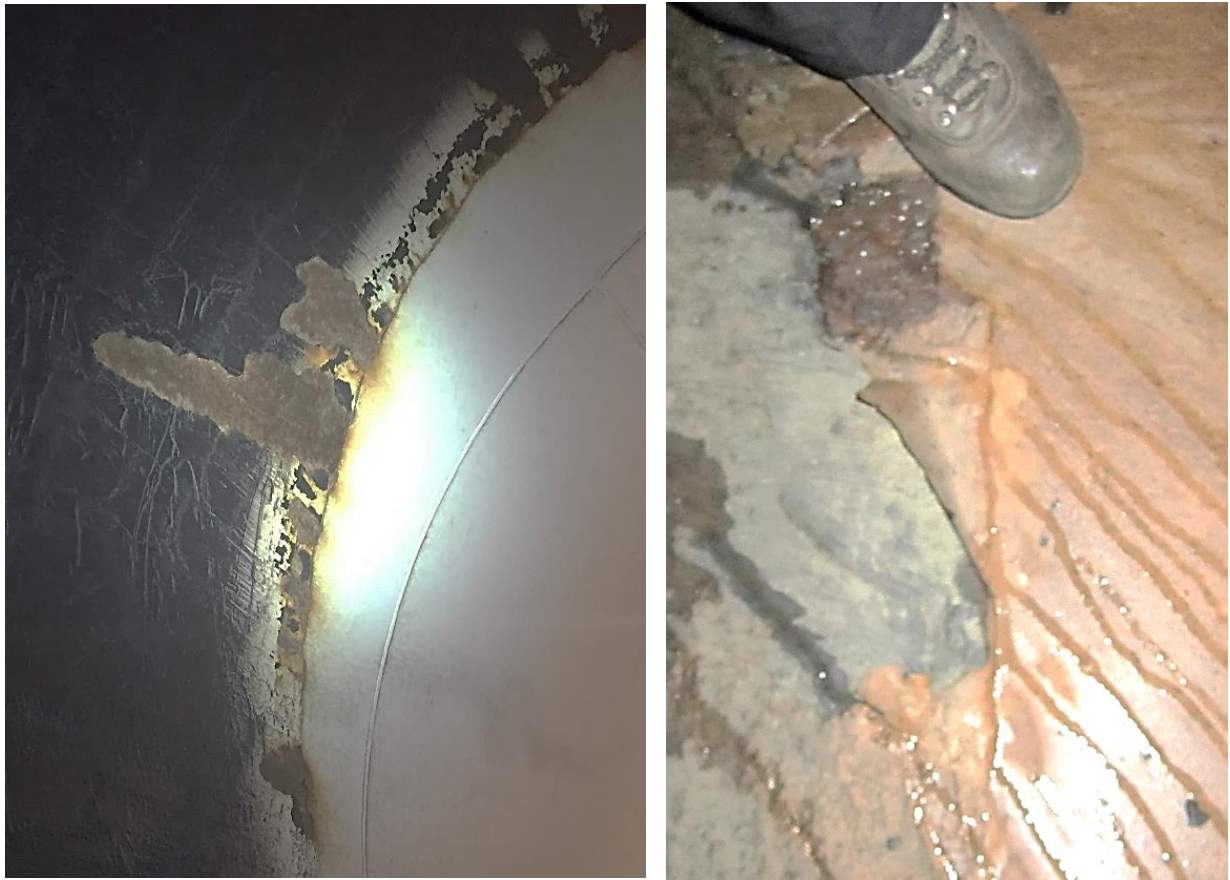
**Figure 1-2. Photograph of Unit 12 discharge tube at Grand Coulee Keys Pump/Generator Plant. Left: Solvent-borne epoxy/coal tar enamel interface; some coal tar enamel has disbonded. Right: Solvent-borne epoxy disbondment at the interface, but no corrosion.**

Experience with solvent-borne epoxy coatings has also resulted in undesirable spot repair results. Figure 1-2 (left) shows an example of a solvent-borne epoxy coating that interfaces with coal tar enamel. Use of solvent-borne epoxy resulted in failures of the coal tar enamel lining, which negatively affected the coal tar enamel coating. Figure 1-2 (right) shows another example of a solvent-borne epoxy coating interfacing with coal tar enamel. Here, the epoxy disbonded from the coal tar enamel in one area, but no corrosion is visible, and the integrity of the enamel was not compromised. This is the desirable compatibility because there is no corrosion at the interface. Unfortunately, the type of solvent-borne epoxy coating used was not documented. The only conclusion that can be made is that solvent-borne epoxies form compatible repairs in some situations, but not in others.

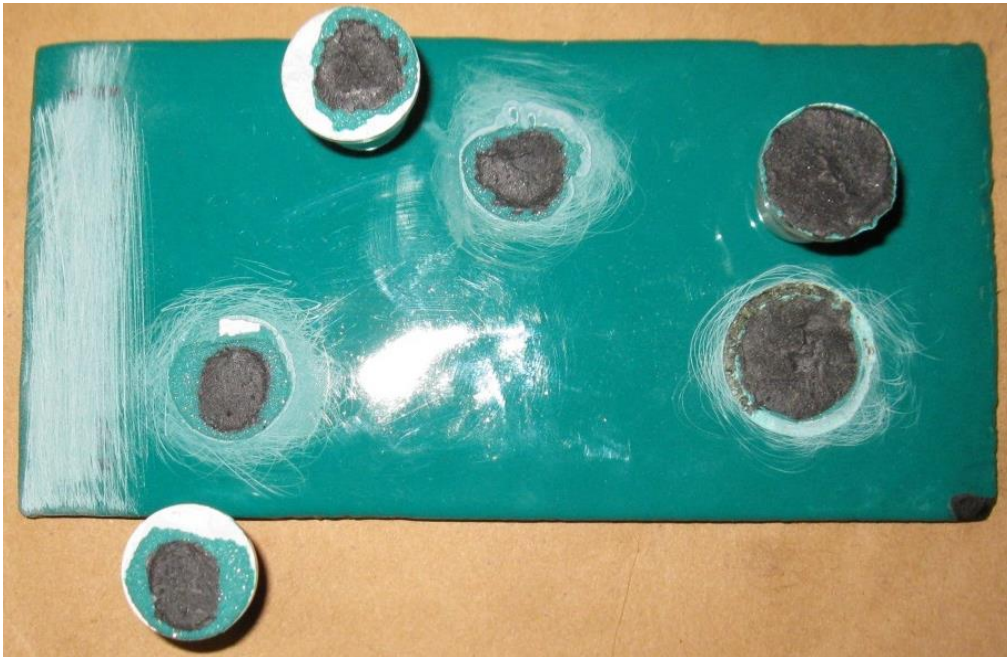
**Figure 1-4. Adhesion between coal tar enamel and Powercrete F-1, depicting failure within the coal tar enamel. Black coating is coal tar enamel, turquoise coating is Powercrete F-1 (100% solids epoxy), and the white is the aluminum dolly.**

The 100% solids epoxies have less shrinkage during the curing process, which reduces stress and improves bond stability. Specifically, these products do not contain aggressive solvents that dissolve or permeate the coal tar enamel. Even after immersion, the adhesion values stayed above 300 lb/in<sup>2</sup>. The laboratory results showed that adequate compatibility existed between coal tar enamel and the 100% solids epoxy, as seen in figure 1-4.
