R-94-17

ACOUSTIC MONITORING OF PRESTRESSED CONCRETE PIPE AT THE AGUA FRIA RIVER SIPHON

December 1994

**U.S. DEPARTMENT OF THE INTERIOR
Bureau of Reclamation
Technical Service Center
Materials Engineering and Research Laboratory Group**

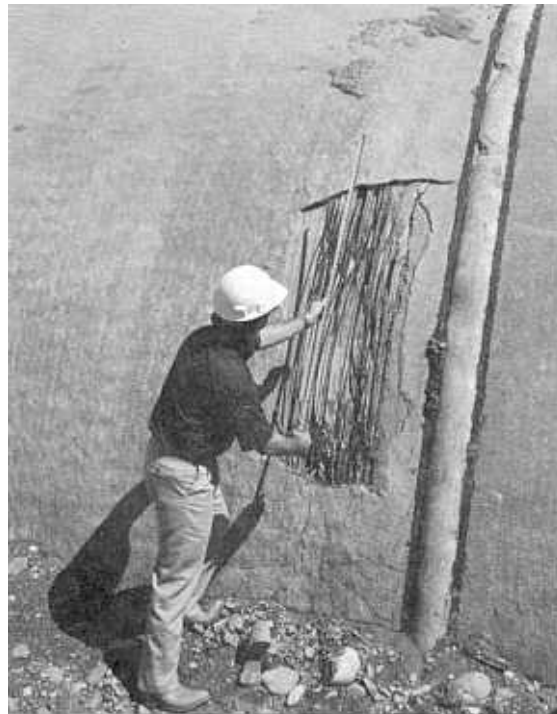
Figure 2. Deteriorated mortar coating with corroded and broken prestressing wire underneath.

The discovery of abnormal ground potential readings prompted pipeline excavation at several locations. Some of the excavated areas showed marked deterioration of the cement mortar coating and the reinforcing wire below it (fig. 2).

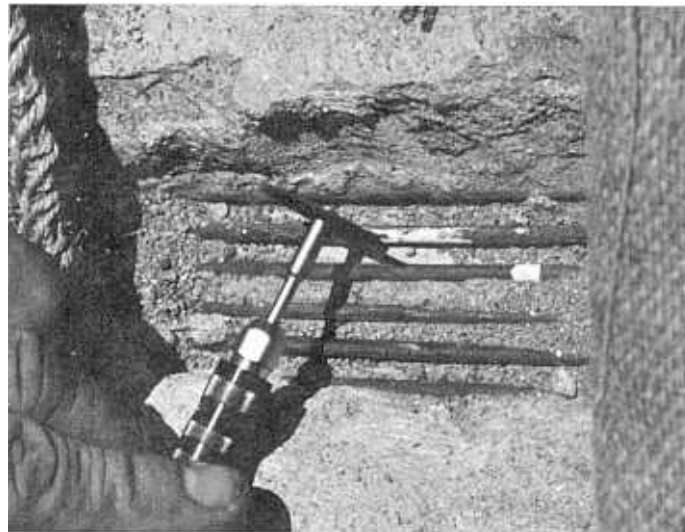
Figure 3. - Prestressing wire being ground with rotating abrasive wheel to induce breakage.

a pulsed sound at 12 kHz. Two sites were selected at which to break wires, one about 500 feet upstream from the outlet hydrophone and the other 5000 feet from the outlet hydrophone near the siphon midpoint. These sites were selected to take advantage of pipeline sections already exposed from previous excavations. The protective mortar coating was removed and two prestressing wires were ground using a rotating abrasive wheel until the wire's cross section was reduced to the point where the stress in the wire caused it to break (fig. 3). Both wire-break signals were detected by the outlet end hydrophone.

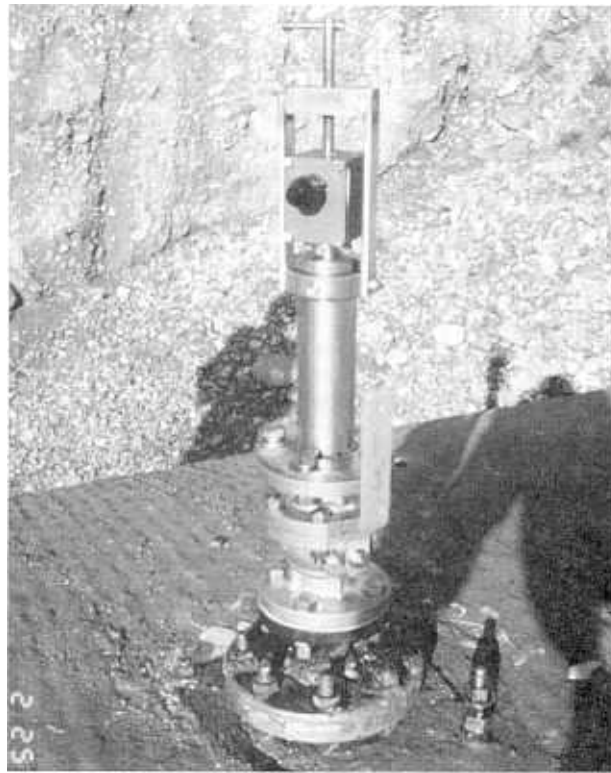
Figure 8. - Wet-tap hydrophone installation.

The pipe is "wet-tapped" by mounting a valve assembly on the outside of the pipe and then boring a hole through the open valve into the pipe wall from the outside while the pipe is under full pressure. The hydrophone is inserted into the pipe through an adaptor with O-ring seals and a ball valve assembly as pictured on figure 8. This system allows for the installation and maintenance of a hydrophone from the outside during normal operation without the use of divers.

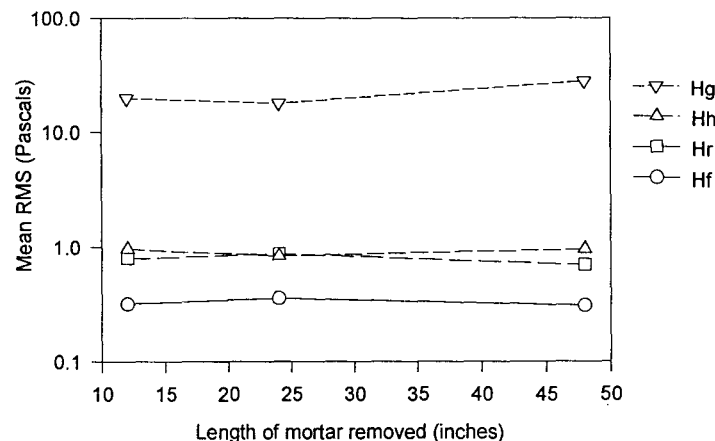
Figure 14. - Mean waveform RMS versus length of mortar removed. Notice apparent lack of correlation.

For the breaks at site G, the mean RMS of the waveforms for each hydrophone is plotted versus the length of mortar removed in figure 14. This plot indicates that no relation appears to exist between the length of mortar removed and the magnitude of the signal.
