**REC-ERC-86-3**

**ANALYSIS OF THE  
BUREAU OF RECLAMATION'S  
USE OF GROUT  
AND GROUT CURTAINS—  
SUMMARY**

**February 1986  
Engineering and Research Center**

**U. S. Department of the Interior  
Bureau of Reclamation**

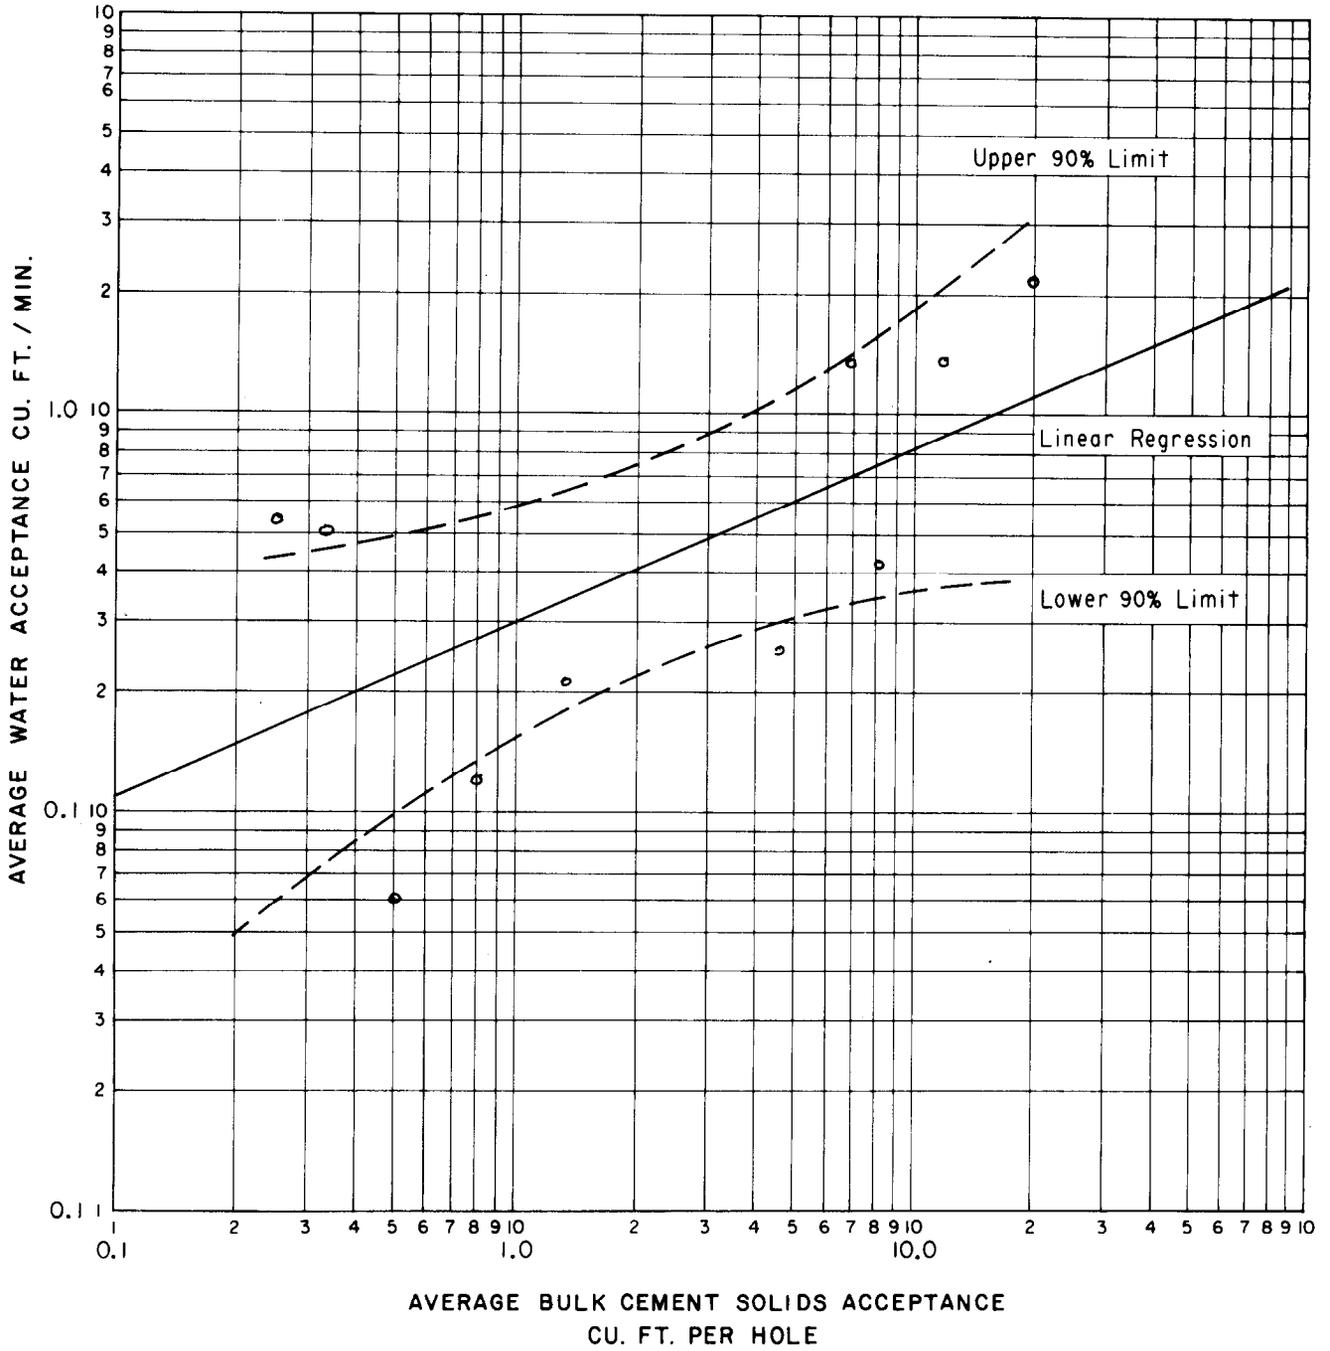
FIGURE 1

AVERAGE WATER ACCEPTANCE  
VS:  
AVERAGE GROUT ACCEPTANCE

Table 12 shows the tabulation of water testing done in Spillway Blocks S2 and S3. The upstream barrier testing was done by the same methods as the Intake barrier holes. The testing of the grid holes (PS-series) was done in accordance with the instructions of Drawing A-10 of Appendix A. These tests showed BP-X to be open in the same manner as Blocks D4, D5 and D6 of the intakes (i.e. fluctuating readings). The upstream barrier holes showed BP-4 to be tight in S2 and S3, however, one must consider the heavy grouting previously in the adjacent Block S1. The water tests in the grid were done with a single stage combining the contact area and BP-4. As such the results for BP-4 cannot be separated from the contact. The water test results for the 33 psi tests were adjusted to 40 psi for plotting on Figure 1.

Table 13 shows a summary of the water tests and solids acceptances for various areas of the foundation. This data was used to plot Figure 1 which shows a plot of the average water acceptances vs: the average cement solids injected, for various areas. Average acceptances were used because of the large grout spreads. That is a hole could have a large water acceptance prior to the grouting of adjacent holes, and then be grouted by interconnection with other holes.

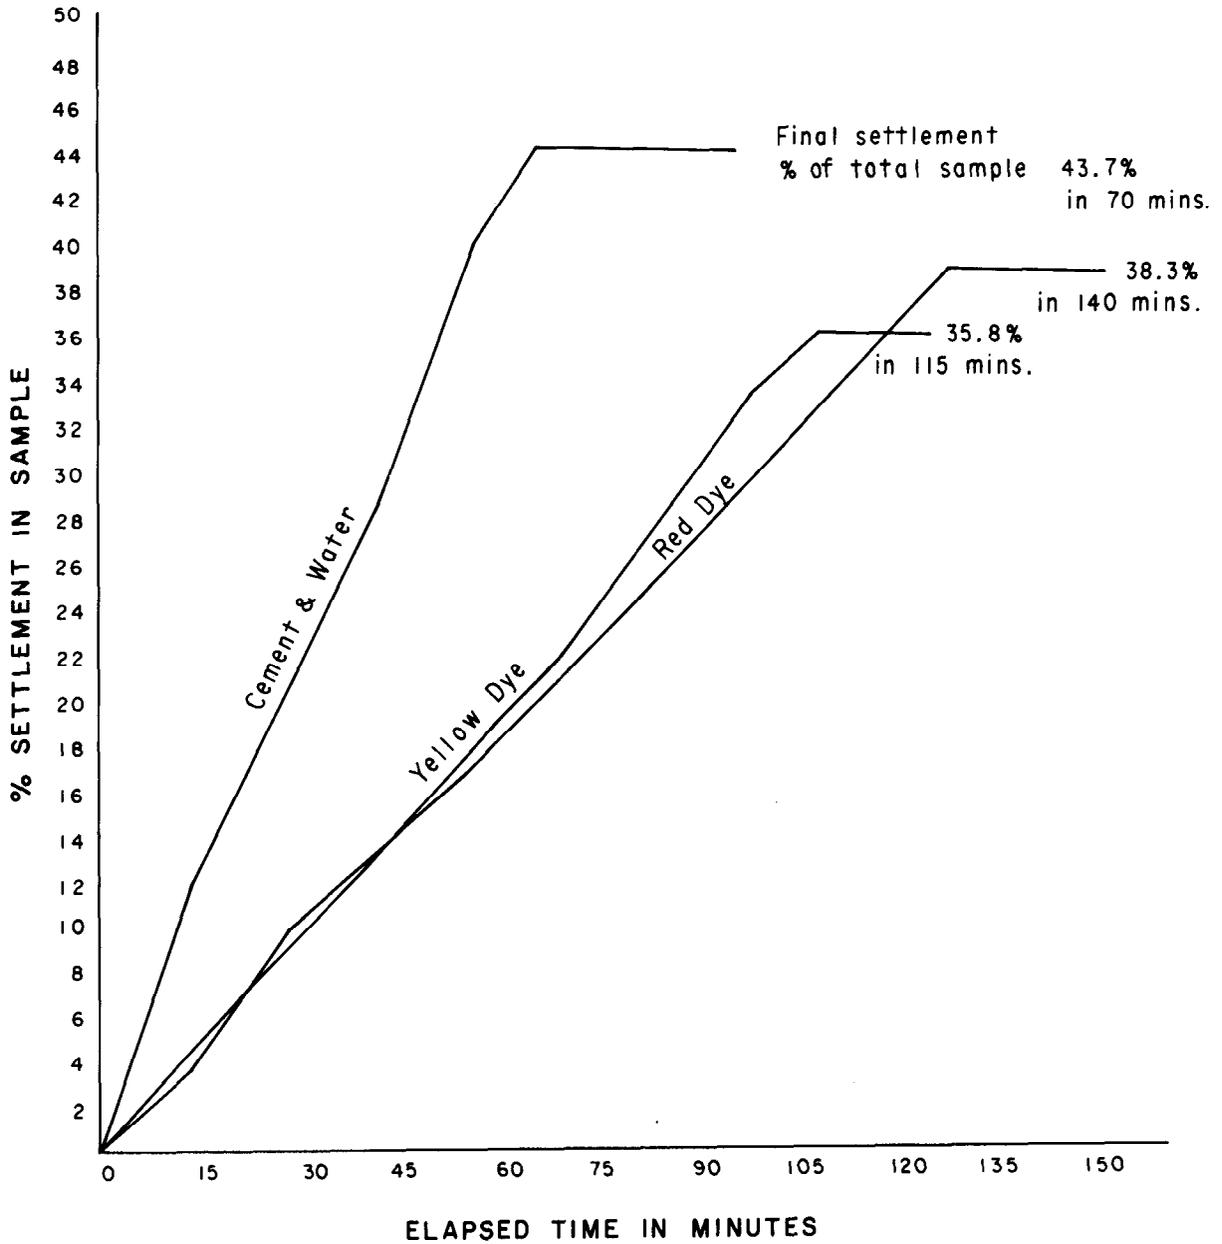
# SETTLEMENT IN DYE - GROUT MIXTURES

Figure 2 is a plot of the percent settlement of solids in grout as affected by iron oxide dyes. This mix used was 500 gms of type 30 cement, 75 mls of water, and 18.75 grains of dye. The mixtures using neat grout, grout with red dye, and grout with yellow dye were mixed for 15 minutes, poured into 400 millilitre 2" diameter calibrated glass cylinders and allowed to

settle. The readings were taken every 5 minutes. The results show that the dyes kept the solids in suspension longer and had a lower overall settlement at the end of the test. Grout strength tests performed on the grout using the dyes were inconclusive but did indicate a reduction in strength of the grout with the use of these red and yellow oxide dyes. These dyes were extensively used throughout the foundation grouting program.
