RECLAMATION

Corrosion Protection in Penstocks

Dave Tordonato

Materials Engineer- Corrosion Group
TSC- Materials and Corrosion Laboratory (MCL)
Denver, CO

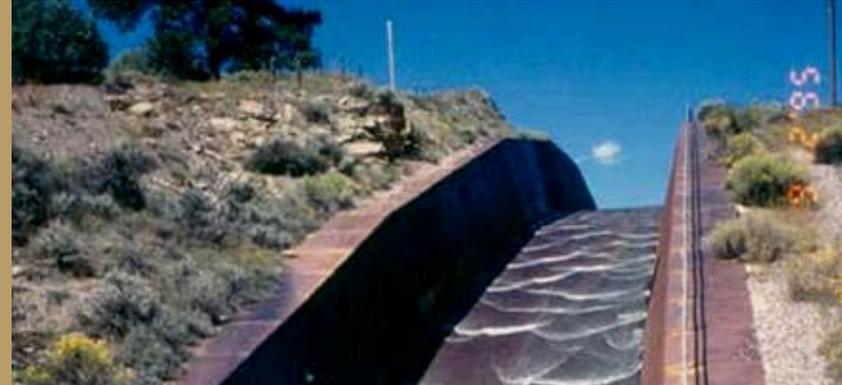
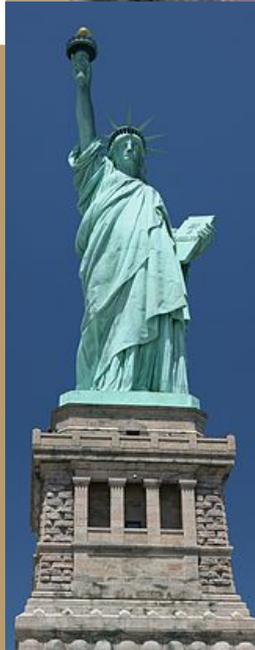
El Vado Dam
Spillway, 1995

General or Uniform Corrosion

- Reactions occur uniformly over the surface, often at a steady and predictable rate
- Most important form based on weight of metal corroded
- Some Solutions:
 - Select a more corrosion resistant material
 - Apply protective coatings
 - Cathodically protect the structure
 - Specify corrosion allowance

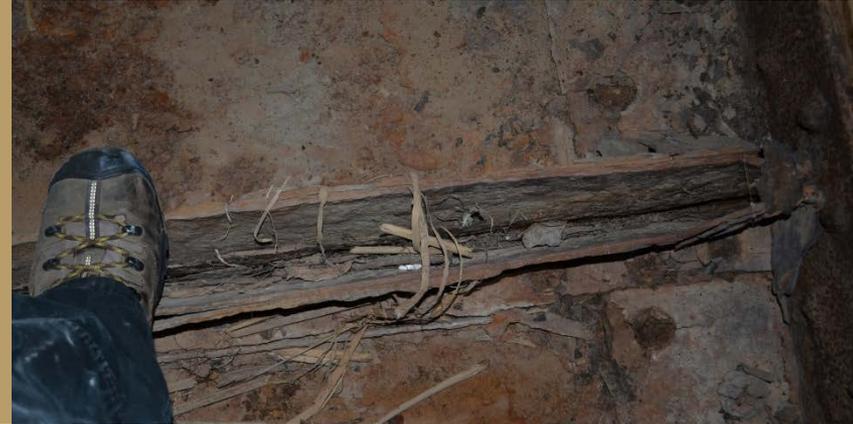
Palo Verde Diversion Dam
Radial Gates, 2013

Crevice Corrosion

- Intensive localized corrosion within crevices and under coatings
- Examples:
 - expansion joints
 - piping supports
- Solutions:
 - Design components to eliminate crevices.
 - Coating repairs and caulking

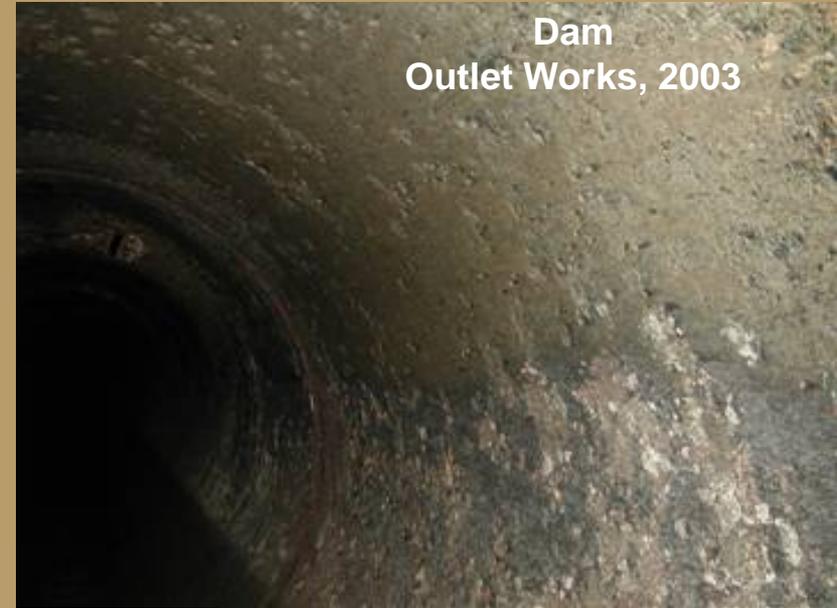
Dam
Outlet Works, 2003

Pitting Corrosion

- Localized attack in an otherwise resistant surface
- Often occurs when protective coating breaks down
- Some Solutions:
 - Select suitably resistant material (316 vs. 304 SS)
 - Apply Protective Coating
 - Cathodic Protection
 - Avoid designs where stagnation, or alternate wetting and drying, can occur in pits

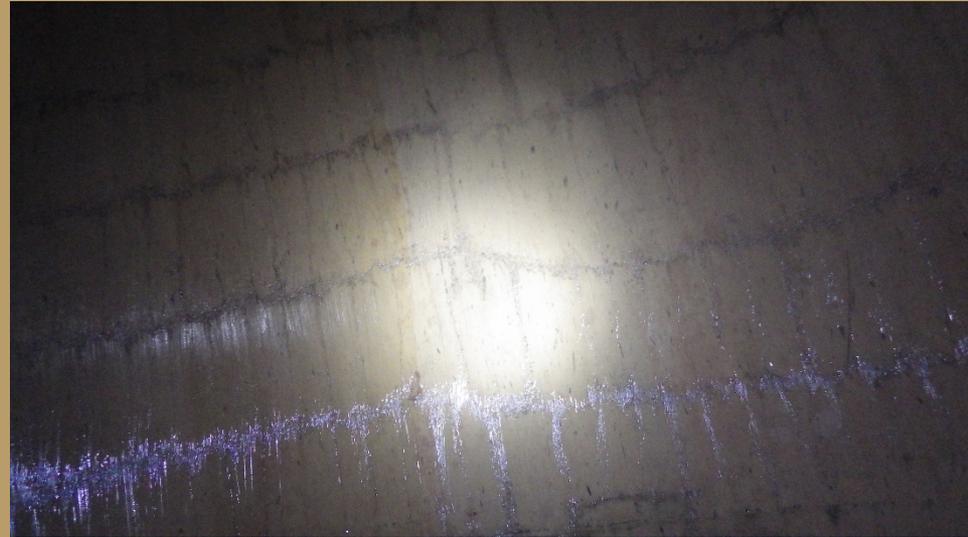
Hand Daubed Coal Tar on pipe crown

- Lining system used by Reclamation and others since 1930s
- Applied in the molten state: may be hand daubed, spin coated, or mopped on
- DFT up to 120 mils (or more)
- Contains Polyaromatic Hydrocarbons (PAH) toxic
- Long lasting, thermoplastic material
- Long lasting in moist, cool conditions
- Can dry and become brittle during aging
- Typical failure mode is alligator cracking, spalling, or sometimes pinhole rusting

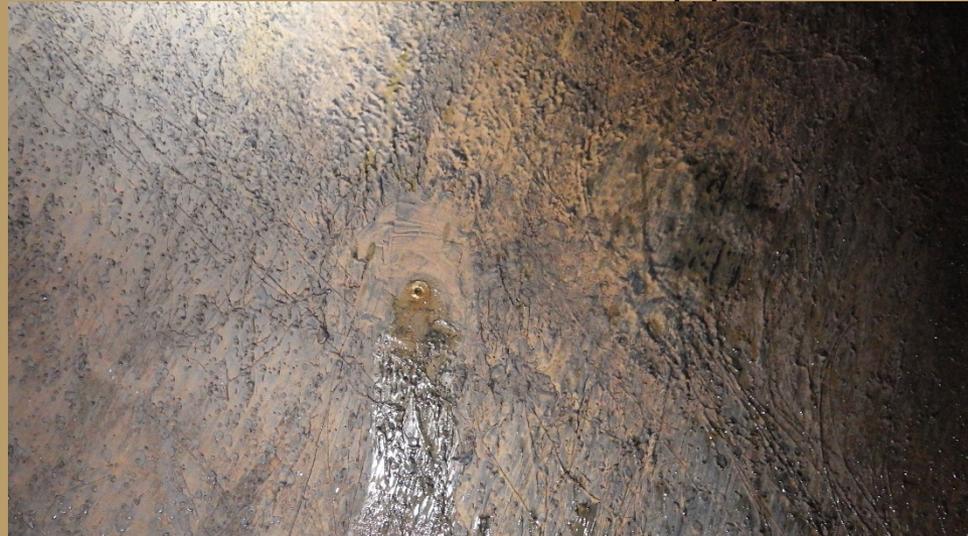
Hand Daubed Coal Tar with drips, note piezometer tap

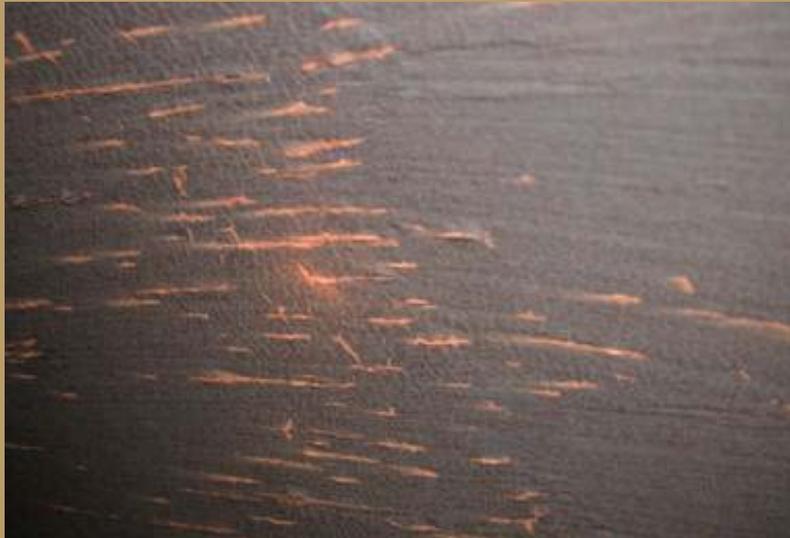
Alligator cracking

Aged Coal Tar Enamel

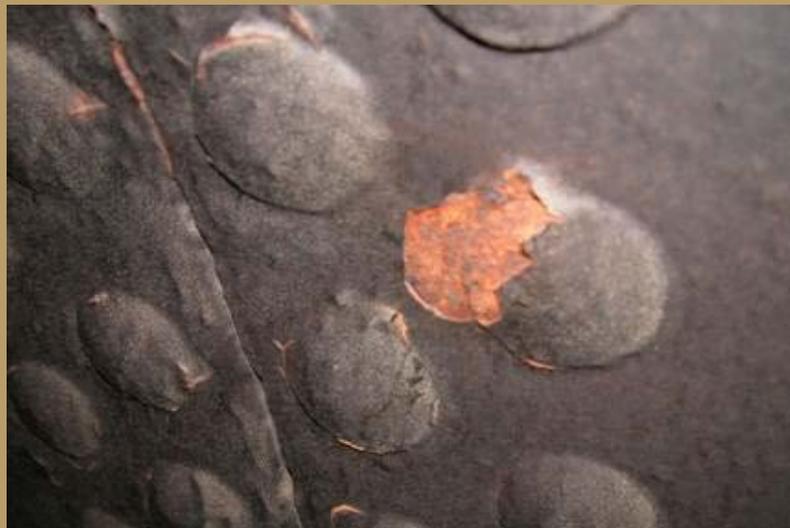
Brittle failure at rivet

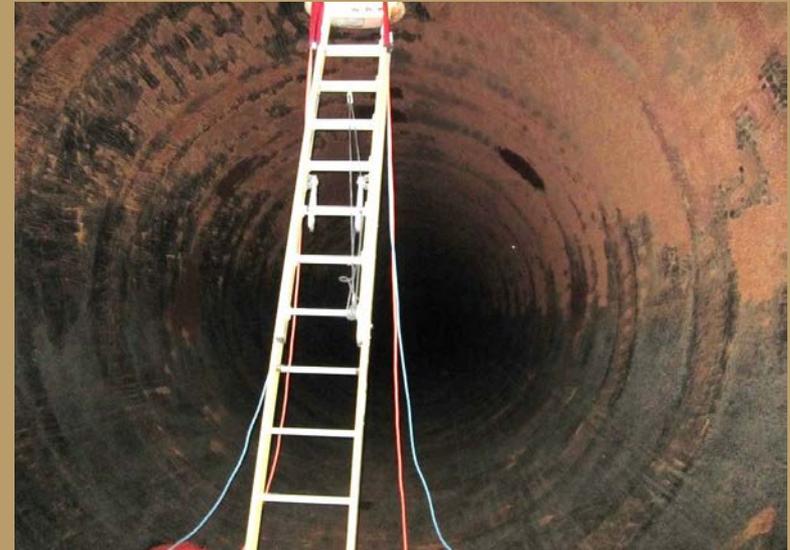
Complete degradation

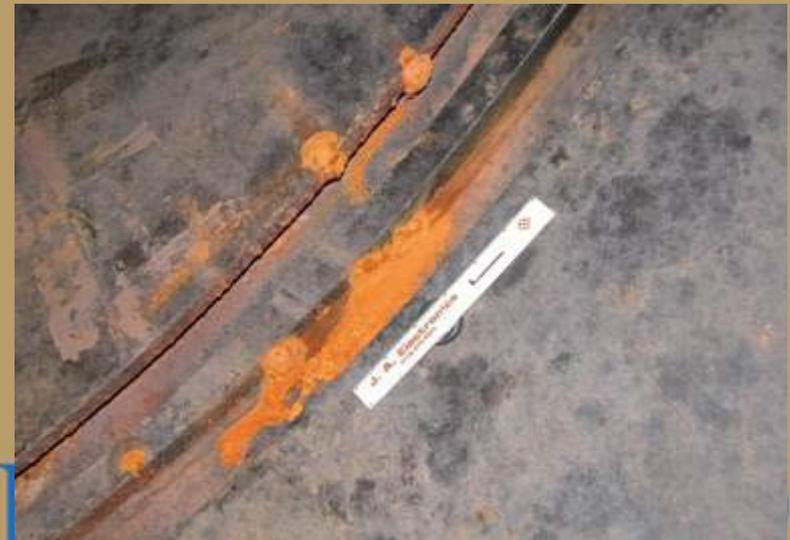
Corrosion at joint

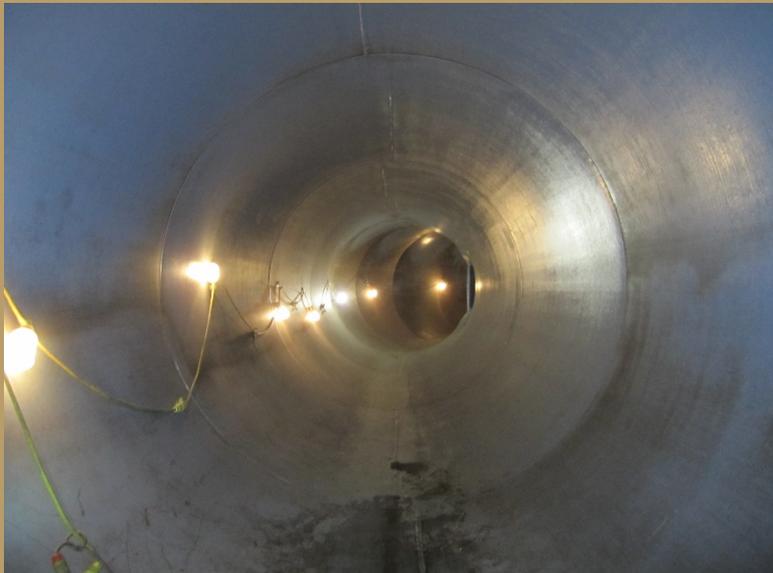
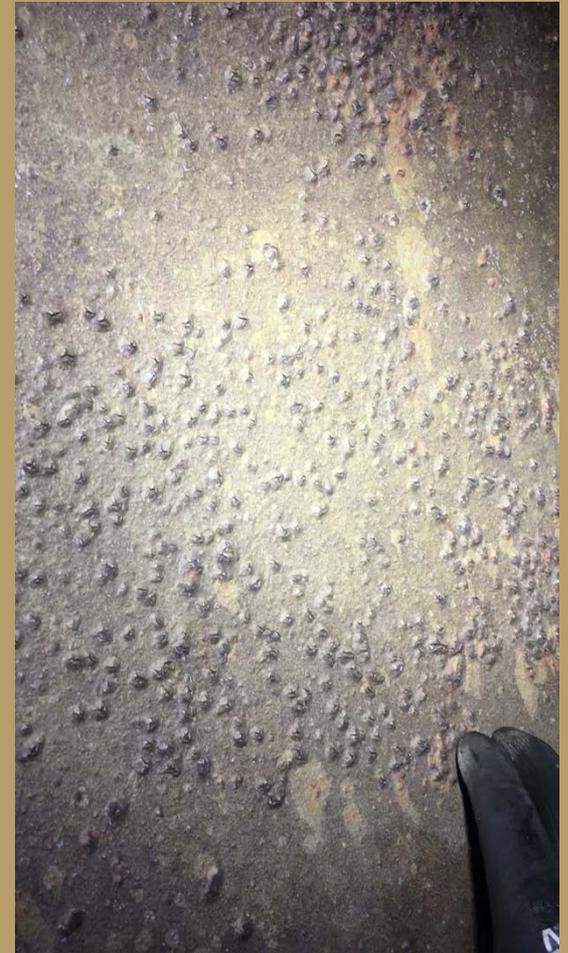
Blister formation on aged vinyl

- Lining system used by Reclamation and others until the early 1990's (VOCs)
- Less common than Coal Tar Enamel
- DFT ~ 12 mils
- Used penstocks with very cold temperatures
- Aging vinyl may show blister formation but does not crack like coal tar

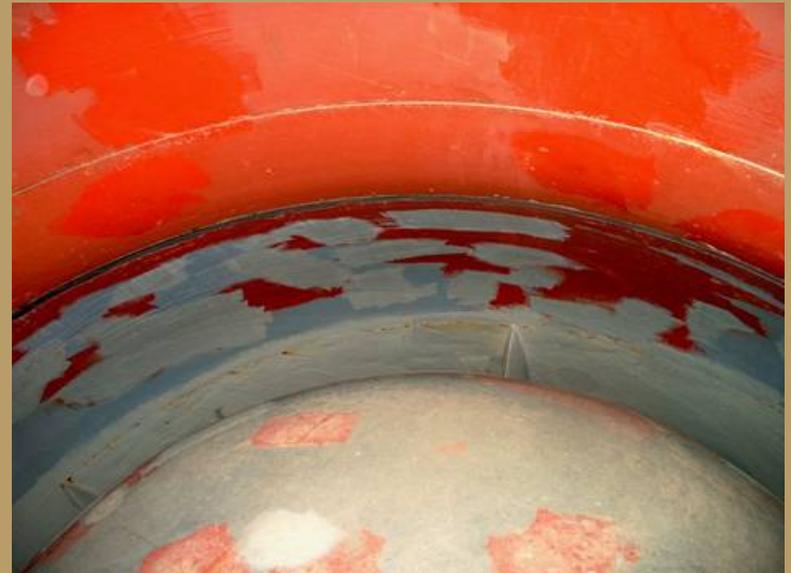
Valve with coating spot repairs

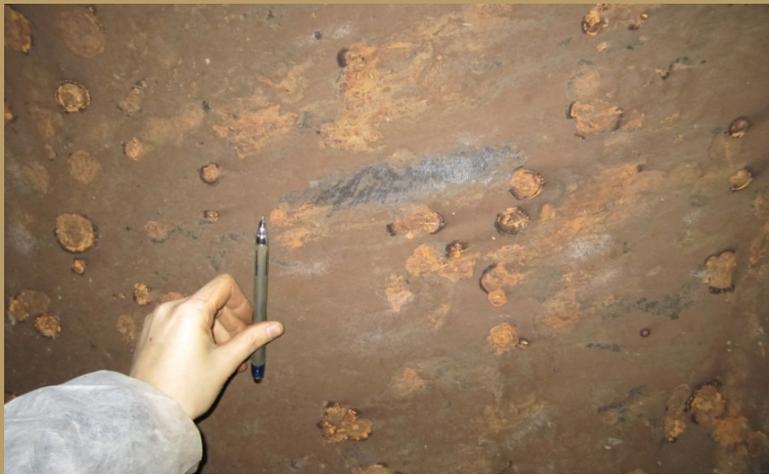
Coal tar enamel lining (70+ years)

- Economical for $> 15\%$ repairs (rule of thumb)
- Restarts maintenance cycle
- Coal Tar enamel requires high pressure water-jetting to remove due to thickness.

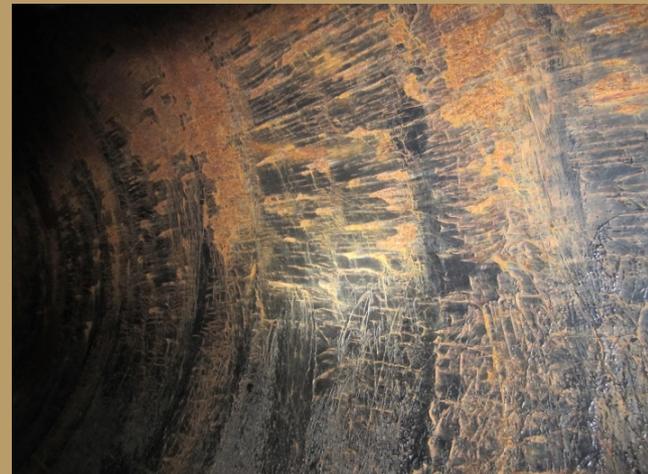
Coal tar enamel lining

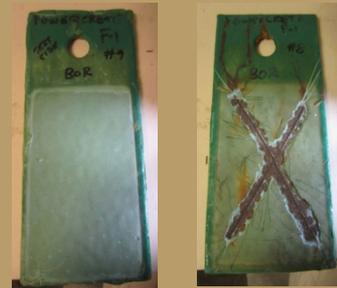
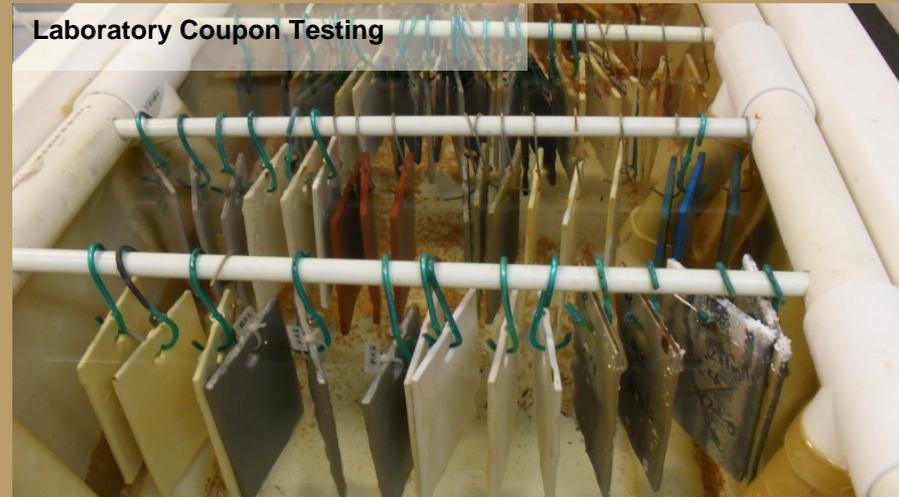
Replacement Lining Materials

- 100% solids epoxies – 50+ mils
- **Materials and Corrosion Laboratory** evaluates products for inclusion into Guidespecs based on:
 - Immersion testing: Rust creep / EIS testing
 - Prohesion testing: Rust creep
 - BOR testing (prohesion with immersion)
 - Rapid Impact
 - Abrasion Resistance
 - Erosion Resistance
 - Cathodic disbondment
 - Adhesion / Wet Adhesion
