Corrosion Webinar Series
PCCP at Reclamation

What is PCCP?

Prestressed Concrete Cylinder Pipe

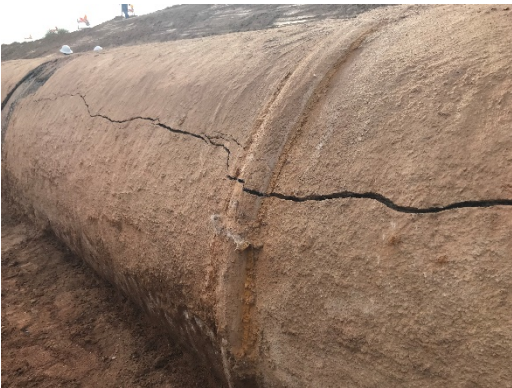
Ak-Chin Link Pipeline

- **Corrosion of Wire leading to Breaks**
 - Defective prestressing wire
 - Incomplete encasement of wire with mortar/cement slurry
 - Insufficient mortar cover
 - Cracking of mortar
 - Carbonation of mortar

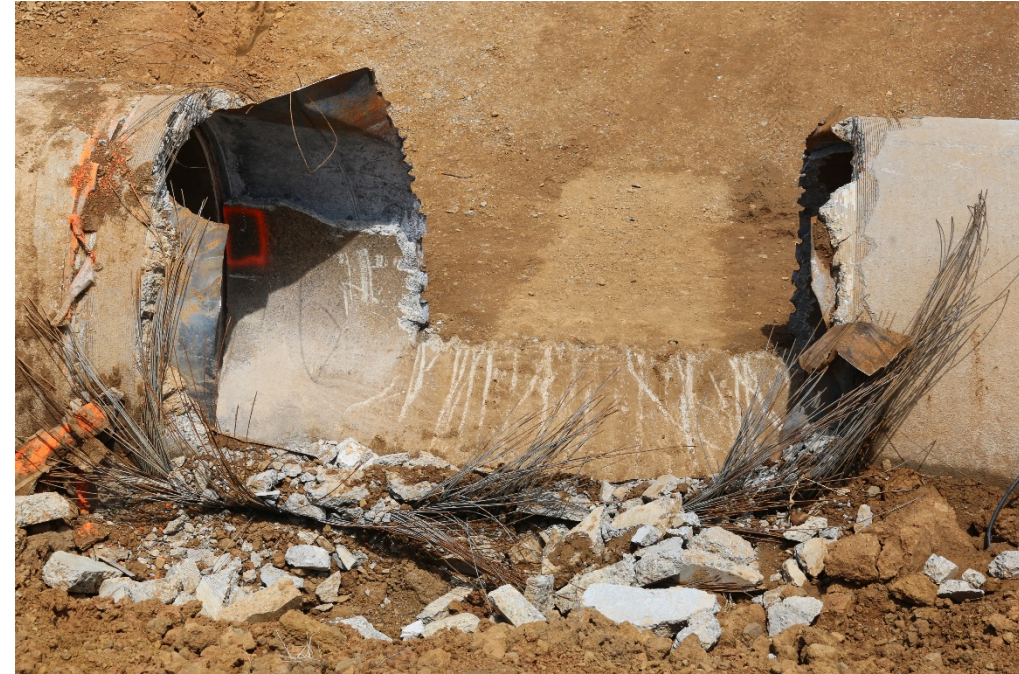
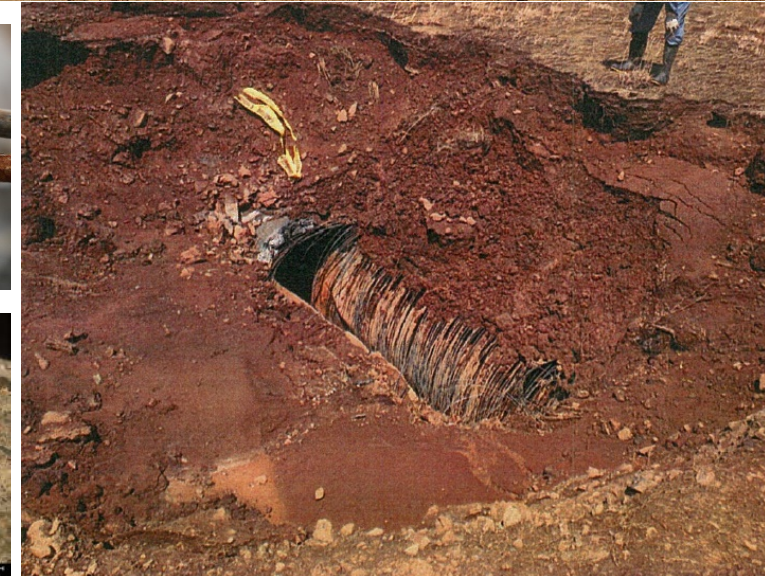
Santa Clara Conduit Failure

- Central Valley Project, California
- Saturday, August 1, 2015
- 10' long, 8' diameter PCCP section failed
- Failure mode: corrosion leading to broken wires
 - Corrosive soil
 - Microcracking and carbonation in mortar coating

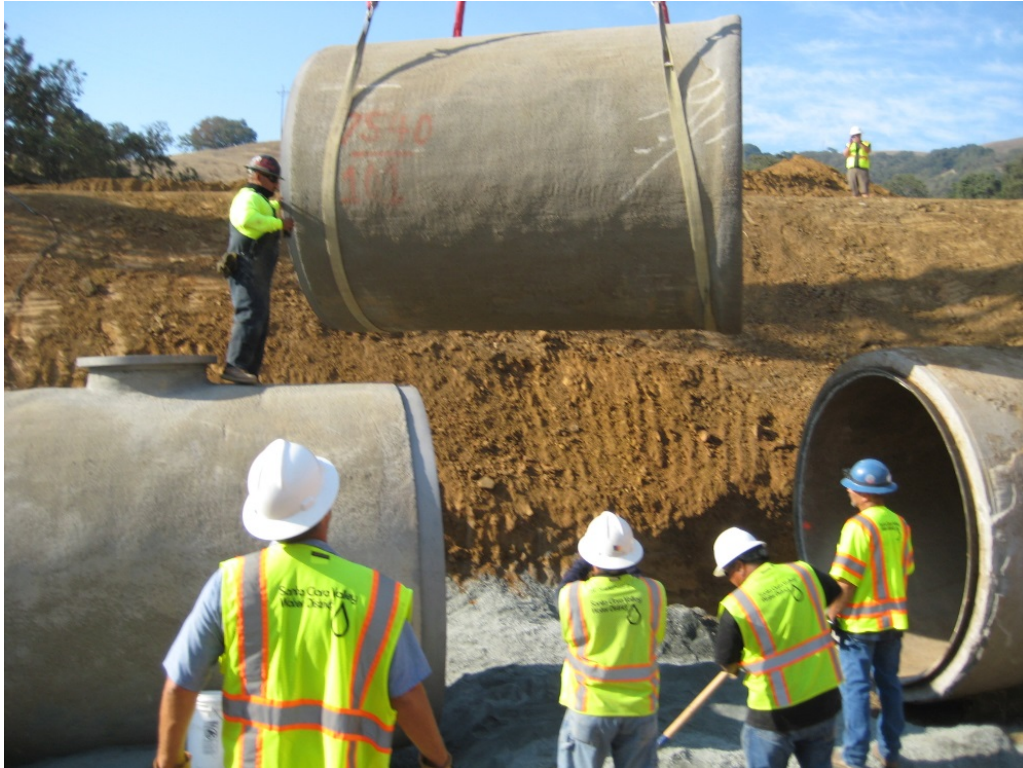
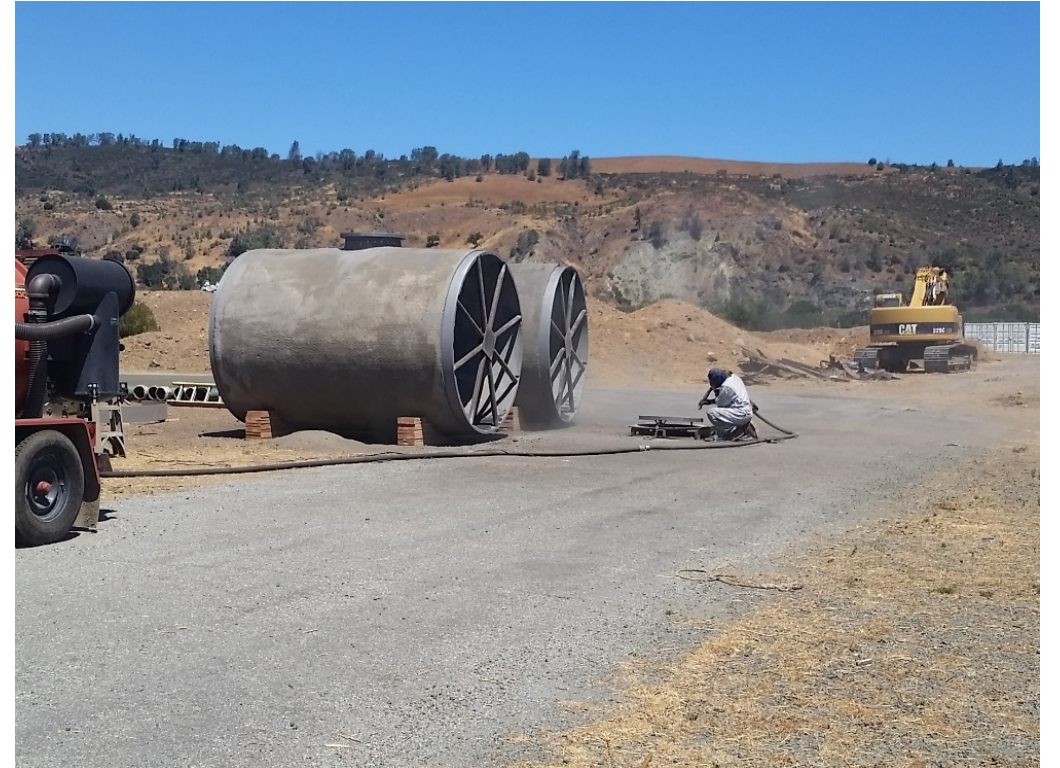
Santa Clara Conduit Failure

- **Emergency Repair:**
 - Replaced with cement mortar lined and coated steel pipe

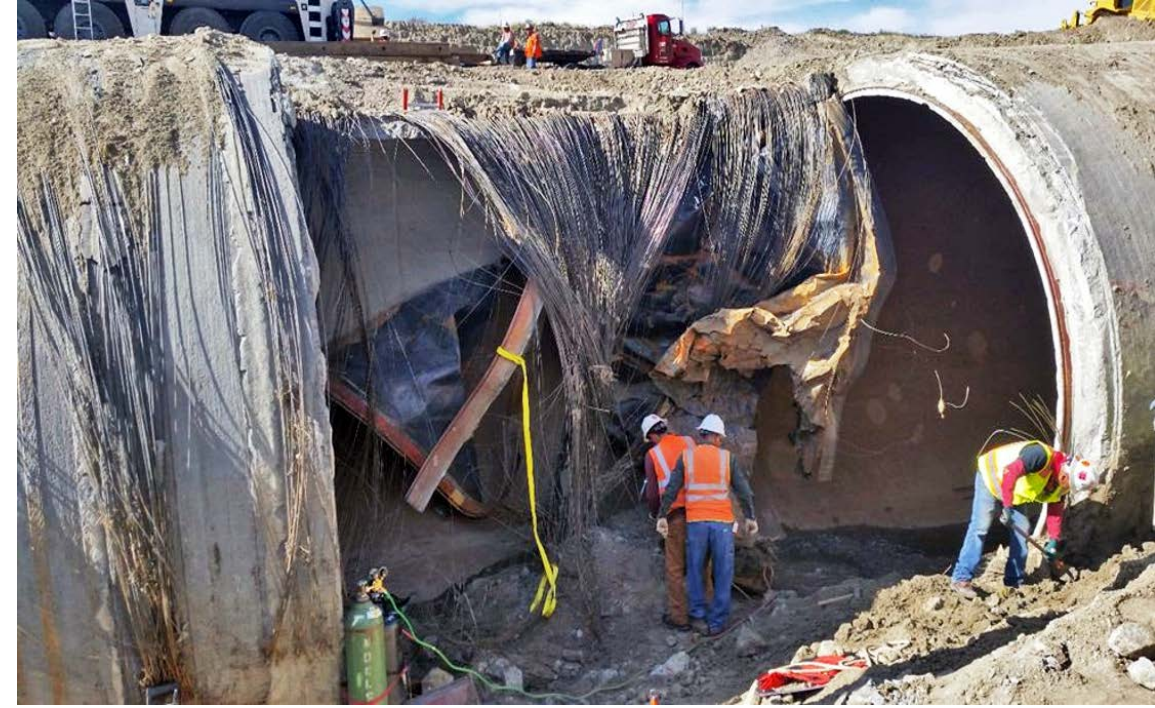
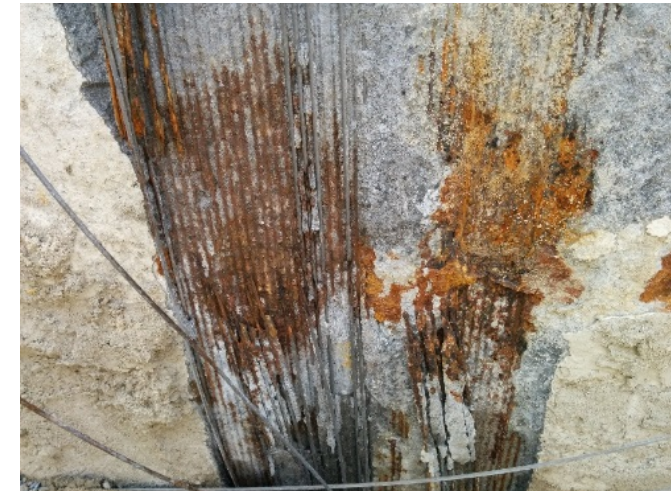
Kutz Siphon Failure

- Navajo Indian Irrigation Project, New Mexico (now BIA owned)
- Friday, May 13, 2016
- Two 40' long, 17.5' diameter PCCP sections failed
- Concrete and water projected 200'
- Lost 1,000 cfs into the San Juan River
- Put 75,000 acres of irrigated land out of service
- Failure mode: corrosion leading to broken wires

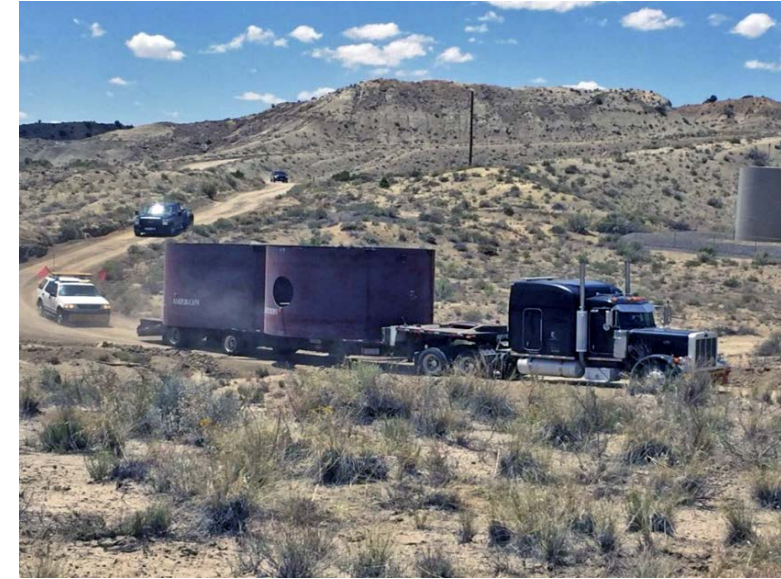
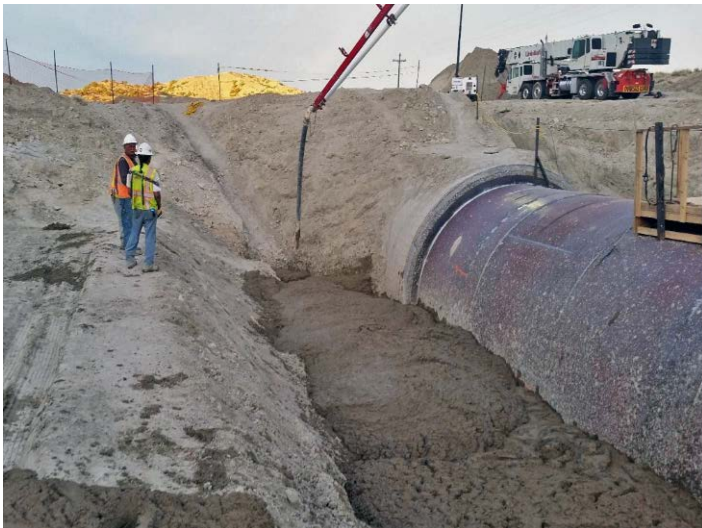
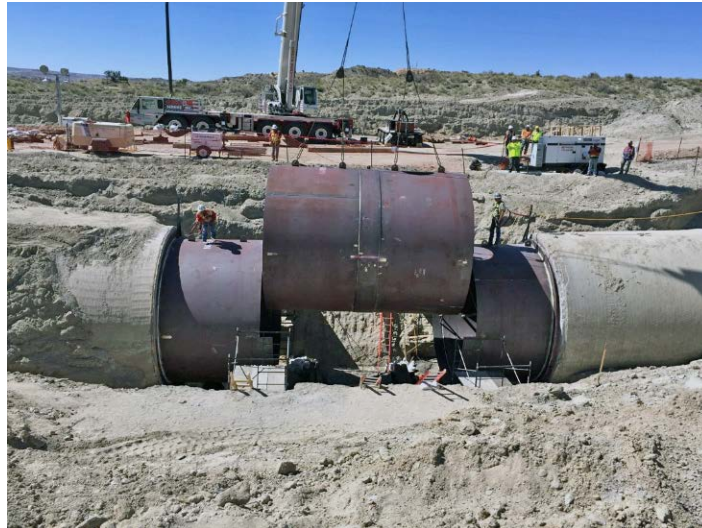
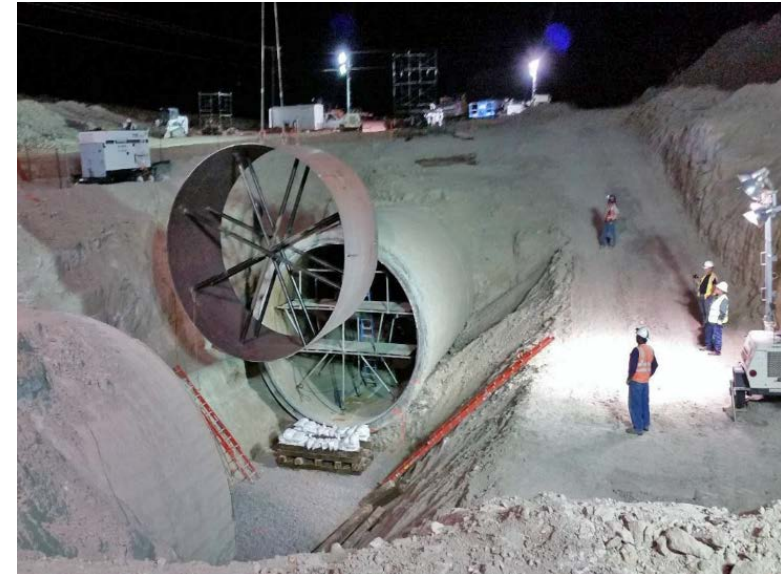
Kutz Siphon Failure

- **Emergency Repair:**
 - Replace with steel
 - Fill with CLSM, no corrosion protection
- **2017-2018 Repair:**
 - Line steel sections with epoxy
 - Install cathodic protection at repair

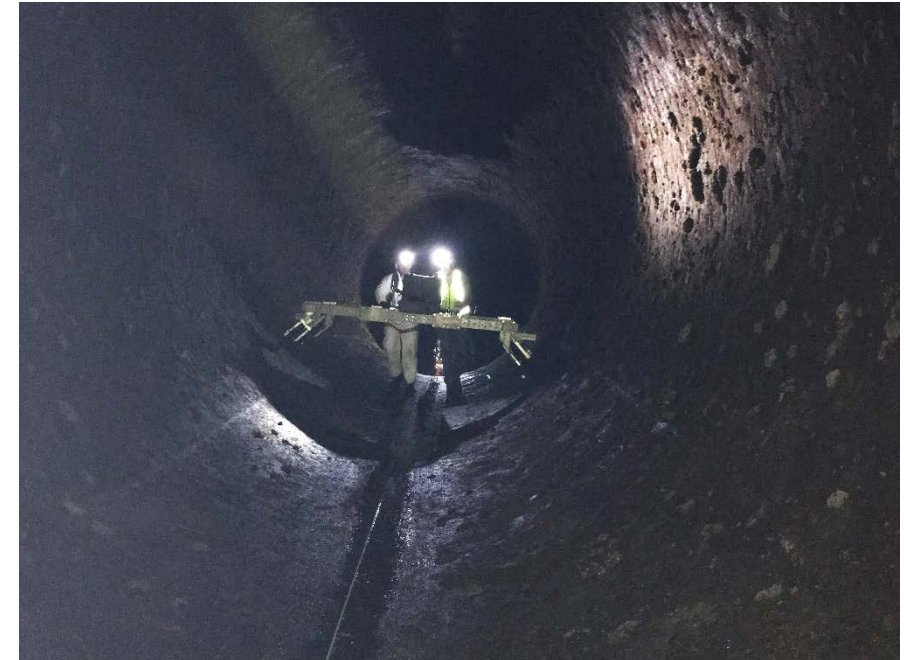
Condition Assessment

- **Visual Inspection (Pipe Interior)**
 - Cracks in core
 - Leaks at joints
- **Acoustic Inspection**
 - Manual sounding- delamination of concrete or un-grouted areas/hollows
 - Impact Echo Testing- delamination, hollows, cracks
 - Free-floating acoustic sensor- leak detection
- **Electromagnetic Inspection**
 - Number and location of prestressing wire breaks
 - Can be conducted for in-service or dewatered pipe
- **Acoustic Fiber Optic Monitoring**
 - Continuous monitoring for wire breaks
 - Cables installed inside pipe
 - Requires monthly/annual monitoring contract

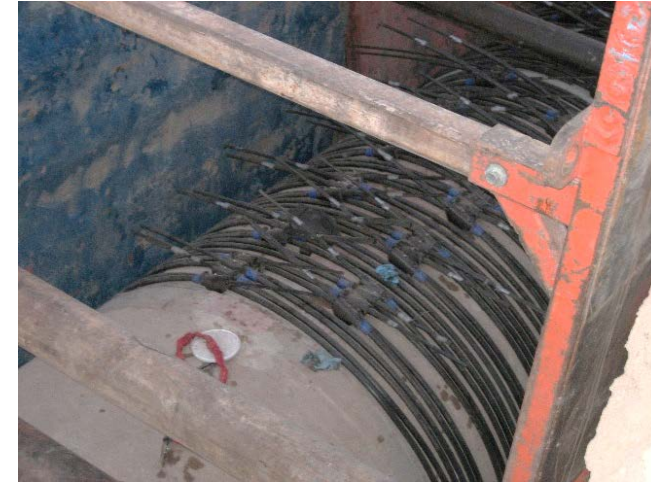
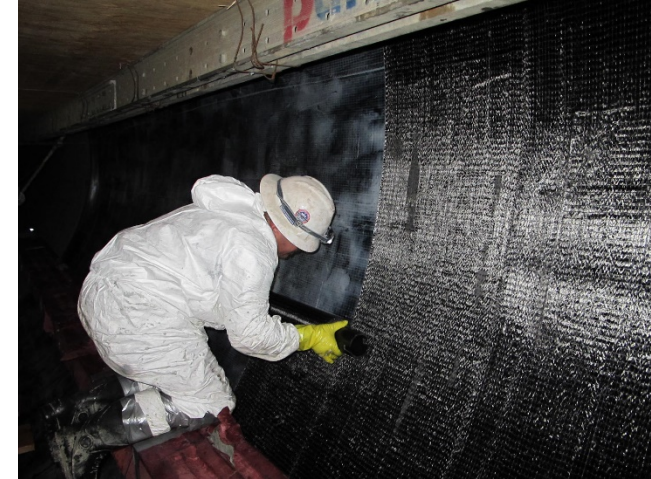
Repair Methods

- **Interior Crack and Joint Repair**
 - Reclamation's "Guide to Concrete Repair, 2nd ed."
 - Surface preparation, repair product application, curing
- **Installation of Cathodic Protection**
 - Requires electrical continuity of protected sections
 - Should not be polarized more negative than $-1000 \text{ mV}_{\text{CSE}}$ to avoid hydrogen embrittlement
- **Wire Splicing and Tendon Wrapping**
 - Exterior repair requiring pipe excavation
 - Use anchor blocks and tensioning devices to install replacement wire or tendons
- **Structural Liner**
 - Internal repair to provide structural support for distressed sections
 - Carbon Fiber Reinforced Polymer (CFRP)
 - Spray-in-Place Pipe (SIPP)
