# **DRAFT River Mile 60 Controlled Outfall Urgent Implementation Environmental Assessment and Finding of No Significant Impact**

**Middle Rio Grande, New Mexico  
Upper Colorado Basin Region**

# River Mile 60 Controlled Outfall Project Description

# **River Mile 60 Controlled Outfall Urgent Implementation Technical Recommendation**

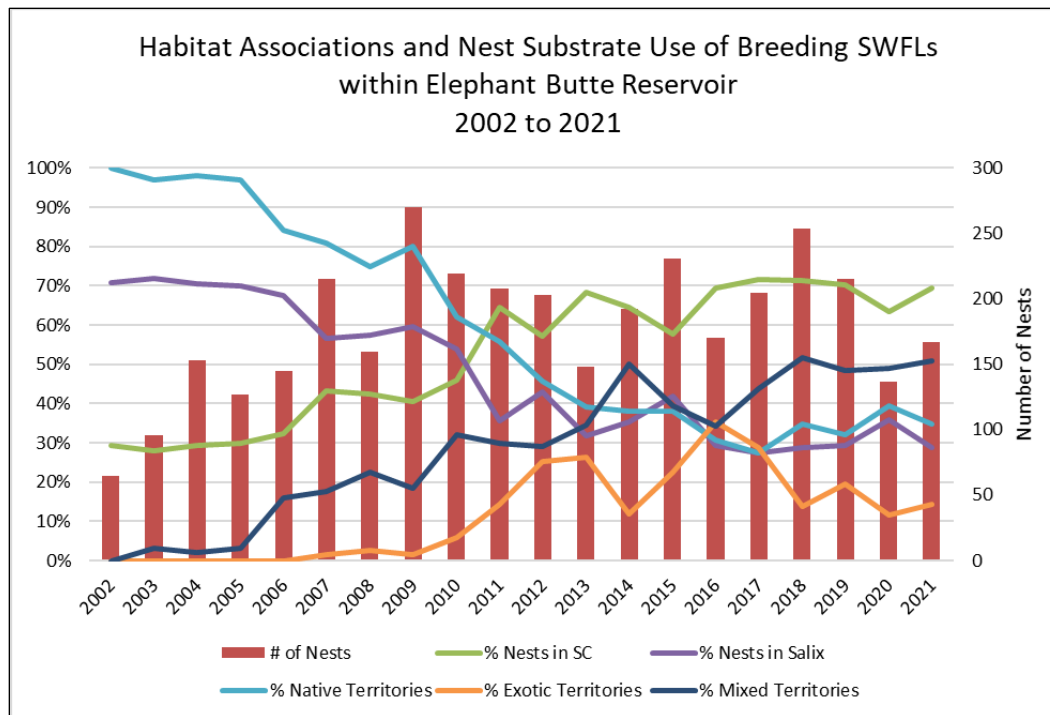
Figure 6. Habitat associations of breeding SWFLs within the Elephant Butte Reservoir delta between 2002 and 2021.
