# **Draft Environmental Assessment for the Corrales River Mile 199 Project**

**Middle Rio Grande Project**

**Upper Colorado Basin Region, Albuquerque Area Office**

# Corrales River Mile (RM) 199 Project Description

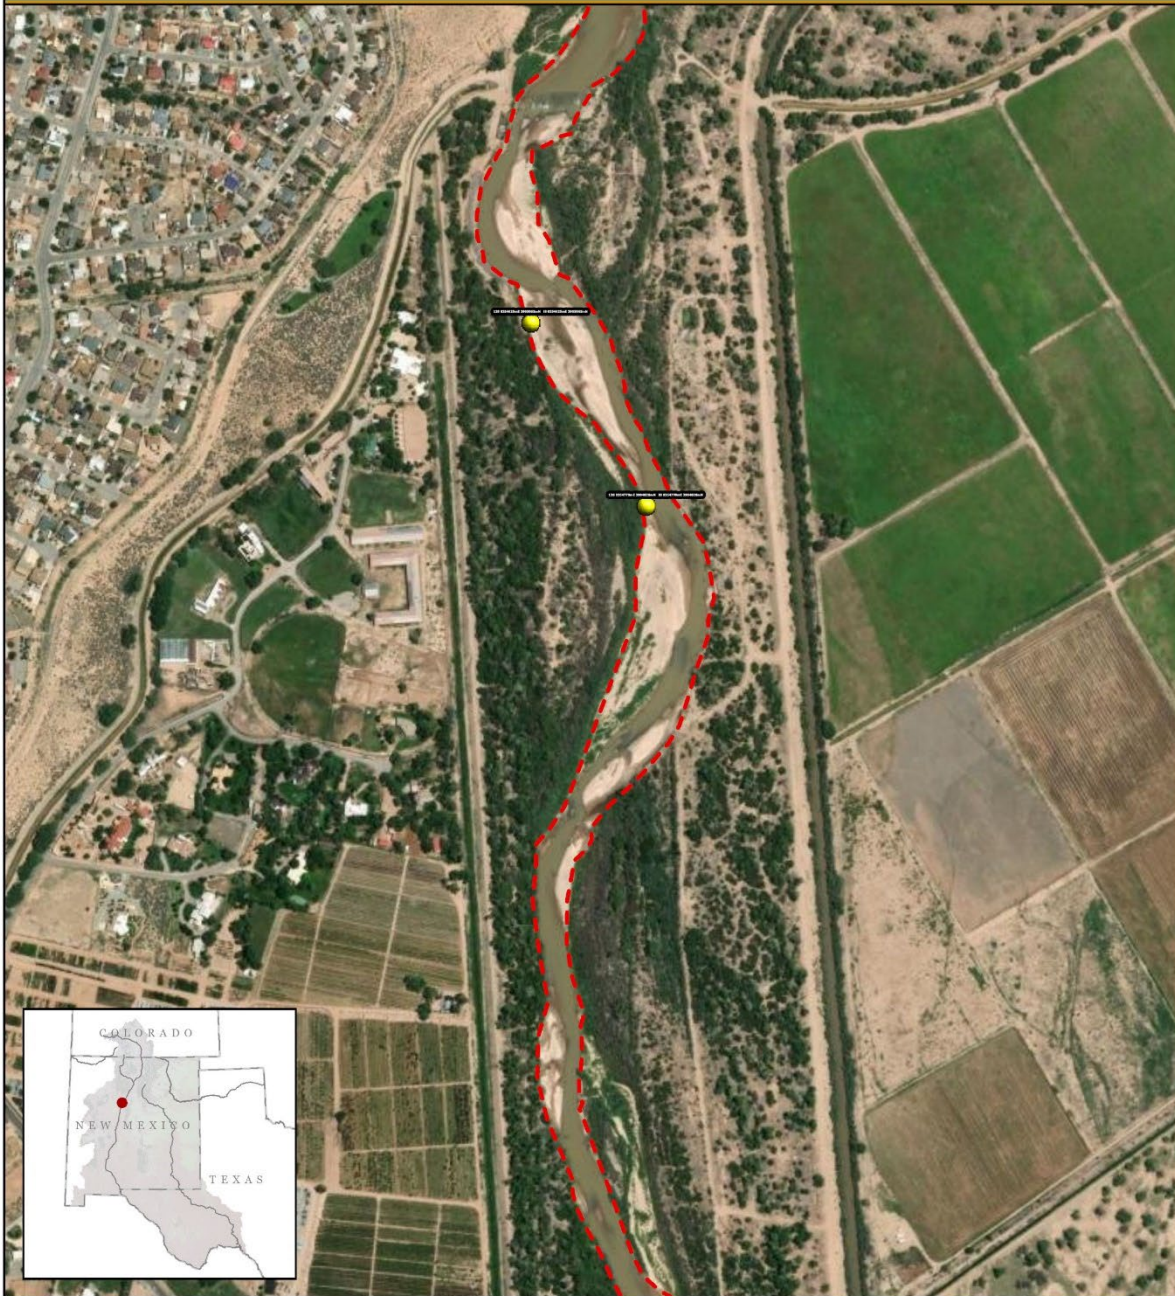
Figure 5: Plan view of project area showing the Ordinary High Water Mark (OHWM) based on field assessment and showing the most recently available aerial imagery.

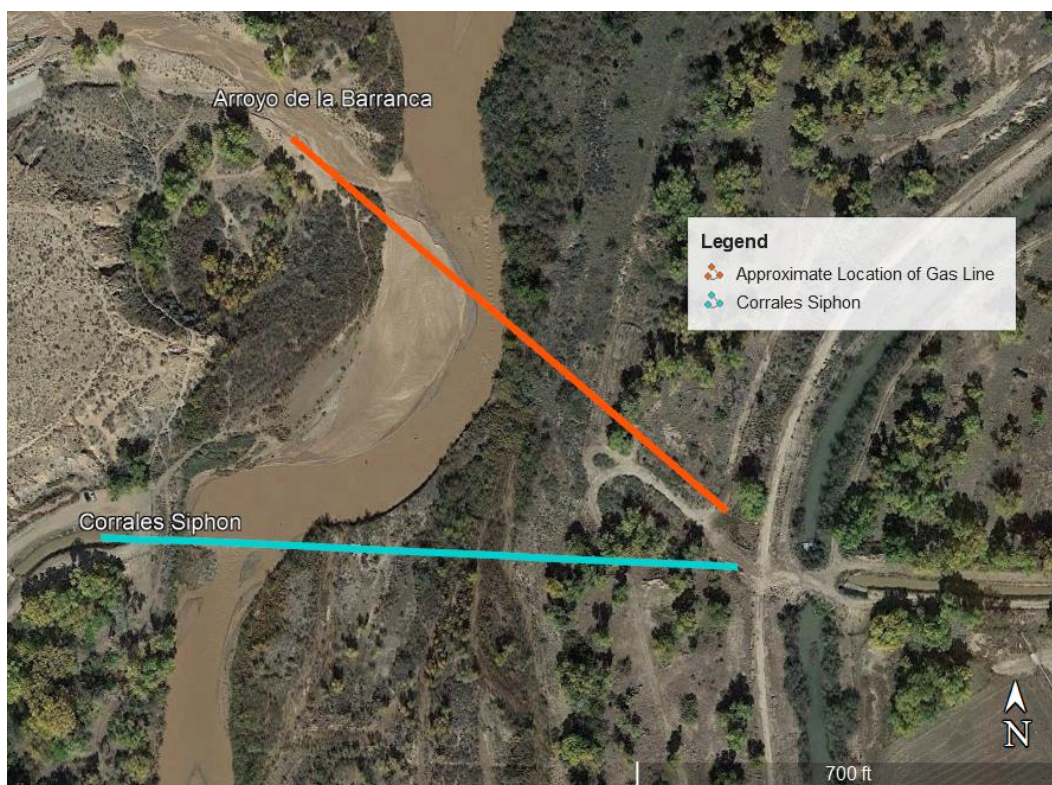
Figure 19: Utilities buried in the floodplain and under the river.

Infrastructure that runs under the river in this area includes a gas line and the Corrales Siphon (Figure 19).

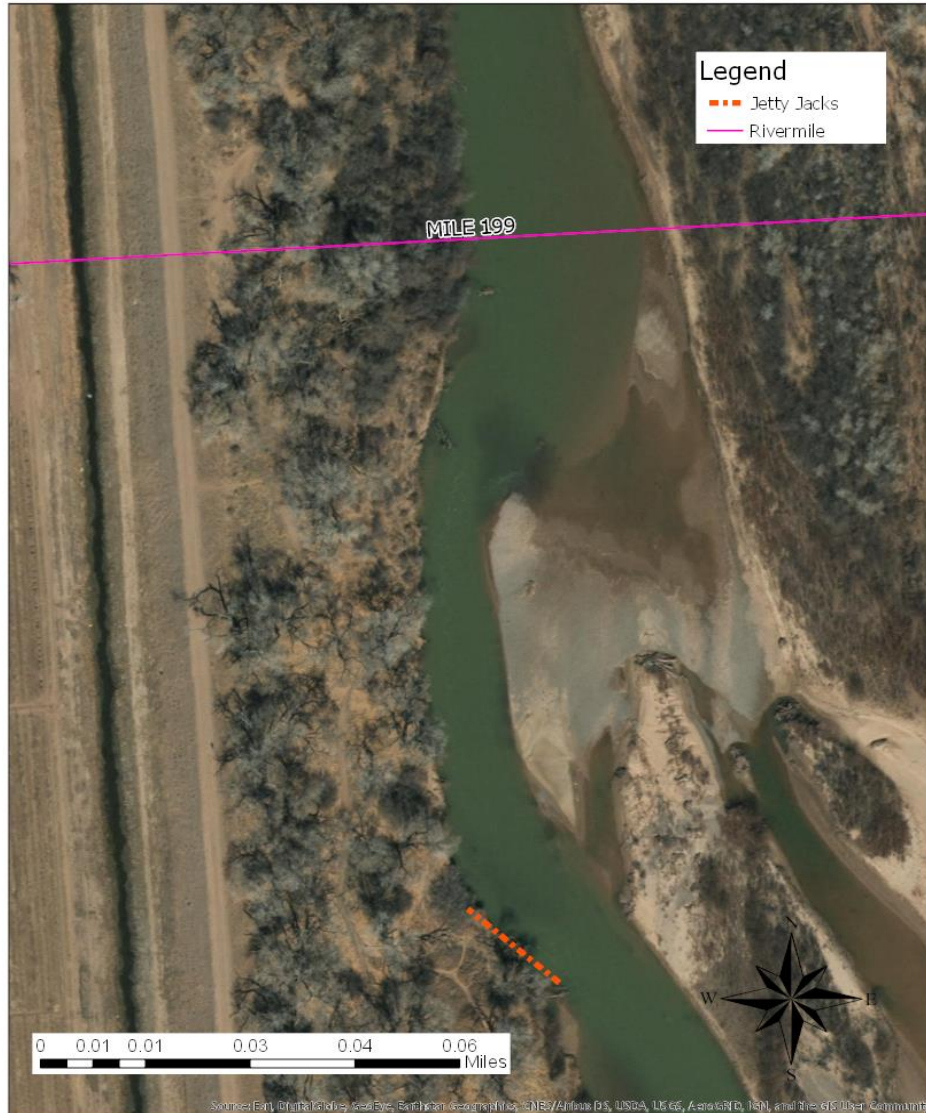
Figure 21: Jetty jacks within the project area.

Two jetty jacks are visible south of River Mile 199 (Figure 21). Most jetty jacks have been removed, but it is possible more jetty jacks are present in the project area. Removal of jetty jacks may be necessary as part of the selected alternative.

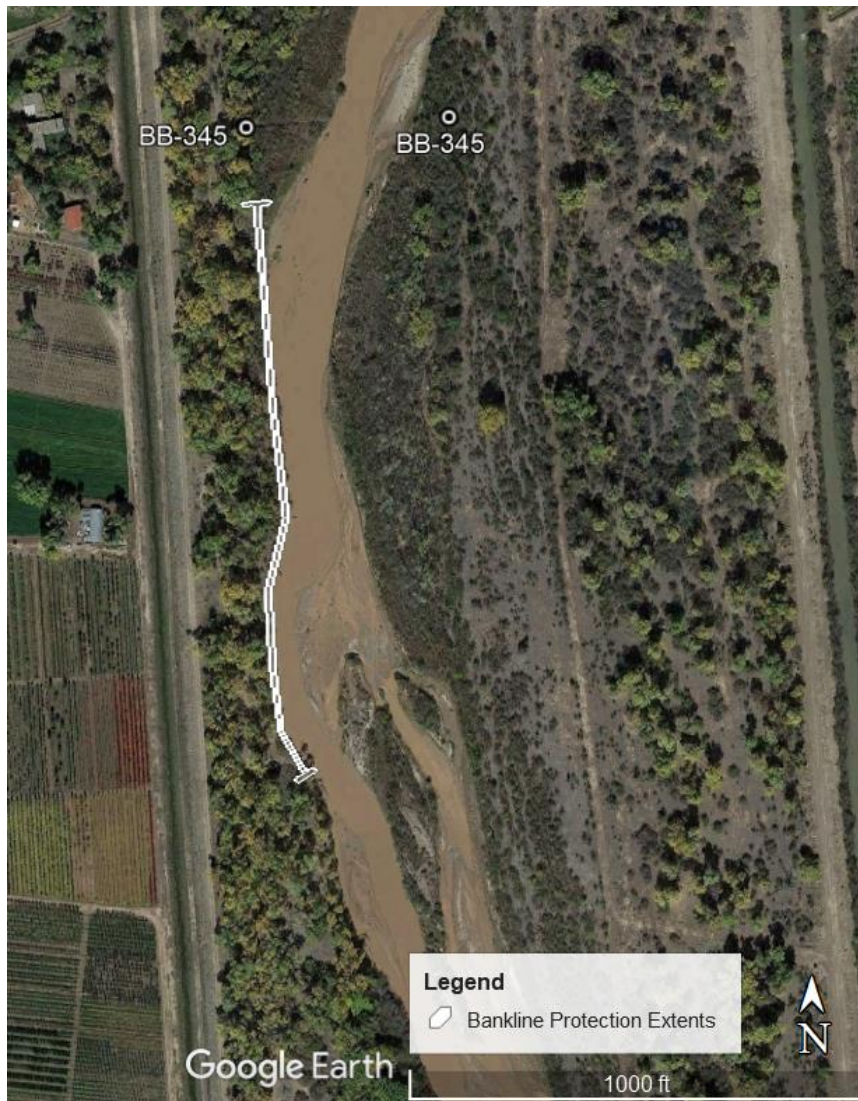
Figure 25: Extents of proposed bankline protection at the RM 199 bend, not including the structural keys and tie backs

At RM 199, which is the bend closest to the levee, the goal is to safely pass the 2-year flood (between 5,600 and 4,000 cfs; see Section 2.5.11) without incurring further erosion towards the levee. At this time, it is proposed to stabilize approximately 1,300 feet of bankline at the RM 199 site (not including the structural keys and tie backs). See Figure 25 for the aerial extents of this proposed bankline protection (not including structural keys and tie backs).

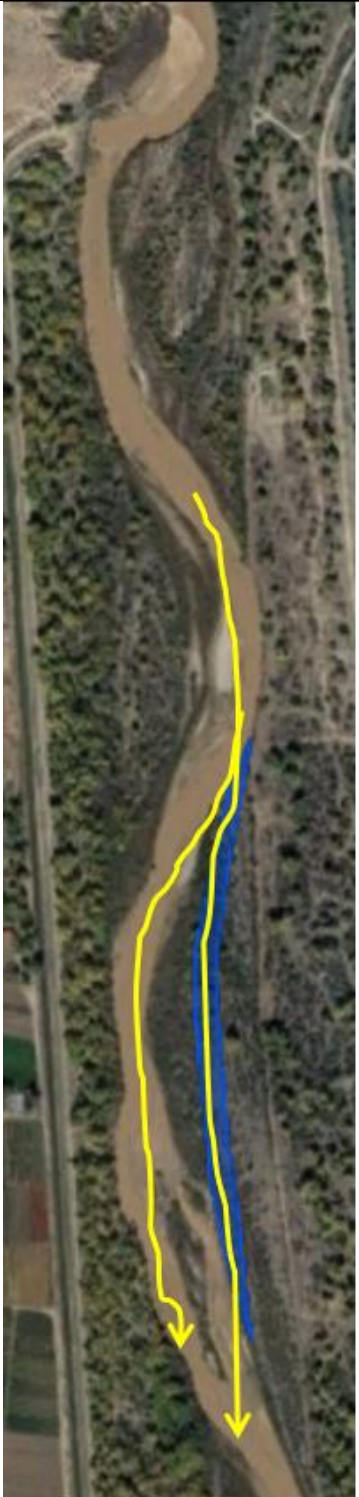
| Step | Actions | Features Completed (flow path shown in yellow) |
|---|---|---|
| 1 | Excavate the cutoff channel on the RM 199 point bar, leaving the entrance and exit plugs in place. Stockpile spoil material on the inside of the RM 199 point bar. Remove entrance and exit plugs to allow flow through the cutoff channel. | |

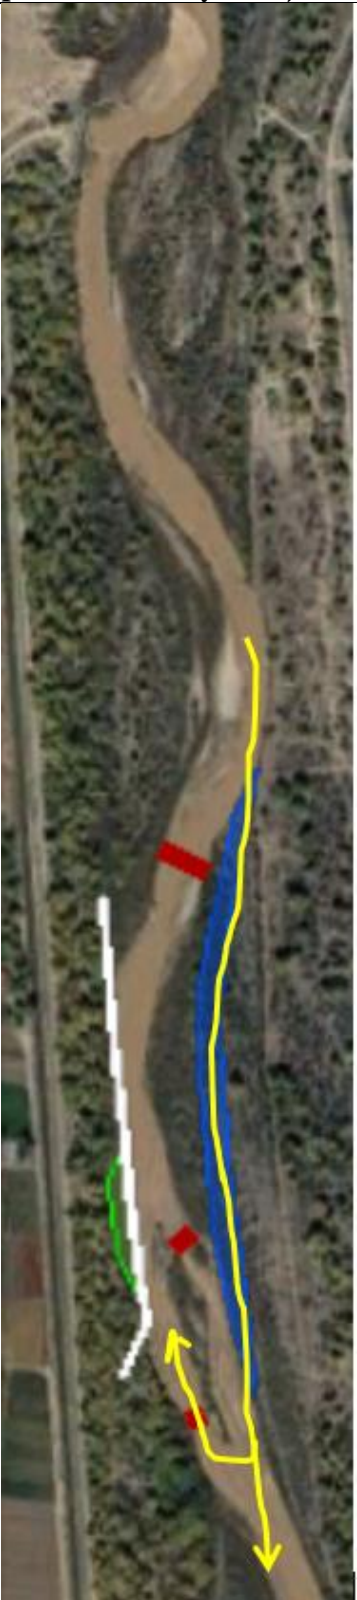
| Step | Actions | Features Completed (flow path shown in yellow) |
|---|---|---|
| 3 | Smooth out the riprap from the downstream temporary riprap diversion cofferdam onto the spoiled material filling the main channel. This will stabilize the slope going from spoil material grade to main channel grade. Leave the upstream temporary riprap diversion cofferdam in place. | <p>The image is an aerial photograph of a river channel. A yellow line with arrows at both ends indicates the flow path, starting from the bottom right and curving towards the top left. A blue area, representing riprap, is located in the middle of the channel, adjacent to the flow path. A red rectangular structure, likely a diversion cofferdam, is positioned across the channel. A white dashed line runs parallel to the left bank. A green line is visible on the left bank near the bottom. The surrounding area is covered in dense green vegetation.</p> |

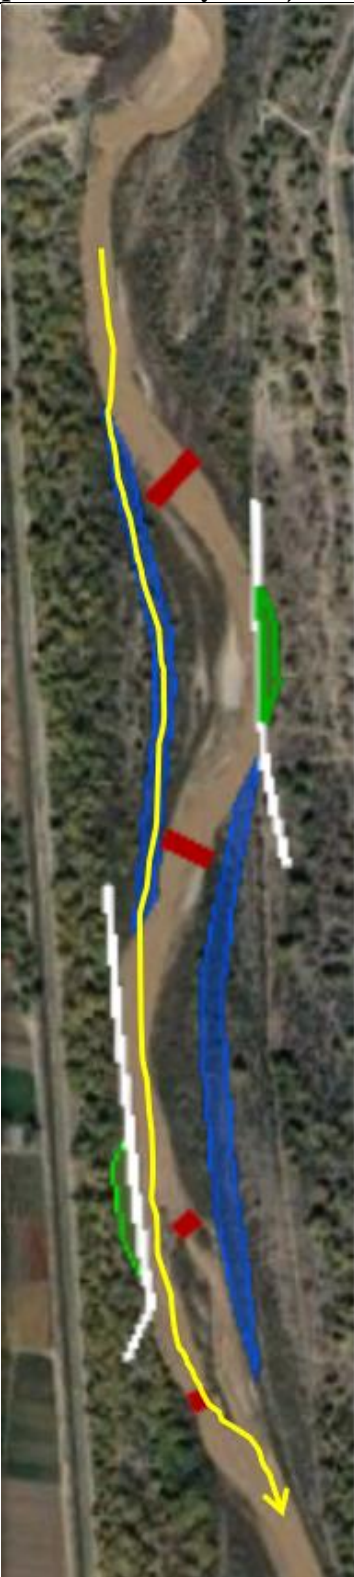
| Step | Actions | Features Completed (flow path shown in yellow) |
|---|---|---|
| 5 | <p>Build temporary riprap diversion cofferdam immediately downstream of the BB-343 cutoff channel entrance. All flows would temporarily be in the cutoff channel and the BB-343 bend would be temporarily dry. On the BB-343 outer bend, construct the LSTP. Place the cutoff channel's spoil material in the (dry) main channel and fill in behind the LSTP for the floodplain bench.</p> | |

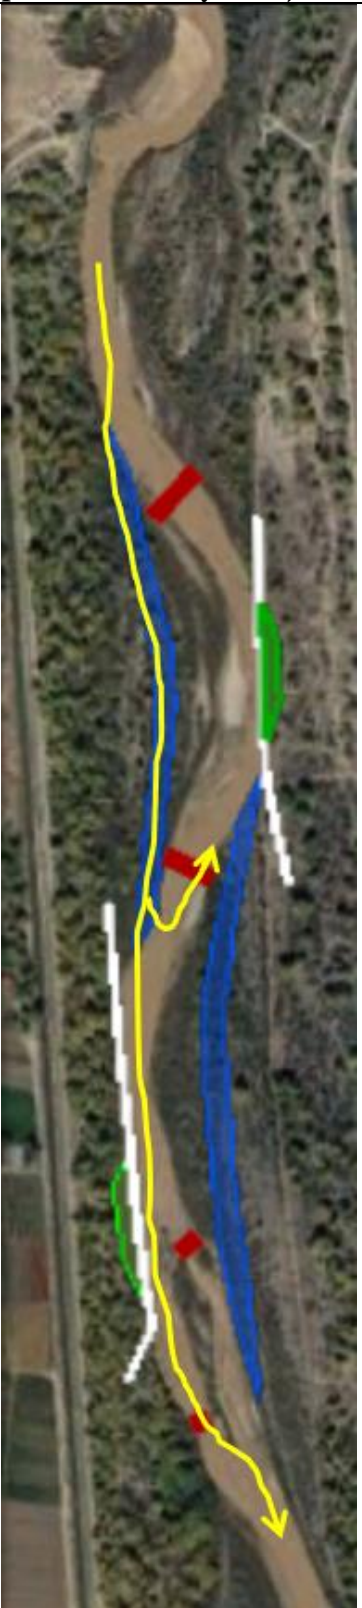
| Step | Actions | Features Completed (flow path shown in yellow) |
|---|---|---|
| 6 | <p>At the temporary riprap diversion cofferdam between BB-343 and RM 199, smooth out the riprap onto the spoiled/fill material now placed upstream and downstream of the temporary riprap diversion cofferdam. This feature will now act as grade control to prevent erosion of fill material.</p> | <p>The image is an aerial photograph of a river channel. A yellow line traces the flow path of the river, starting from the top and moving downwards. The path is slightly curved. On either side of the flow path, there are blue-shaded areas representing riprap. Red arrows are placed along the flow path, indicating the direction of flow. A green rectangular area is visible on the right side of the channel, and a white dashed line runs parallel to the flow path on the right. The surrounding area is a mix of brown and green, indicating a natural river environment.</p> |
