Finding of No Significant Impact and Environmental Assessment for the Corrales River Mile 199 Project

Middle Rio Grande Project

Upper Colorado Basin Region, Albuquerque Area Office

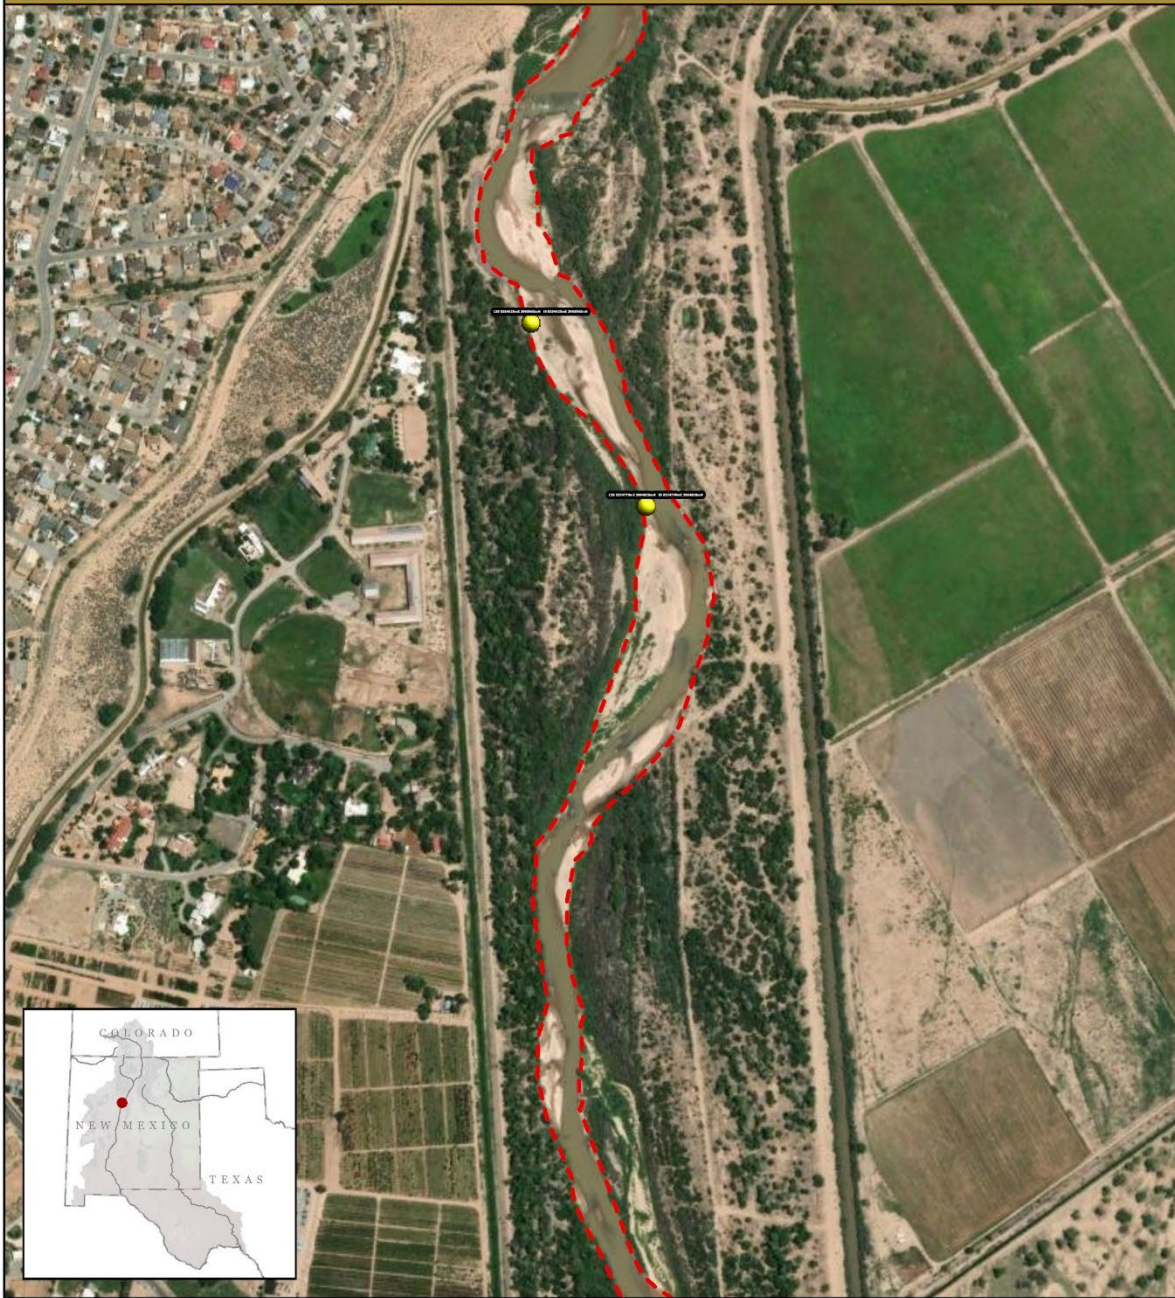
Figure 5: Plan view of project area showing the Ordinary High Water Mark (OHWM) based on field assessment and showing the most recently available aerial imagery.

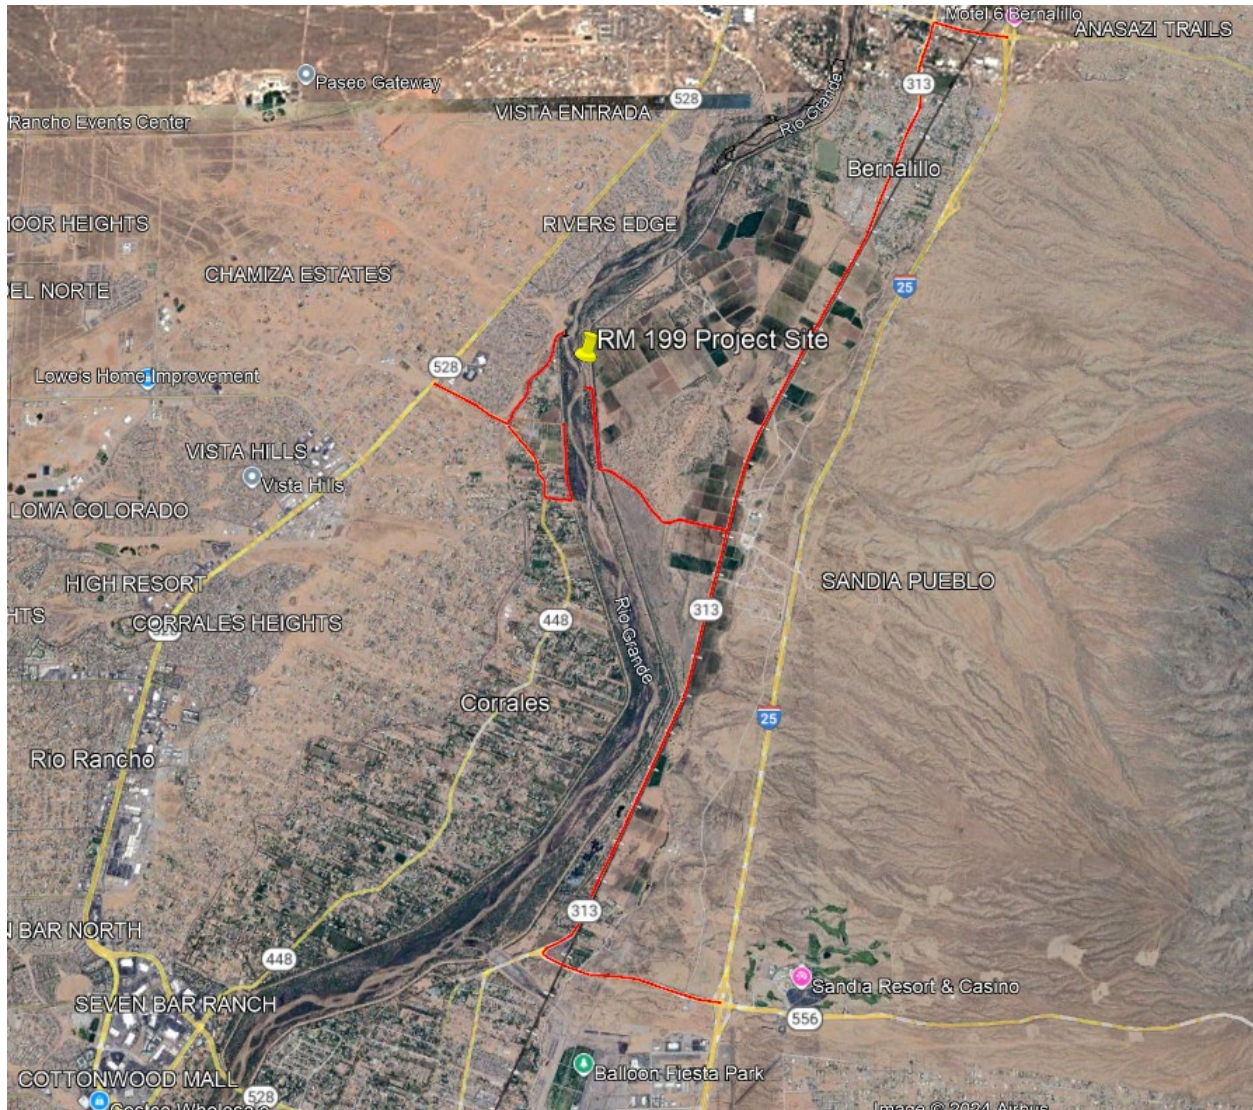
Figure 6: RM 199 River Maintenance Site access routes accessible from US Interstate 25 and US Hwy 528.

Site access from I-25 will be via the Bosque road through Sandia Pueblo via US Hwy 313 as shown in Figure 6 below. From Bosque road cross the riverside canal at the concrete fire bridge and from there drive along the levee road. Alternate site access to the east side is from Bernalillo going south along US Hwy 313.

Access to the project area from the west side is along Corrales Siphon Road off of US Hwy 448. Take US Hwy 528 to US 448 (Corrales Road) and turn north onto Corrales Siphon Road. Alternately, take Corrales Road to the Harvey Jones Channel and drive North along the levee road. This route is owned by the Southern Sandoval County Flood Control Authority (SSCAFCA).

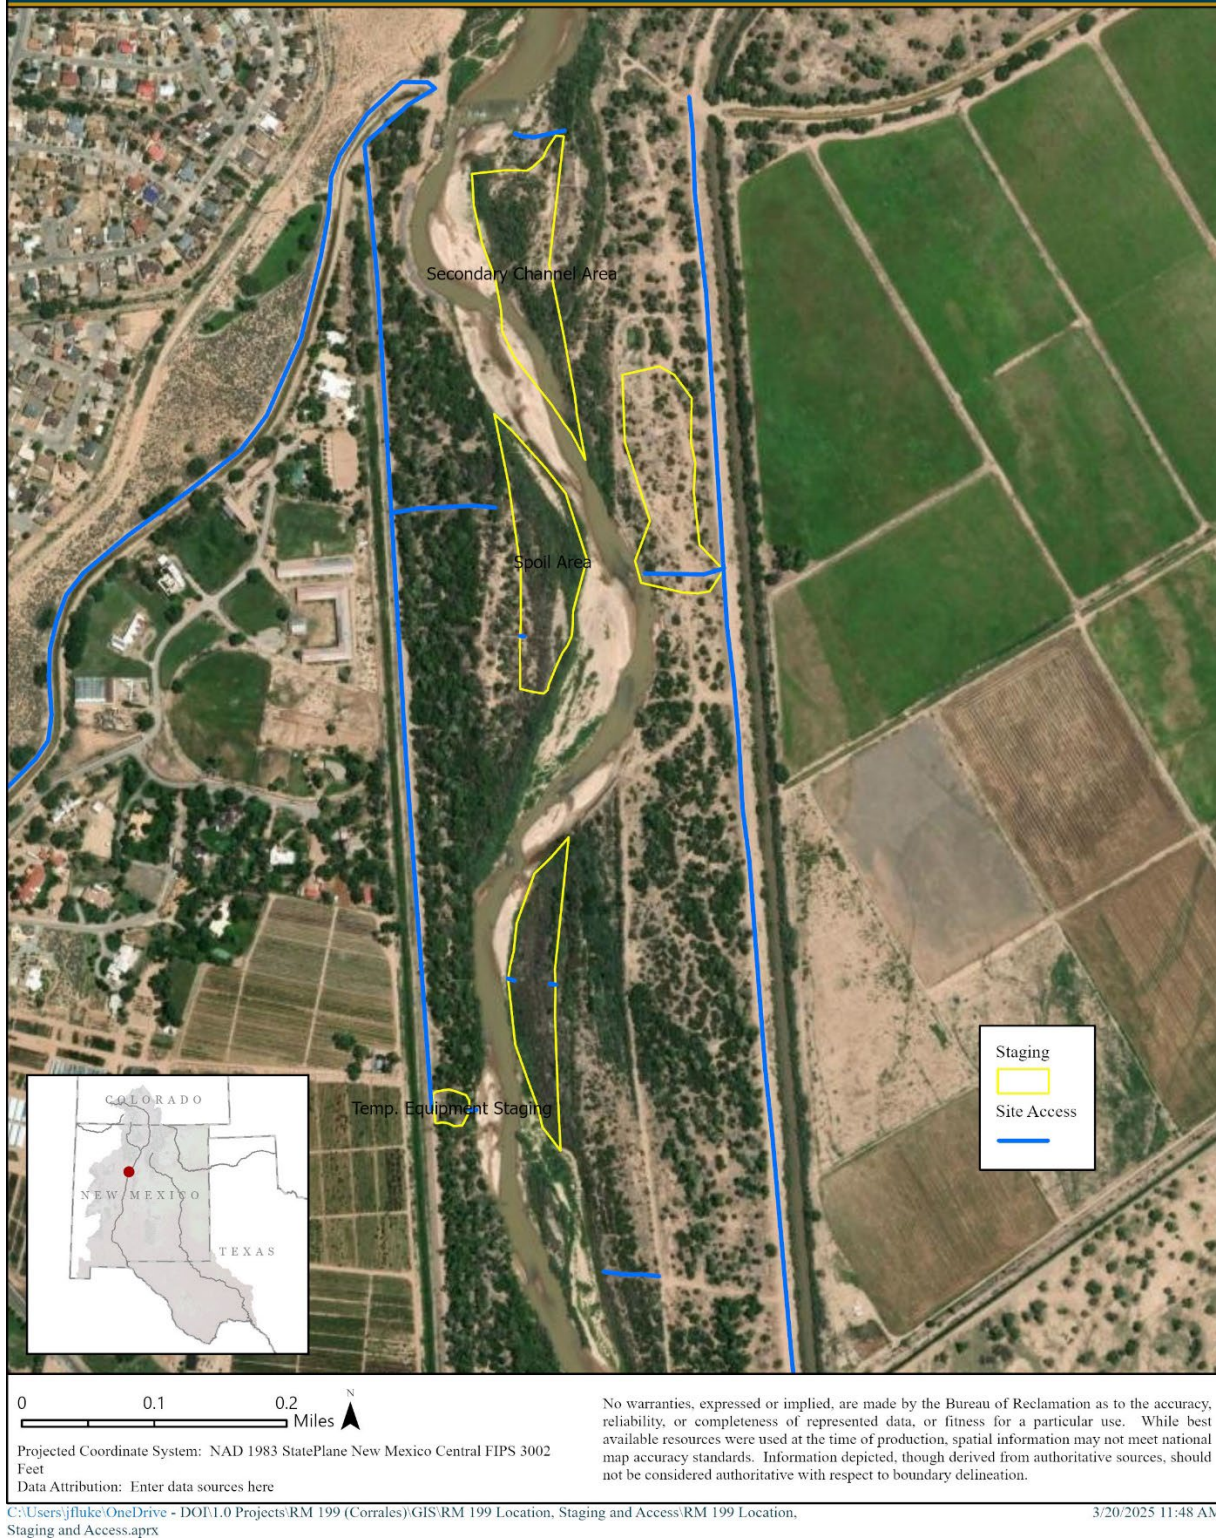
Figure 7: Plan view of project area showing the planned access routes and staging areas.

The staging areas for the construction equipment and temporary riprap and/or fill material storage needed during the construction operations will be mainly along the eastern side of the river along the BB-343 bend.

Excavate the cutoff/side channel on the RM 199 point bar, leaving the entrance and exit plugs in place. Stockpile spoil material on the inside of the RM 199-point bar (see Figure 7). Remove entrance and exit plugs to allow flow through the newly excavated cutoff/side channel.

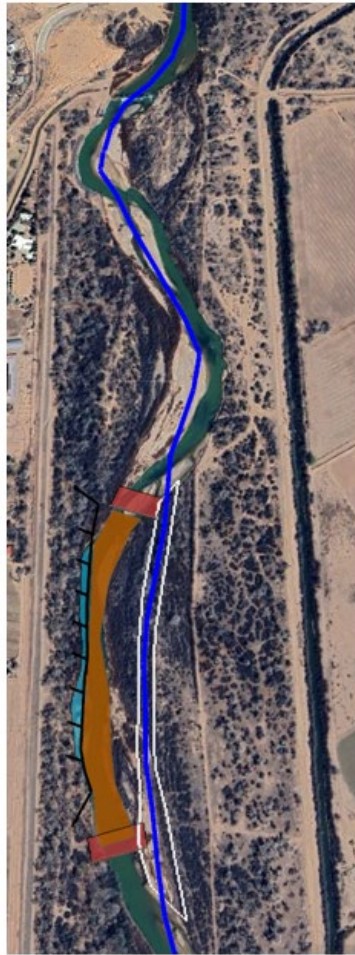
Phase I

- RM 199 Bend LSTP and backfill
- Side Channel (Sandia side)
- Main channel fill
- Bed Control features (x2)

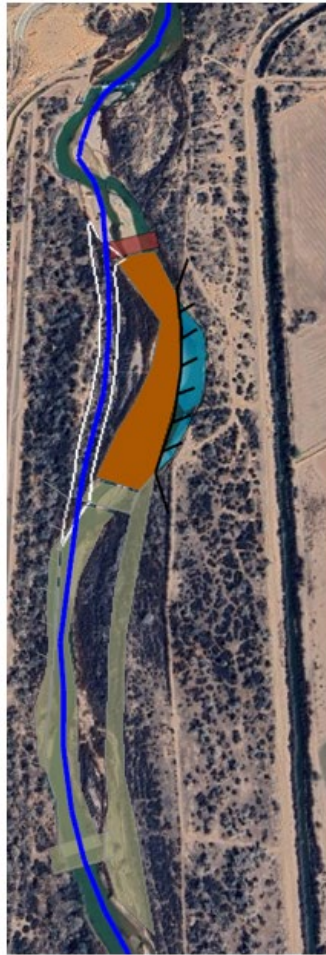
Phase II

- BB-343 Bend LSTP and backfill
- Side Channel (Corrales side)
- Main channel fill
- Bed Control feature

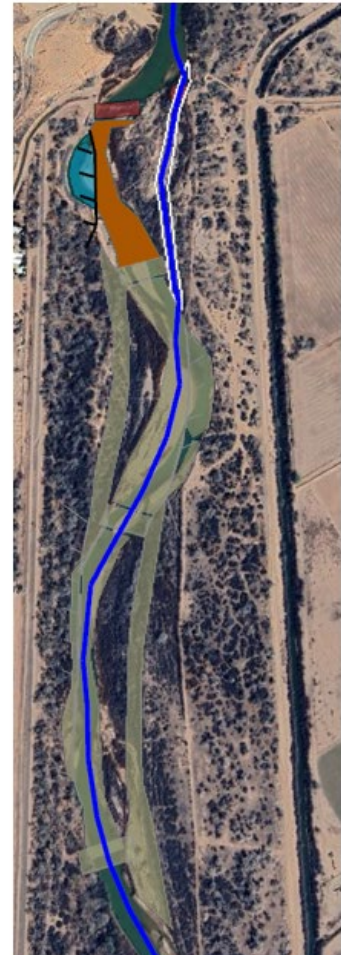
Phase III

- Corrales Siphon Bend LSTP and backfill
- Side Channel (Sandia side)
- Main channel fill
- Bed Control feature x2 (main channel and side channel)

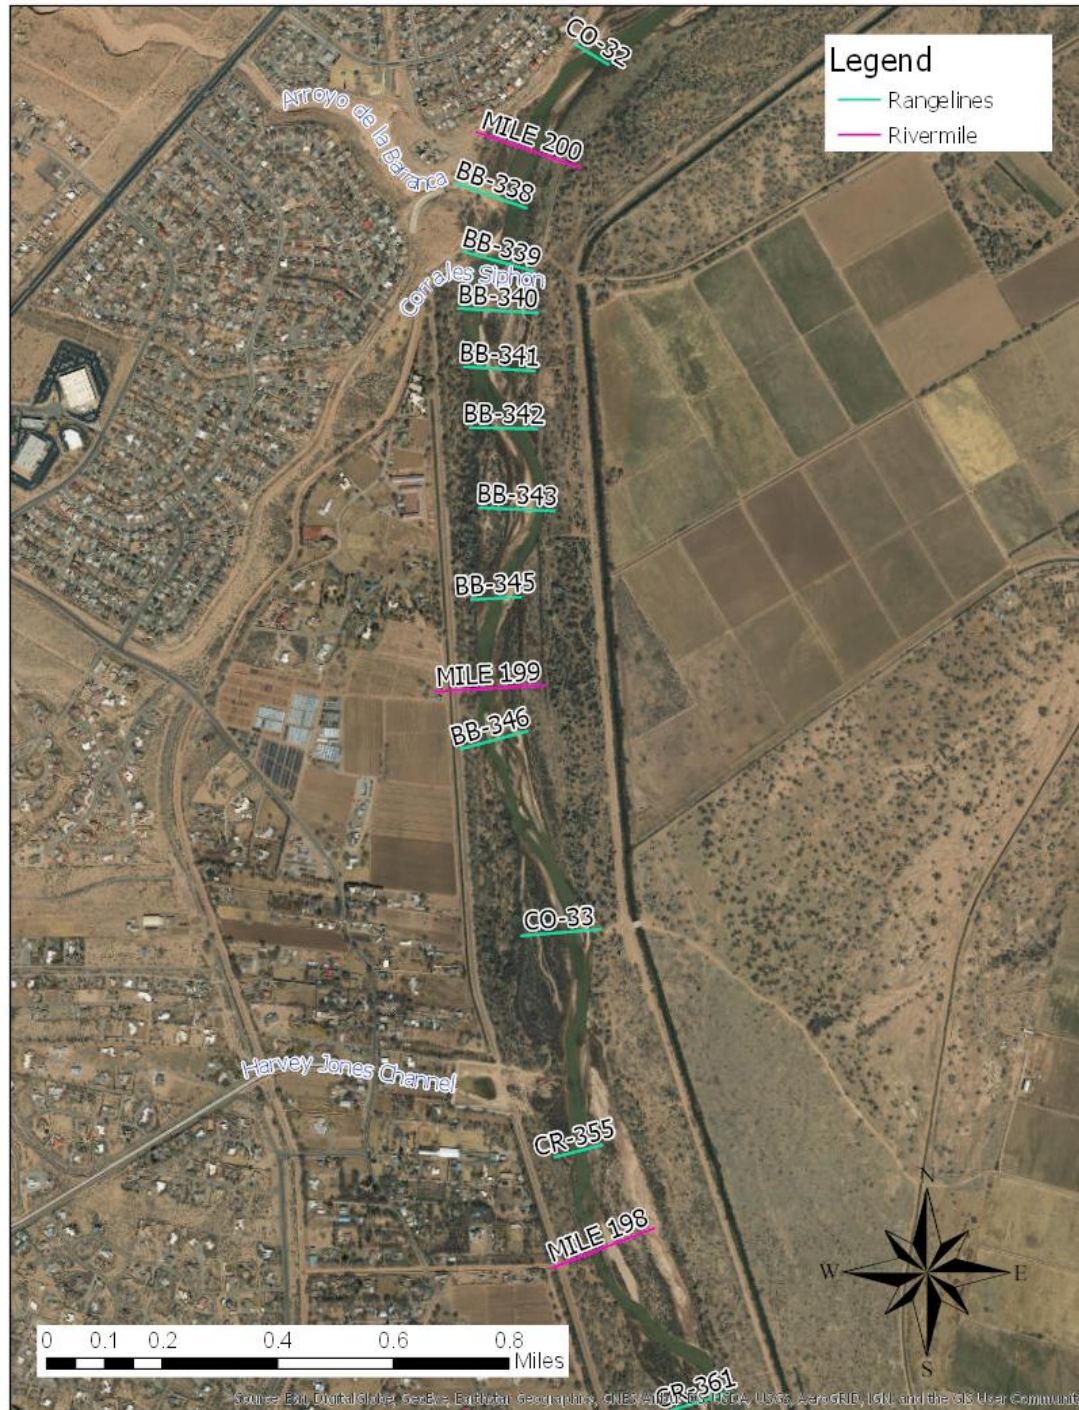
Figure 3: Plan view of cross section lines in the vicinity of the Corrales RM 199 Project area

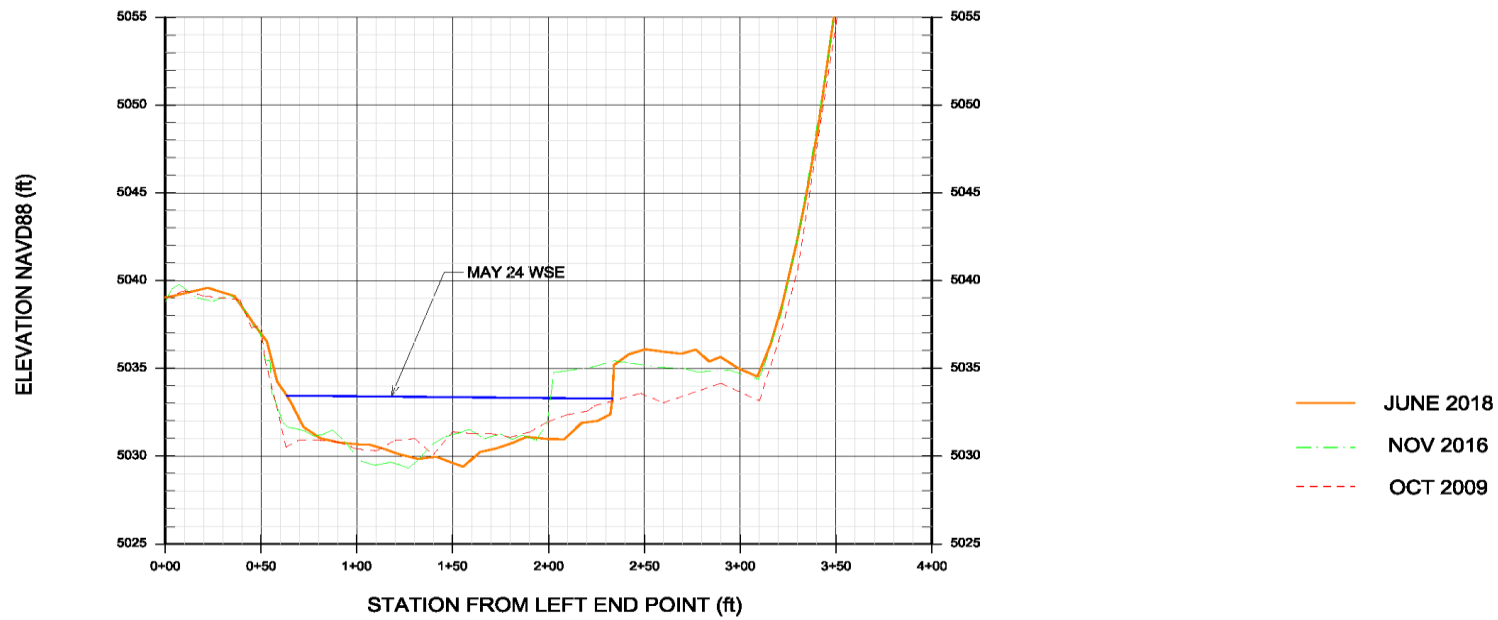
Figure 4: Cross section at CO-32 (approximately 1,650 feet upstream of Arroyo de la Barranca) depicted looking downstream

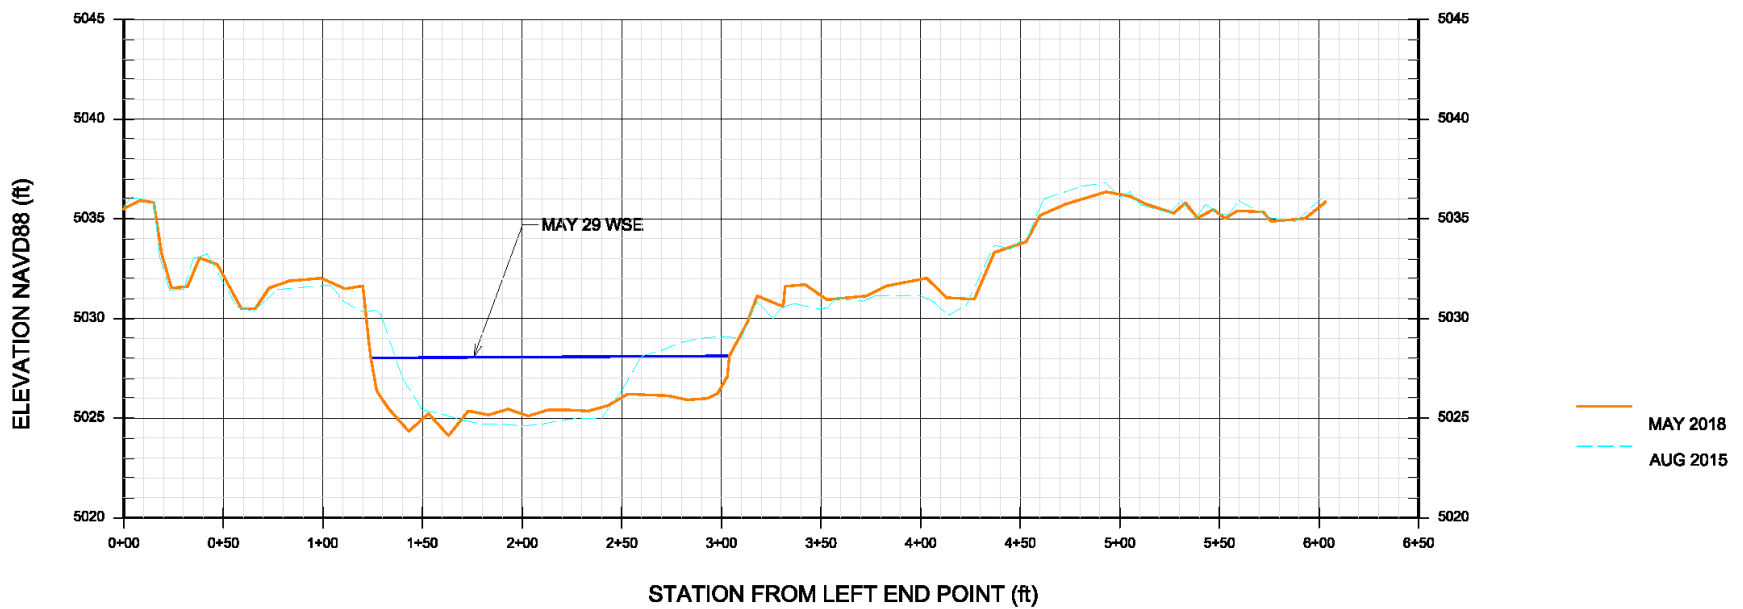
Figure 9: Cross section at BB-342 (approximately 1,550 feet downstream of Corrales Siphon, on run) depicted looking downstream

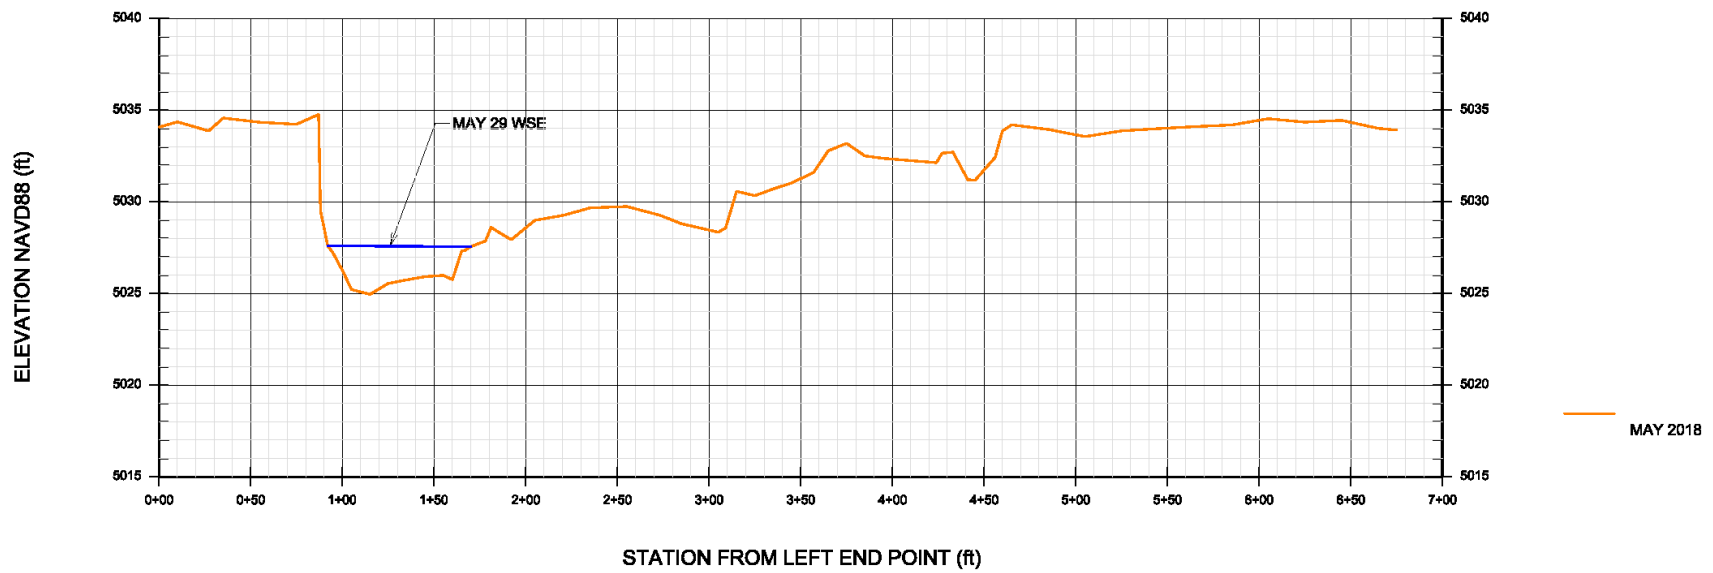
Figure 10: Cross section at BB-343 (highly erosional bend) depicted looking downstream

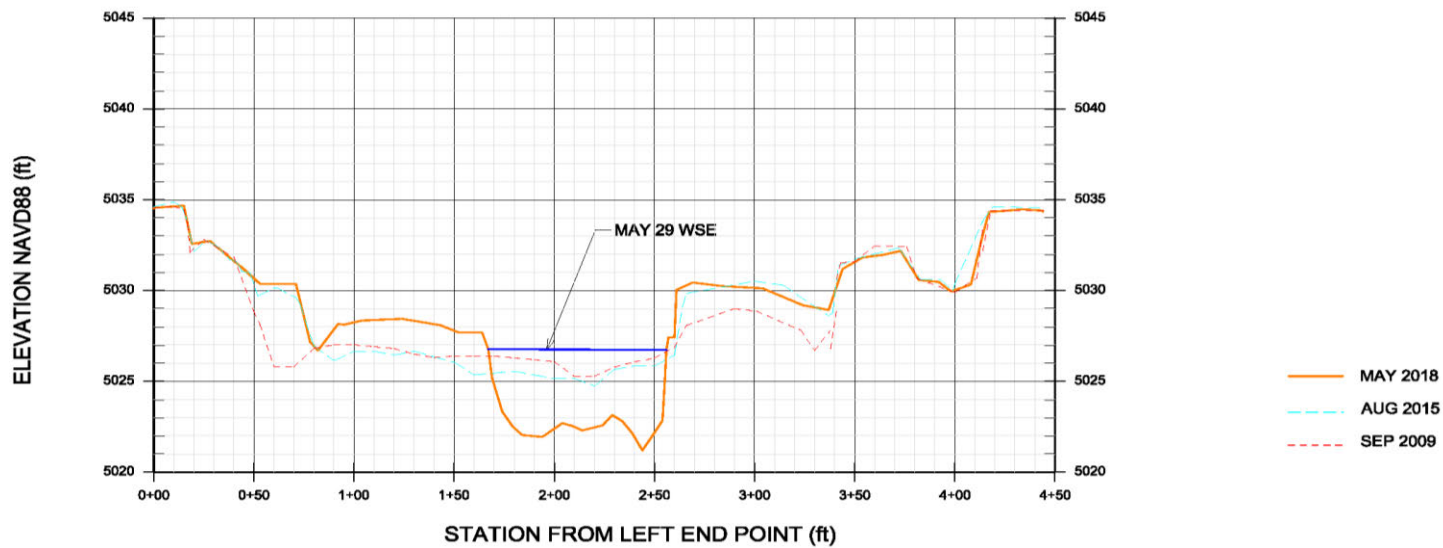
Figure 11: Cross section at BB-345 (on run upstream of RM 199 bend) depicted looking downstream

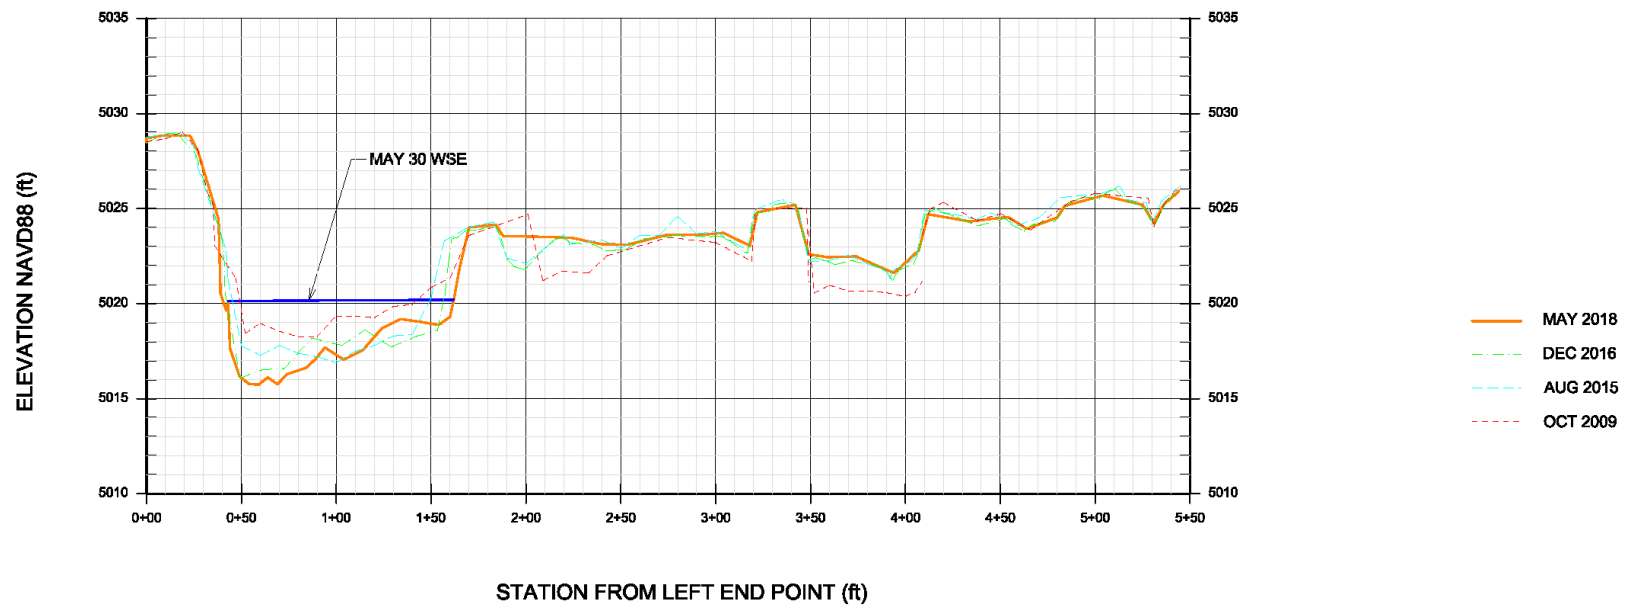
Figure 15: Cross section at CR-361 (downstream end of project, on an outer bend apex) depicted looking downstream

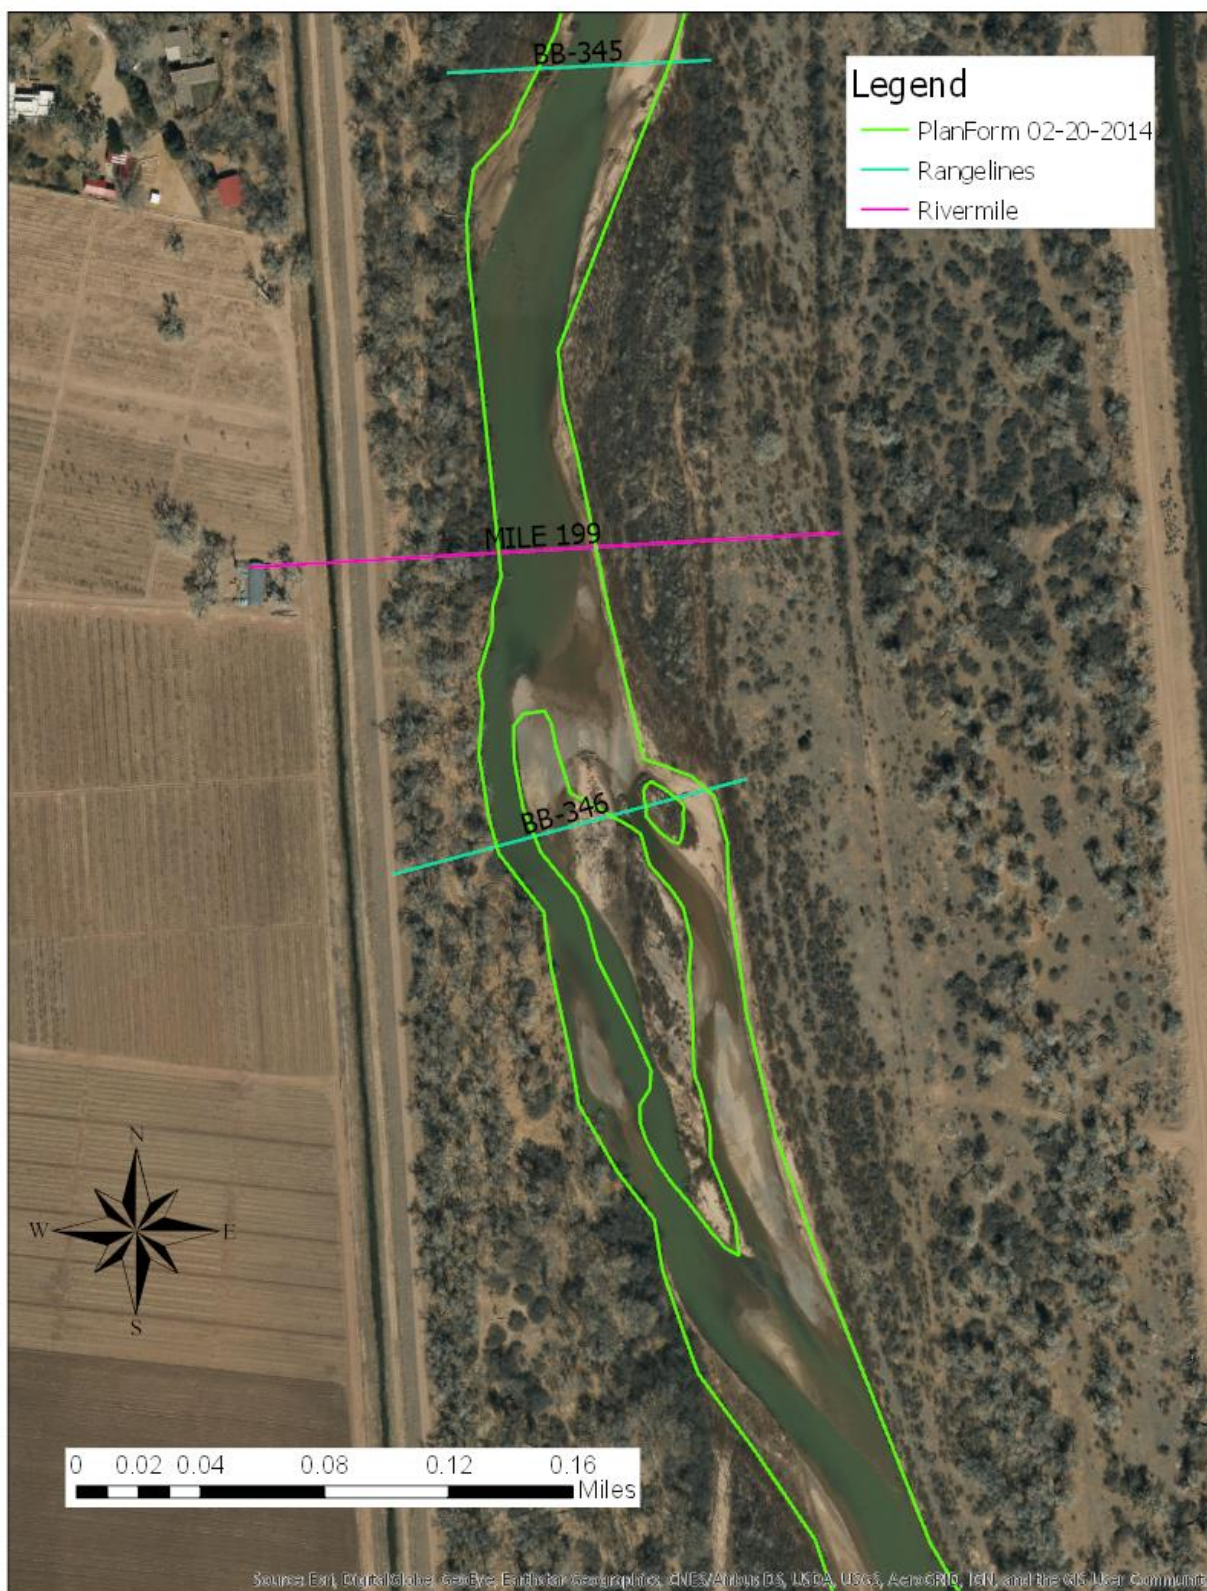
Figure 17: 2014 Rio Grande planform outline on 2018 aerial imagery (Esri GIS) at the RM 199 bend

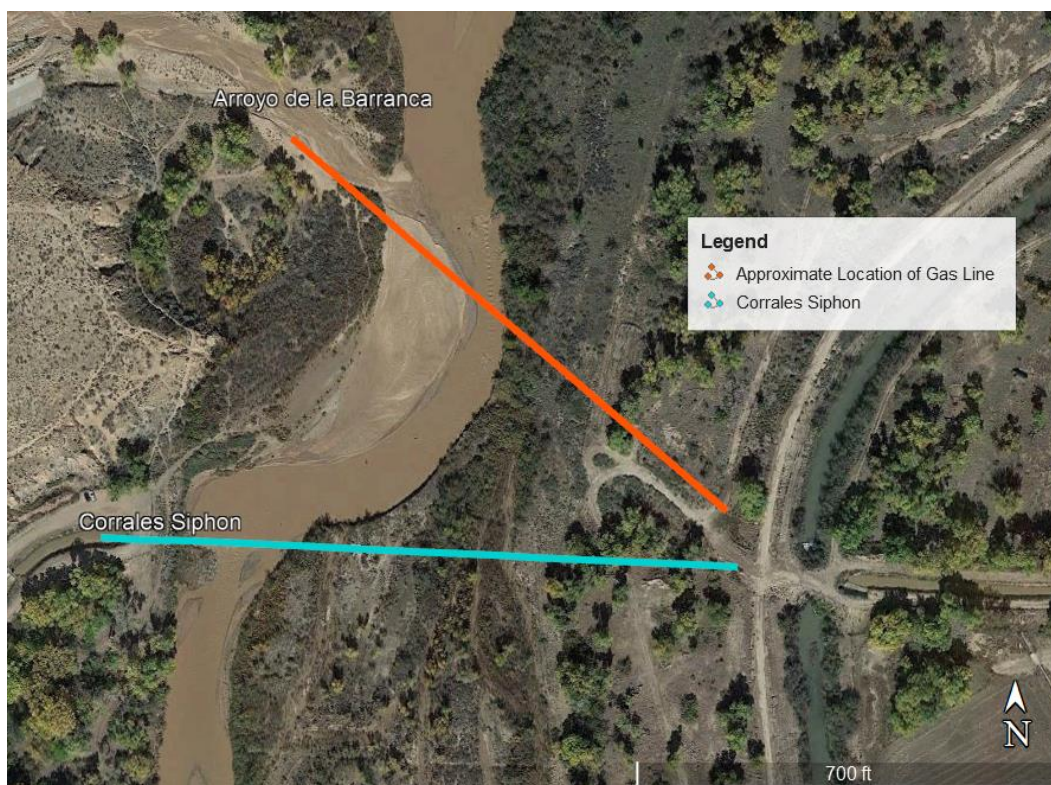
Infrastructure that runs under the river in this area includes a gas line and the Corrales Siphon (Figure 19).

Figure 19: Utilities buried in the floodplain and under the river.

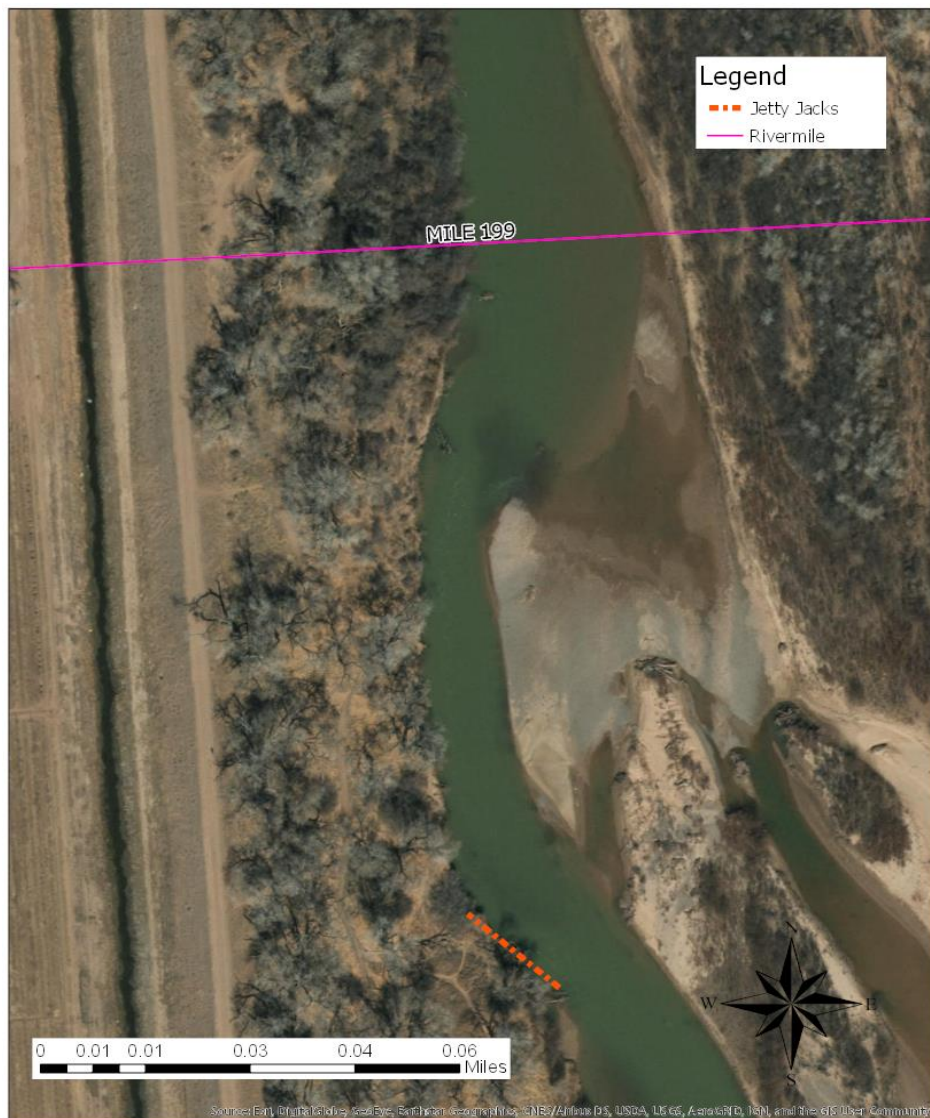
Two jetty jacks are visible south of River Mile 199 (Figure 21). Most jetty jacks have been removed, but it is possible more jetty jacks are present in the project area. Removal of jetty jacks may be necessary as part of the selected alternative.

Figure 21: Jetty jacks within the project area.

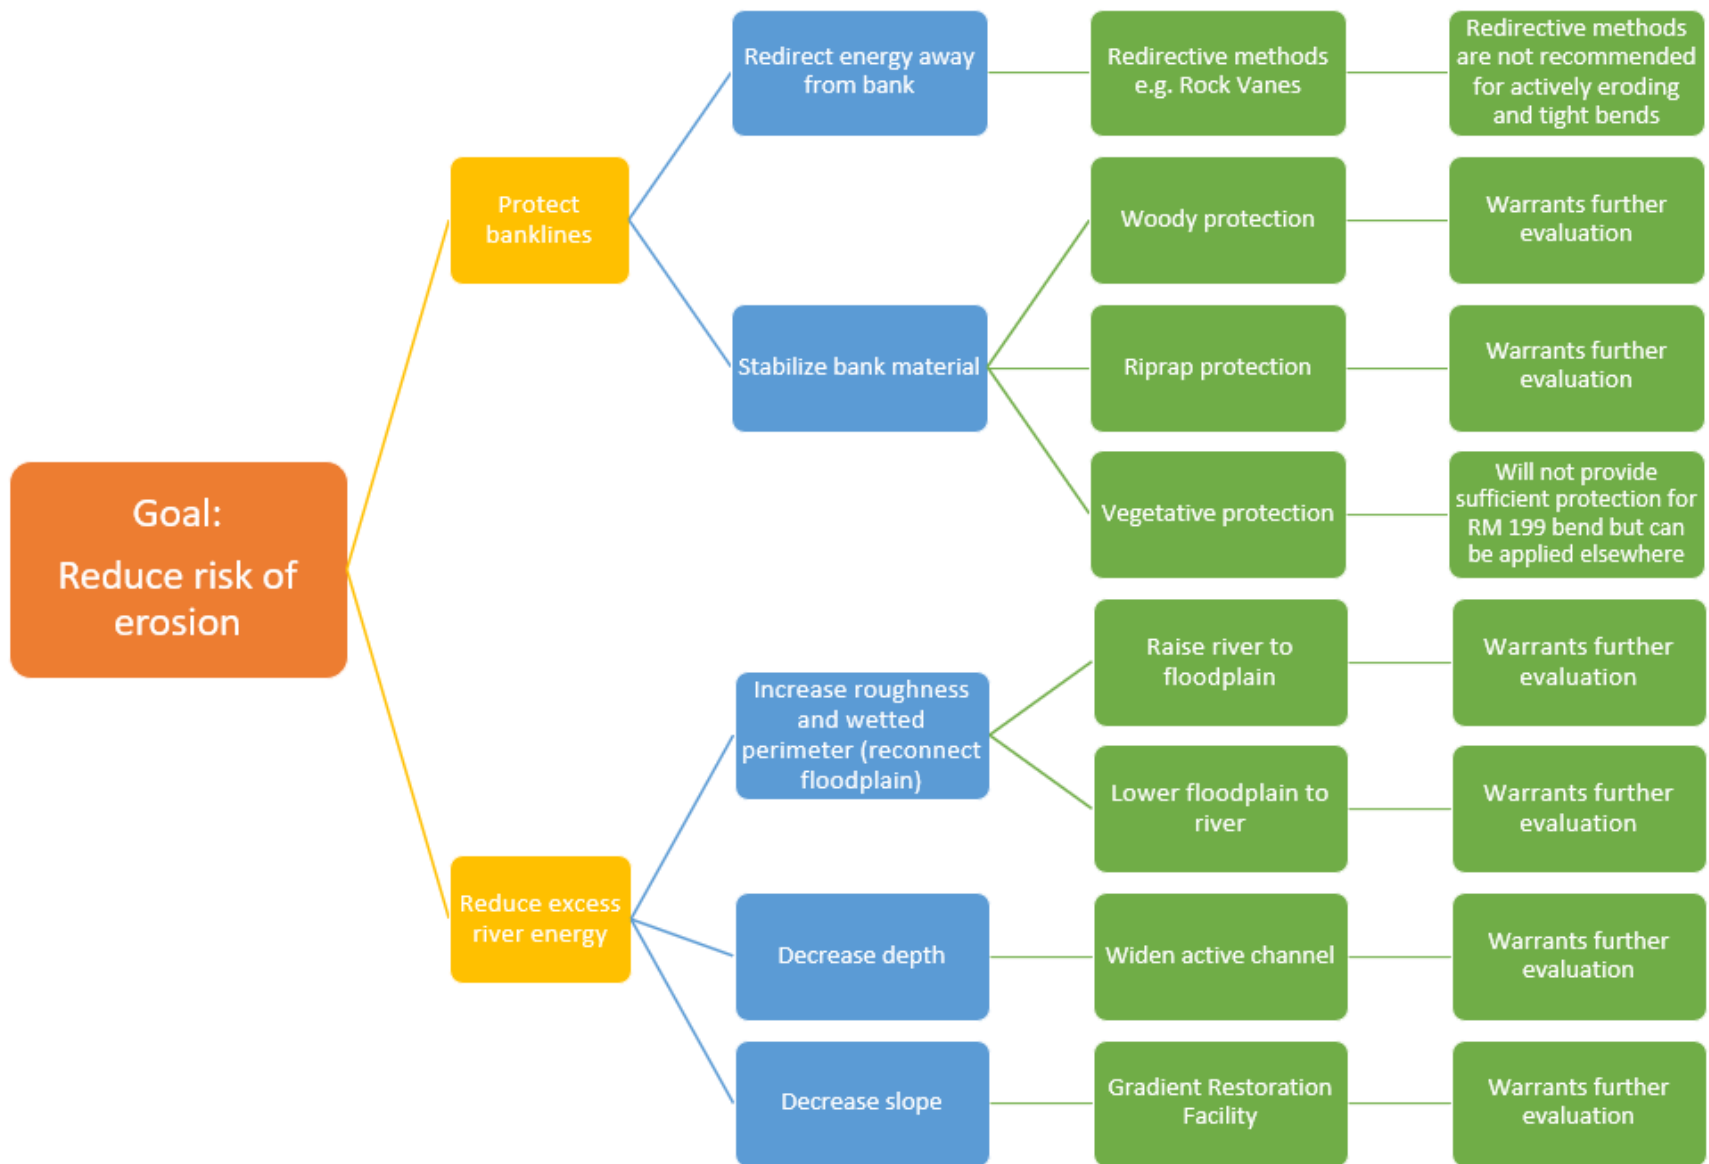
Figure 23: Decision tree considering strategies to achieve the project goal

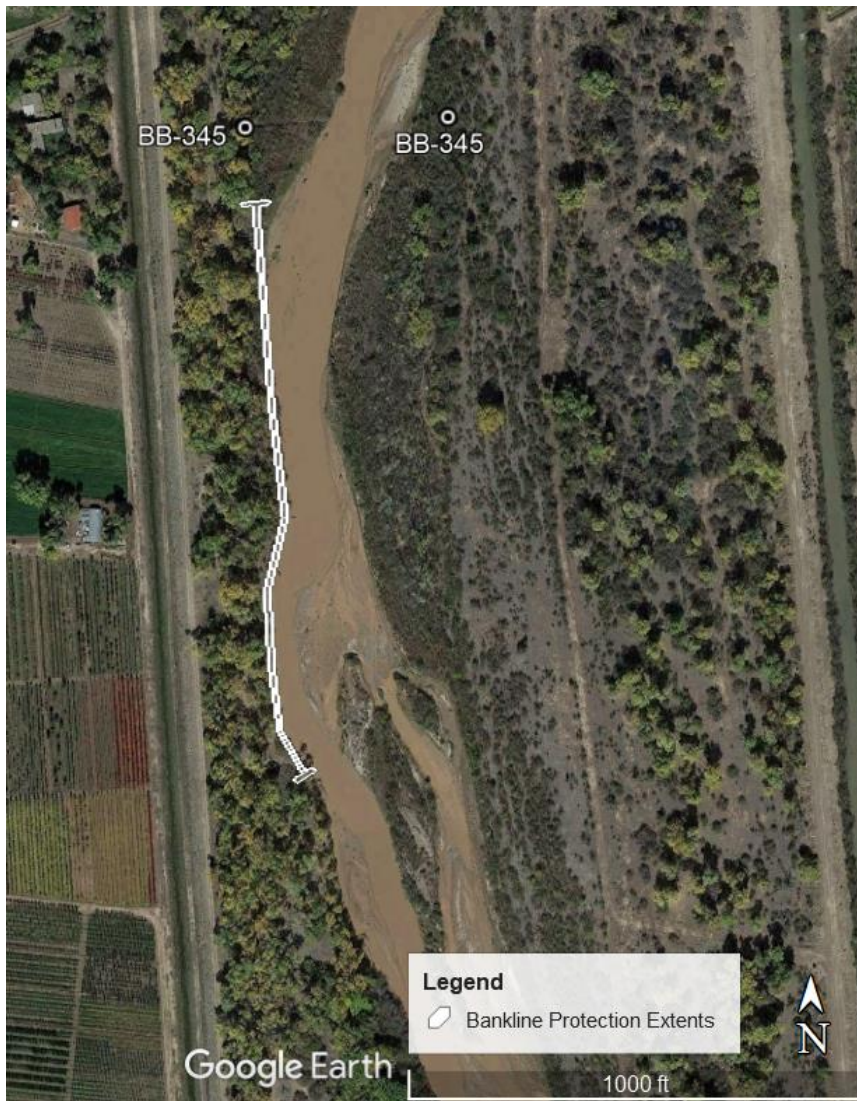
At RM 199, which is the bend closest to the levee, the goal is to safely pass the 2-year flood (between 5,600 and 4,000 cfs; see Section 2.5.11) without incurring further erosion towards the levee. At this time, it is proposed to stabilize approximately 1,300 feet of bankline at the RM 199 site (not including the structural keys and tie backs). See Figure 25 for the aerial extents of this proposed bankline protection (not including structural keys and tie backs).

Figure 25: Extents of proposed bankline protection at the RM 199 bend, not including the structural keys and tie backs

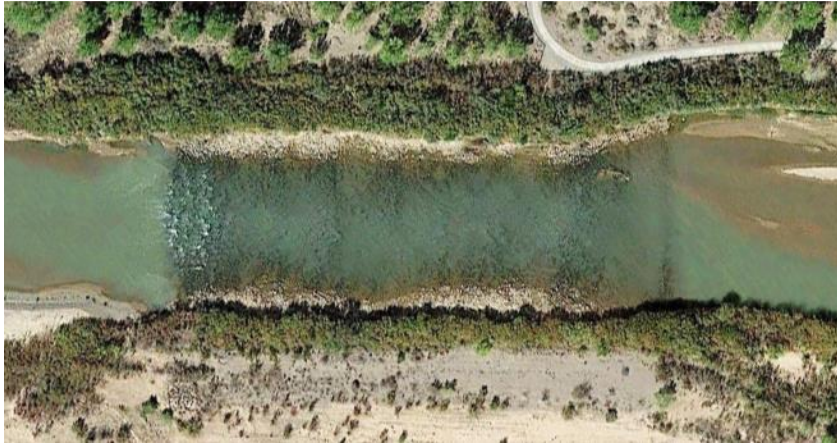
The GRFs would have a sheetpile wall that crosses the entire width of the river and into both banks. The sheetpile wall fixes the riverbed elevation and is usually set 1–3 feet above the existing bed elevation. A downstream rock apron (approximately 500 feet long) is needed to protect the sheetpile and allow for a sloped transition for upstream fish movement (see Figure 30 for an example GRF near RM 205). The structures would tie into the abandoned upper floodplain with structural keys to prevent the river from flanking the structure. The apron's riprap material would increase the roughness of the river at these sections. Two case scenarios of the GRFs will be evaluated with

Figure 30: Example of a GRF near RM 205

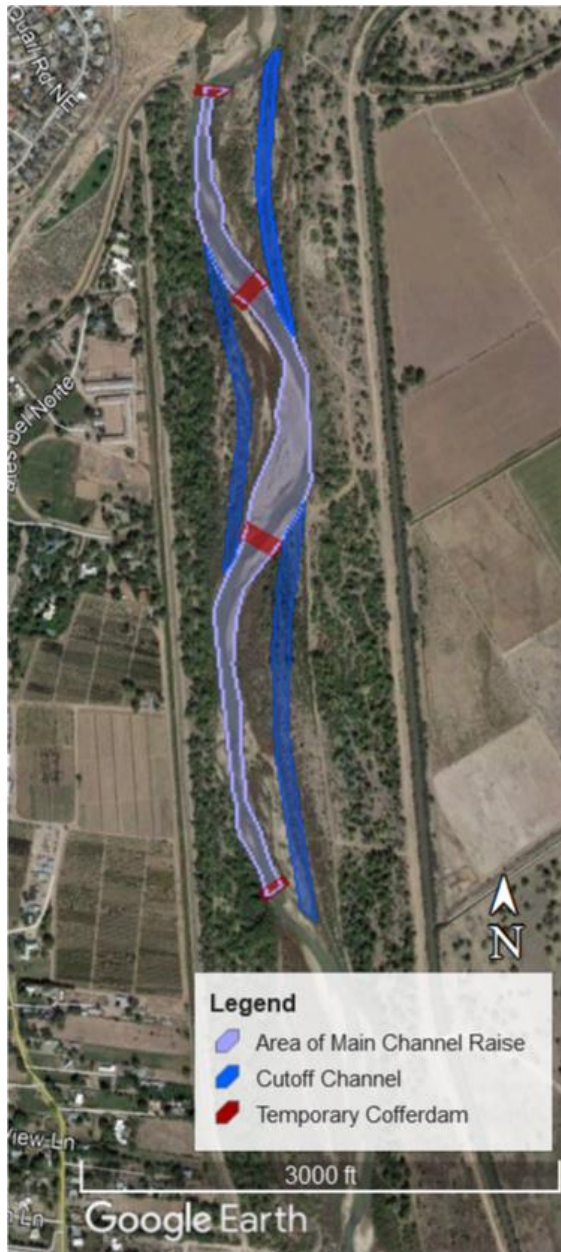
This alternative would raise the river bed by one to three feet and widen the active channel by roughly 90 feet. This would be accomplished by creating a cutoff channel through each meander's inner bend, and placing the excavated materials in the main channel to raise the main channel (see Figure 33 for a conceptual plan view of these components). The cutoff channel would be excavated

For this alternative evaluation, cutoff channels would be built at all five inner bends from Corrales Siphon to the RM 198 bend. Each cutoff channel would be built one at a time, from downstream to upstream. The cut material from each channel will be temporarily stockpiled until the cutoff channel is finished. Then the entire river will be temporarily diverted into the cutoff channel alignment with a temporary cofferdam near the upstream inlet of the cutoff channel. Then the excavated cutoff channel spoil materials will be moved into the existing channel along the outer bank and used to raise the existing channel bed. Then the temporary cofferdam diversion would be removed, and the river would be allowed to split flows between the existing river channel and the new cutoff channel.

Figure 33: Cutoff channel alternative components, zooming in on the three upper bends to better demonstrate details

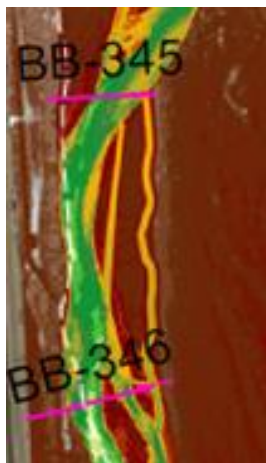
Figure 36: Topography map showing example design of limited side channels (orange) on the RM 199 point bar (red)

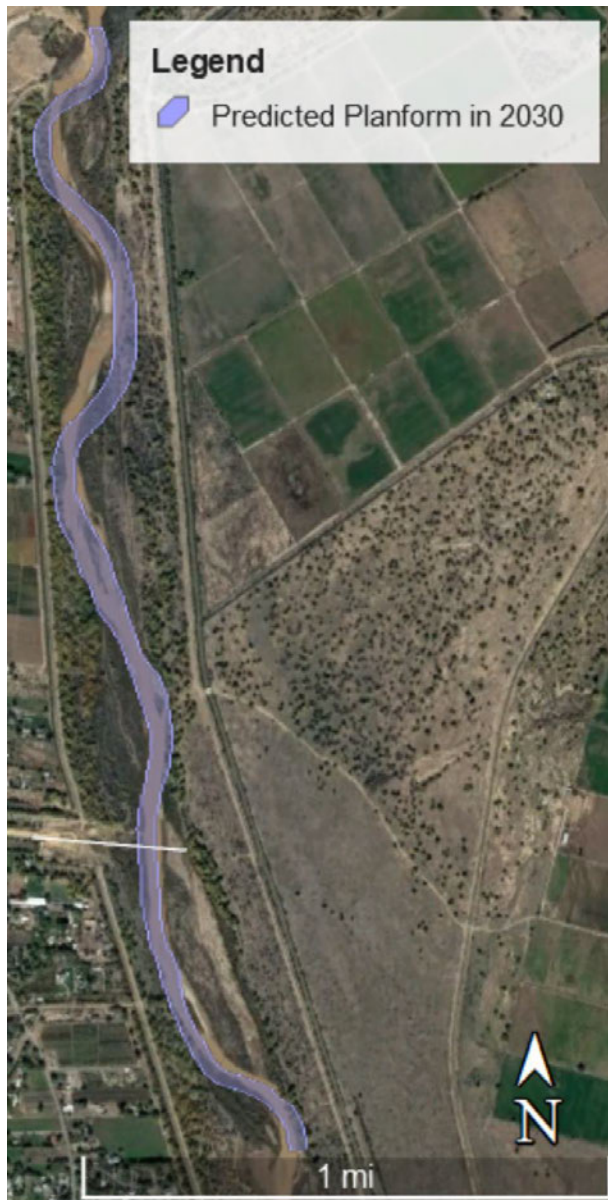
Figure 37: Predicted planform for year 2030 based on erosion rate and direction between 2013 and 2020

This bend movement analysis was used to predict a planform for year 2030 (shown in Figure 37). However, it should be noted that as seen in the past in this reach, some areas may unexpectedly start eroding while other stop eroding, so the level of certainty in future planform predictions is very low. To model this no-action alternative in HEC-RAS, the current geometry of the river (October 2019 LiDAR and bathymetry data) was used since the predicted future terrain has low certainty.

All these trends will have significant negative impacts on the no-action alternative. Without action, the river will continue to incise, further disconnecting itself from its floodplain. The hydraulic depths will increase, the velocities will increase, and the bank erosion will increase. The meander bends will continue to migrate and increasingly threaten the levees. See Figure 37 for the predicted planform based on current erosion rates for year 2030 if the no-action alternative is selected.
