Finding of No Significant Impact and Environmental Assessment for the Corrales River Mile 199 Project

Middle Rio Grande Project

Upper Colorado Basin Region, Albuquerque Area Office

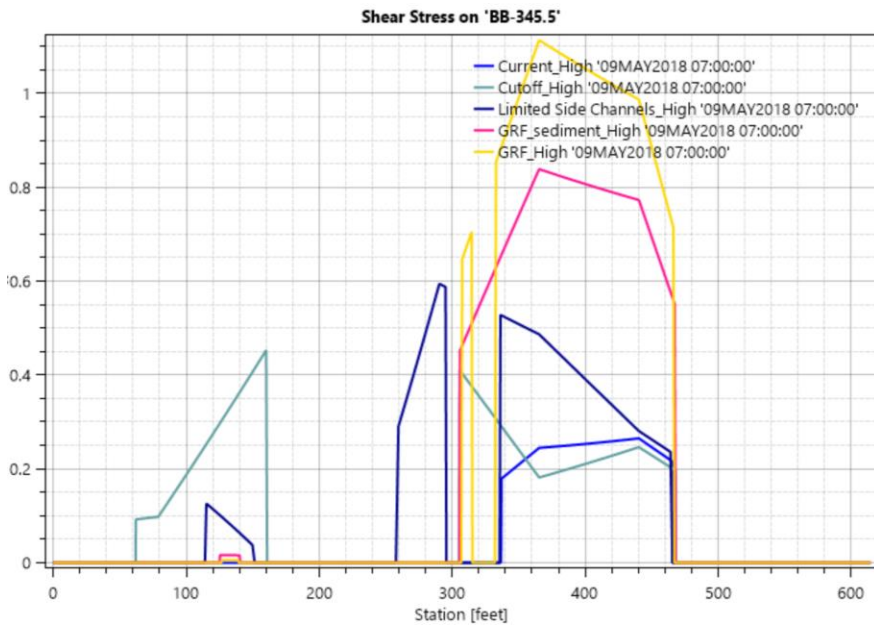
Figure 56: a) Cross section of terrain for all four models on BB- 345.5 and, b) Shear Stress at BB-345.5

Figure 56 a & b shows river cross section and shear stress along the cross section BB-345.5. This is at the upstream side of the RM 199 bend where the river is only 200 feet from the levee, and where the changed angle of attack from the upstream side created new erosion in 2019. At this location, the cutoff channels have really shifted the shear stress onto the east floodplain, away from the eroding bank (approx. Sta. 460) and have also reduced the shear stress along the river channel.

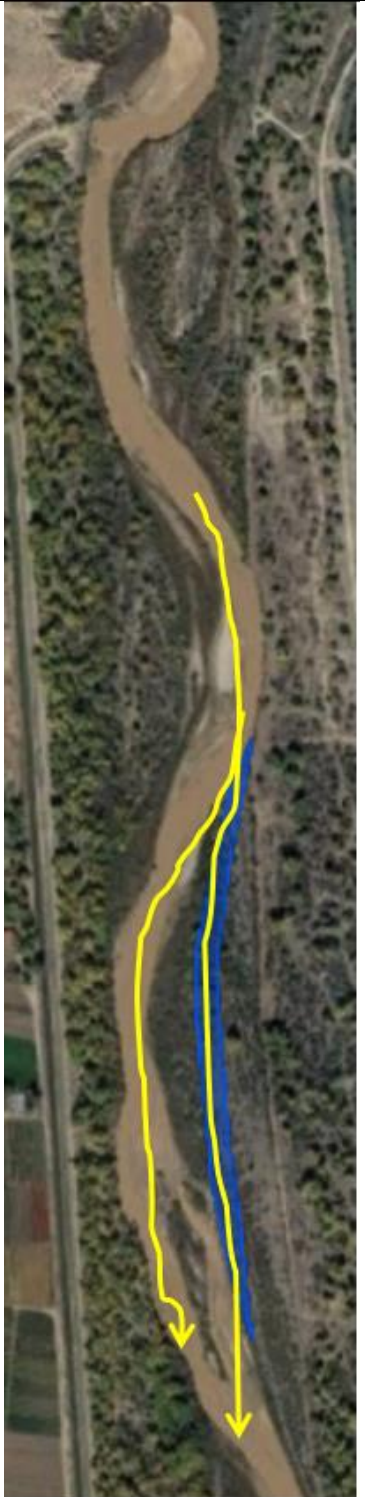
Step	Actions	Features Completed (flow path shown in yellow)
1	Excavate the cutoff channel on the RM 199 point bar, leaving the entrance and exit plugs in place. Stockpile spoil material on the inside of the RM 199 point bar. Remove entrance and exit plugs to allow flow through the cutoff channel.

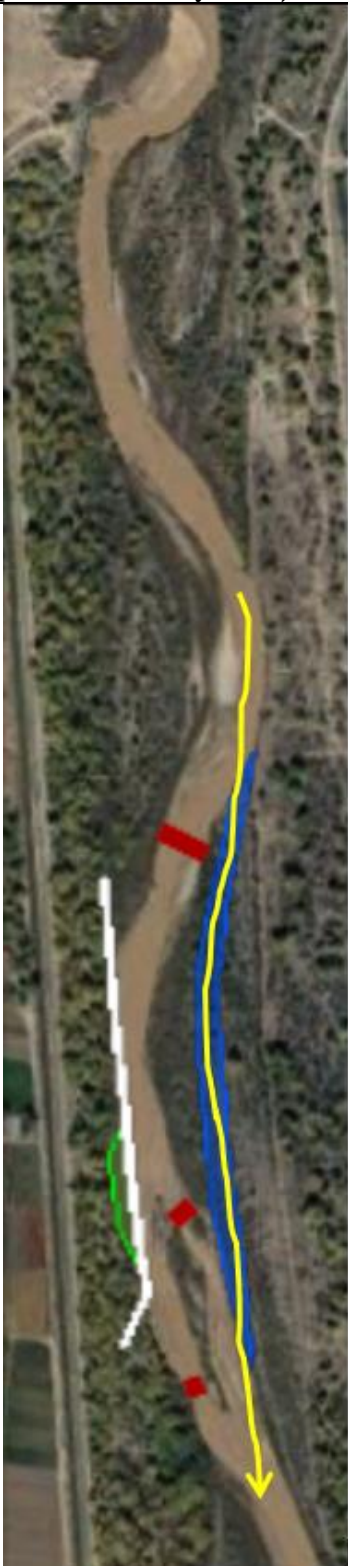
Step	Actions	Features Completed (flow path shown in yellow)
2	<p>Build temporary riprap diversion cofferdam immediately downstream and upstream of the RM 199 cutoff channel entrance and exit, respectively. All flows would temporarily be in the cutoff channel and the RM 199 bend would be temporarily dry. On the RM 199 outer bend, construct the LSTP. Place cutoff channel's spoil material in the (dry) main channel and fill in behind the LSTP for the floodplain bench.</p>

<p>The image is an aerial photograph of a river bend. A yellow line with an arrow at the bottom indicates the flow path, which follows the outer curve of the bend. A blue line runs parallel to the yellow line, representing a channel or cutoff. Several red rectangular markers are placed along the riverbank, likely indicating construction sites or cofferdam locations. A green line is visible on the left side of the bend, and a white dashed line runs along the inner curve of the bend.</p>

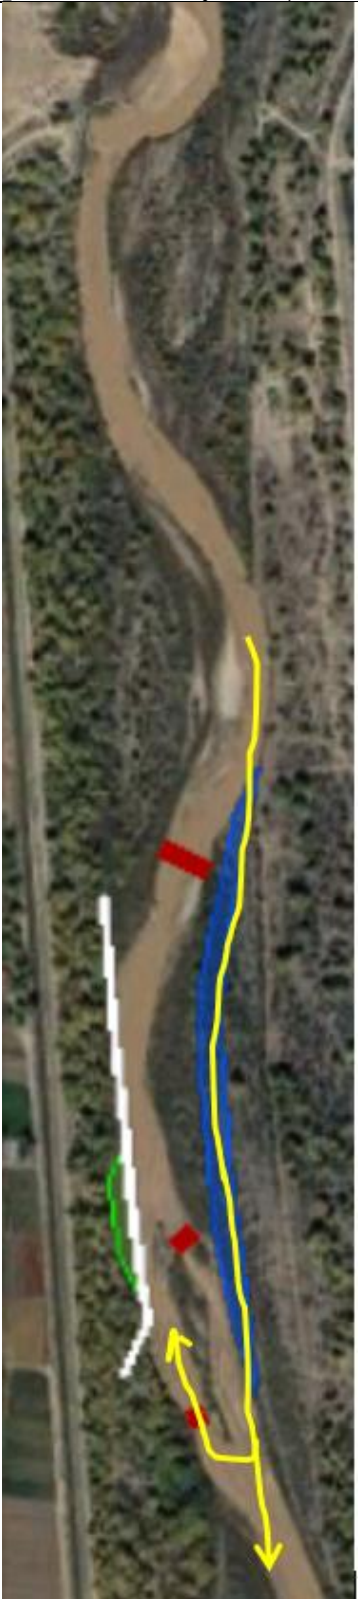
Step	Actions	Features Completed (flow path shown in yellow)
3	Smooth out the riprap from the downstream temporary riprap diversion cofferdam onto the spoiled material filling the main channel. This will stabilize the slope going from spoil material grade to main channel grade. Leave the upstream temporary riprap diversion cofferdam in place.

<p>The image is an aerial photograph of a river channel. A yellow line with arrows at both ends indicates the flow path, starting from the bottom right and curving towards the top left. A blue area, representing riprap, is situated along the right bank of the channel. A red rectangular structure, likely a diversion cofferdam, is located on the left bank. A white dashed line runs parallel to the left bank. A green area is visible on the left bank near the bottom. The river water is a light brown color, and the surrounding land is covered in green vegetation.</p>

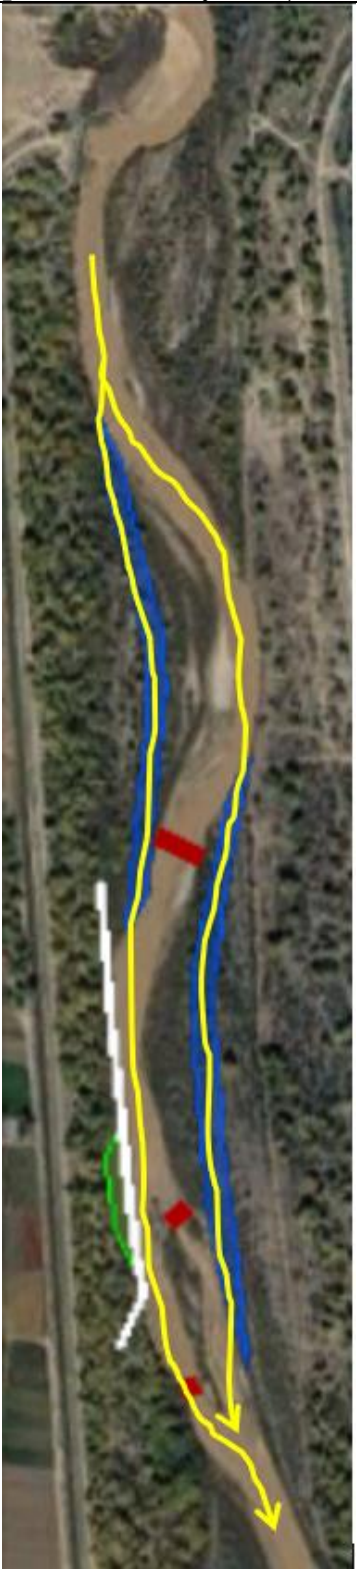
Step	Actions	Features Completed (flow path shown in yellow)
4	Excavate the cutoff channel on the BB-343 point bar, leaving the entrance and exit plugs in place. Stockpile spoil material on the inside of the point bar. Remove entrance and exit plugs to allow flow through the cutoff channel.

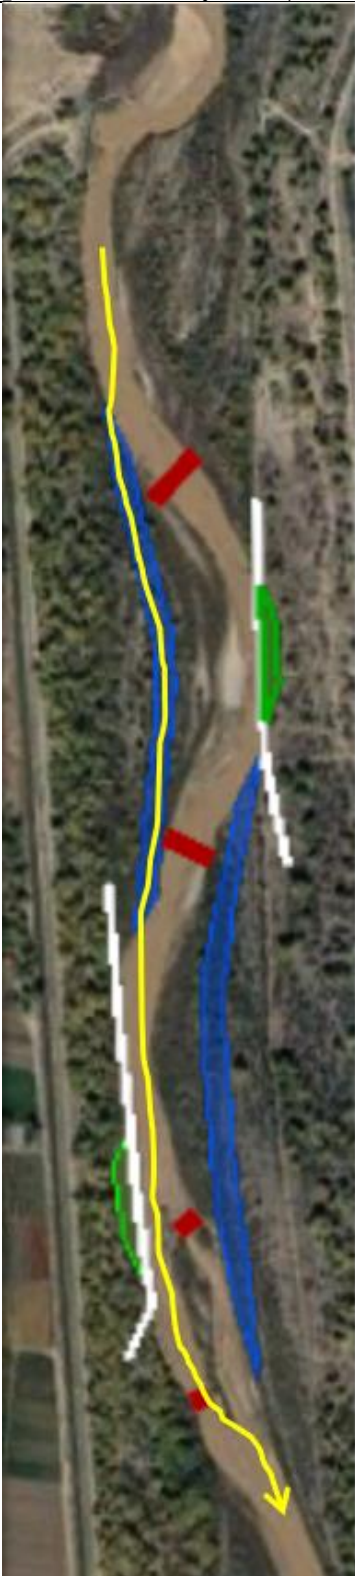
Step	Actions	Features Completed (flow path shown in yellow)
5	<p>Build temporary riprap diversion cofferdam immediately downstream of the BB-343 cutoff channel entrance. All flows would temporarily be in the cutoff channel and the BB-343 bend would be temporarily dry. On the BB-343 outer bend, construct the LSTP. Place the cutoff channel's spoil material in the (dry) main channel and fill in behind the LSTP for the floodplain bench.</p>

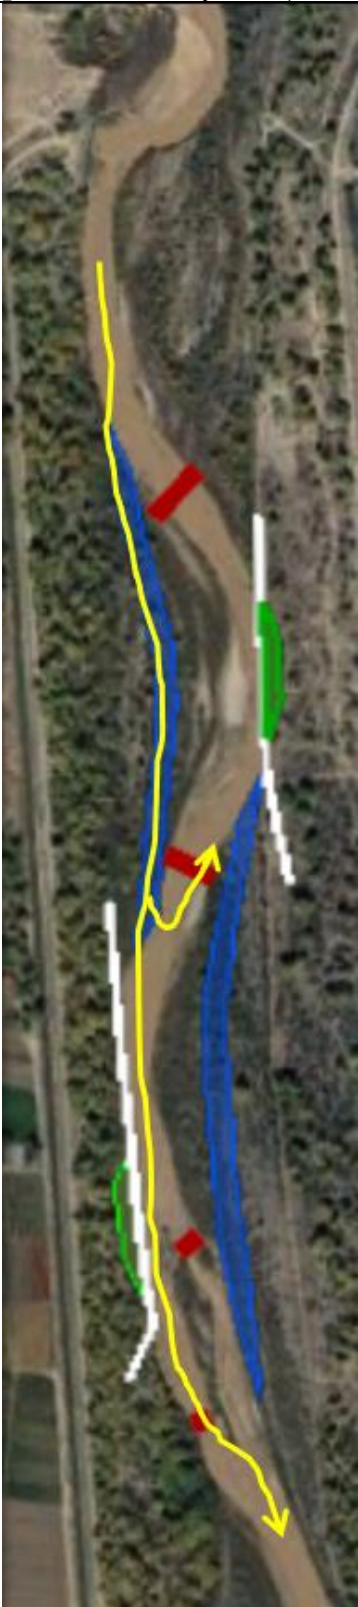
Step	Actions	Features Completed (flow path shown in yellow)
6	<p>At the temporary riprap diversion cofferdam between BB-343 and RM 199, smooth out the riprap onto the spoiled/fill material now placed upstream and downstream of the temporary riprap diversion cofferdam. This feature will now act as grade control to prevent erosion of fill material.</p>

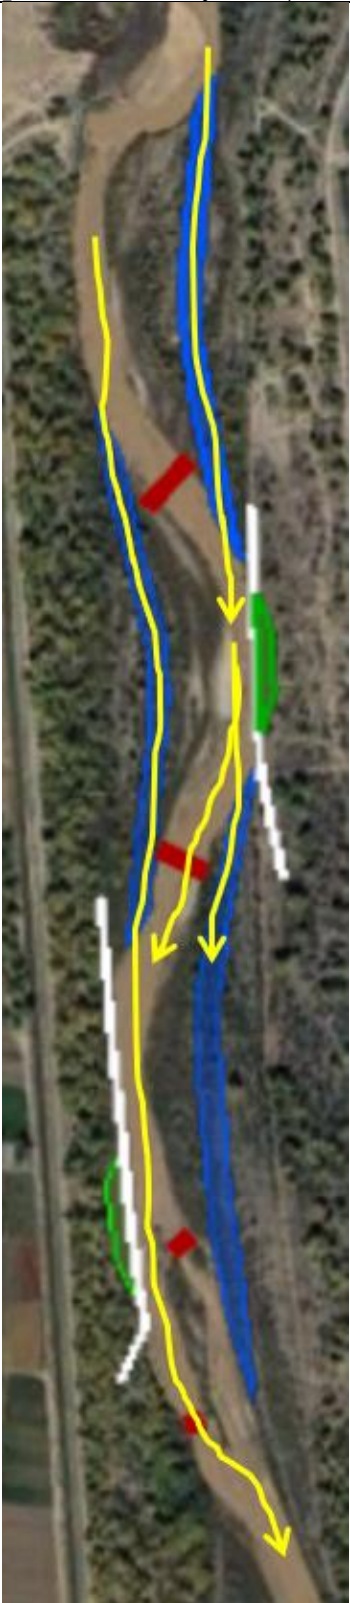
Step	Actions	Features Completed (flow path shown in yellow)
7	<p>Excavate the cutoff channel on the Corrales Siphon point bar, leaving the entrance and exit plugs in place. Stockpile spoil material on the inside of the Corrales Siphon point bar. Place a small layer of riprap immediately downstream of the siphon's alignment inside the cutoff channel to minimize potential downcutting to the siphon. Remove entrance and exit plugs to allow flow through the cutoff channel.</p>

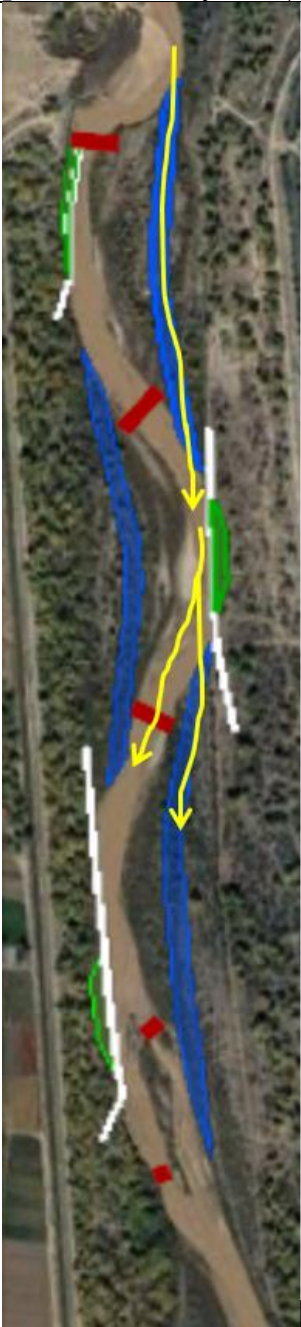
Step	Actions	Features Completed (flow path shown in yellow)
8	<p>Build a temporary riprap diversion cofferdam on top of the siphon's downstream riprap protection installed by MRGCD. (If MRGCD is opposed to a temporary riprap diversion cofferdam on top of the siphon's riprap protection, the cofferdam could also be placed closer to the upstream entrance of the cutoff channel. However, this configuration would require a much longer cofferdam). All flows would temporarily be in the cutoff channel and the Corrales Siphon bend would be temporarily dry. On the Corrales Siphon bend, construct the LSTP. Place the cutoff channel's spoil material in the (dry) main channel and fill in behind the LSTP for the floodplain bench.</p>

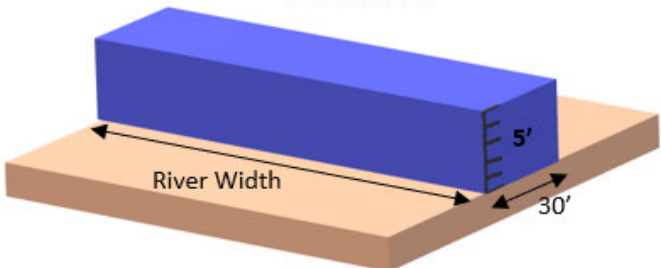
Channel bed material</p> <p>Cofferdam</p>

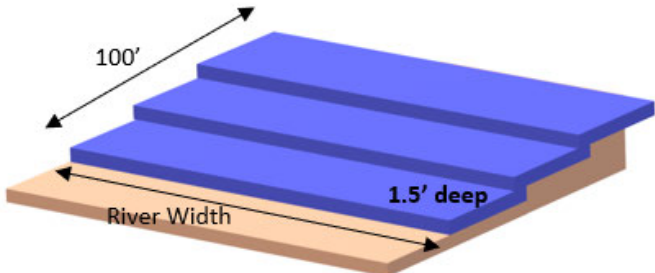
Bed control downstream of RM 199 bend (final configuration after material is spoiled)	<p>Approx. 1-2 feet of fill placed on upstream side of cofferdam</p> <p>Then the cofferdam is smoothed in the upstream direction over the new fill material with the resulting riprap layer being approx. 1.5' thick, 100' long, and no greater than 0.002 slope</p>

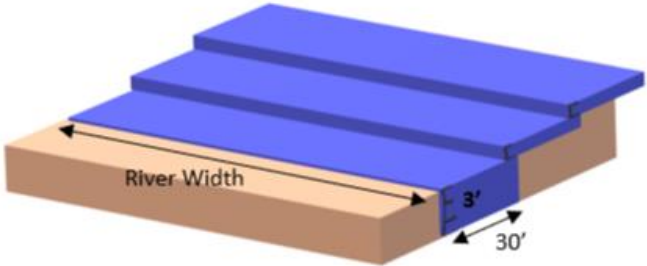
Feature	Description	Rough Conceptual Diagram
Two intermediate bed control features (final configuration)	<p>Approx. 3 feet of fill placed on both sides of cofferdam</p> <p>Then the top 2' of cofferdam riprap is smoothed in the upstream direction at approx. 1' thick, 60' long, and approx. 0.001 slope</p>

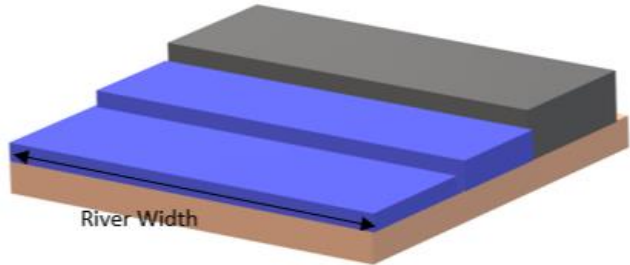
Bed control at Corrales Siphon -- additional bed control is unnecessary at Corrales Siphon since there is already riprap protection present (installed by MRGCD); thus, cofferdam riprap will be used to improve the slope of the existing (MRGCD's) riprap protection	<p>The cofferdam at Corrales Siphon would consist of approx. 1-2' of riprap on top of the existing riprap protection to ensure water is blocked from flowing downstream.</p> <p>After approx. 3 feet of fill placed on the downstream side of cofferdam, the excess riprap on top of the existing Corrales Siphon riprap would be smoothed in the downstream direction to improve the slope of the existing riprap and add an apron (scour protection).</p>
