Rio Grande Channel Analysis: Highway 380 to Elephant Butte Delta (RM 87 to RM 45)

Interior Region 7: Upper Colorado Basin

Prepared by Bureau of Reclamation, Albuquerque Area Office, Albuquerque, New Mexico

Technical Services Division, River Analysis Group

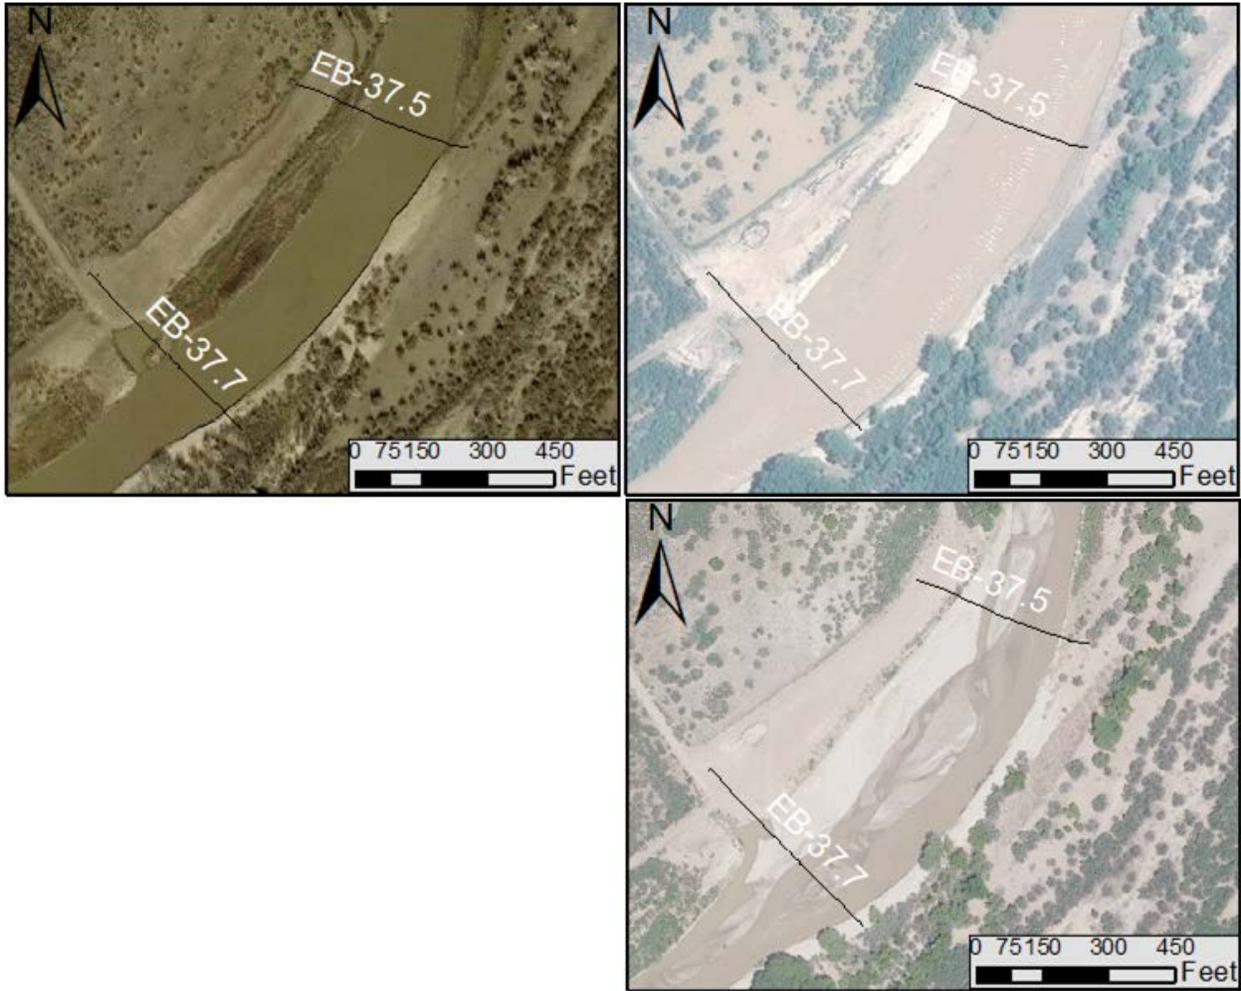
Figure 16: Widening of non-vegetated width at cross sections EB-37.5 and 37.7 from 2012 (top left) to 2016 (top right) as the vegetated sand bar on the western bank was cleared and submerged. From 2016 to 2018 (bottom right), EB-37.5 narrowed slightly as vegetation re-established on the western bank. EB-37.7 widened from 2016 to 2018 as vegetation on the western bank retreated.

bank moving away from the channel, then widened more between 2016 and 2018 as the vegetation grew sparse at the eastern channel bank (Figure 15). The cross sections EB-37.5 and EB-37.7 widened from 2012 to 2016 as the vegetated western bank became a partially submerged sand bar with less dense vegetation (Figure 16). From 2016 to 2018, EB-37.5 narrowed as vegetation became established on the western bank while EB-37.7 widened as vegetation on the western bank became sparser. The changes at EB-37.5 and 37.7 may be related to clearing by Reclamation rather than natural processes since these cross sections coincide with a staging area. EB-38.2 narrowed from 2012 to 2016 as vegetation became established on both banks, then widened between 2016 and 2018 as smaller vegetation on the east bank disappeared Figure 17.

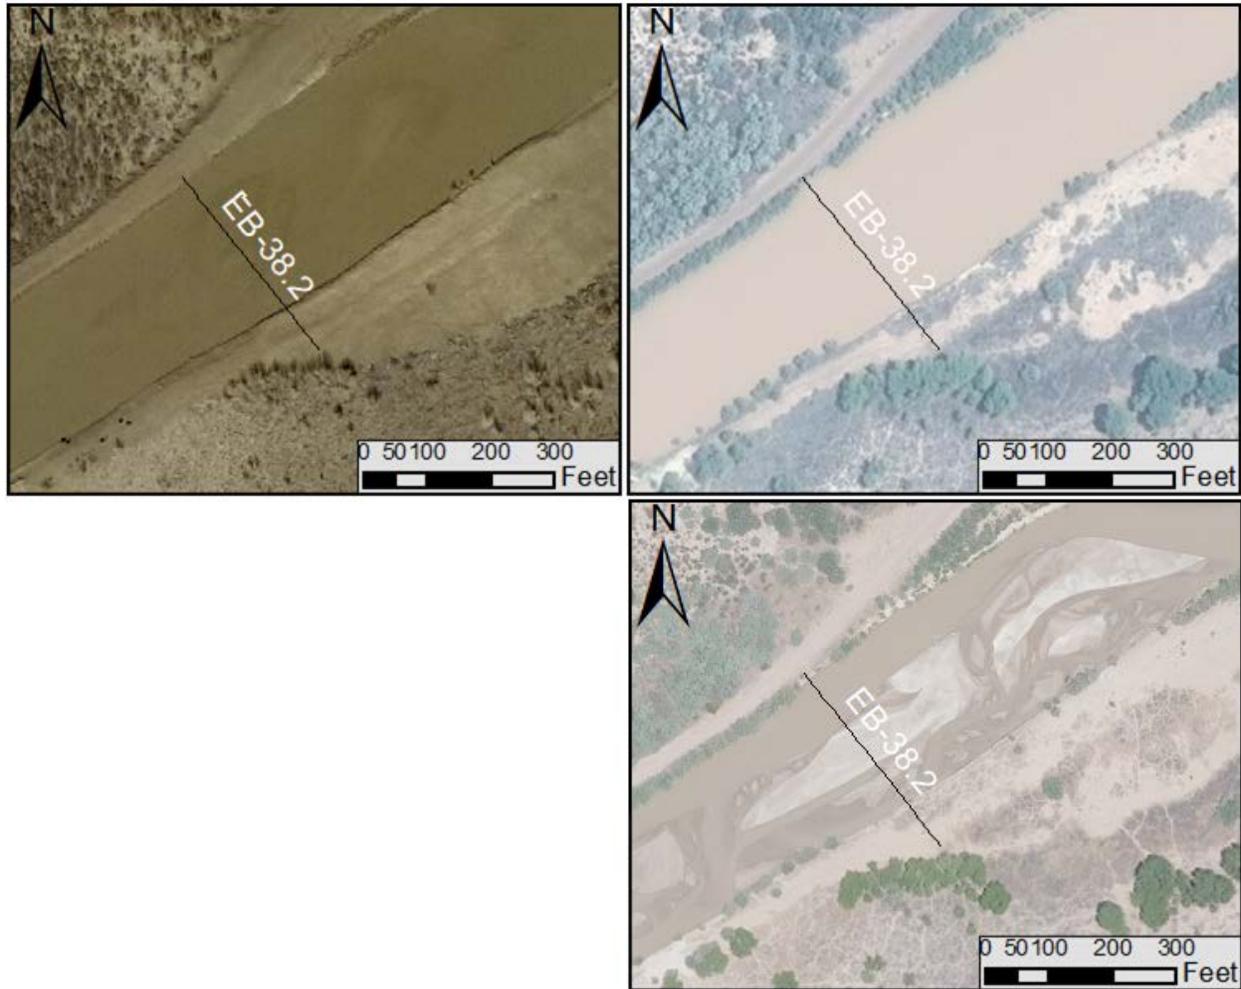
Figure 17: Narrowing of non-vegetated width at cross section EB-38.2 as vegetation became established on both banks from 2012 (top left) to 2016 (top right). The cross section widened from 2016 to 2018 (bottom right) as vegetation on the eastern bank disappeared.

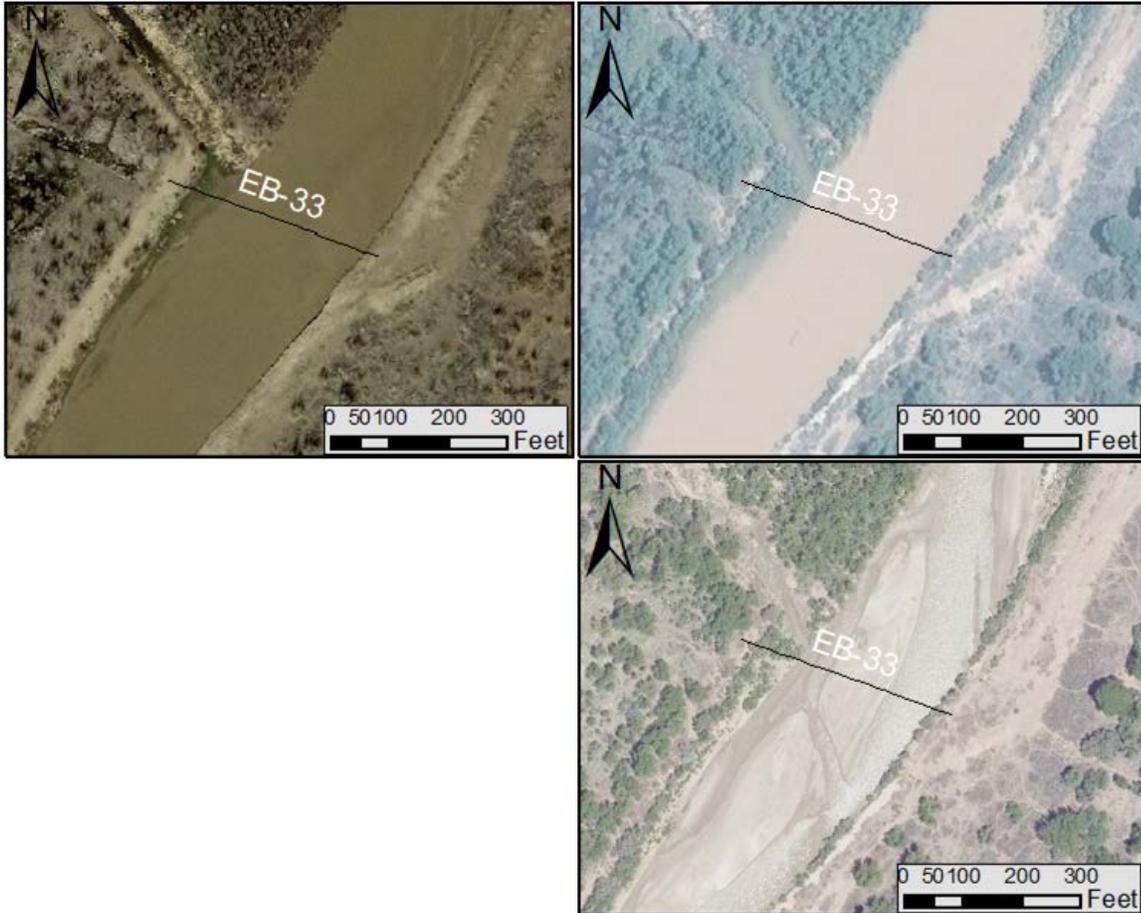
Figure 21: Narrowing of non-vegetated width at cross section EB-33 from 2012 (top left) to 2016 (top right) and 2018 (bottom right).

section at EB-17.35 (Fort Craig Bend) narrowed between 2012 and 2016 as vegetation established on both banks, then kept approximately the same non-vegetated width from 2016 to 2018 (Figure 20). EB-33 narrowed substantially from 2012 to 2016 as vegetation grew on both banks and the western bank migrated toward the channel, then narrowed further as the western bank continued to migrate toward the channel between 2016 and 2018 (Figure 21). Lastly, EB-50 narrowed from 2012 to 2016 as vegetation became established on the sand bar connected to the eastern bank (Figure 22). Vegetation retreated from the bank slightly on both sides of the channel from 2016 to 2018, widening the channel slightly.

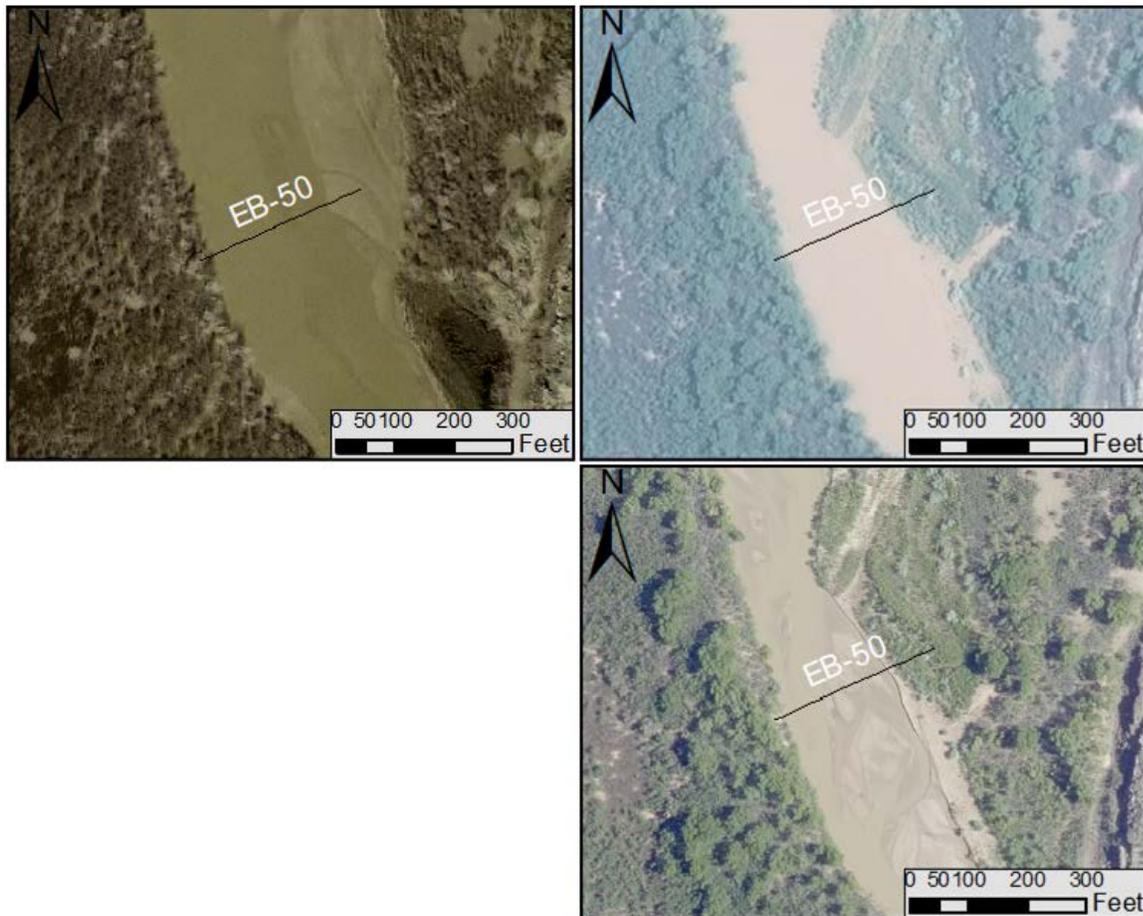
Figure 22: Narrowing of non-vegetated width at cross section EB-50 from 2012 (top left) to 2016 (top right) as vegetation grew on the sand bar connected to the eastern bank. The non-vegetated width increased very slightly from 2016 to 2018 (bottom right).

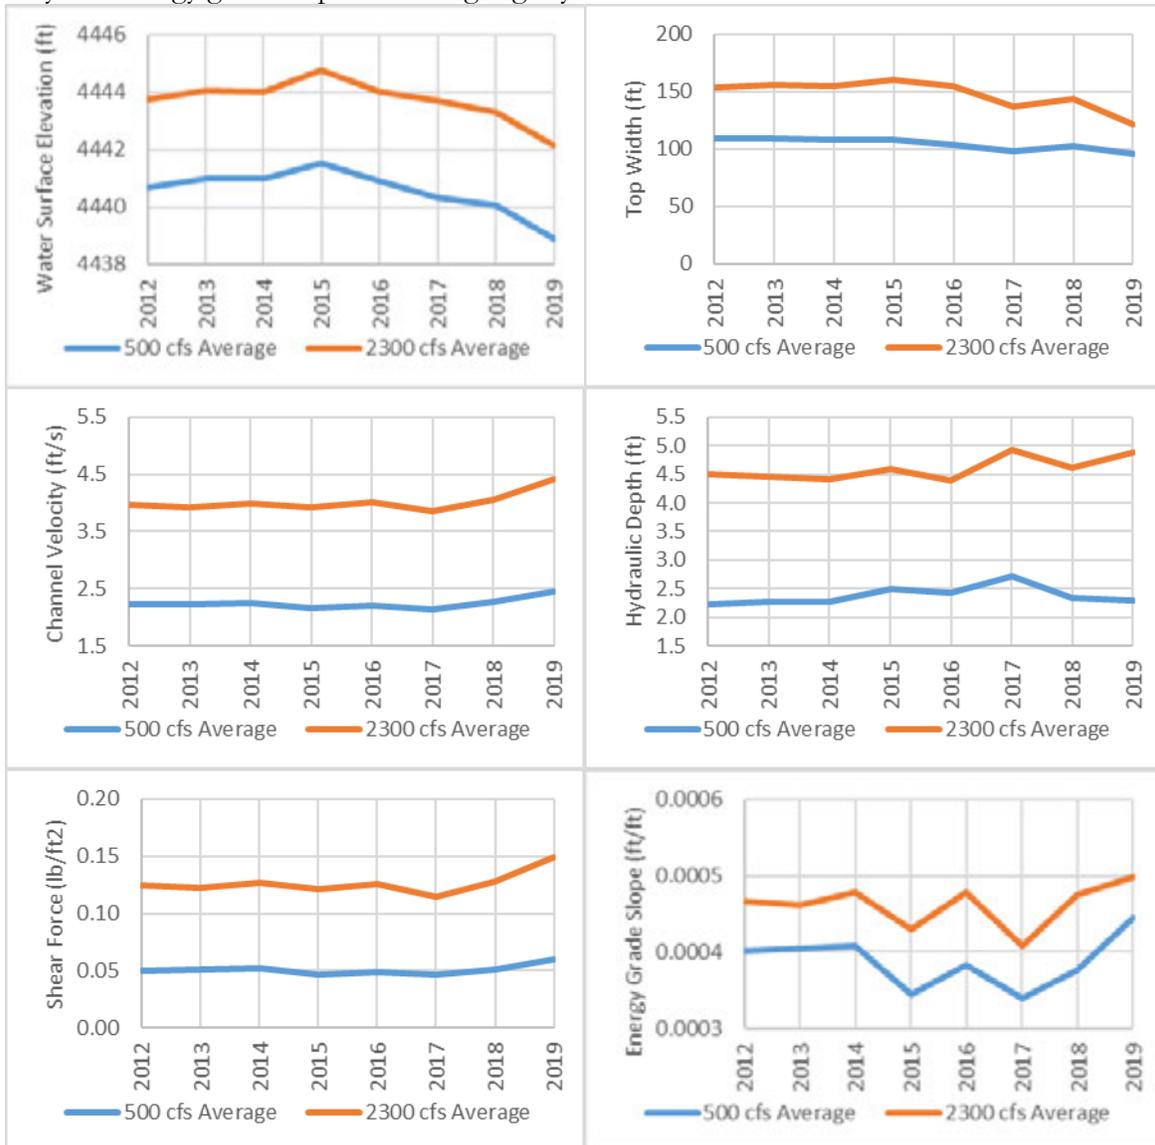
Similarly to Subreach 2 and 3, Subreach 4 underwent overall degradation between 2012 and 2019. This is reflected in the overall decreased water surface elevations at the 500 cfs and 2300 cfs flow rates. Other hydraulic parameters were relatively stable between 2012 and 2019, with channel velocity and energy grade slope increasing slightly.

Figure 68: Subreach-average hydraulic parameters at the 500 cfs and 2300 cfs flow rates for Subreach 4.

The distance-weighted average and maximum hydraulic variables resulting from the 25% and 50% exceedance flows of 500 cfs and 2,300 cfs are summarized graphically in Figure 65 through Figure 70 below.
