CHAPTER 2 ALTERNATIVES

2.2.2 Alternative B: Proposed Action

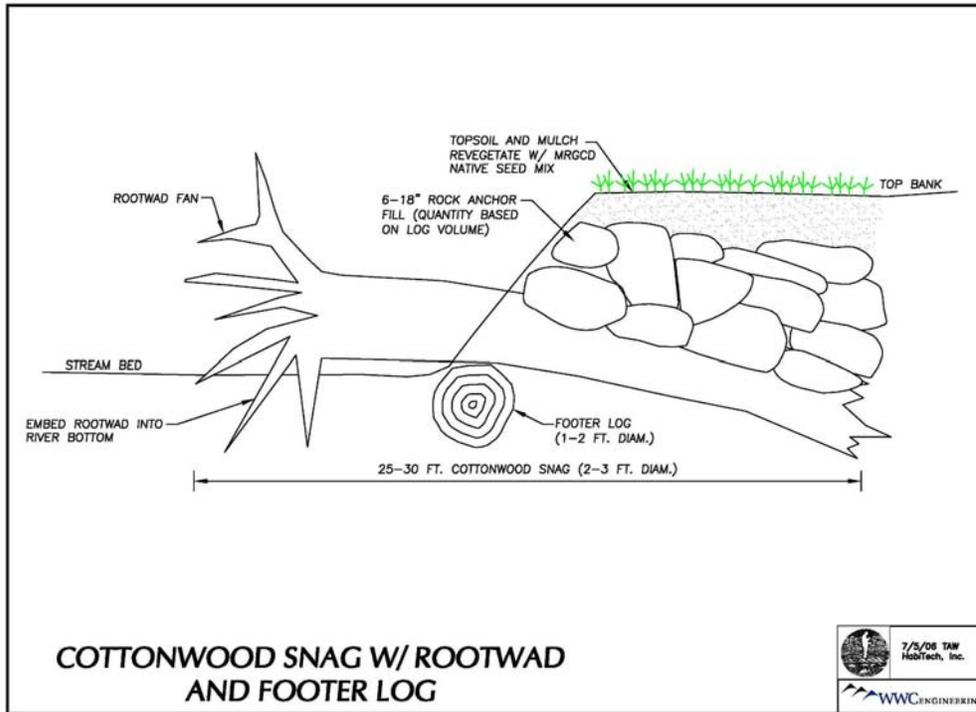
Figure 2. Conceptual engineering drawing of large cottonwood snag anchored on the river bank.

From three to eight large cottonwood snags would be anchored at the mouths of the three drain outfalls as shown in the general conceptual engineering drawing (Fig. 2). About 0.5 to 1.0 acres of improved wetted habitat will be created at each of the three selected sites. The total amount of habitat created in terms of number of acres however, is not the most critical measure because perennially wetted habitats such as these are disproportionately important to silvery minnows.

Depending on the individual treatment, the large cottonwood snags would be installed either in the bank or in the channel. For bank installation, a trench would be dug out and the log/root wad set in, backfilled with rock and soil, and revegetated. In-channel placements would require anchoring similar to the method originally described for the cottonwood snags placed in the Albuquerque Reach described in Wesche et al. (2004) and as shown in the general schematic (Fig. 2).

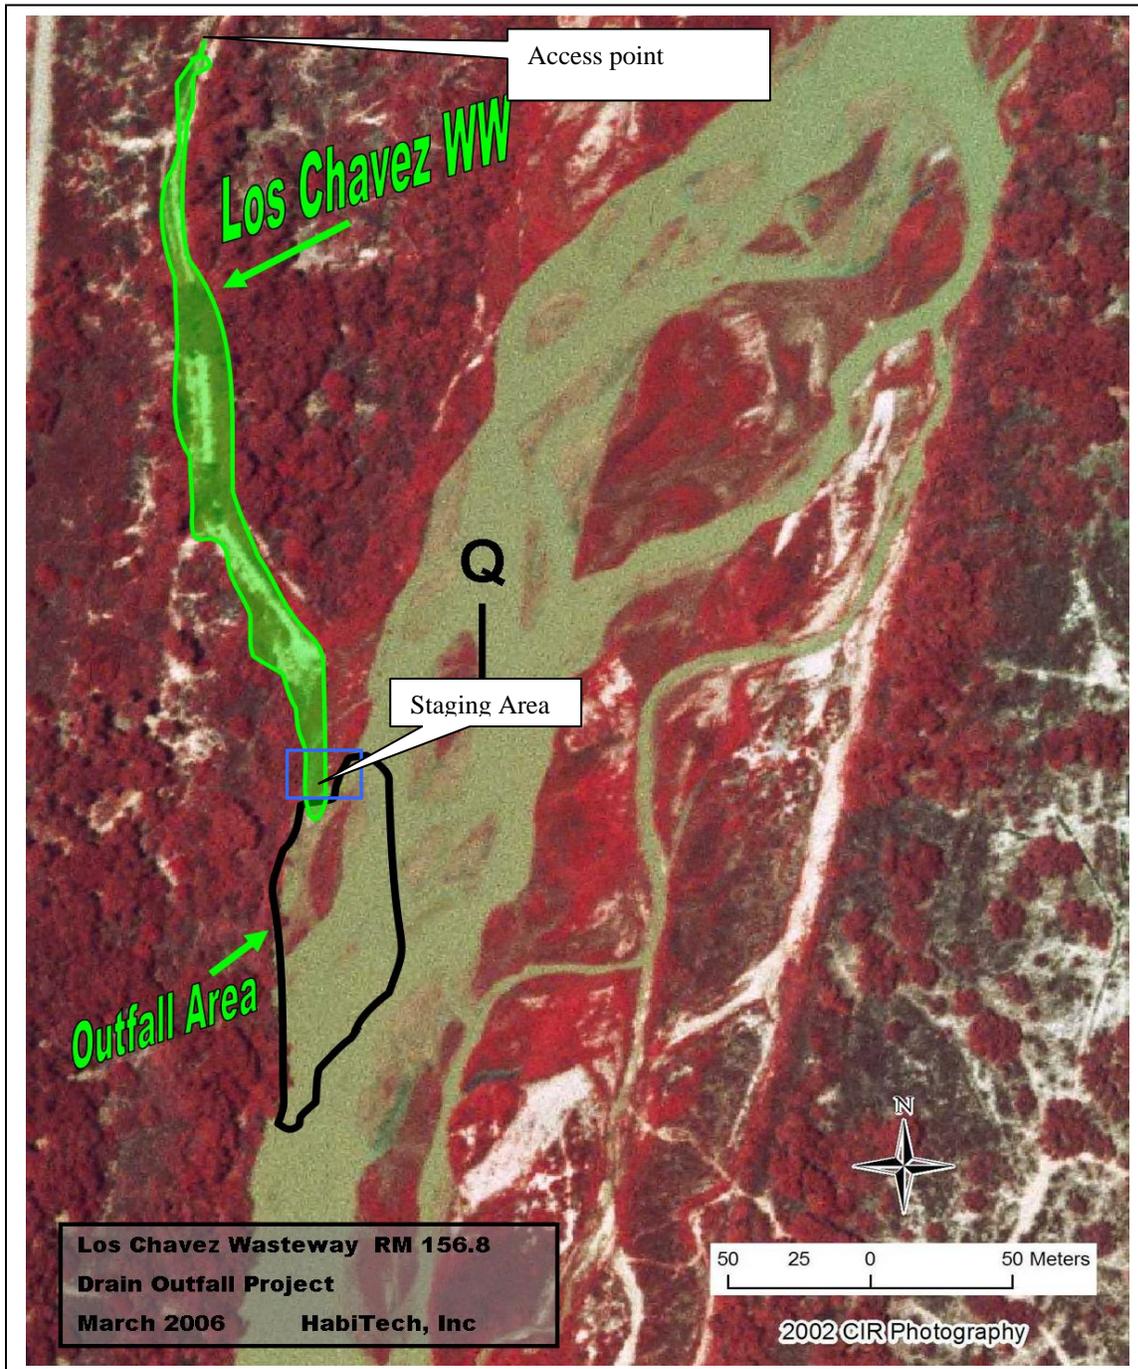
Figure 3. Aerial view of the Los Chavez Wasteway drain outfall showing the access point, staging area and outfall area where the habitat enhancement would occur.

An aerial view of the Los Chavez Wasteway located at river mile (RM) 156.8, shows the relationship of the drain outfall to the main river channel, the general access point and the staging area (Fig. 3).

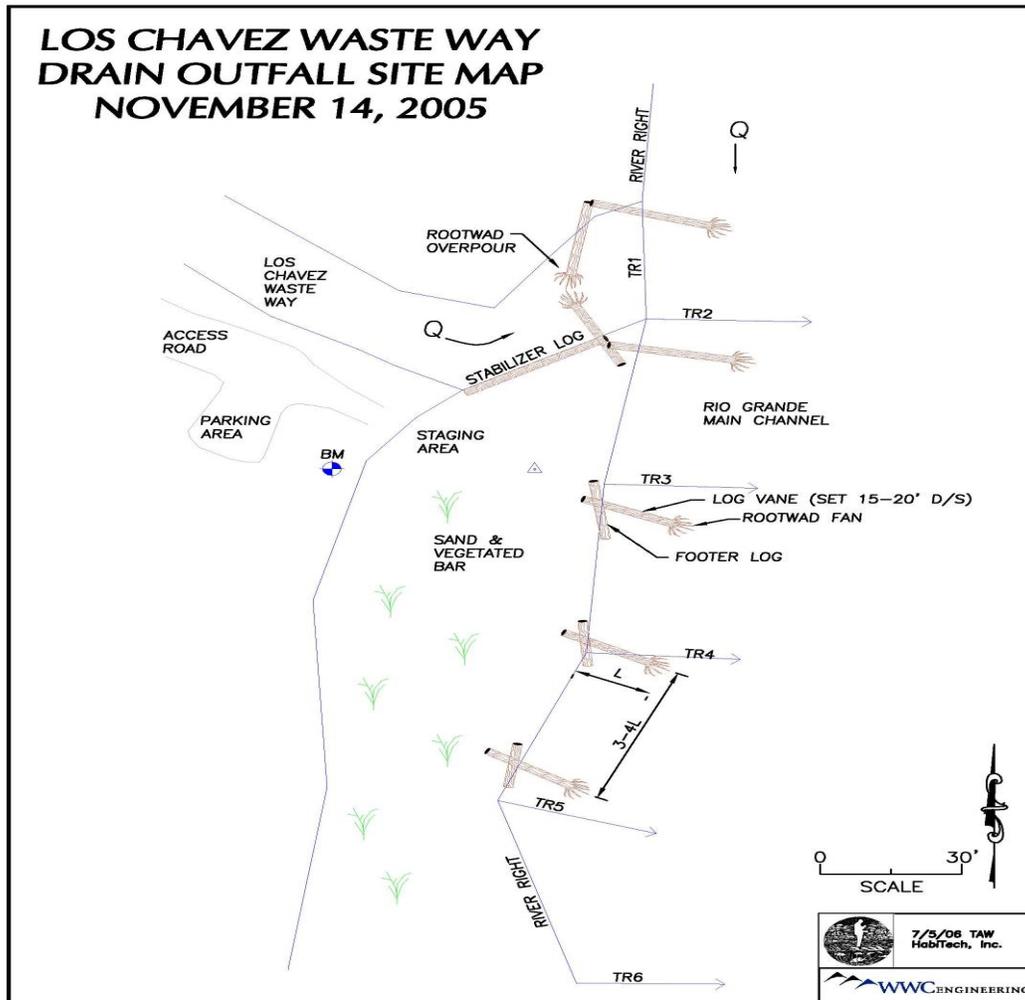
Figure 4. Site plan for the Los Chavez drain outfall.

Large cottonwood snags would be anchored in the mouth of the drain outfall and slightly downstream of the outfall as shown in Figure 4. A small staging area will be located at the end of the road, approximately 100 ft. in length by approximately 50 ft. wide (Fig. 5). No vegetation clearing will be required. A number of large standing dead cottonwood snags are available from

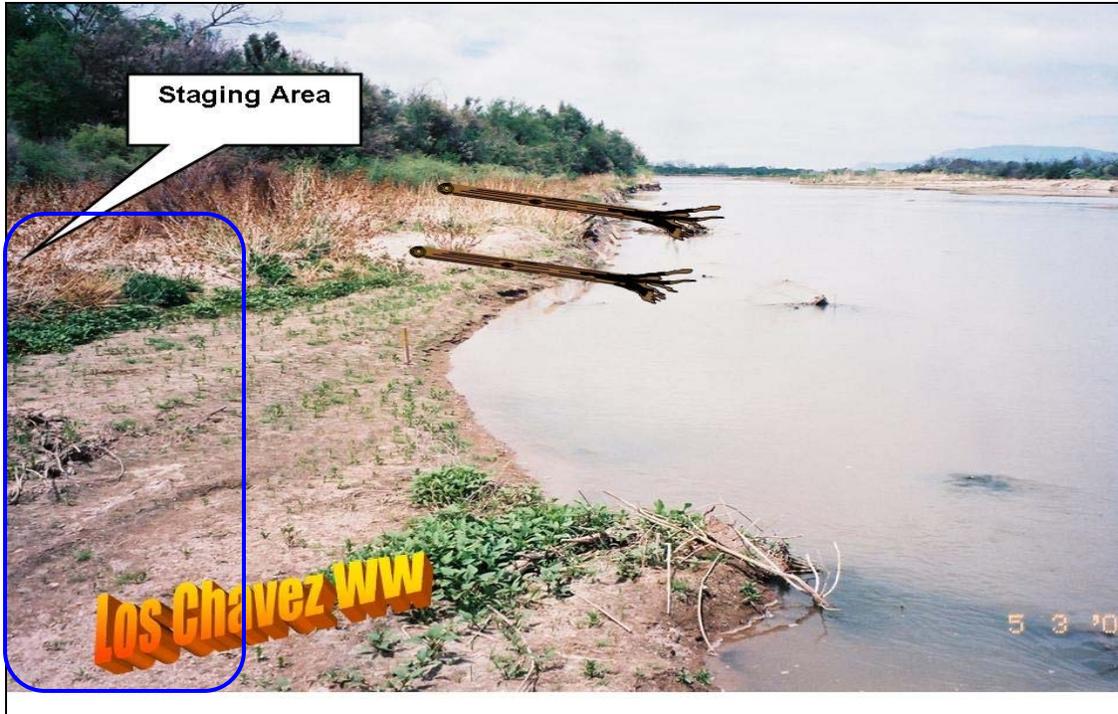
Figure 5. Closeup of the staging area for the Los Chavez Wasteway outfall.

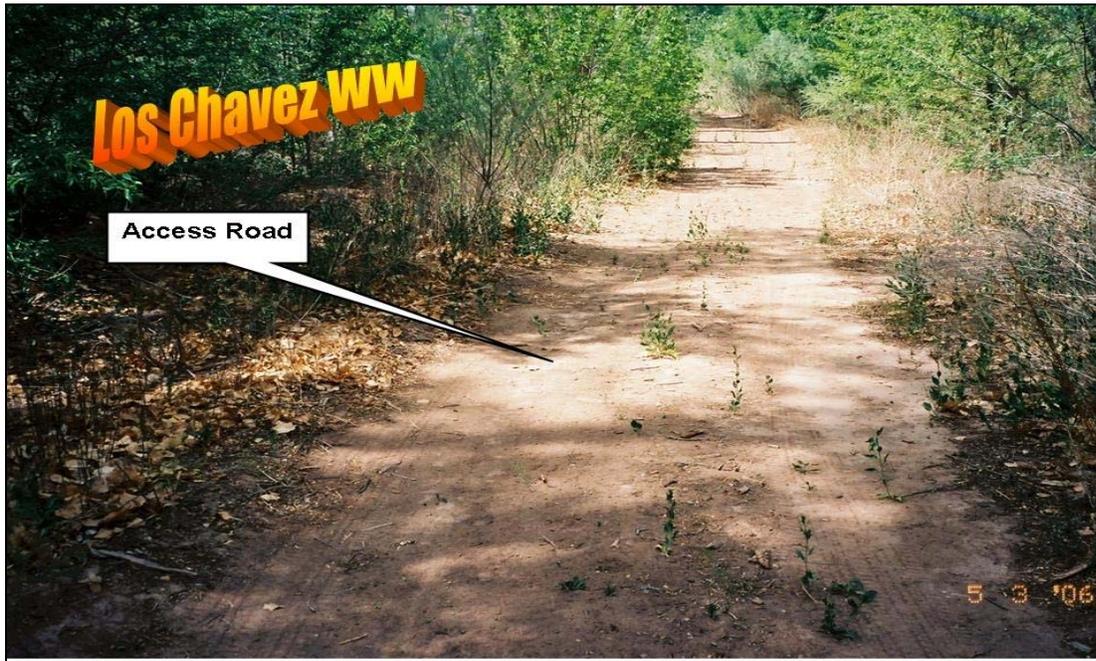
Figure 6. Access road to the Los Chavez Wasteway drain outfall.

Access to the Los Chavez Wasteway is via an existing road (Fig. 6). Recreational and river management activities have kept the road clear of brush and debris and no vegetation removal will be required.

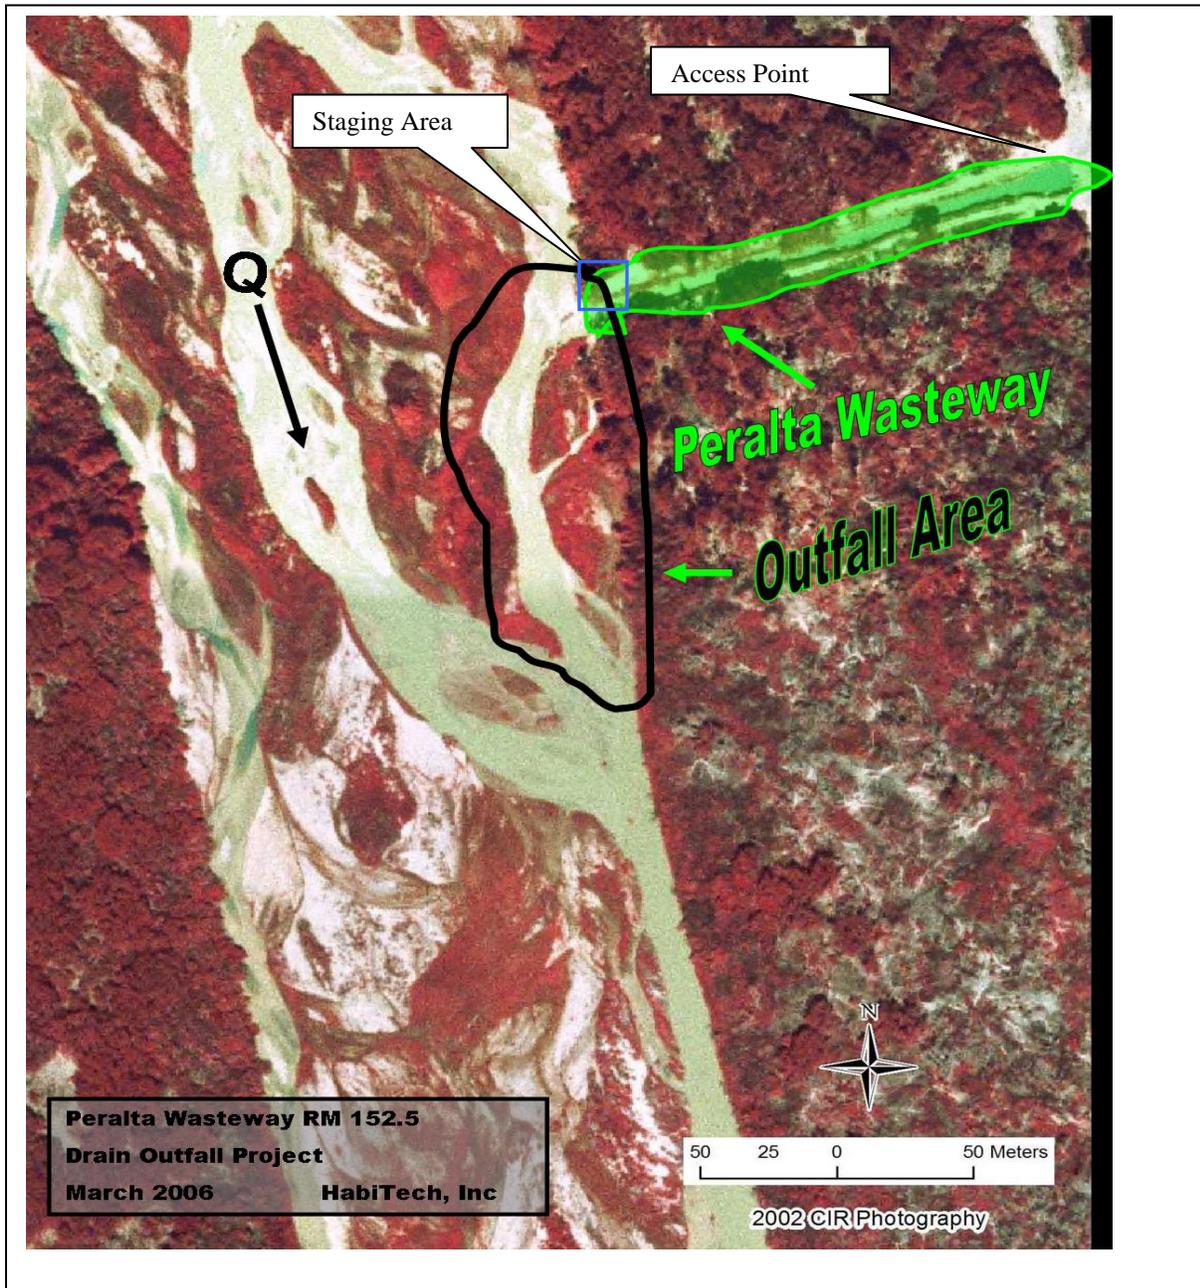
Figure 7. Aerial view of the Peralta Wasteway drain outfall.

An aerial photo of the Peralta Wasteway Main Canal Wasteway (Peralta Wasteway) located at RM 152.5, shows the relationship of the wasteway to the main river channel, as well as the access point and the staging area (Fig. 7).

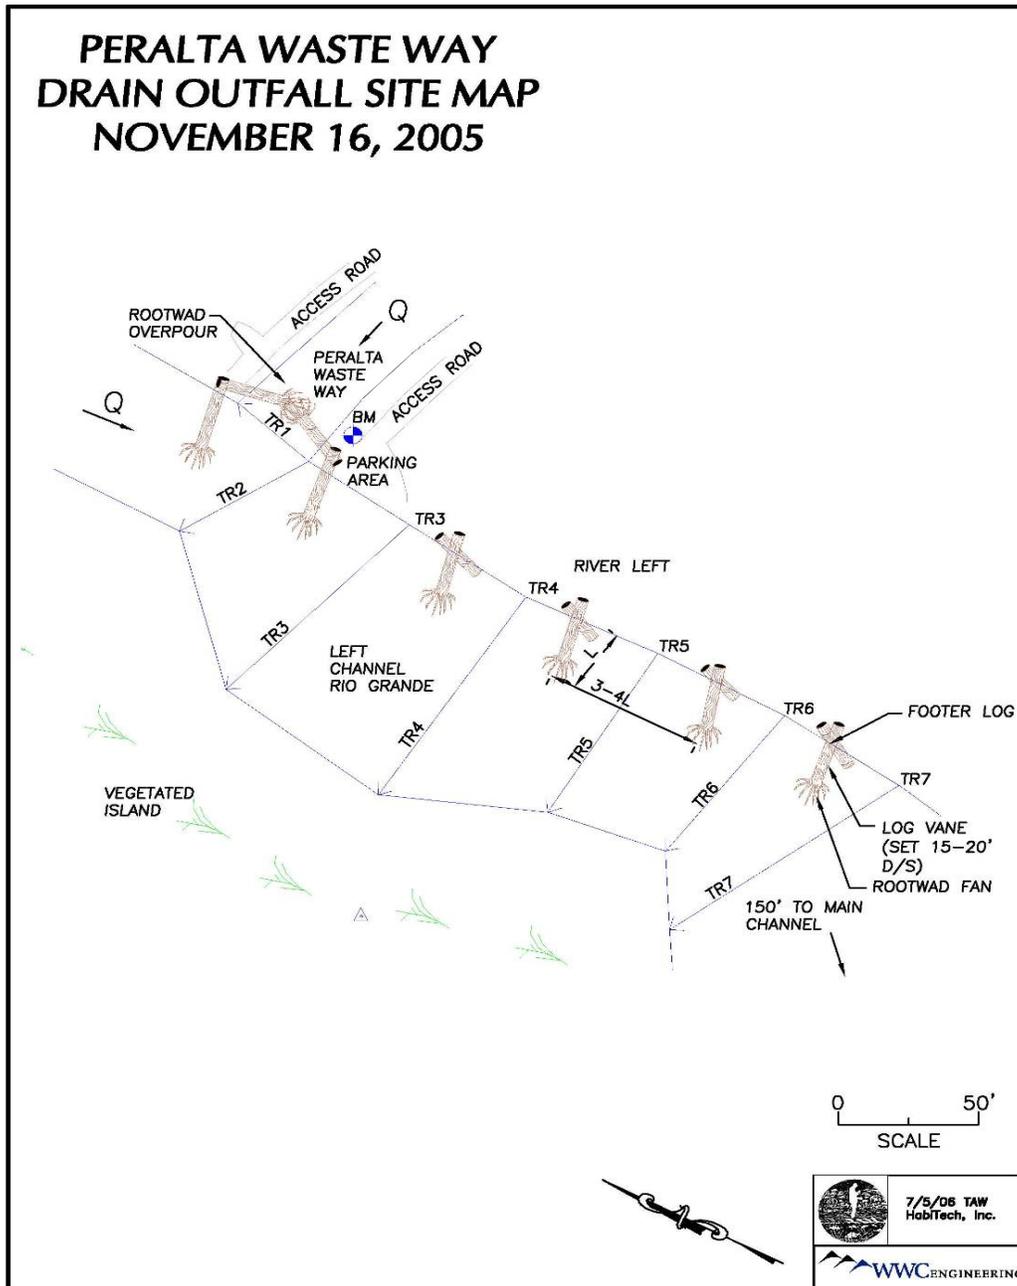
Figure 8. Site Plan for the Peralta Wasteway Drain Outfall.

Figure 8 is the site plan for anchoring large cottonwood snags in the mouth of the drain outfall and slightly downstream.

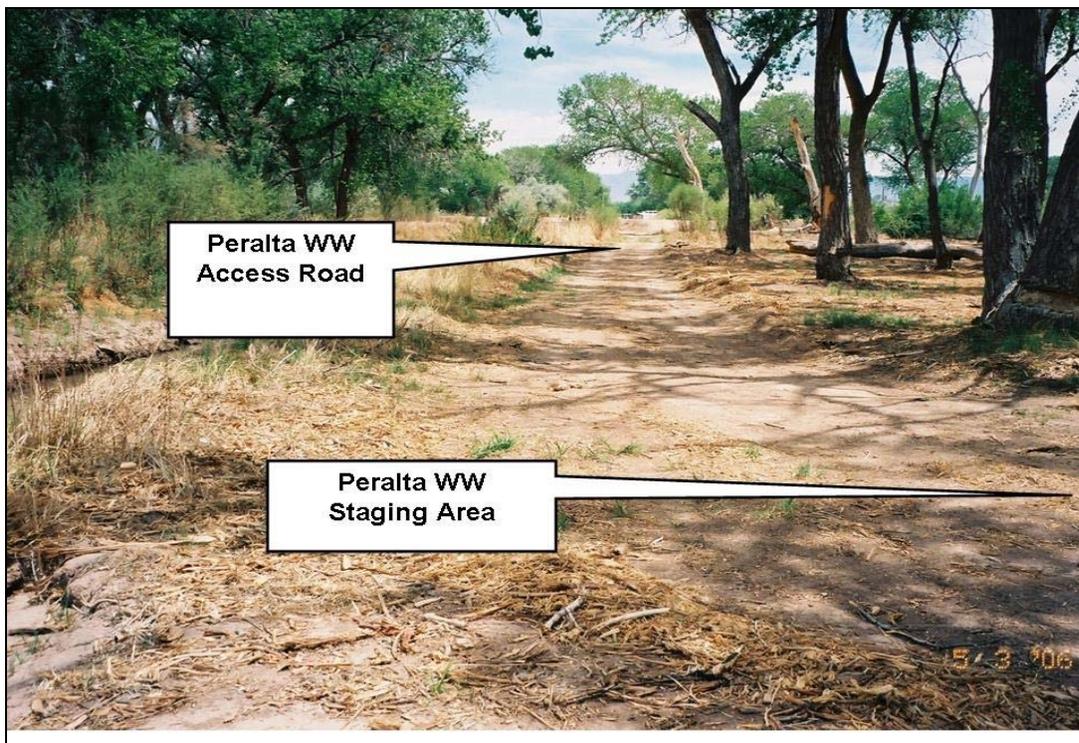
Figure 9. Access point and staging for the Peralta Wasteway Drain Outfall.

The Peralta Wasteway is accessible by a well developed dirt road used primarily for recreation use and water management activities (Fig. 9). A small staging area will be sited at the drain in already-existing cleared area near the drain outfall (Fig 10). The staging area will be approximately 100 feet long by 50 feet wide. Priority will be given to utilizing already downed cottonwood snags from MRGCD or BOR maintenance activities if available within an economically practical distance. If not available, cottonwood snags would be obtained from the

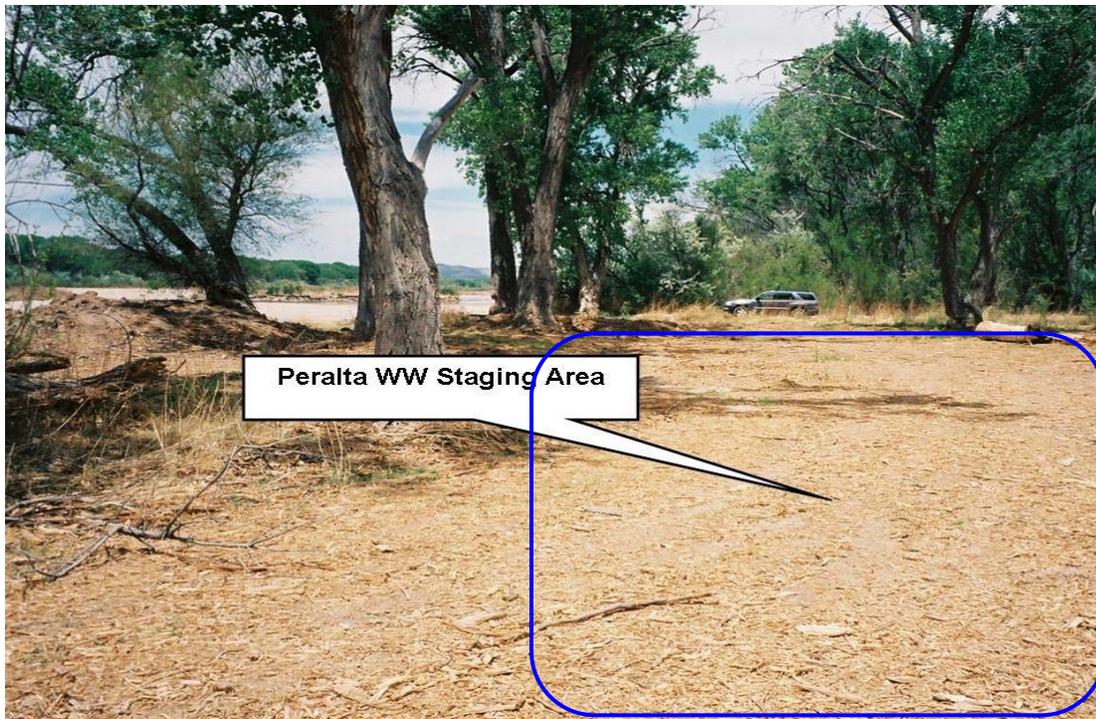
Figure 10. Peralta Wasteway showing the heavily impacted road area proposed for the staging area. A portion of the staging is in the foreground, out of the photo. Approximate dimensions are 100 ft long by 50 ft. wide.

cleared area adjacent to the access road (on the right side of the road in Fig. 10). An excavator will be used to dig out the root wad and tip over the standing snag. The snag would either be dragged or lifted and carried to the site using a front end loader. No vegetation will be disturbed as existing roadways and cleared areas will be used. The areas where the snags would be obtained adjacent to the drains have been mechanically cleared of non-native vegetation.

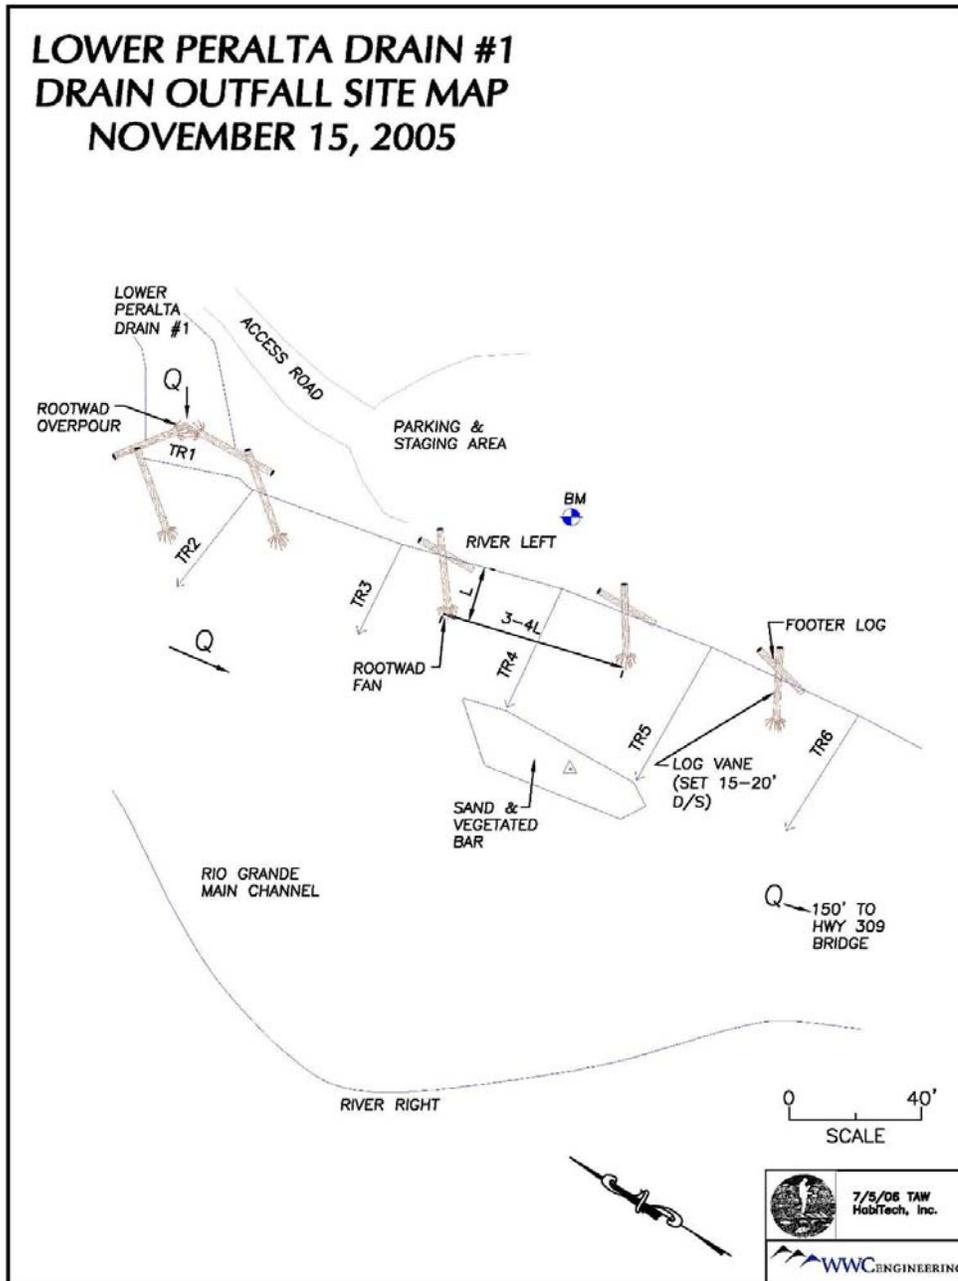
Figure 12. Site Plan for Lower Peralta #1.

The relationship of the drain outfall to the main river channel, as well as the location of the access road and staging is shown in an aerial view (Fig. 11). The site plan showing the approximate location of cottonwood log placement is shown in Fig. 12. The Lower Peralta Drain #1 is accessible by a well developed dirt road used primarily for recreation use and water management activities. A small staging area will be sited near the drain in already-existing cleared areas.

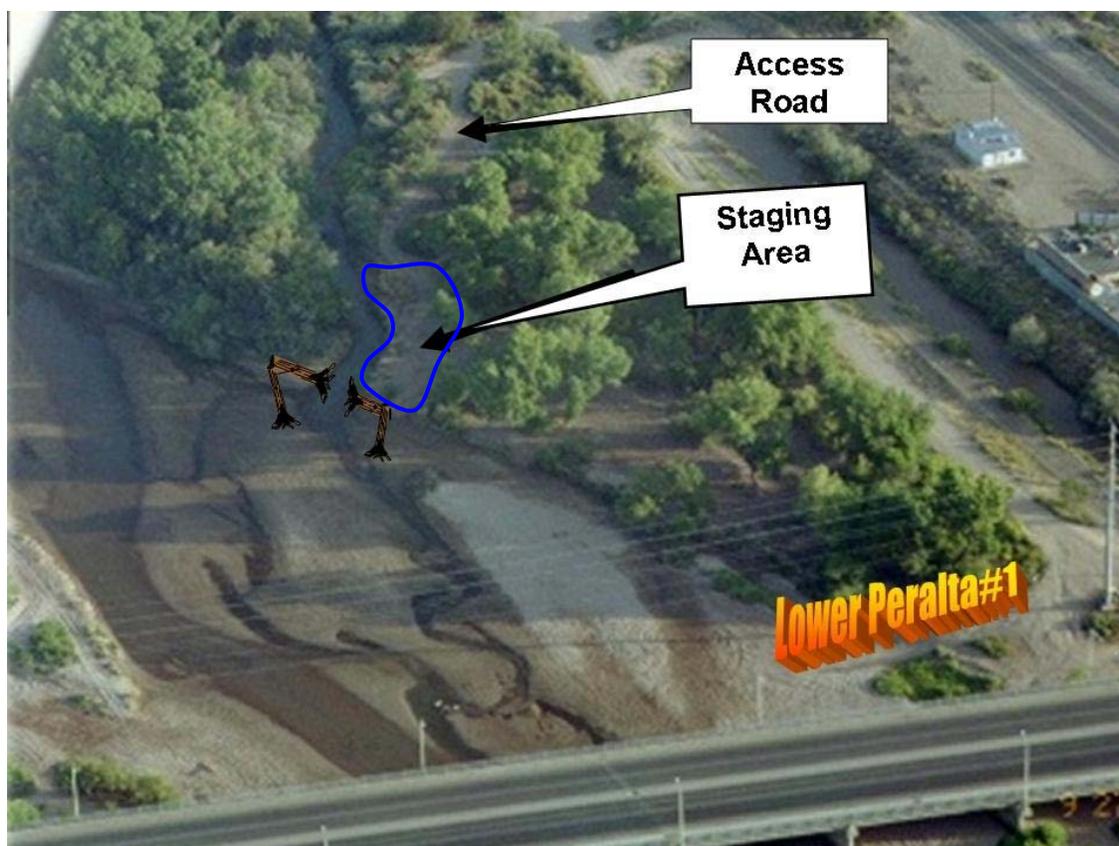
Figure 13. Location of the access road and staging area for the Lower Peralta #1 Drain.
