RECLAMATION

Middle Rio Grande River Maintenance Plan Part 1 Report

Middle Rio Grande Project, NM
Upper Colorado Region

May 31, 2007

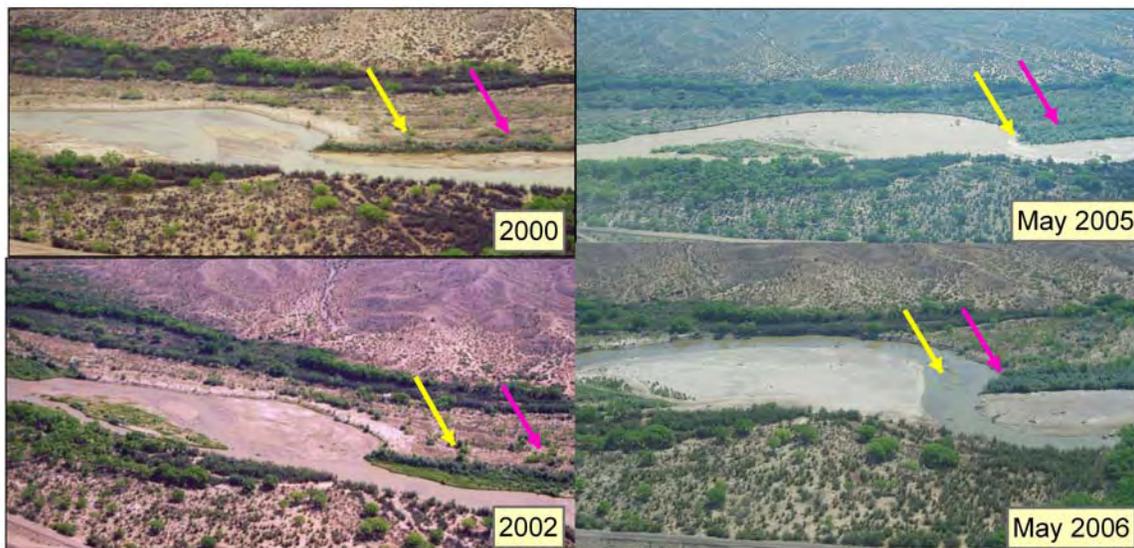
The Middle Rio Grande is a complex and changing river system which presents many maintenance challenges. For example, the rapidly migrating bend in Figure 1 is the middle bend in a series of three migrating bends. The yellow arrow points to the same cluster of trees in 2000, 2002, and 2005, which are gone by 2006. The pink arrow points to the approximate location of the 2006 bend apex in all years. This bend is only one example of a series of fast changing bends in the recently incised reach downstream of San Acacia Diversion Dam that threaten the LFCC levee to the west.

Figure 1. Rapidly migrating bend at River Mile 110. (Flow is left to right.)

Figure 1 provides an example. Migration and incision usually occur with the spring runoffs. Lateral migration and incision occurred with the July through October 2006 monsoon rains. These changes in the channel morphology and physical processes demonstrate the speed at which change occurs in the Middle Rio Grande and help explain the rapid increase of river maintenance sites of concern throughout the management area. Along with these highly visible changes, the bed sediments are coarsening throughout most of the watershed, thereby changing the governing processes for sediment transport and contributing to bank erosion and meander development and other in-channel processes. This complex and changing river system presents many maintenance challenges. At this time, maintenance activities are not performed in White Rock Canyon reach and Elephant Butte Reservoir.

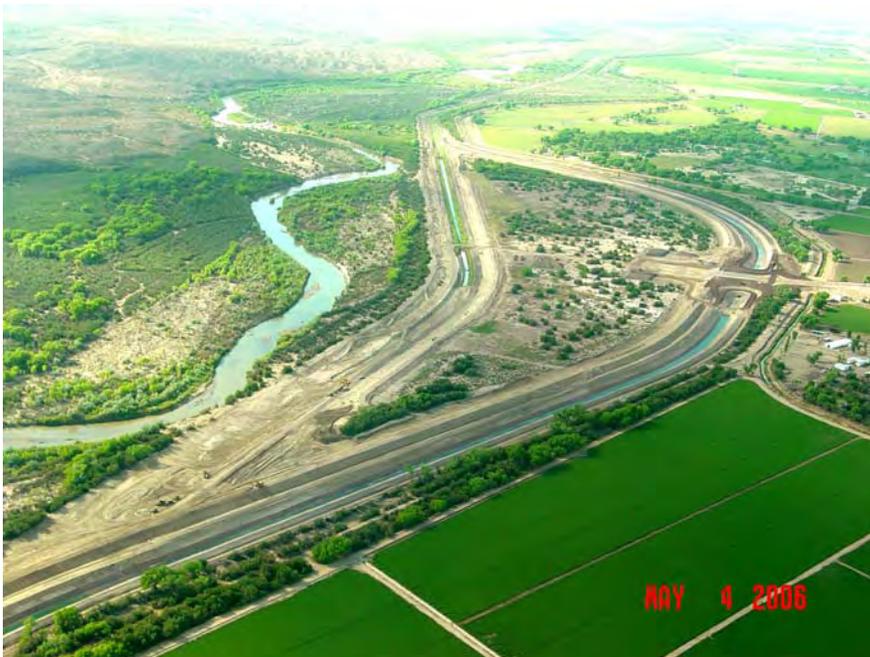
Recent river maintenance projects have been designed to address habitat needs as well as erosion problems. Levee setback, a method in which the levee is relocated away from the point of erosion in the channel, was used at the Santa Fe River Confluence and the San Acacia River Mile 113 and 114 priority sites (Figure 2). This technique improves habitat by increasing the area of the floodplain and providing greater latitude for fluvial processes.

Figure 2. Levee setback at river mile 113/114

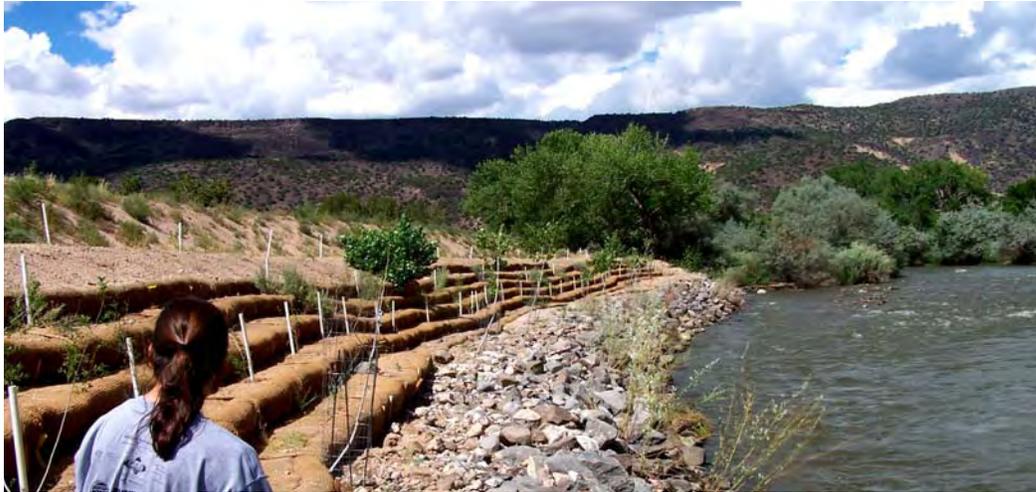
The Santa Ana and La Canova priority site projects (Figure 3) included a bio-engineered bankline consisting of a rock toe and several layers of coir fabric-encapsulated soil planted with native vegetation. The native vegetation provides wildlife habitat and increases soil stability as the plants mature. At Santa Ana, the rock toe of the bio-engineered bankline was sized to be mobile at very high flows, allowing the channel dimensions to naturally adjust to the hydrology.

Figure 3. Bioengineered bankline at La Canova

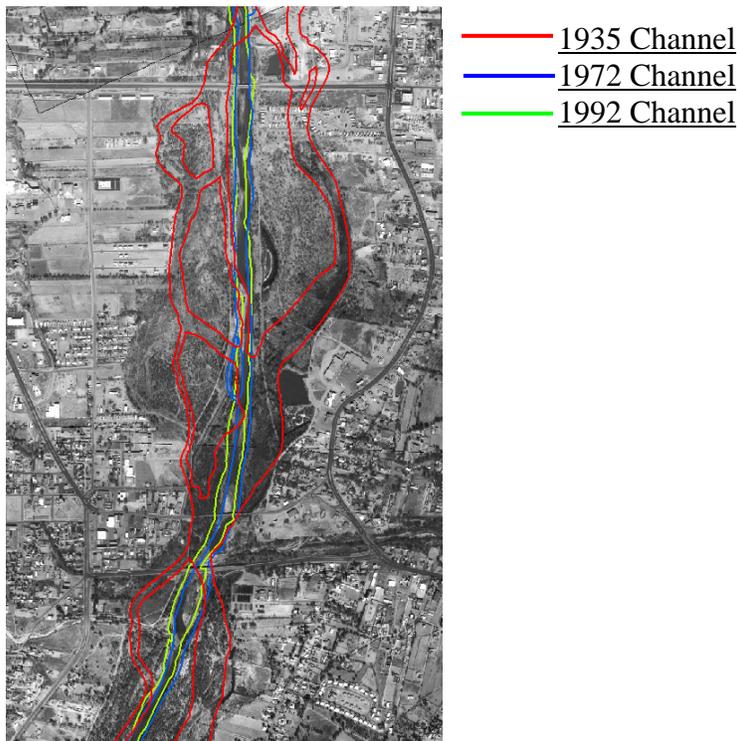
An extensive channelization project in the 1950s was aimed at creating a single thread channel, limited to a much narrower floodplain (Figure 5 and Figure 6). Earthwork, jetty jacks, and vegetation clearing were all used to that end. The relatively straight channel in the upper portion of the reach indicates that those efforts were mostly successful, but the sinuous channel in the lower portion of the reach indicates a higher potential for lateral migration.

Figure 5. Upper Portion of Rio Chama to Otowi Reach, within the town of Espanola, showing straight channel and narrow floodplain (2001 Aerial Photo)

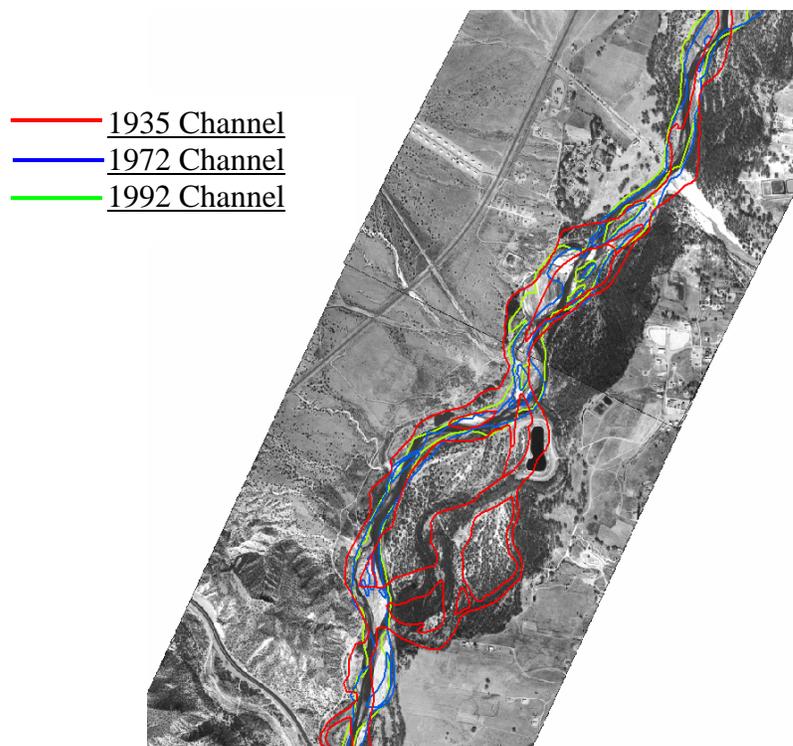
Figure 6. Lower Portion of Rio Chama to Otowi Reach, on San Ildefonso Pueblo, Showing Relatively Sinuous Channel (2001 Aerial Photo)

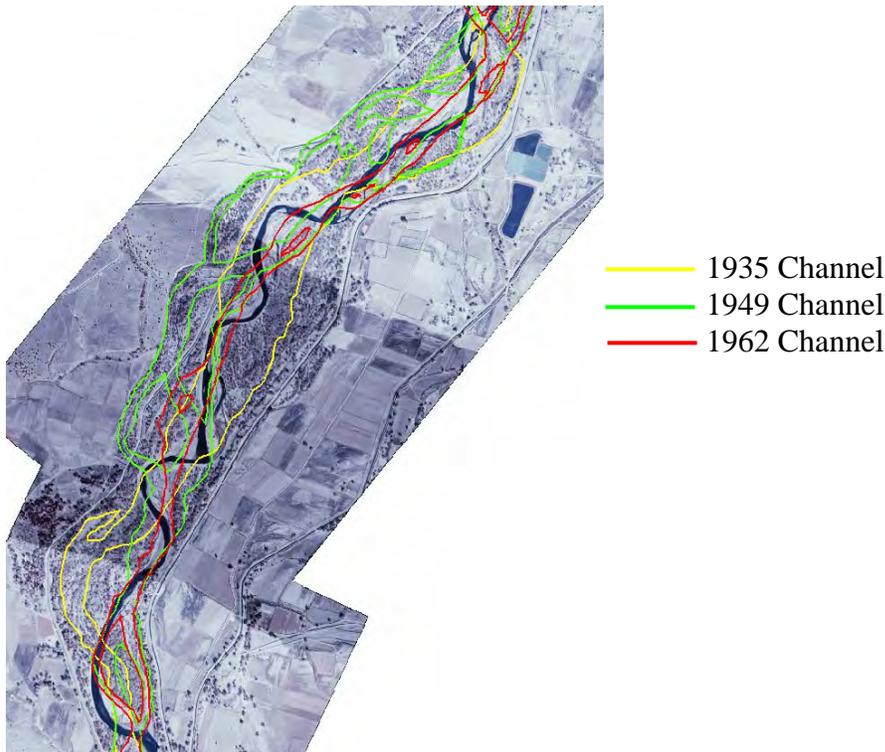
Figure 7. Portion of Cochiti to Angostura Reach, on Santo Domingo Pueblo, Showing Narrowing (2006 Aerial Photo)

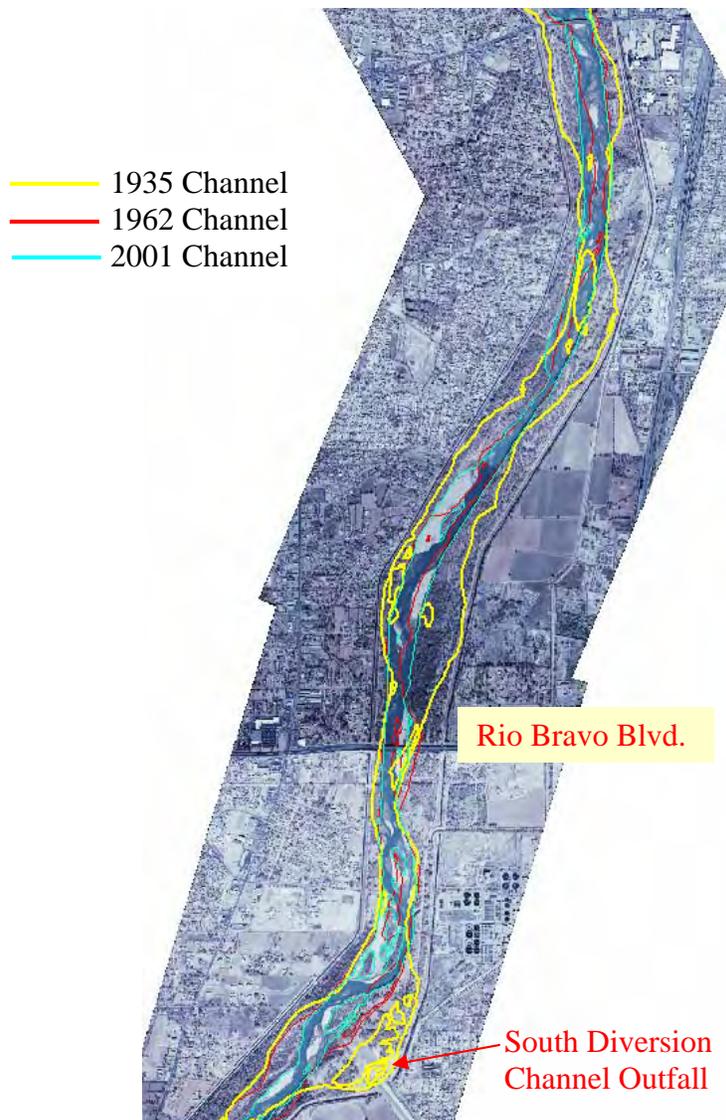
Just as in the upstream Cochiti to Angostura reach, initial efforts at channelization in the 1930s consisted of excavating a relatively narrow floodway, in the same general location as the river, and constructing spoil levees (Figure 8). This was in response to bed aggradation and flooding. After the channelization, however, both continued to be problems, and the river bed was often higher than the ground outside the levees.

Figure 8. Portion of Angostura to Isleta Reach, Showing More Narrow Channel in Same Alignment (2006 Aerial Photo)

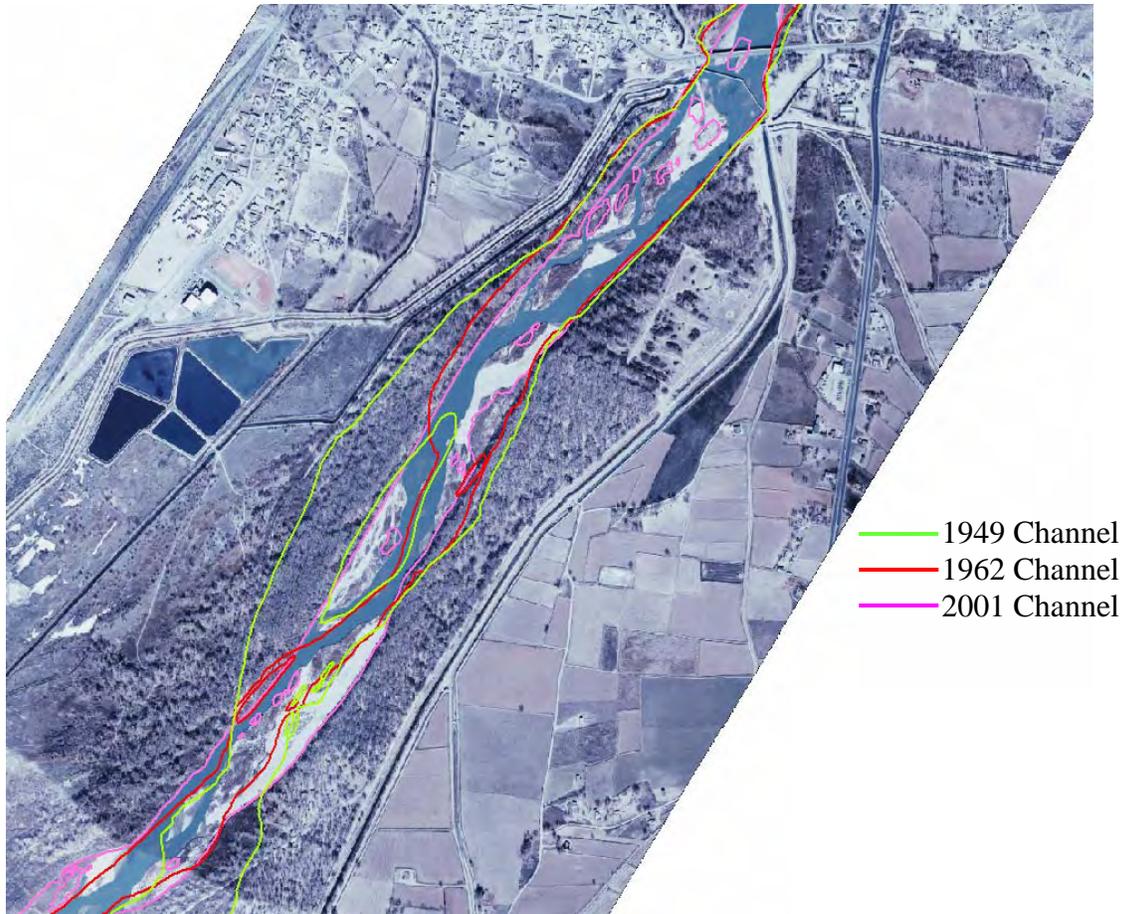
After 2001, macro-dunes in the Belen reach became less active and woody vegetation started growing on them during abnormally low water years. This bar stabilization process created numerous islands that effectively reduced the channel width and concentrated the low and moderate flows into only two or three small channels. Of note in Figure 9 is the dramatic increase in the size of the islands in five years between 2001 and 2006.

Figure 9. Isleta to Rio Puerco Reach, Downstream from Isleta Diversion Dam (2006 Aerial Photo)

2001. A significant amount of narrowing occurred between 2001 and 2002 which coincides with the formation of numerous islands and vegetated sand bars. Since 2002, the channel has begun shifting towards a single-thread planform, with the islands becoming bank attached (see Figure 9). The unvegetated portion of the channel has decreased significantly and a more sinuous low flow channel is forming. Despite relatively stable bed elevations, the reach has seen significant amounts of vegetation growth on bars and islands in the past few years which stabilized these features. In the 2007 thalweg profile data, there is an area of flatter slope from State Highway 309 in Belen to upstream of US Highway 60. The reach downstream to the Rio Puerco is a bit steeper. Identifying the stable slope using SRH-SIAM with the current bed material and the narrowed channel geometry would help determine whether the bed elevations will remain stable or if incision is likely to instigate lateral migration.

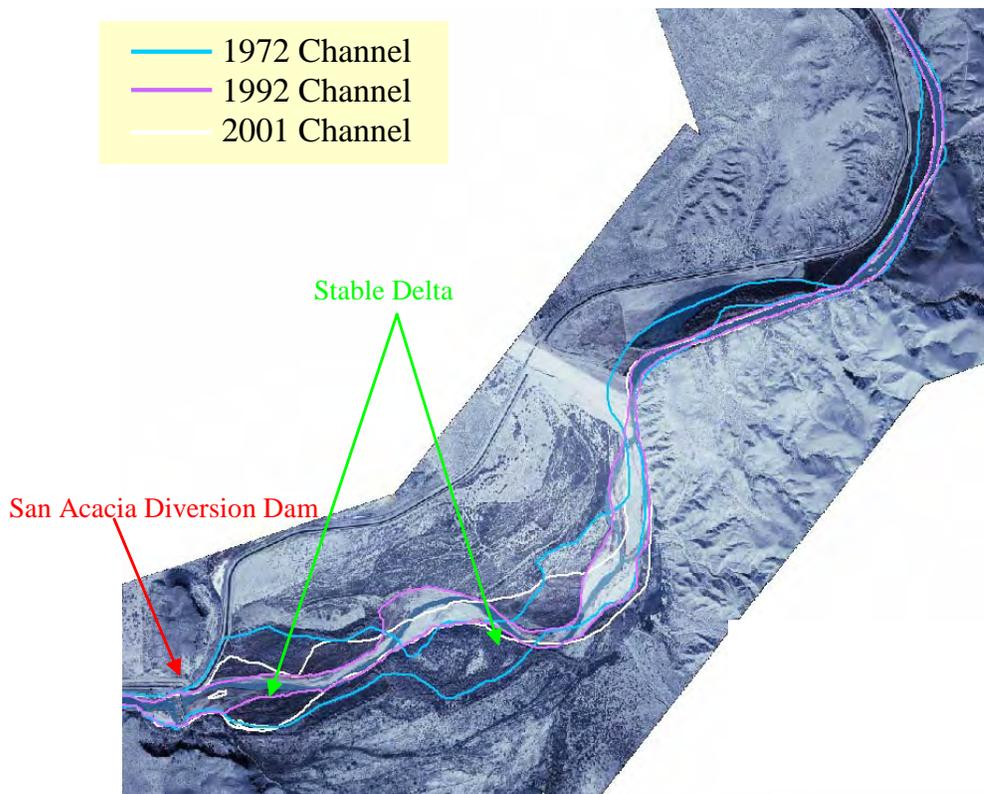
Presumably due to a basin-wide reduction in sand supply, gravel has become a large component of the bed material in this reach, especially downstream from the Rio Salado confluence. The Rio Salado, in the last few decades, has added large amounts of coarse material and appears to be acting as a significant grade control with a flatter slope upstream and much steeper downstream. The Salado fan is relatively erosion resistant and pushes the river up against the very resistant ancient terrace on the left bank. Downstream of the Rio Salado, the bed material is bimodal with sand dunes sporadically covering a gravel bed (Bauer and Hilldale 2004). A large delta stabilized by vegetation has formed upstream from San Acacia diversion dam, reducing channel width and potentially stabilizing the planform. Channel migration has been rapid in areas immediately upstream of the San Acacia Diversion dam (Figure 10).

Figure 10. Isleta to San Acacia Reach, Upstream from San Acacia Diversion Dam (2006 Aerial Photo)

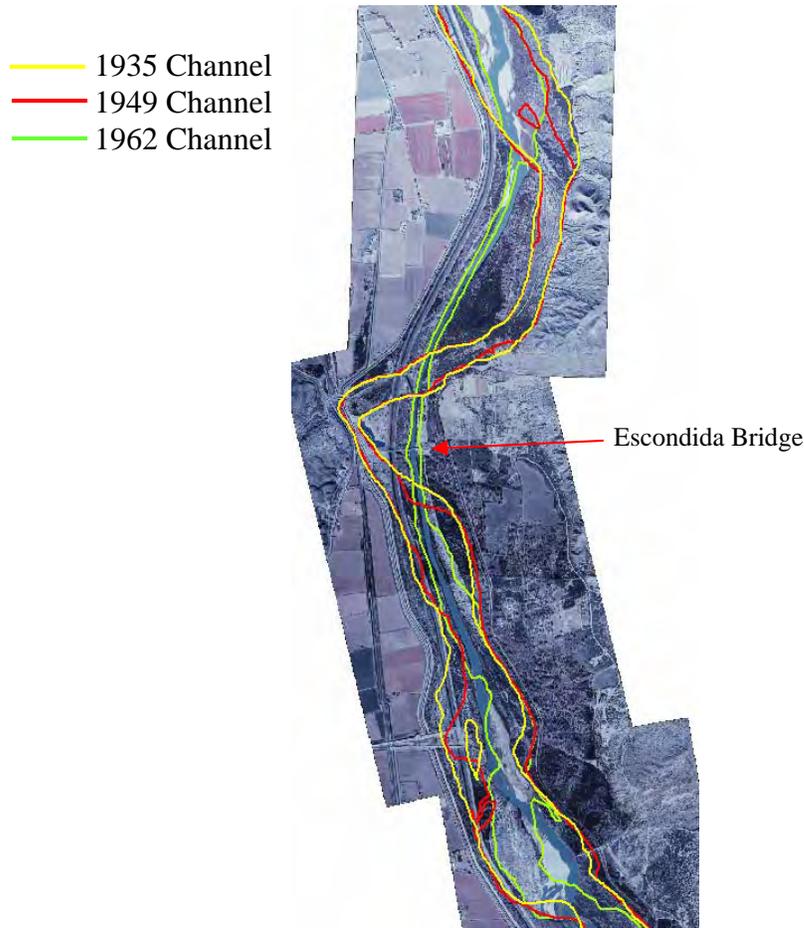
A spoil levee was built during construction of the LFCC and has successfully constrained flows. The levee is on the west side of the river, between the LFCC and the river. It constrains the river on the west (Makar and Strand 2003). In addition, large-scale channelization took place in the early 1950s. Work included straightening and deepening the channel, as well as vegetation clearing and placing Kellner jetty jacks. Approximately two miles of Floodway in the Escondida area were narrowed and straightened (Figure 11).

Figure 11. San Acacia to Arroyo de las Cañas Reach, Channelization Near the Escondida Bridge (2006 Aerial Photo)

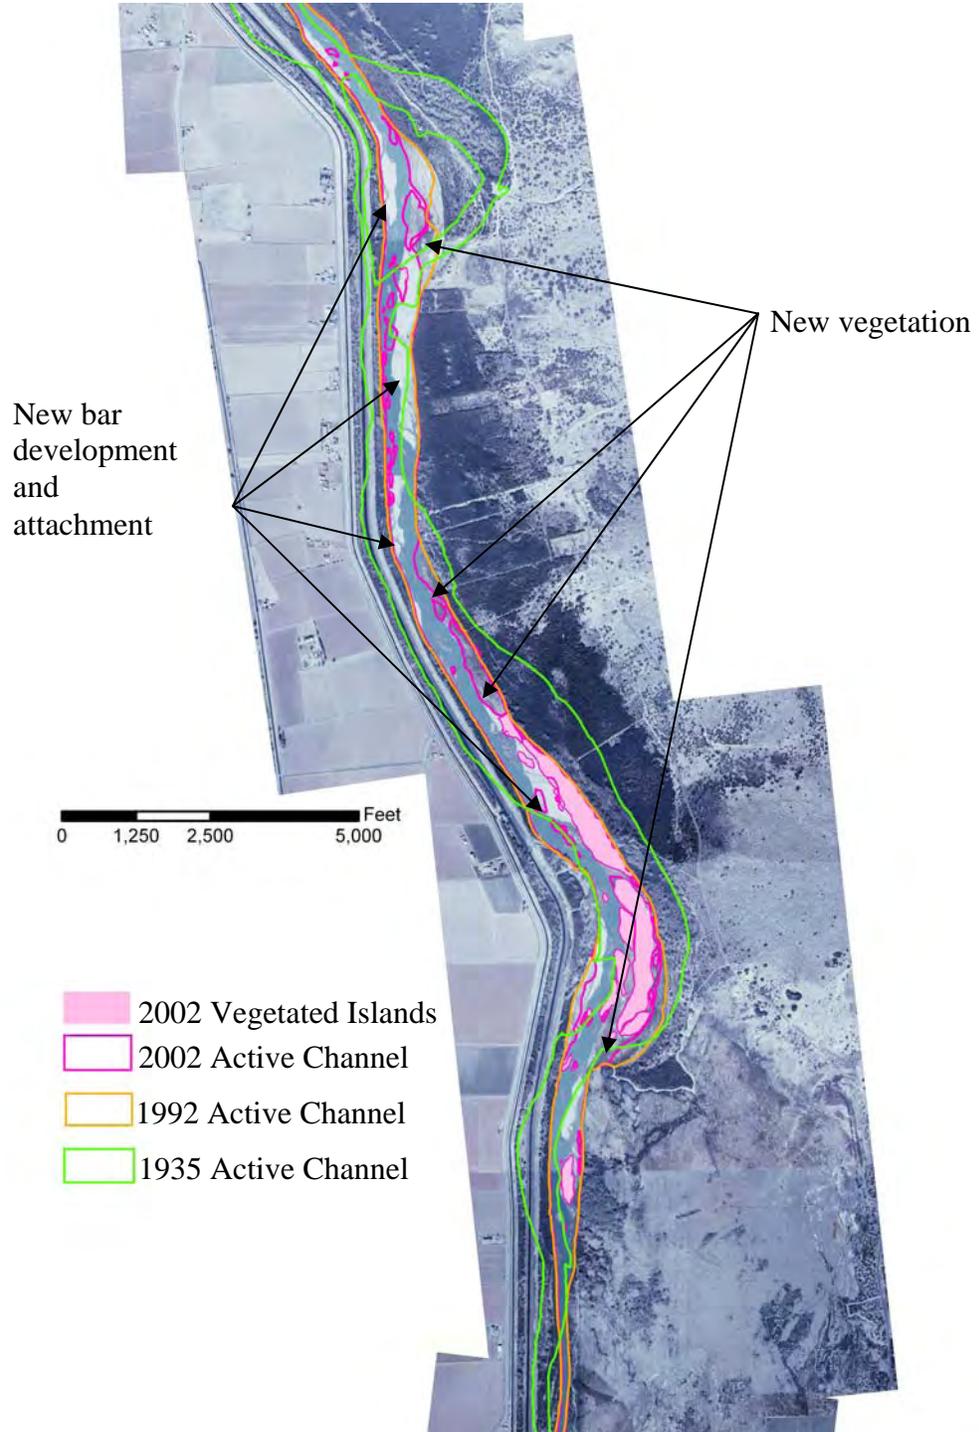
Figure 12. Arroyo de las Cañas to San Antonio Reach, Upstream of Highway 380 (2006 Aerial Photo)

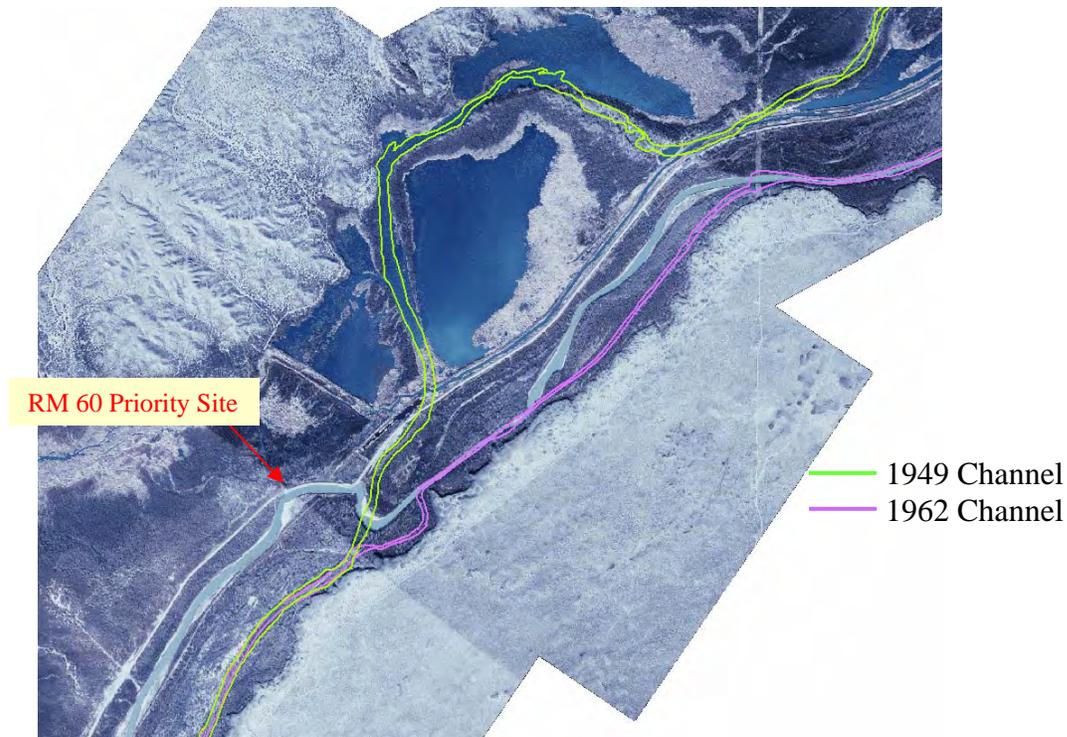
With the exception of the area that is within the BDANWR above RM 80, there was extensive channelization work and floodway clearing in the 1950s (Makar and Strand 2003). In addition, the LFCC was constructed during this time, as detailed in chapter 16. During the LFCC construction, the floodway was moved to the east side of the river valley (Makar and Strand 2003). Figure 13 shows this change.

Figure 13. RM 78 to Elephant Butte reach, Near River Mile 60 (2006 Aerial Photo)
