## Geology of Salazar Pit Area

Prepared by Tamara Massong

Technical report, 2004, Department of the Interior, Bureau of Reclamation, Albuquerque Area Office, Environment Division.

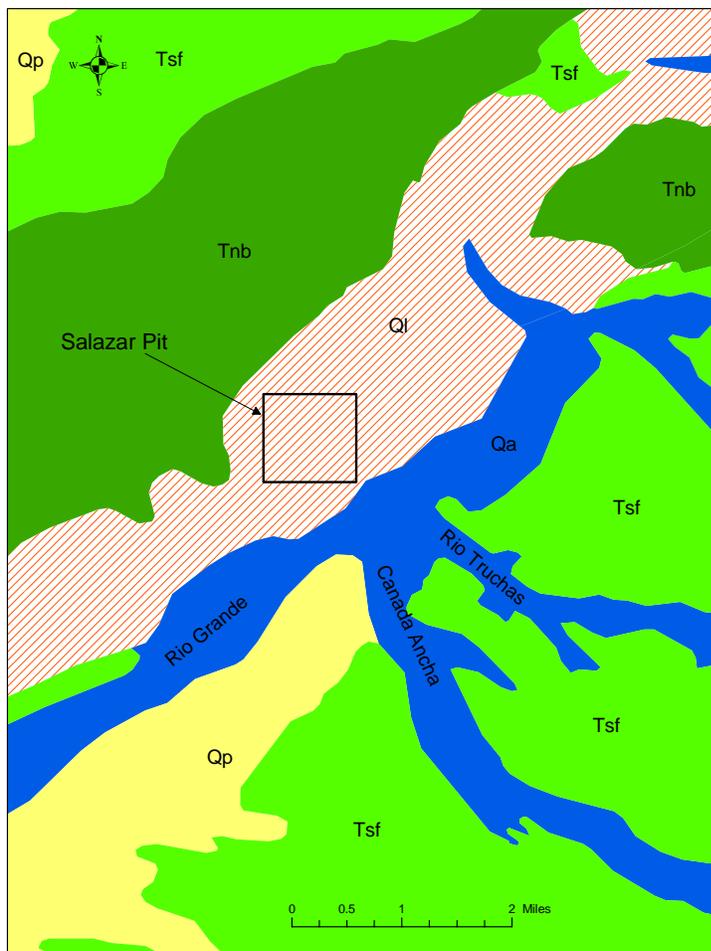
**Figure 1:** Enlarged section of the Geologic Map of New Mexico (Anderson et al., 1997). Qa – Quaternary alluvium (upper and middle); Ql – Quaternary landslide deposits or colluvium; Qp – Quaternary, Piedmont alluvial deposits, upper and middle quaternary; Tnb – basalt and andesite flows; Neogene - includes flows interbedded with Santa Fe and Gila Groups; Tsf – Lower and Middle Santa Fe Group - Miocene and upper most Oligocene in age.

The Salazar Pit project area is surrounded by Quaternary landslides (Figure 1) that originated in an extrusive igneous formation that caps sedimentary rocks (Anderson et al., 1997 and Kelley, 1978). Two geologic maps were reviewed to compile the geology of the Salazar Pit area: Geology of the Espanola Basin, NM (Kelley, 1978) and The Geologic Map of New Mexico (Anderson et al., 1997), released in digital form (Figure 1).

The geology map created by Kelley (1978) shows that the Salazar Pit area is within a wide band of deep-seated landslides. The landslides originated on a basalt-capped landform

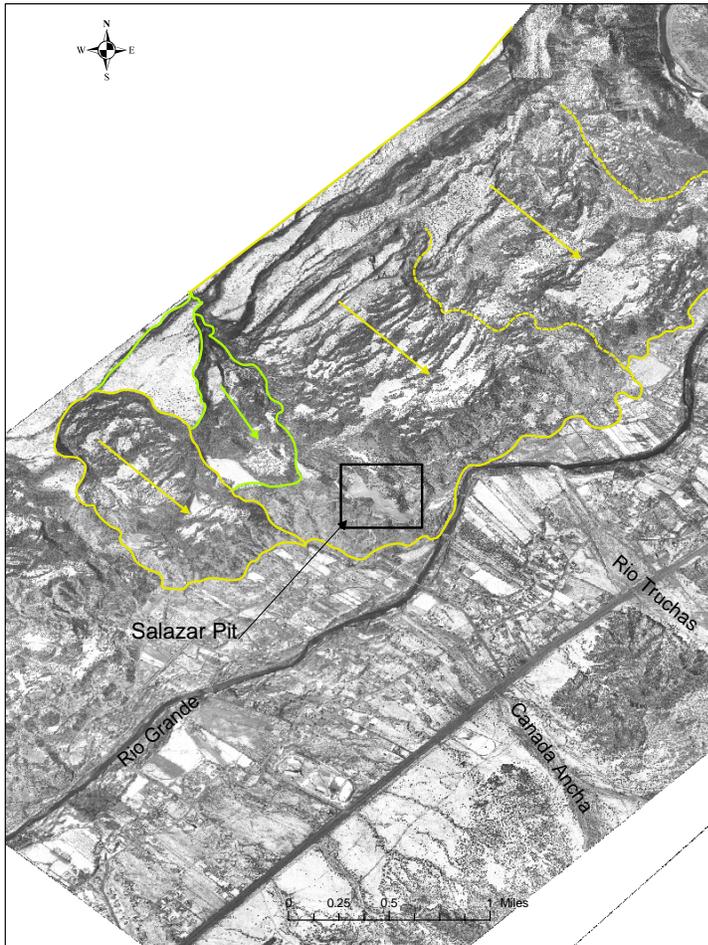
**Figure 2:** 2002 aerial photograph of the Salazar Pit area showing the large, Quaternary landslides in the immediate vicinity of the project; the yellow lines denote the larger primary landslides, while the green lines denote a landslide that appears to be a secondary landslide (younger than the larger landslides).

The movement of the landslides upslope from the project area appears to have been in two stages (Figure 2). The larger landslides (outlined in yellow in Figure 2) appear to have moved first and extend from the current day top of slope to the river valley. The secondary landslide (outlined in green) is likely a re-activated a portion of the larger landslide. Regardless, this landslide appears to ‘sit’ on top of the larger landslide is likely younger in age. The Salazar Pit project area is located almost immediately downslope from this secondary landslide.

As viewed on Figure 2, a drainage/arroyo forms along the northeastern edge of the secondary landslide which ultimately flows through the Salazar Pit area. The arroyo also appears to drain the secondary landslide deposit. Through the Salazar Pit area, the arroyo has a relatively steep slope at ~10% (pers. comm. K-I Smith, 2004); the channel margins are poorly formed; no distinct banklines or floodplains area have formed. Due to the steep channel slope, sediment transport appears to be dominated by hillslope processes that are enhanced by water runoff; as a result, the bed material is not sorted and the channel is not able to form fluvial features such as steps or riffles.
