U.S. Department of the Interior Bureau of Reclamation

RESEARCH NOTE

Domestic Supply Intake Modification to Enable Quagga Mussel Control

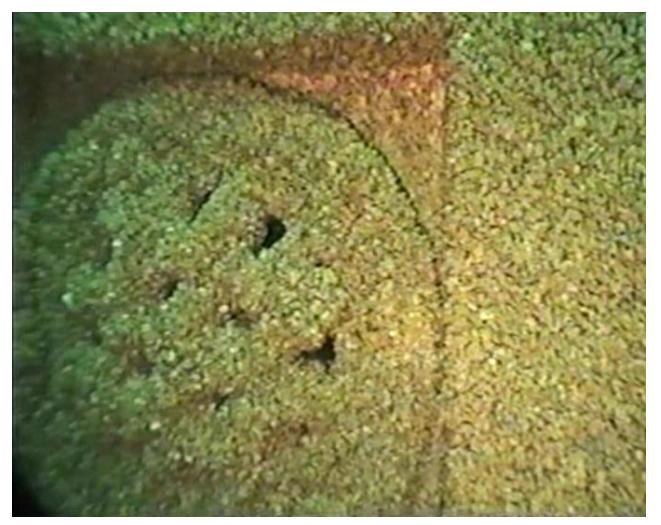
Figure 1. Heavy quagga mussel fouling on domestic intake at Davis dam.

Much of Reclamation's existing infrastructure was not originally designed for controlling zebra and quagga mussel fouling. In many cases, domestic and cooling water intakes are not regulated at the reservoir. Instead, the nearest control valve may be located inside the dam or power plant. Without the ability to shut-off pipelines at the source, considerable lengths of intake pipe are susceptible to mussel fouling making it difficult and costly to maintain (i.e., chemically treat or manually cleanout.) Figure 1 shows the heavily fouled domestic water intake grating at Reclamation's Davis dam. This intake is located at a depth of approximately 80 ft and the image highlights the difficulties in maintaining operability for such a system. Another considerable difficulty is that in some cases these intakes are located inside of power intake trashrack structures, meaning that units would require shut down in order to clean the lines manually using divers and water jetting equipment.

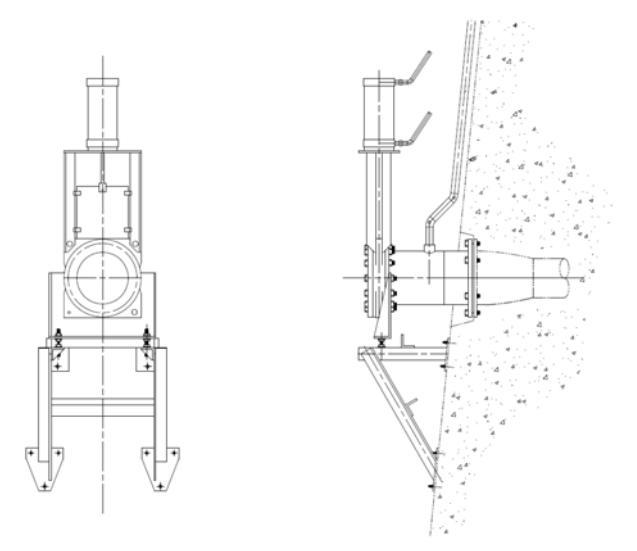
Figure 2. Schematic of shut off retrofit.

As a means for maintaining the domestic supply system at Davis dam, modifications to the intake were designed to allow shut off at the reservoir. The retrofit comprised a pneumatically operated knife gate (Fig. 2). In December 2008, the valve assembly was installed at Davis dam by divers.

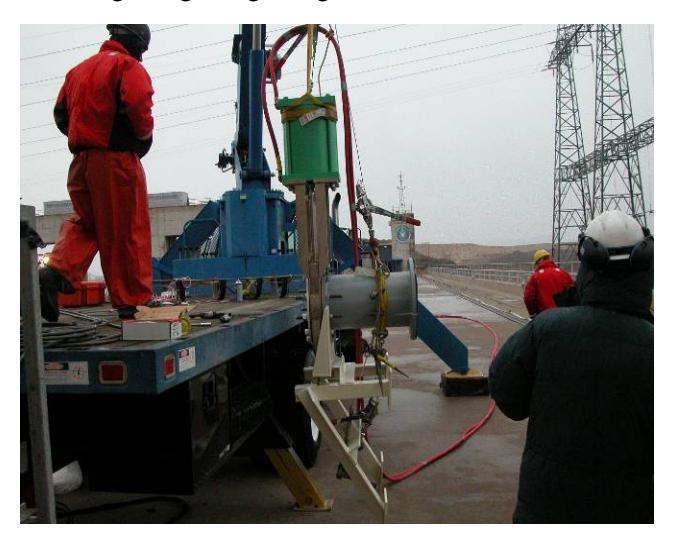
Figure 3. Knife gate assembly prior to installation

The knife gate assembly consisted of a 2–ft-long, 10in-diamter pipe extension connected to the existing intake grating flange (Fig. 3).

U.S. Department of the Interior Bureau of Reclamation The extension was equipped with a 2-in-diameter female coupling connected to a 2-in-diameter feed line running up to the surface. Finally, a support structure was included for the entire valve assembly and attached to the dam face. Figure 3 shows the assembly prior to diver installation.
