PAP-1013

Nimbus Hatchery Fish Barrier Physical Model Study

Tom Gill Water Resources Research Laboratory, USBR Denver, CO

August 2002

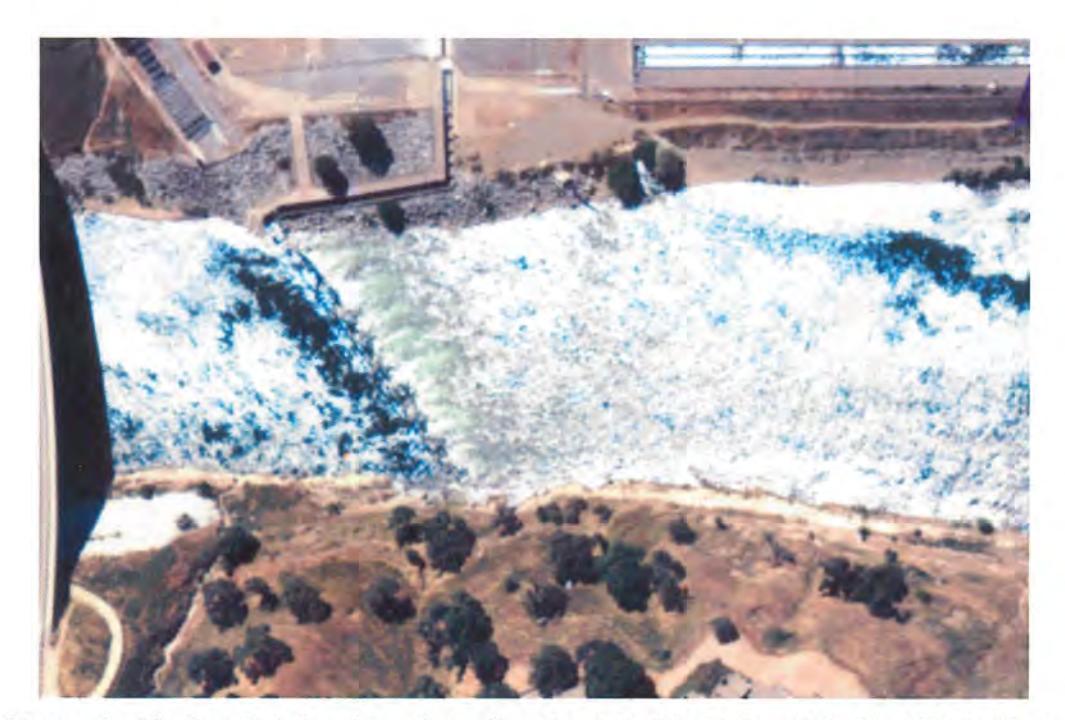
Figure 1: Nimbus fish barrier – flow direction is left to right. Note the fish ladder leading from the left side of the structure in the upper part of the photograph.

The Nimbus hatchery fish barrier is located on the American River a short distance downstream of Nimbus Dam. Construction of the fish barrier was completed in 1955. The structure angles downstream away from the fish ladder entrance on the left bank, making approximately a 55° angle with the stream banks. Figure 1 is an aerial view of the Nimbus fish barrier.

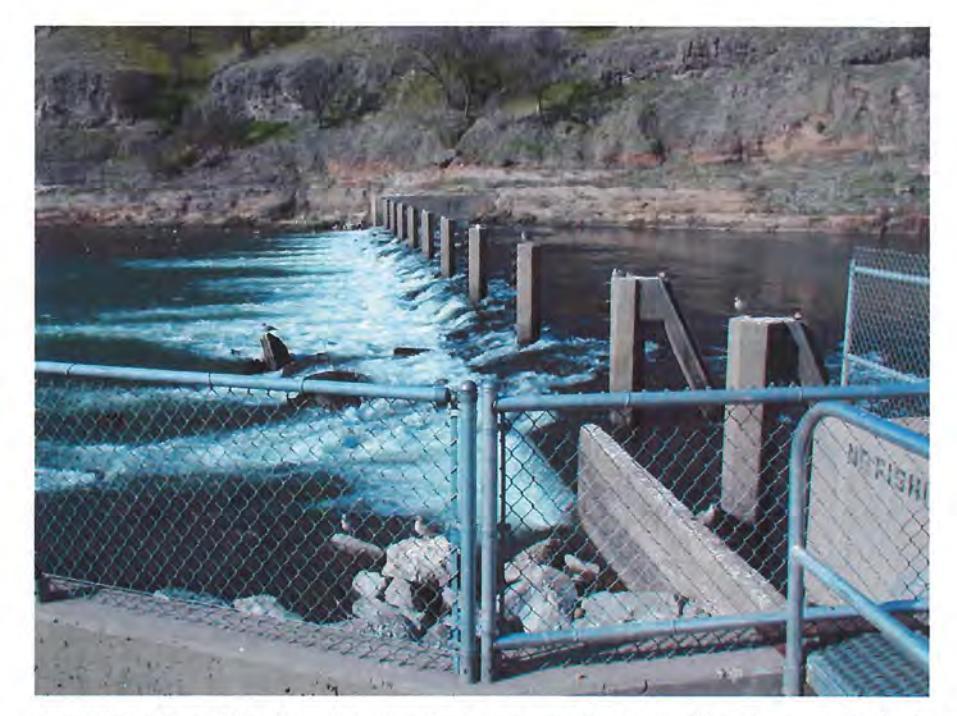
Figure 2: Existing Nimbus fish barrier piers, without walkway or pickets installed

The structure features concrete abutments at the ends and concrete piers spaced 30 ft on center across the span of the structure. The piers rest on spread footers constructed several feet below the stream bed on bedrock. Figure 2 is a view from the left bank showing the piers of the existing structure that are spaced approximately 30 ft apart.

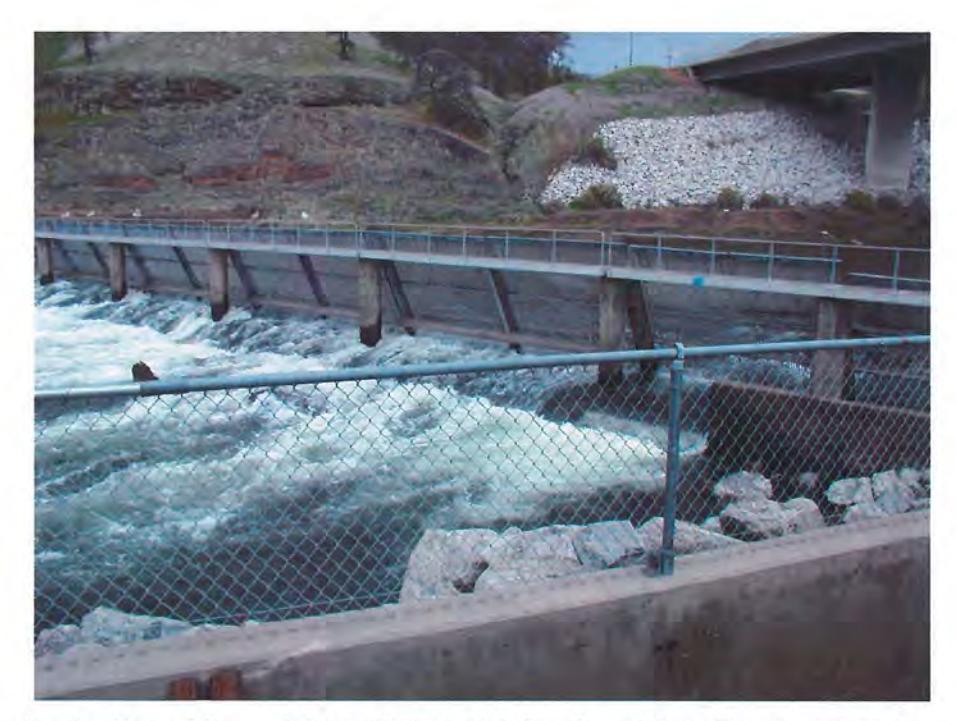
Figure 3: Section of the existing Nimbus fish barrier with walkway and pickets installed

Picket racks are installed by mid-September of each year for the spawning run then are removed in late December or early January. An overhead cableway is used to first install a walkway/support-rack atop the piers, then to install the picket racks which are supported by the walkway. When not in use, components are stored in an area beside the river under the cableway. Figure 3 shows the left side of the structure with walkway and picket racks installed.

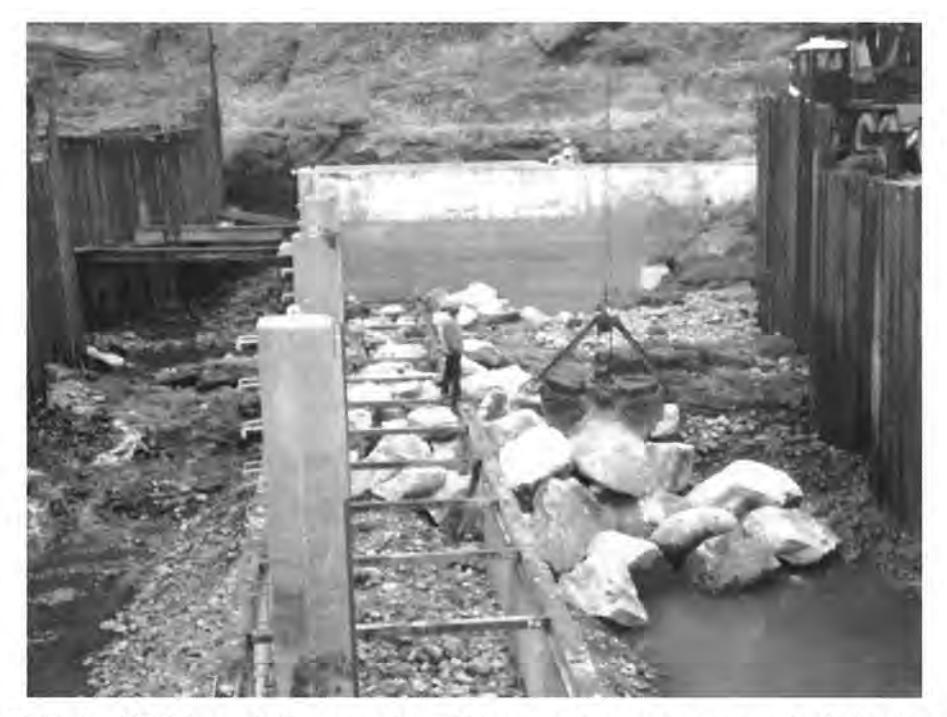
FIGURE 4: 1963 foundation repairs – Wire mesh screens were installed and large riprap was placed between the screens and upstream of the barrier.

Bed scour has been another problem. Initially, a steel mat covered by bed material was placed across the stream bed to limit erosion underneath the pickets. This proved insufficient to control erosion, and fish were able to pass under pickets. Figure 4 shows construction of upgrades that were done during 1963. At that time, wire mesh screens were installed vertically along upstream and downstream piling rows. Large riprap was placed along the foundation to control scour. By the mid 1980's the wire mesh had apparently deteriorated and scour under the pickets was again a problem. Placement of cobbles to fill voids under the pickets has been performed repeatedly since that time.

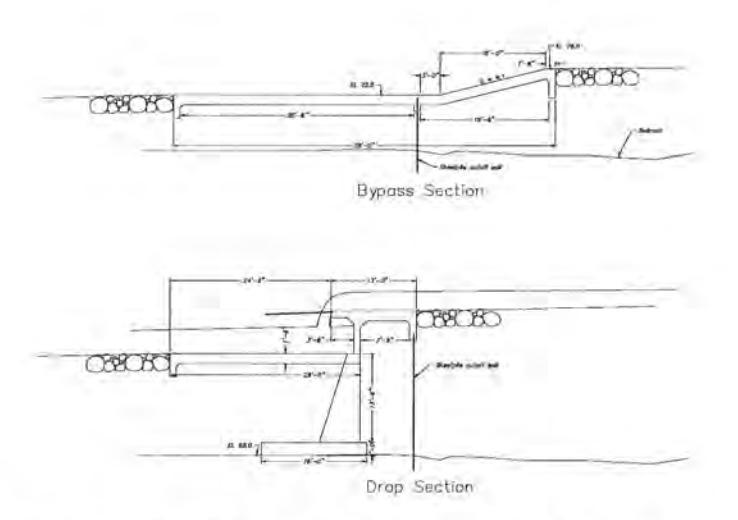
Figure 5. Cross sections of the bypass (top) and drop (bottom) components of the conceptual design for the replacement structure.

Between the left bank and the bypass section, the structure features a vertical drop. It will consist of a 13 ft wide concrete sill on the upstream side. This width includes a 3 ft overhang extending in the downstream direction over a vertical concrete wall. Floating

bar racks will be hinged to the downstream edge of this overhang. A sheet pile cutoff wall will be installed below the upstream edge of the sill. A 28 ft wide concrete apron will extend from the base of the vertical wall on the downstream side. In the conceptual design supplied by the MP Region, the elevation of both the upstream sill and downstream apron would vary across the structure.

Beginning at the left side, the first 35 ft of the structure would have a sill elevation of 79 ft and an apron elevation of 73.5 ft. Over the 180 ft span between this 35 ft section and the bypass section, the sill would slope upward from the 79 ft elevation to an elevation of 80 ft next to the bypass. Over the same span, the apron would slope downward from an elevation of 73.5 ft to 72.5 ft next to the bypass. The objectives of the sloped sections are to increase the amount of flow on the fish ladder side approaching the structure when river discharge is low, and to enhance downstream attraction flows toward the fish ladder entrance. Figure 5 shows sketches of these cross sections.

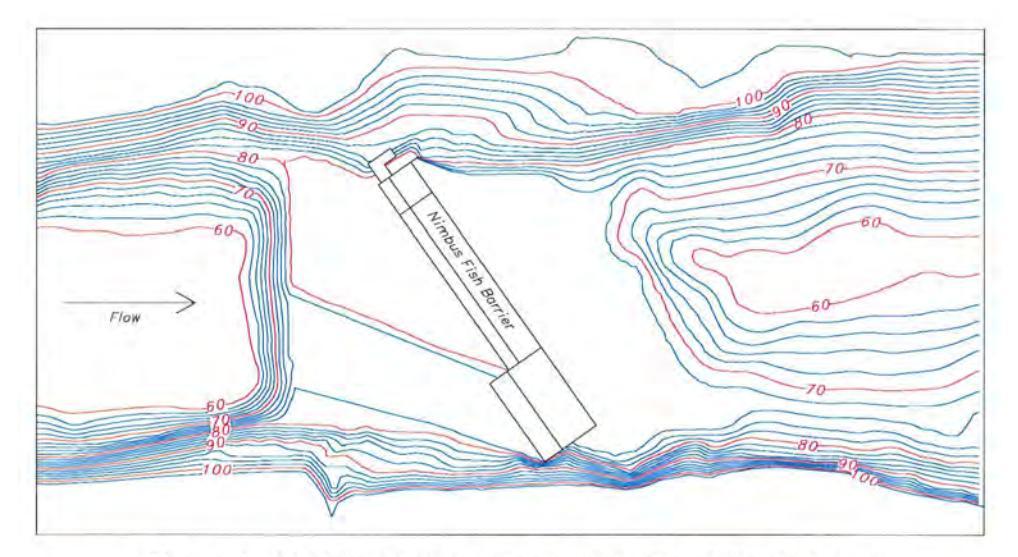
Figure 6. Model stream bank and bed elevation contours

The impact created by the uncertainty of the streambed elevation data is diminished by the fact that a significant amount of bed shaping and armoring will be require for the concept design in the vicinity of the structure. Using sill, apron and bypass elevations, a bed shape was developed to be consistent with the desired performance of the structure. Beyond the reshaped segment of the stream near the structure, the streambed was modeled in a shape similar to that indicated by the supplied contour data in both upstream and downstream directions. Figure 6 shows the topography of the model.

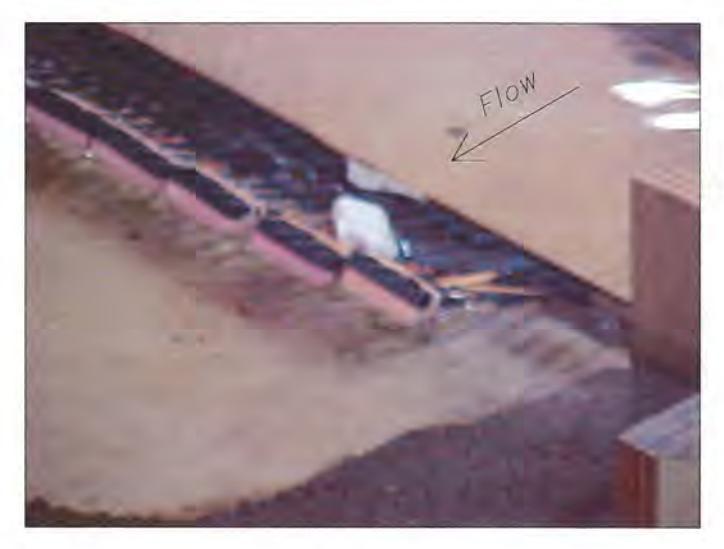
Figure 7. Floating screens under flow conditions—during this initial "wetting" of the model, styrofoam floats in the picture are held in place by rubber bands. They were subsequently attached using an adhesive. Note the debris hanging on the screens.

Floating screens in the prototype drawings were to be constructed of ¾ in schedule 40 pipe with approximately a 54% open space. The concept design calls for screens 10 ft long by 4 ft wide. An unspecified type of floatation device was to be attached to the underneath side of the trailing end of the screens to attain the proper buoyancy. Screens for the model were machined from sheets of PVC plastic. At the small, (1:30), scale of the model, it was assumed that viscosity forces would have an increased impact. To compensate for this effect the model screens were designed with a larger 62% open space. Floats cut from Styrofoam material were attached to the underneath

side of the downstream ends of the screens. Figure 7 shows the model screens with flow passing.

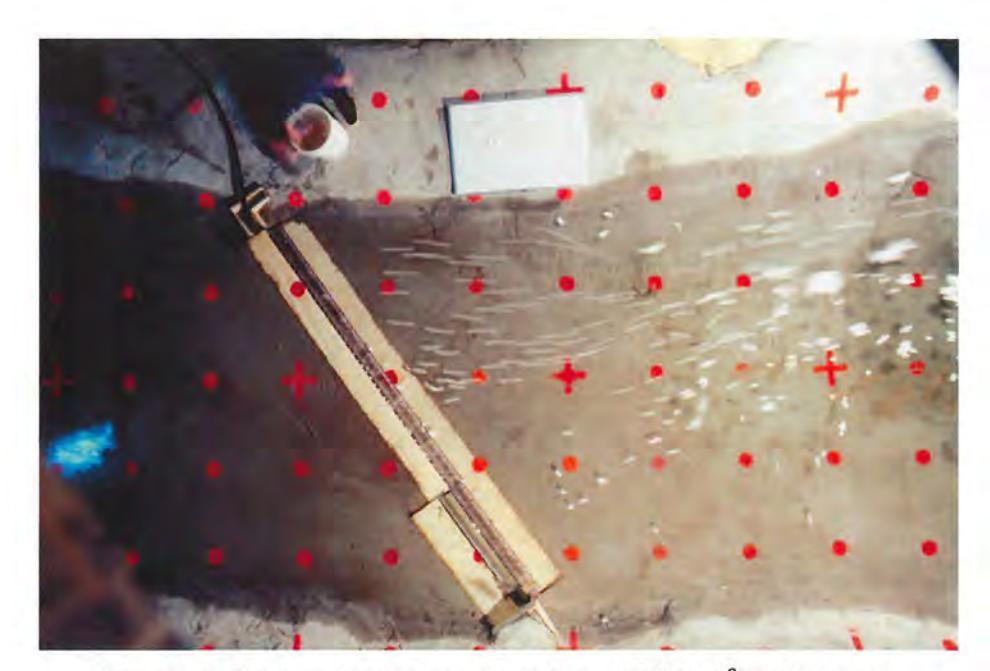
Figure 8. A "streak" photograph taken at 2060 ft³/s discharge Note the geo-reference grid of circles and crosses, as well as the optical distortion.

Color 400 film was developed as 4 in X 6 in prints from which bitmap images were scanned. The bitmap images were imported into an Autocad file which contained the model boundaries, the fish barrier footprint and the 2ft X 2 ft (model scale) grid. Using Autocad tools, the imported image could be scaled, rotated and moved to align the geo-reference points in the photo with those in the drawing. To account for optical distortion in the image, it was necessary to adjust scaling and position for different regions of the model. Figure 8 is a typical "streak" photograph.

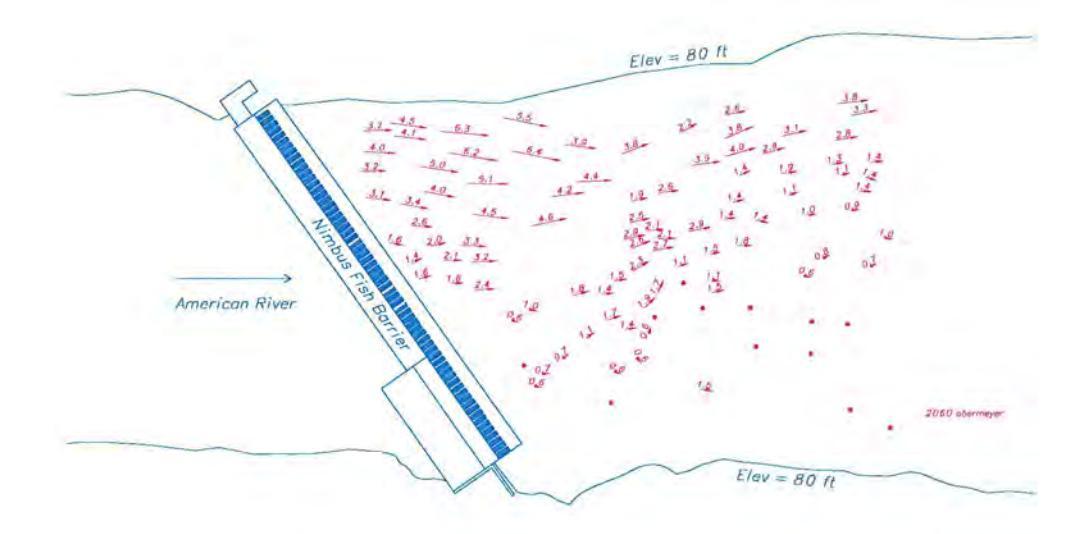
Figure 9. Vector diagram of the attraction flow velocity field for a 2060 ft³/s discharge

LISP routine recorded the digitized streaks with an arrow and a numeric value in ft/s. For streaks indicating a velocity less than 0.5 ft/s, the LISP routine enters a dot. Figure 9 shows a velocity field developed from streak photographs.
