Assessing 50 years of ecological changes at campsites along the Colorado River in Grand Canyon

H.C. Fairley¹, M.L. Scott² and A.H. Fairley¹ Annual Reporting Meeting, January 25, 2023

¹ US Geological Survey, Southwest Biological Science Center, Grand Canyon Monitoring and Research Center²Colorado State University

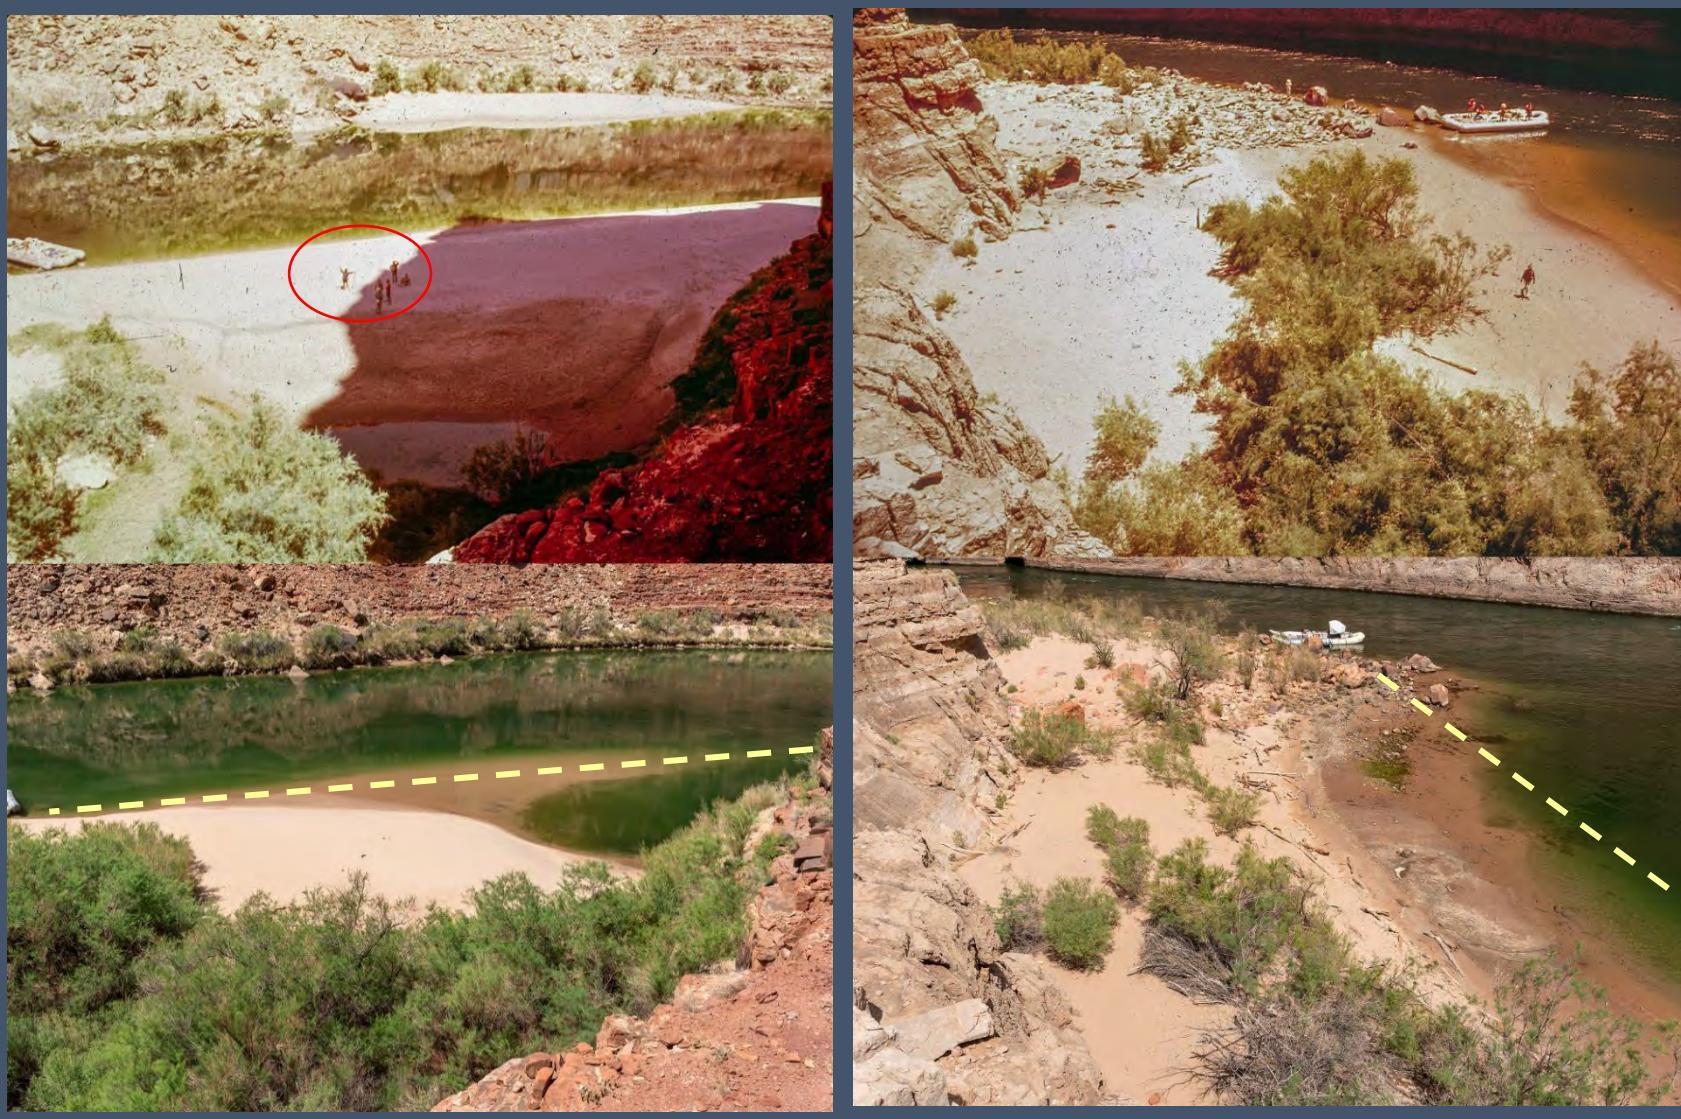
USGS Examples: Beach Front Erosion

RM 19.4L, top: original photo, July 1973 Bottom: match by A.H Fairley, 4/29/22

RM 31.9R, top: original photo, July 1973 Bottom: match by A.H Fairley, 4/29/22

- Shoreline erosion/bank steepening at >50% sites
- Sand deflation at 56% of sites examined
- Sand inflation at 37% of sites examined
- Sand surfaces generally less active due to reduction in sand deposition, soil crust development, vegetation increase

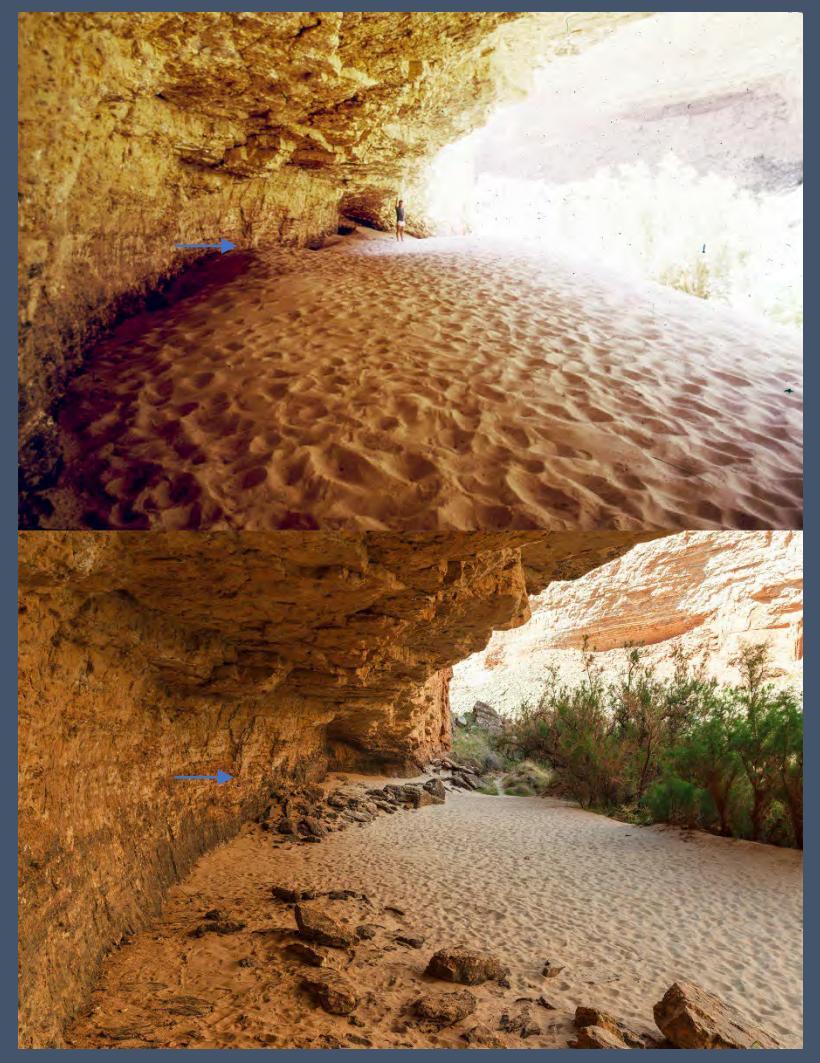
RM 44.1L, top photo: July 1973 Bottom photo: A.H Fairley, 5/8/21

Examples of Deflation

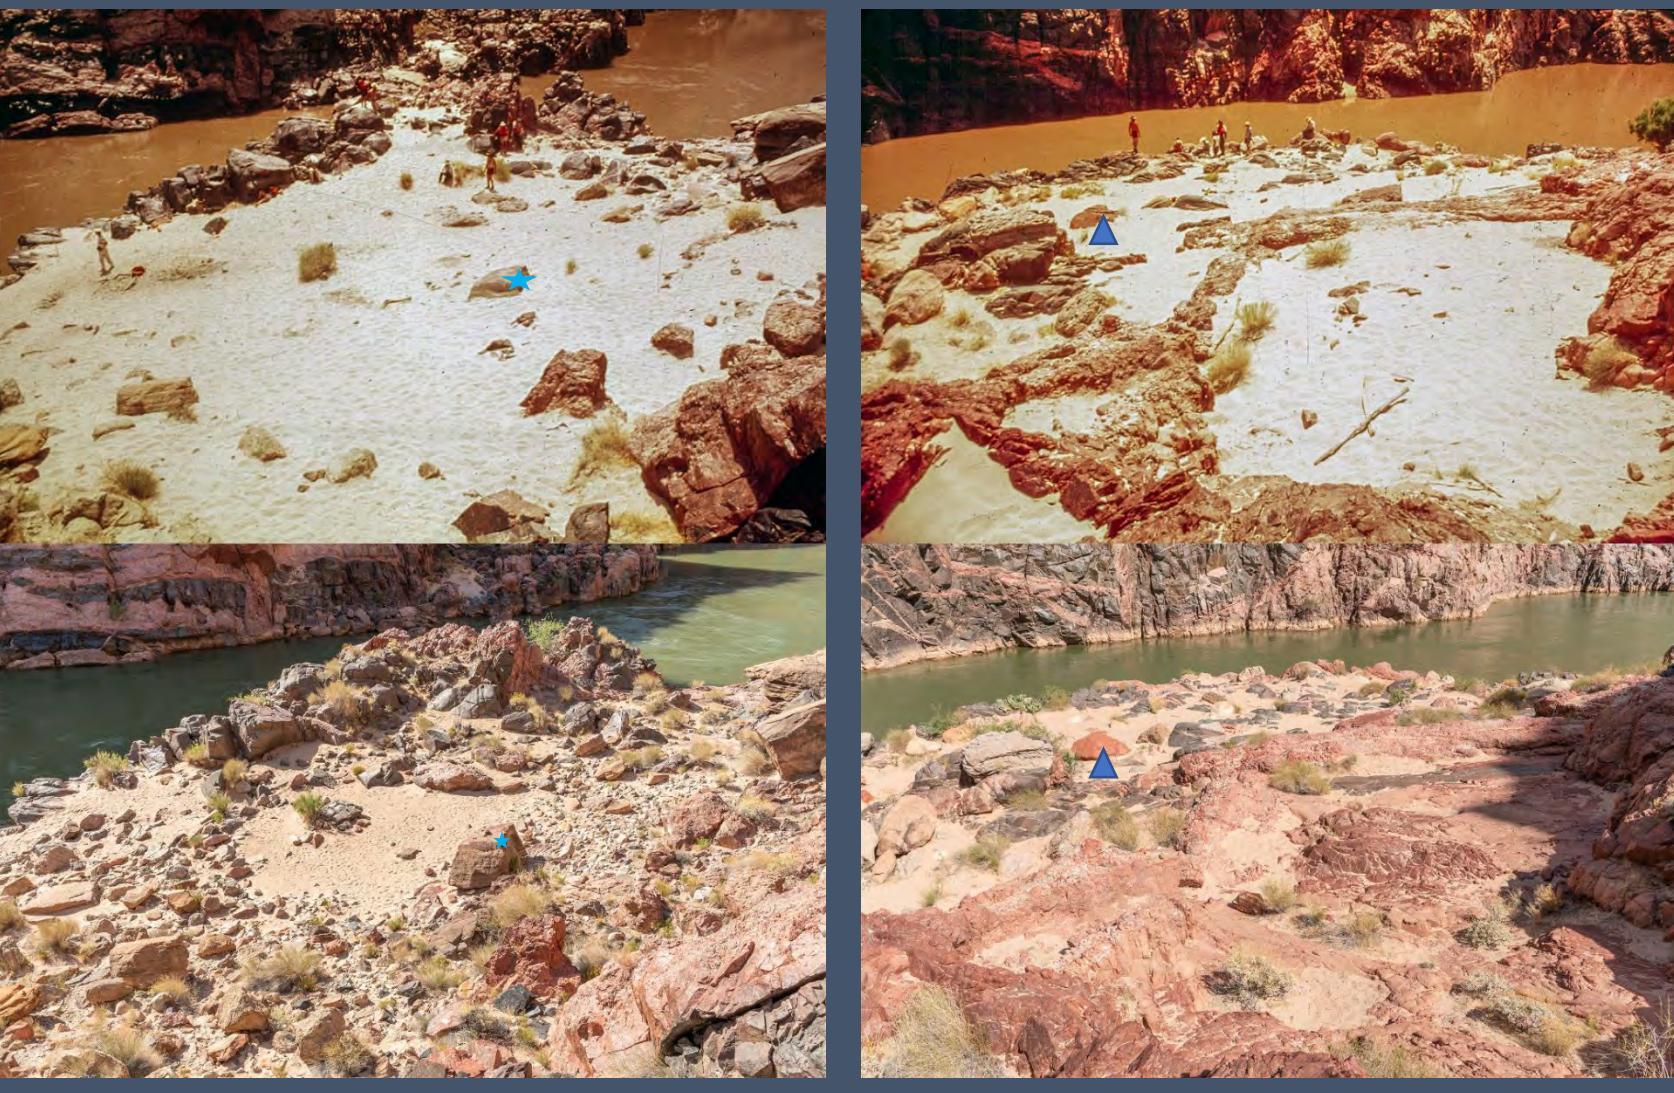
RM 114.9R, top: original photo, July 1973 Bottom: match by A.H Fairley, 5/8/22

RM 115.1R, top: original photo, July 1973 Bottom: match by A.H Fairley, 5/8/22

Both inflation and deflation may be evident

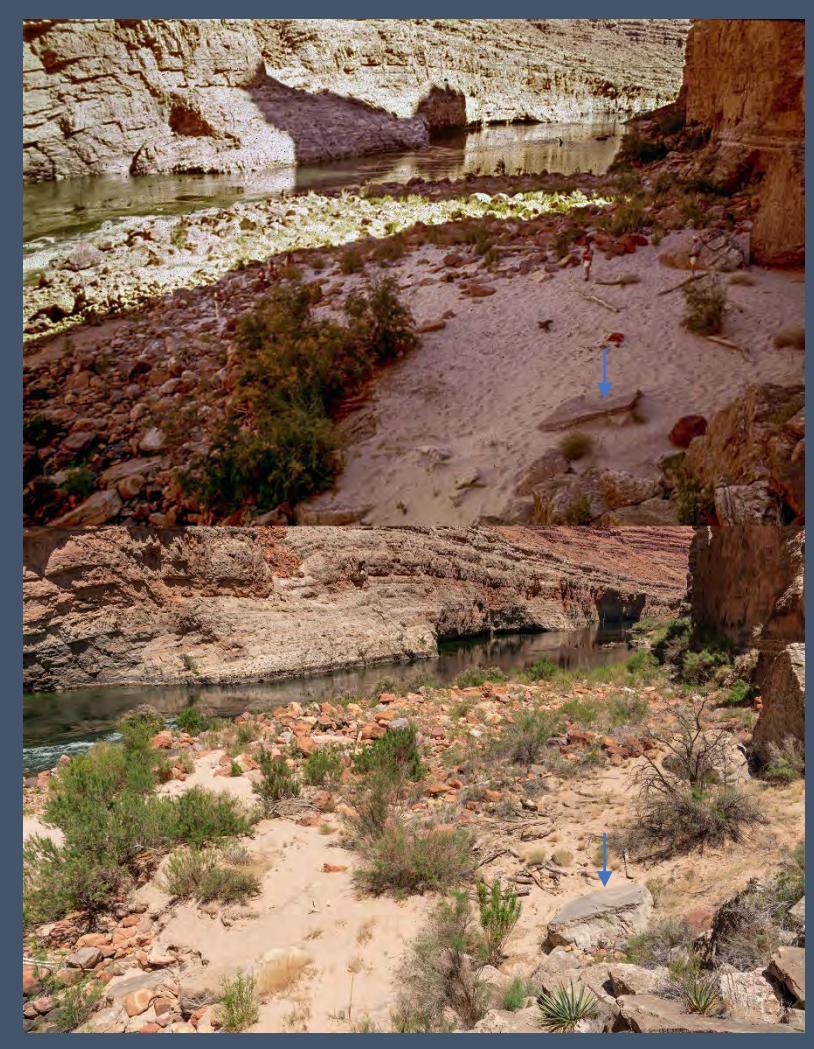
RM 26.9L, Top photo: July 1973 Bottom photo: A.H Fairley, 5/7/21

≥USGS More examples of inflation/deflation

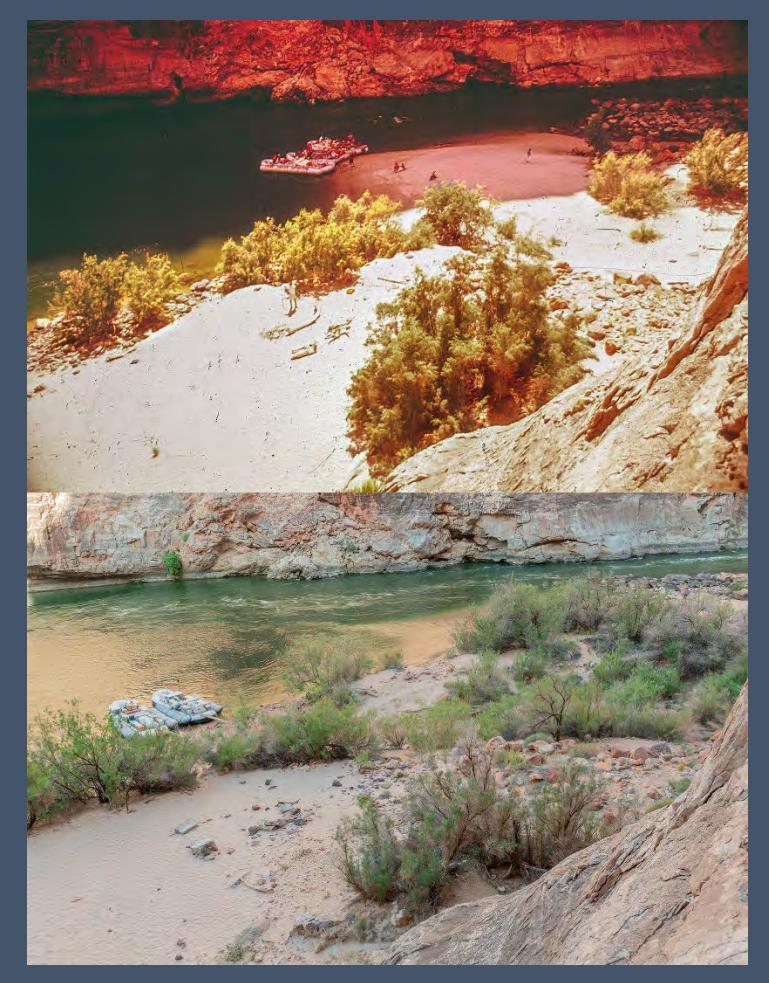
Nautiloid, RM 35.1L. Top: July 1973; Bottom photo: A.H. Fairley 5/1/22

Subscription Subscription Strate and USGS Vegetation encroachment is prevalent. Density varies by substrate and use Examples of two popular camps with light vegetation encroachment

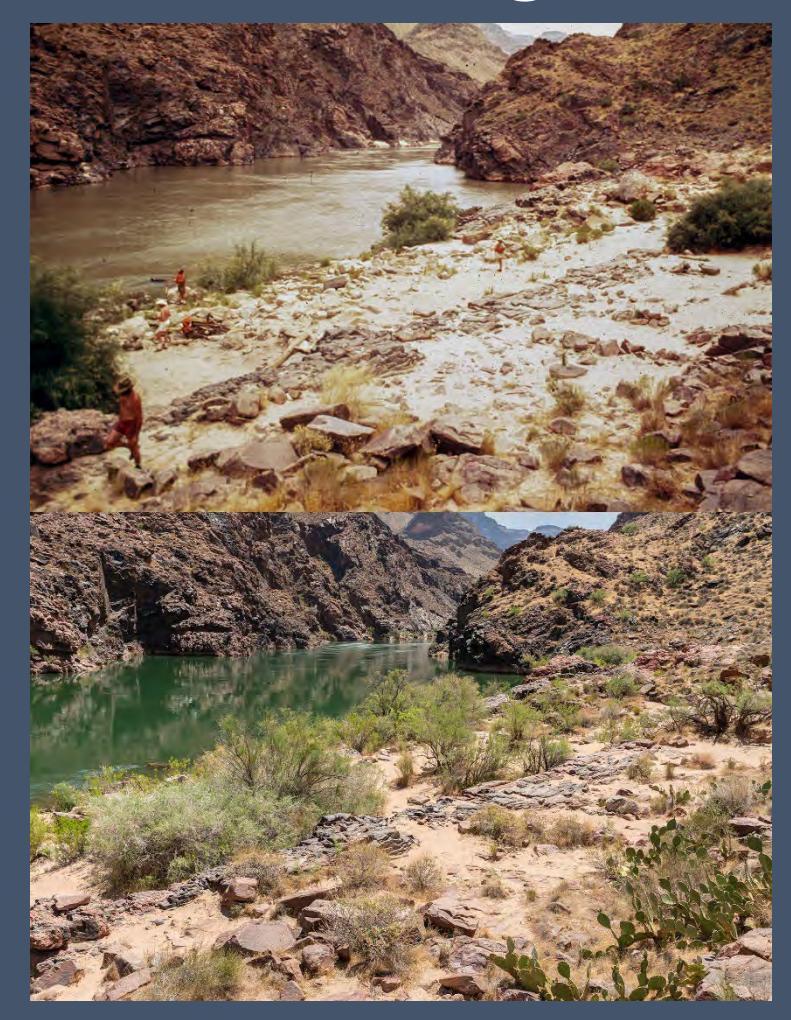
RM 136.8L. Top photo: July 1973 Bottom photo: A.H. Fairley, 5/12/22

≥USGS Examples of camps with medium vegetation encroachment

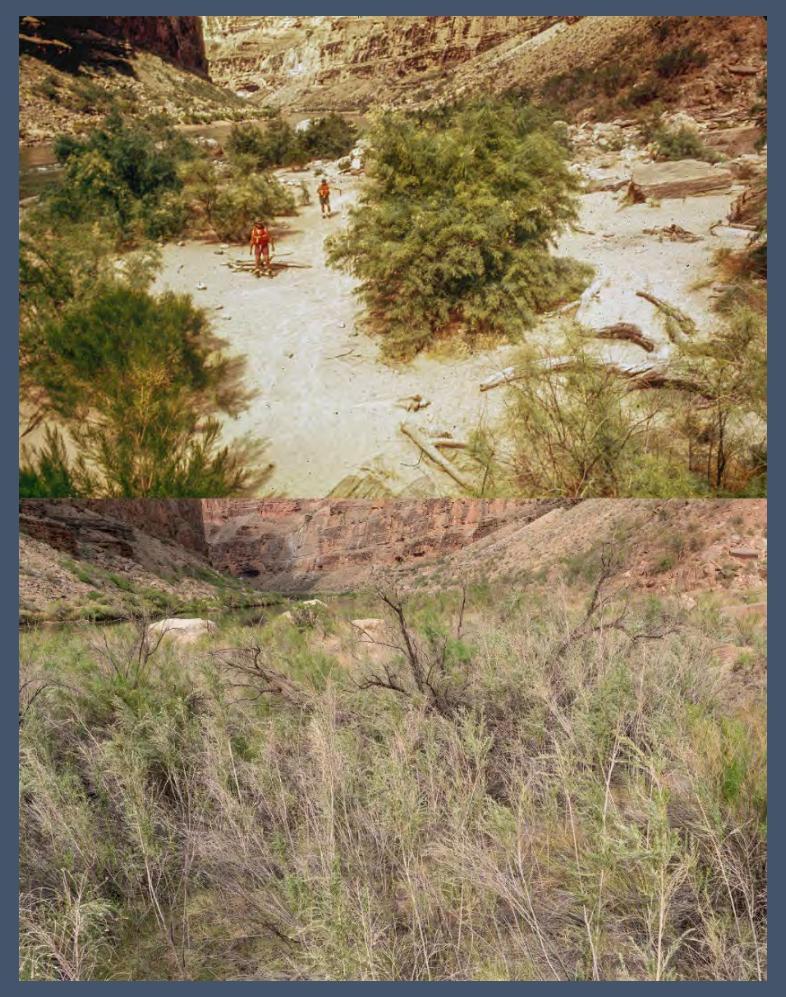
RM 170.5L. Top photo: July 1973 Bottom photo: A.H Fairley, 5/12/22

Examples of heavy vegetation encroachment

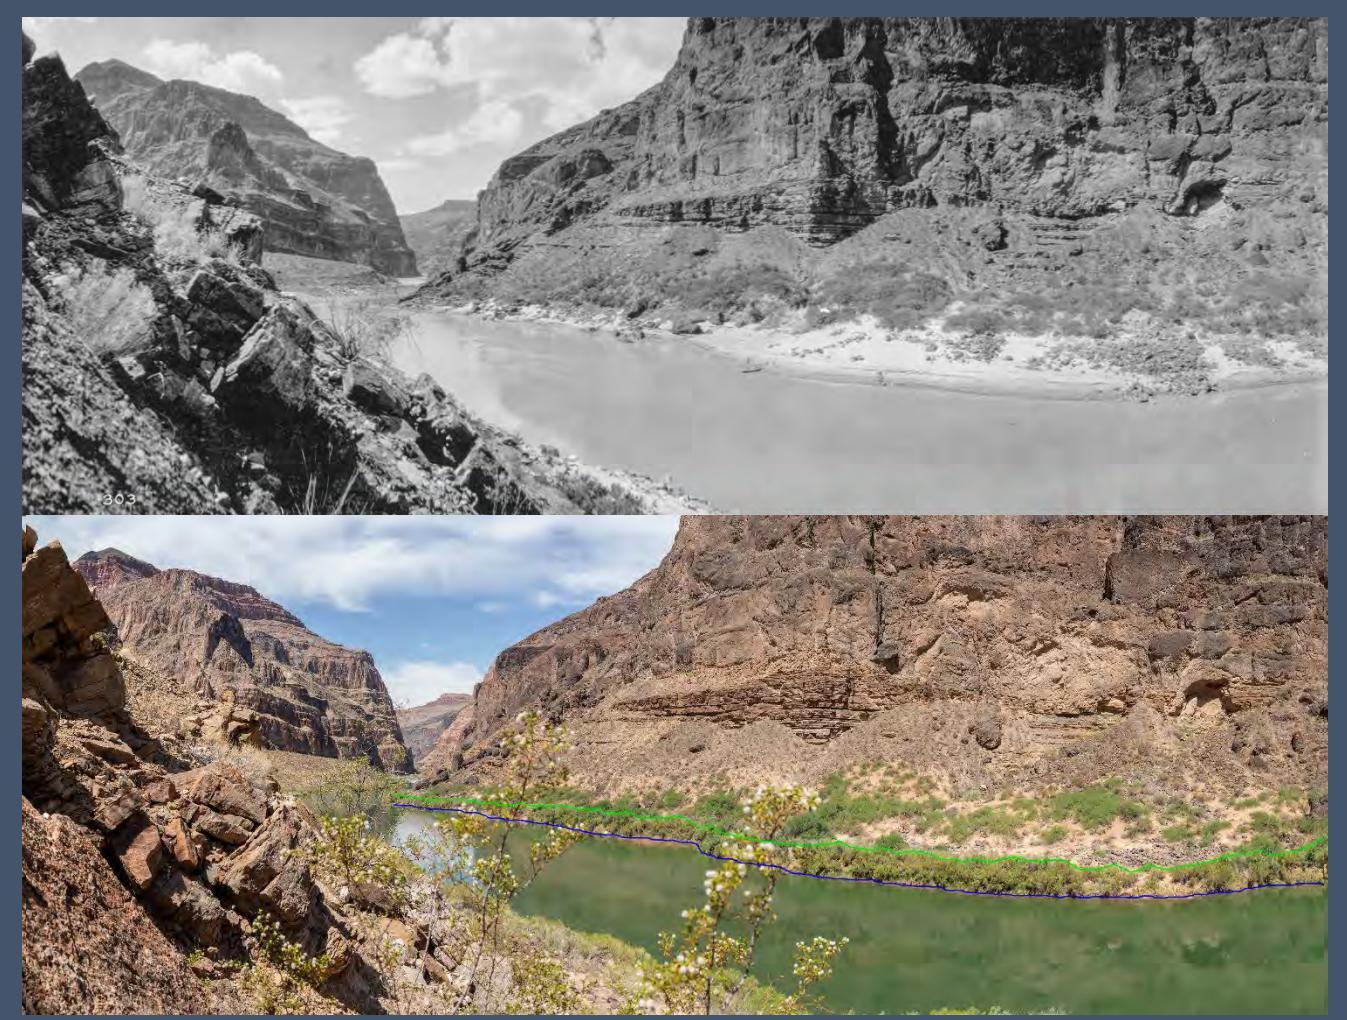
RM 199.2L, Top photo: E.C. LaRue 9/18/1923 Bottom photo: A.H. Fairley, 5/19/2021

Medium to dense nearshore vegetation cover present at 92% of sites

Nearshore vegetation encroachment contributes to bank steepening/retreat

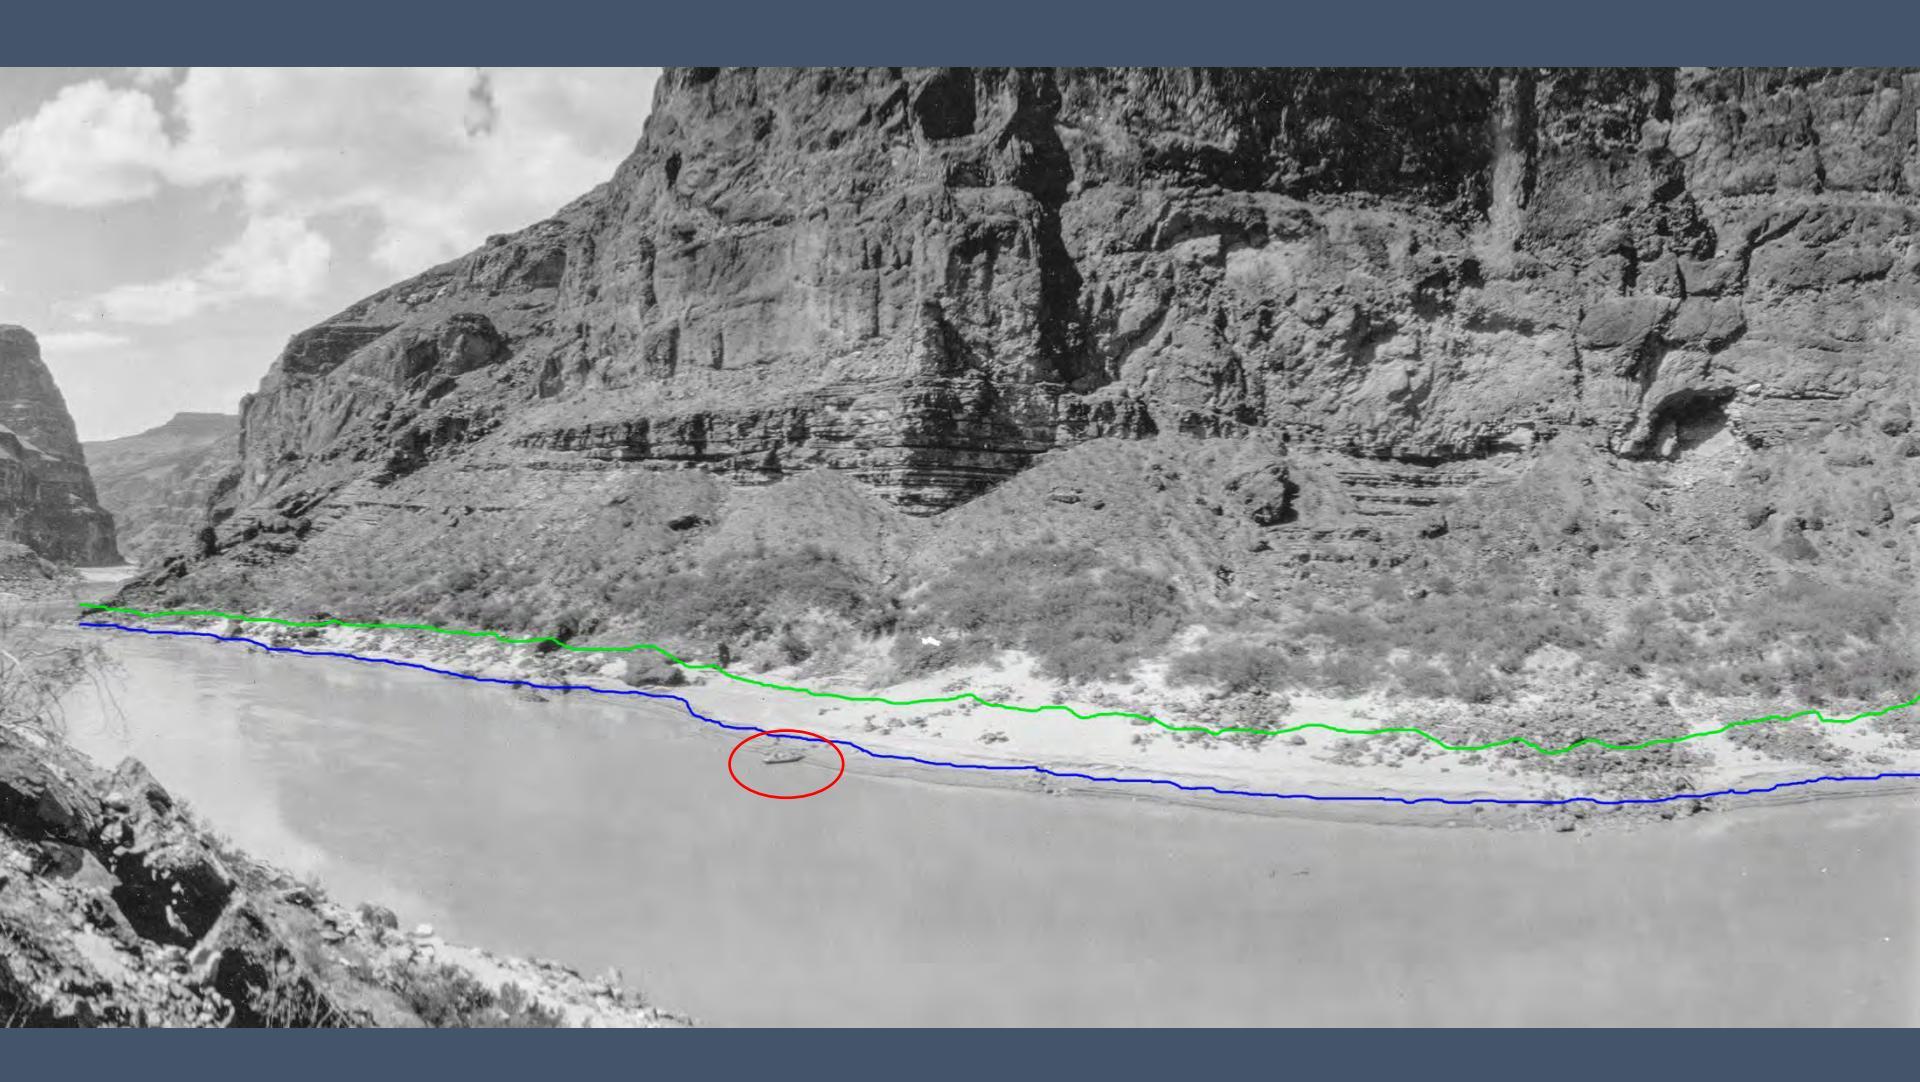
Photograph by M. Scott, April 30, 2018

Zone 1* vegetation

Bank armoring

- discharge range: 226-708 m³/s (8,000-25,000 cfs) (post-dam modified low fluctuating flow regime)
- obligate riparian shrubs (*Baccharis* spp, *Salix exigua, Pluchea sericea*)
- + herbaceous species are armoring banks

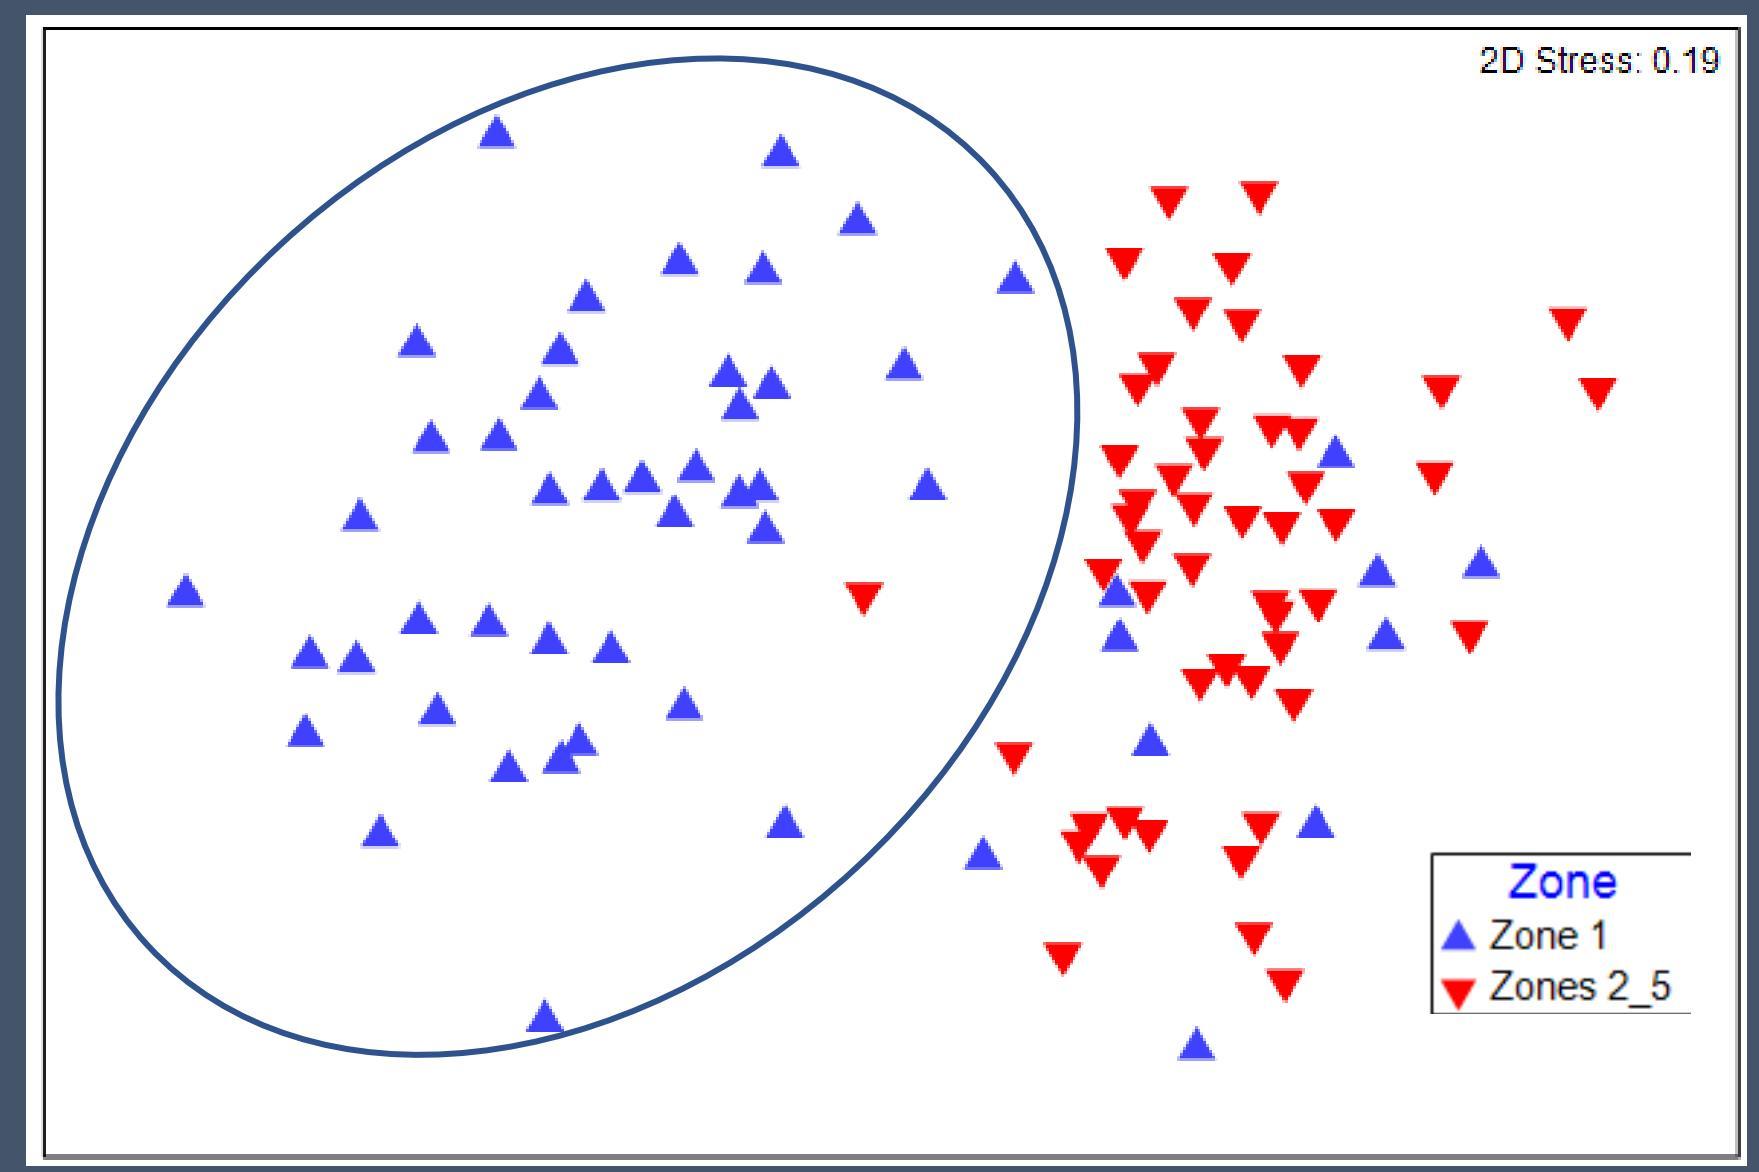
Results: Zone 1 NMDS ordination, Bray-Curtis dissimilarity
