* HYDRAULIC LABORATORY REPORT NO. 136
*
* - - -

* HYDRAULIC MODEL STUDIES FOR THE DESIGN
* OF
* ROSS DAM SPILLWAYS
* CITY OF SEATTLE, WASHINGTON
*
* - - -

* J. N. BRADLEY and C. J. HOFFMAN
*
* - - -

* Denver, Colorado,
* Oct. 12, 1943
*
* *****

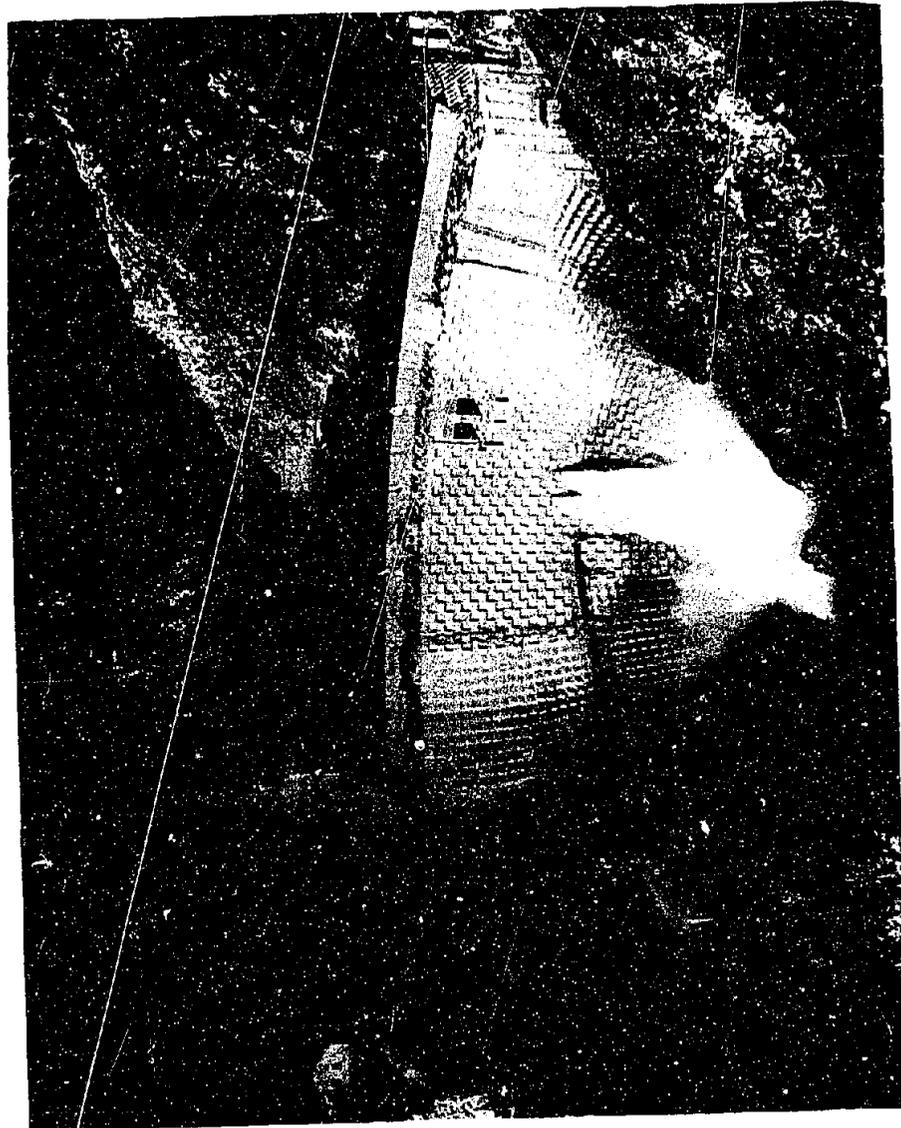
FIGURE 2

ROSS DAM--INITIAL DEVELOPMENT
TO ELEVATION 1365

The first stage of Ross Dam has been completed to elevation 1365 (figure 2), consisting of an arch ring about 1180 feet long at the crest, rising 165 feet above the tailwater, which is the reservoir level for Diablo Dam. The crest of this dam is surmounted by a 15-foot timber dam over which the floodwater spills. The tentative plan is to continue construction in several stages to an ultimate height of about 520 feet above tailwater, or elevation 1725. At this final stage the dam will be constructed as a gravity arch section by adding to the downstream face of the thin arch dam. The immediate plan is to continue the arch ring construction from its present stage in two steps, first to about elevation 1550 and later to elevation 1650. These are referred to in this report as the second and third stages, respectively.

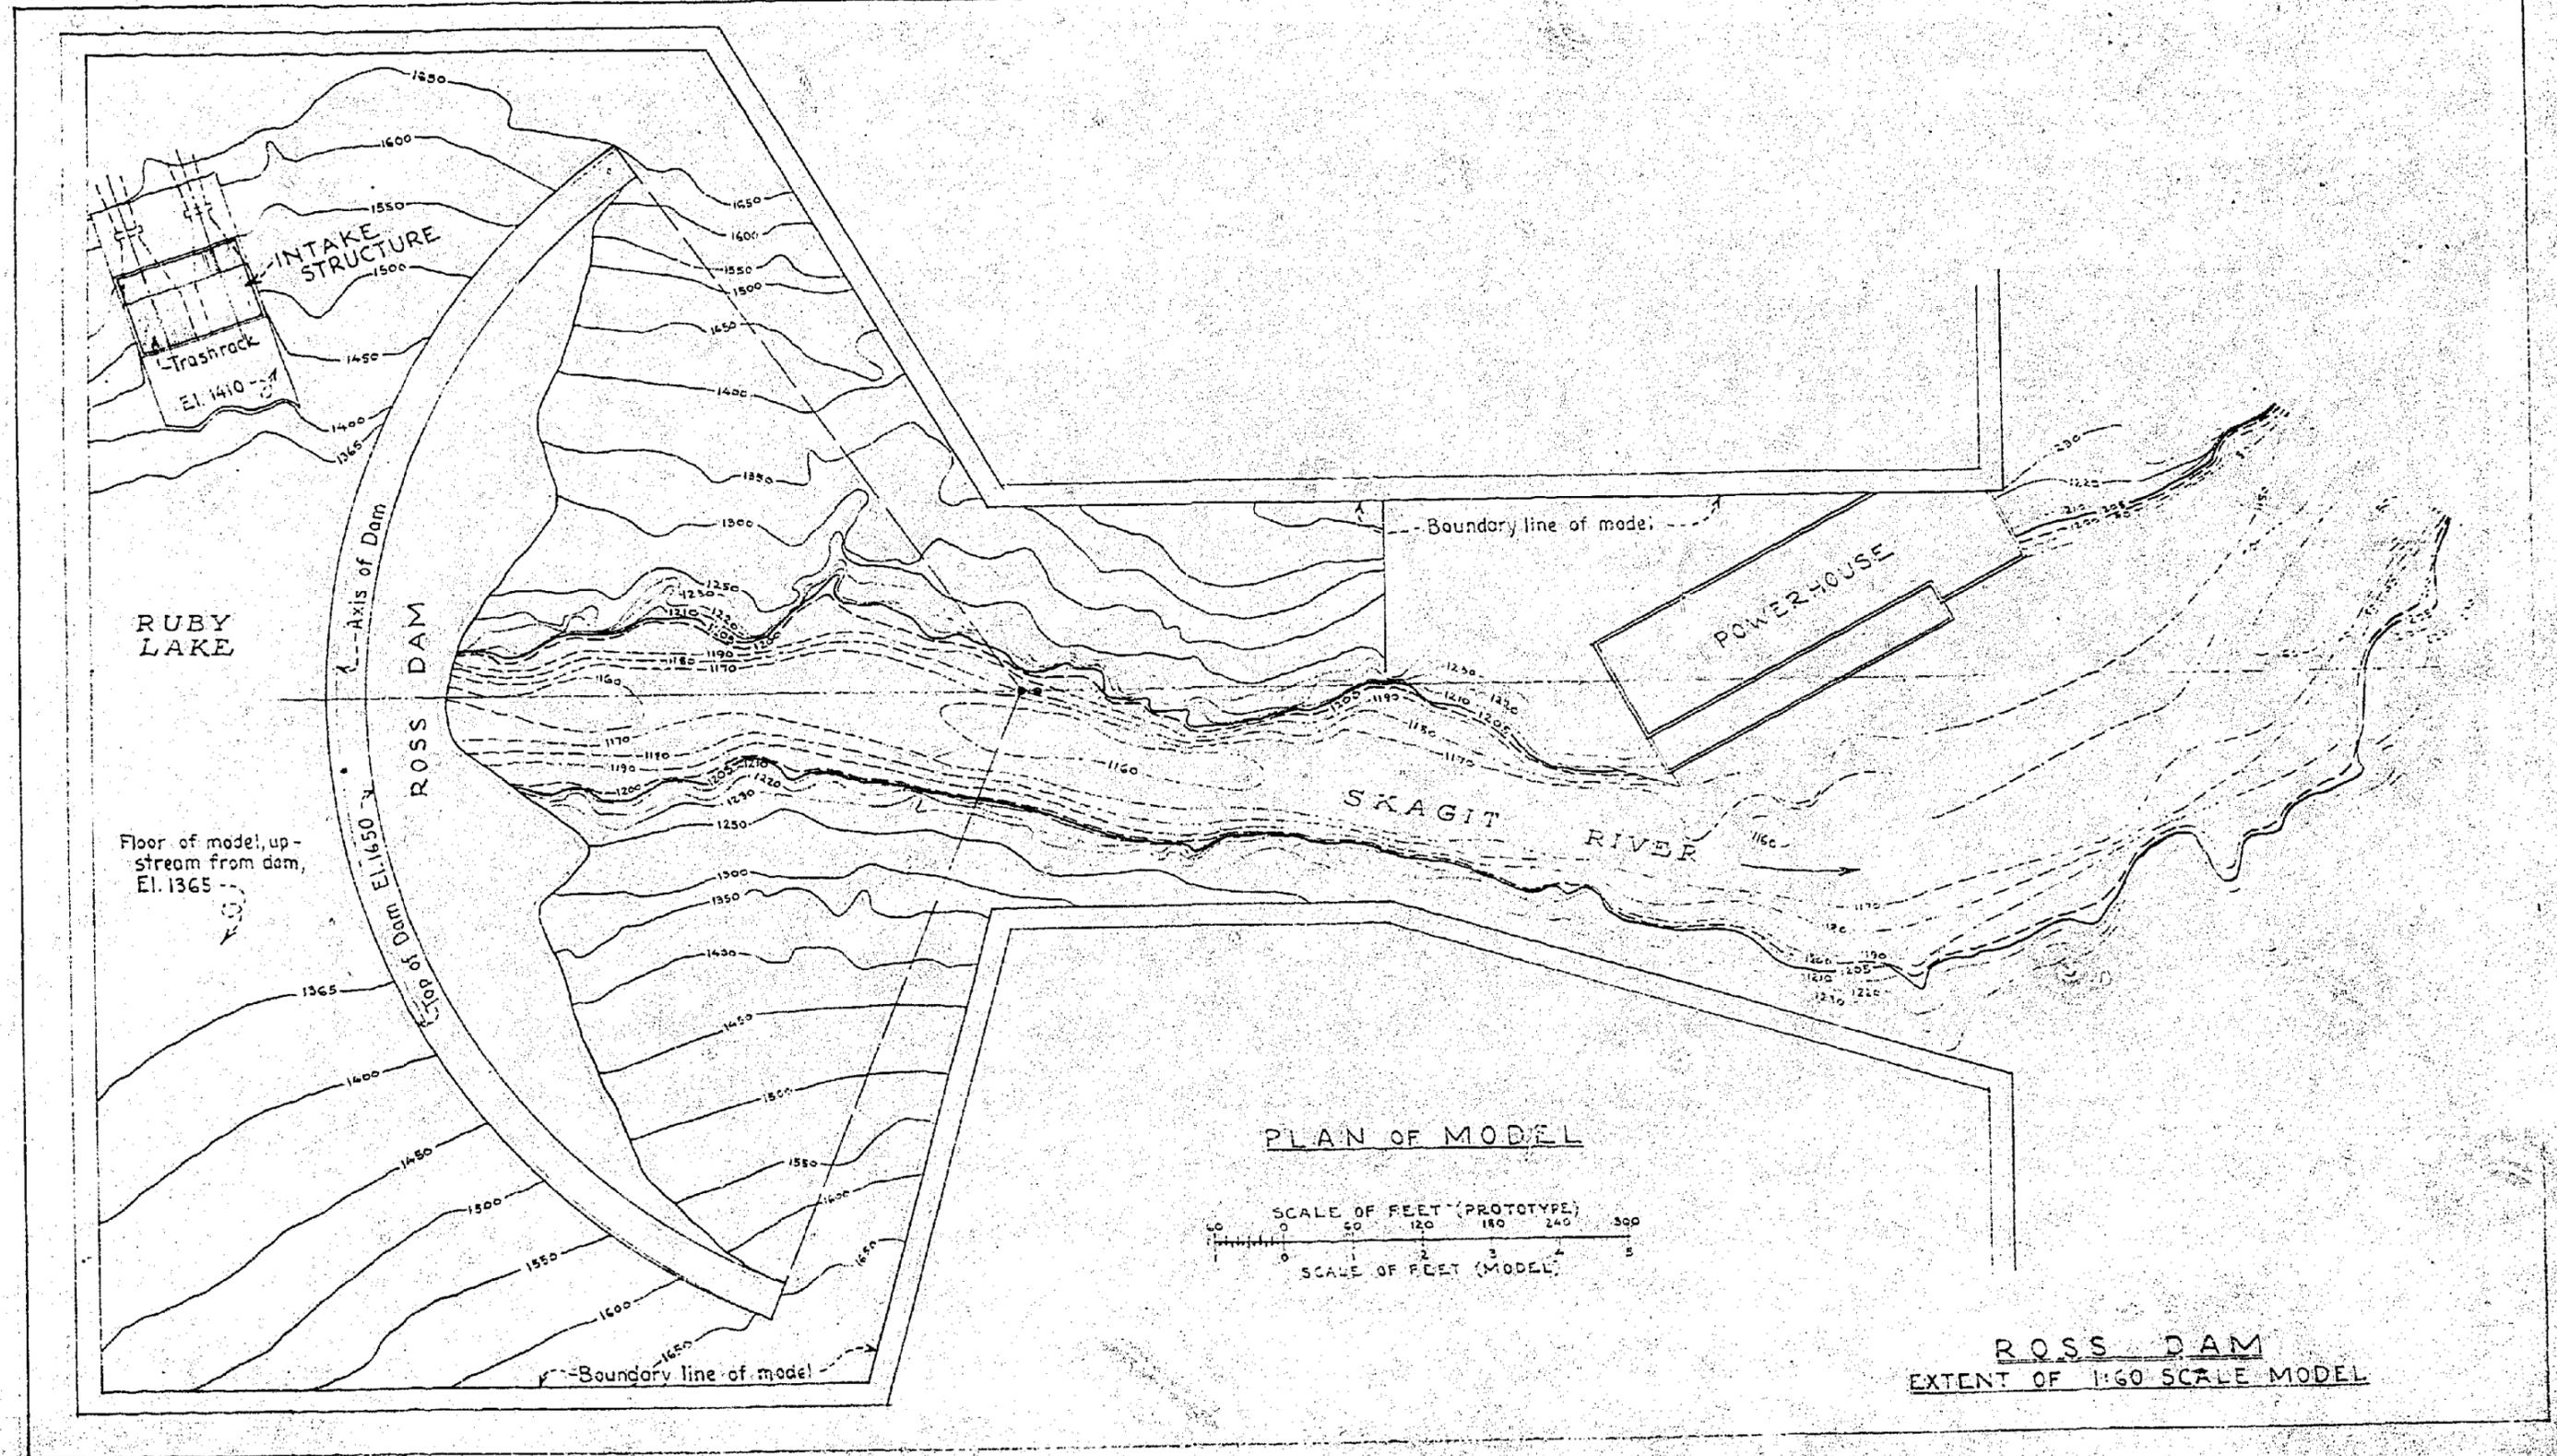
PLAN OF MODEL

ROSS DAM
EXTENT OF 1:60 SCALE MODEL

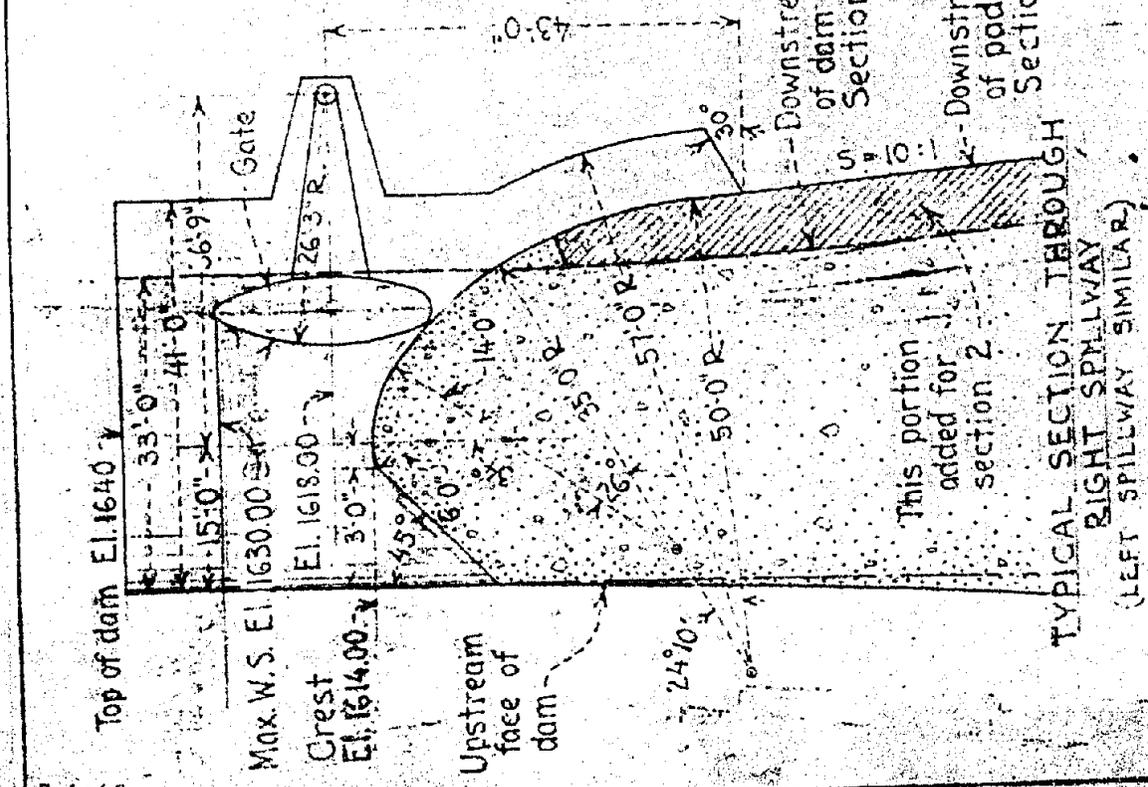
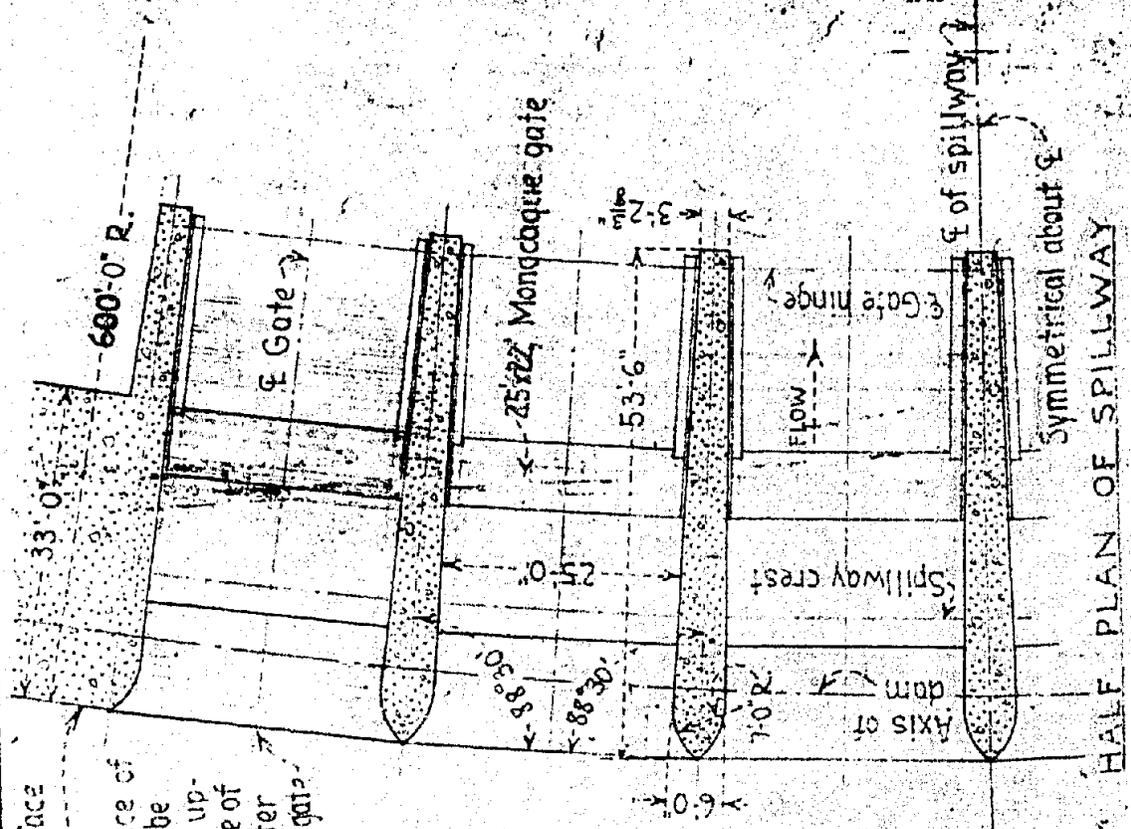
ROSS DAM SPILLWAY
 OVERFLOW SECTIONS 1 AND 2

5. Overflow section 1. As a preliminary trial, overflow section 1 (figure 6) was constructed to a 1:60 scale with provision for 35,000 second-feet controlled by six 25- by 22-foot monocoque gates. The center line of the overflow section was midway between construction joints 5 and 6. Although it was intended that similar spillways be located near each abutment, thus making the total spillway capacity 70,000 second-feet, each of the preliminary designs was constructed on one side only. In other words, each succeeding design was alternately constructed on one side and the following design on the opposite side. The crest of overflow section 1 was at elevation 1614.0, making the reservoir elevation approximately 1630 for a discharge of 35,000 second-feet. The gates were set downstream from the crest, as shown on figure 6, to obtain a trajectory with initial velocity directed at a downward angle rather than horizontal as is usually the case. The portion of the overflow section upstream from the gates was designed to produce no subatmospheric pressures in this region for discharges up to 35,000 second-feet.

Overflow section 2 (figure 6) was the same as section 1 except for the concrete pad added to the downstream face of the dam. The jet performed as desired for the lower discharges but sprung free of the pad intermittently for discharges greater than 25,000 second-feet. The steepness of the overflow shape encouraged vortices to play back and forth across the section, producing very unstable flow. Photographs of this spillway are shown for a discharge of 35,000 second-feet on figure 7 A and B. The original topography had not been disturbed.

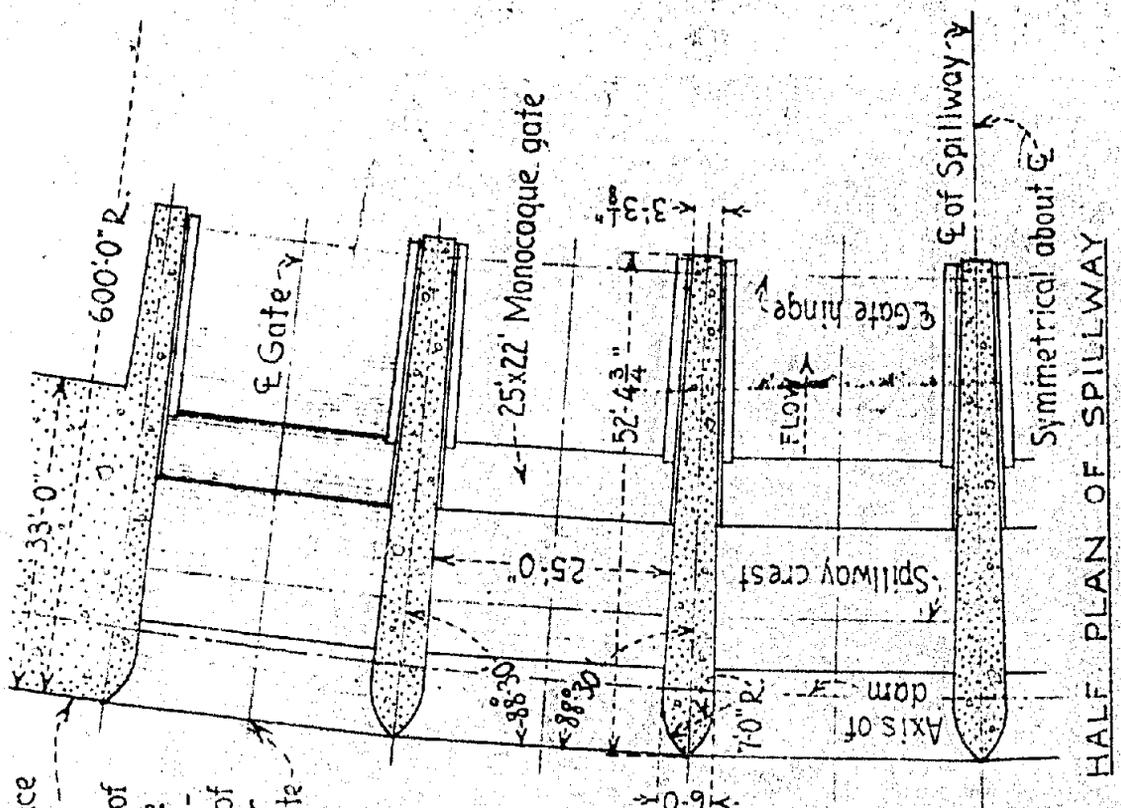
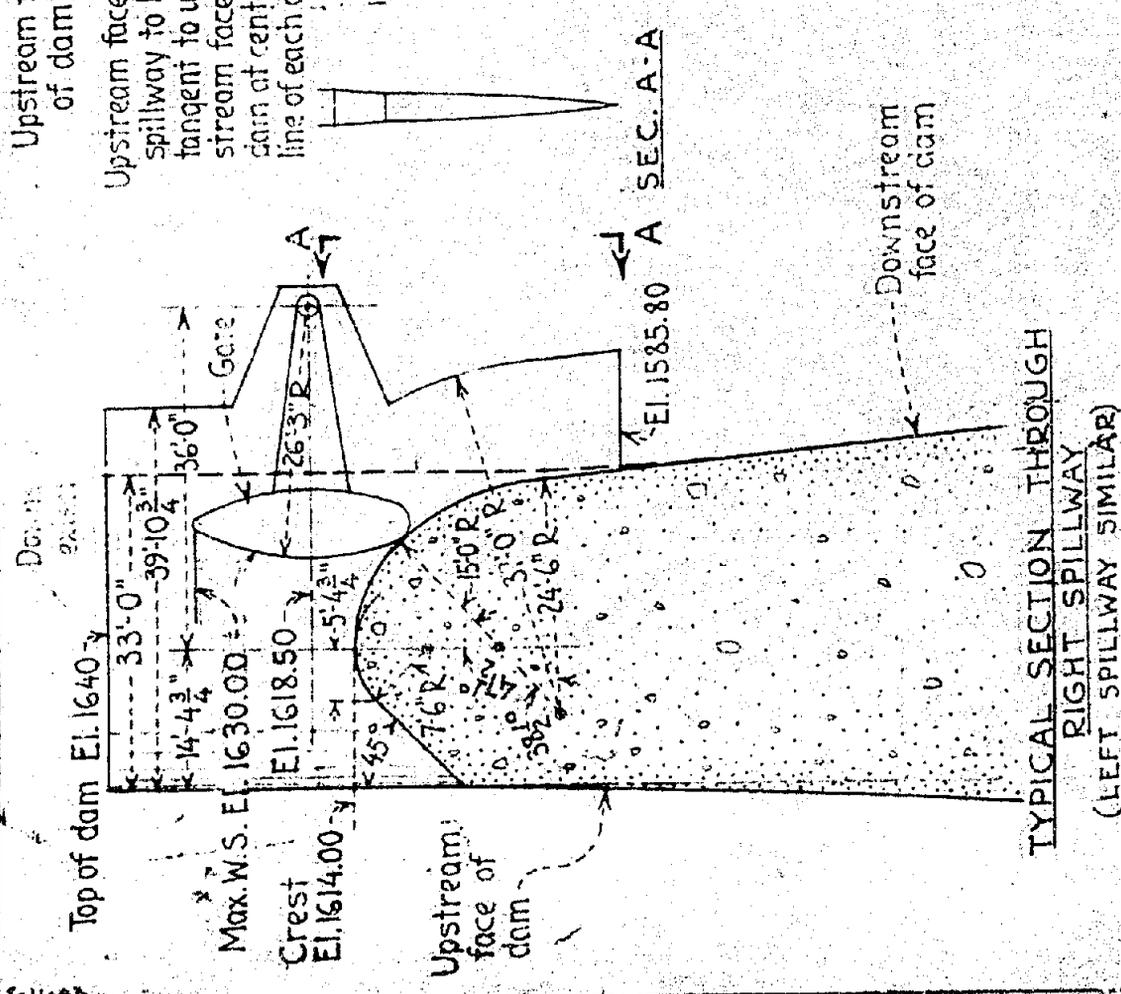
ROSS DAM SPILLWAY OVERFLOW SECTION 3

7. Overflow section 3. Overflow section 3 (figure 8) consisted of a combination of two radii used with no intention of simulating the

actual shape of the lower nappe of the overfalling sheet. The padding on the dam face was removed and the gates again suspended to operate on the curved portion of the overflow section. In this case, the object was to develop negative pressures under the jet in an attempt to virtually force the sheet of water against the overflow face. Results were less desirable than for the preceding case as vortices made it possible for air to enter intermittently under the jet, resulting in an intolerable make-and-break action. Photographs of this spillway are shown for a discharge of 35,000 second-feet on figure 7 A and C. The natural topography was still intact.

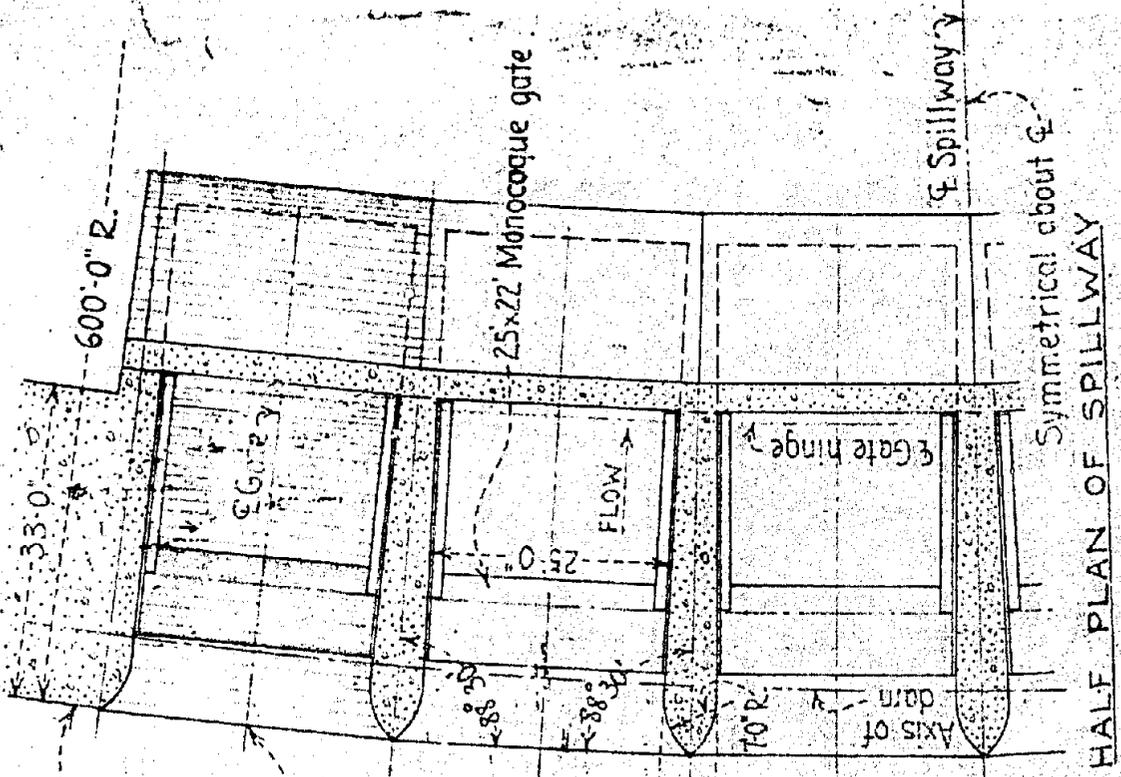
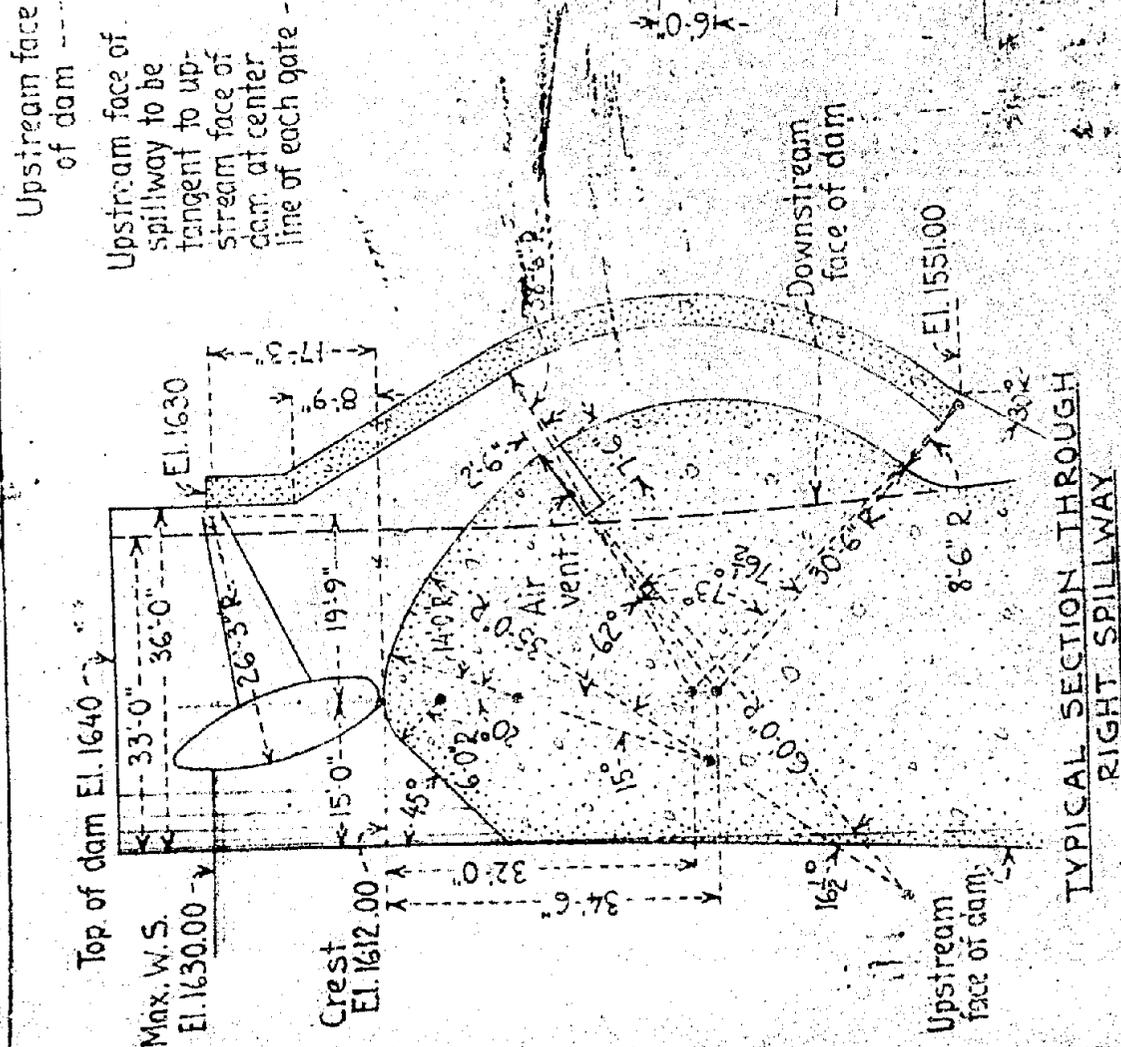
TYPICAL SECTION THROUGH
RIGHT SPILLWAY
(LEFT SPILLWAY SIMILAR)

ROSS DAM SPILLWAY
OVERFLOW SECTION 4

8. Overflow section 4. It became apparent that the design of a free overflow shape to perform as desired was a remote possibility, especially with the limitation prohibiting cutting into the dam below elevation 1600. In the design of overflow section 4 (figure 9), an attempt was made to force the overfalling jet against the dam face by a deflector plate. The overflow face projected past the downstream face of the dam on which a vent slot was provided for aeration under the jet. The gates were suspended directly over the crest, thus decreasing their height. The passageway between the overflow face and the deflector wall was proportioned to flow full at the maximum discharge.

The spillway was operated with and without aeration beneath the jet. The flow conditions were improved, but there was a decided pulsation in flow when air was admitted beneath the nappe. A less noticeable fluctuation occurred when the air supply was discontinued. In neither case, however, could pulsation of flow be tolerated. A second disadvantage of this design was the abrupt angle at which the jet impinged against the dam face as it emerged from the conduit. On striking the dam, a portion of the jet was deflected away from the face. Uncertainty existed as to the damage that might result at the zone of impact. Photographs of overflow section 4 discharging at 35,000 second-feet are shown on figure 10 A and B. In this case the canyon wall adjacent to the spillway was excavated on a 1-1/4:1 slope measured normal to the line of centers of the dam.

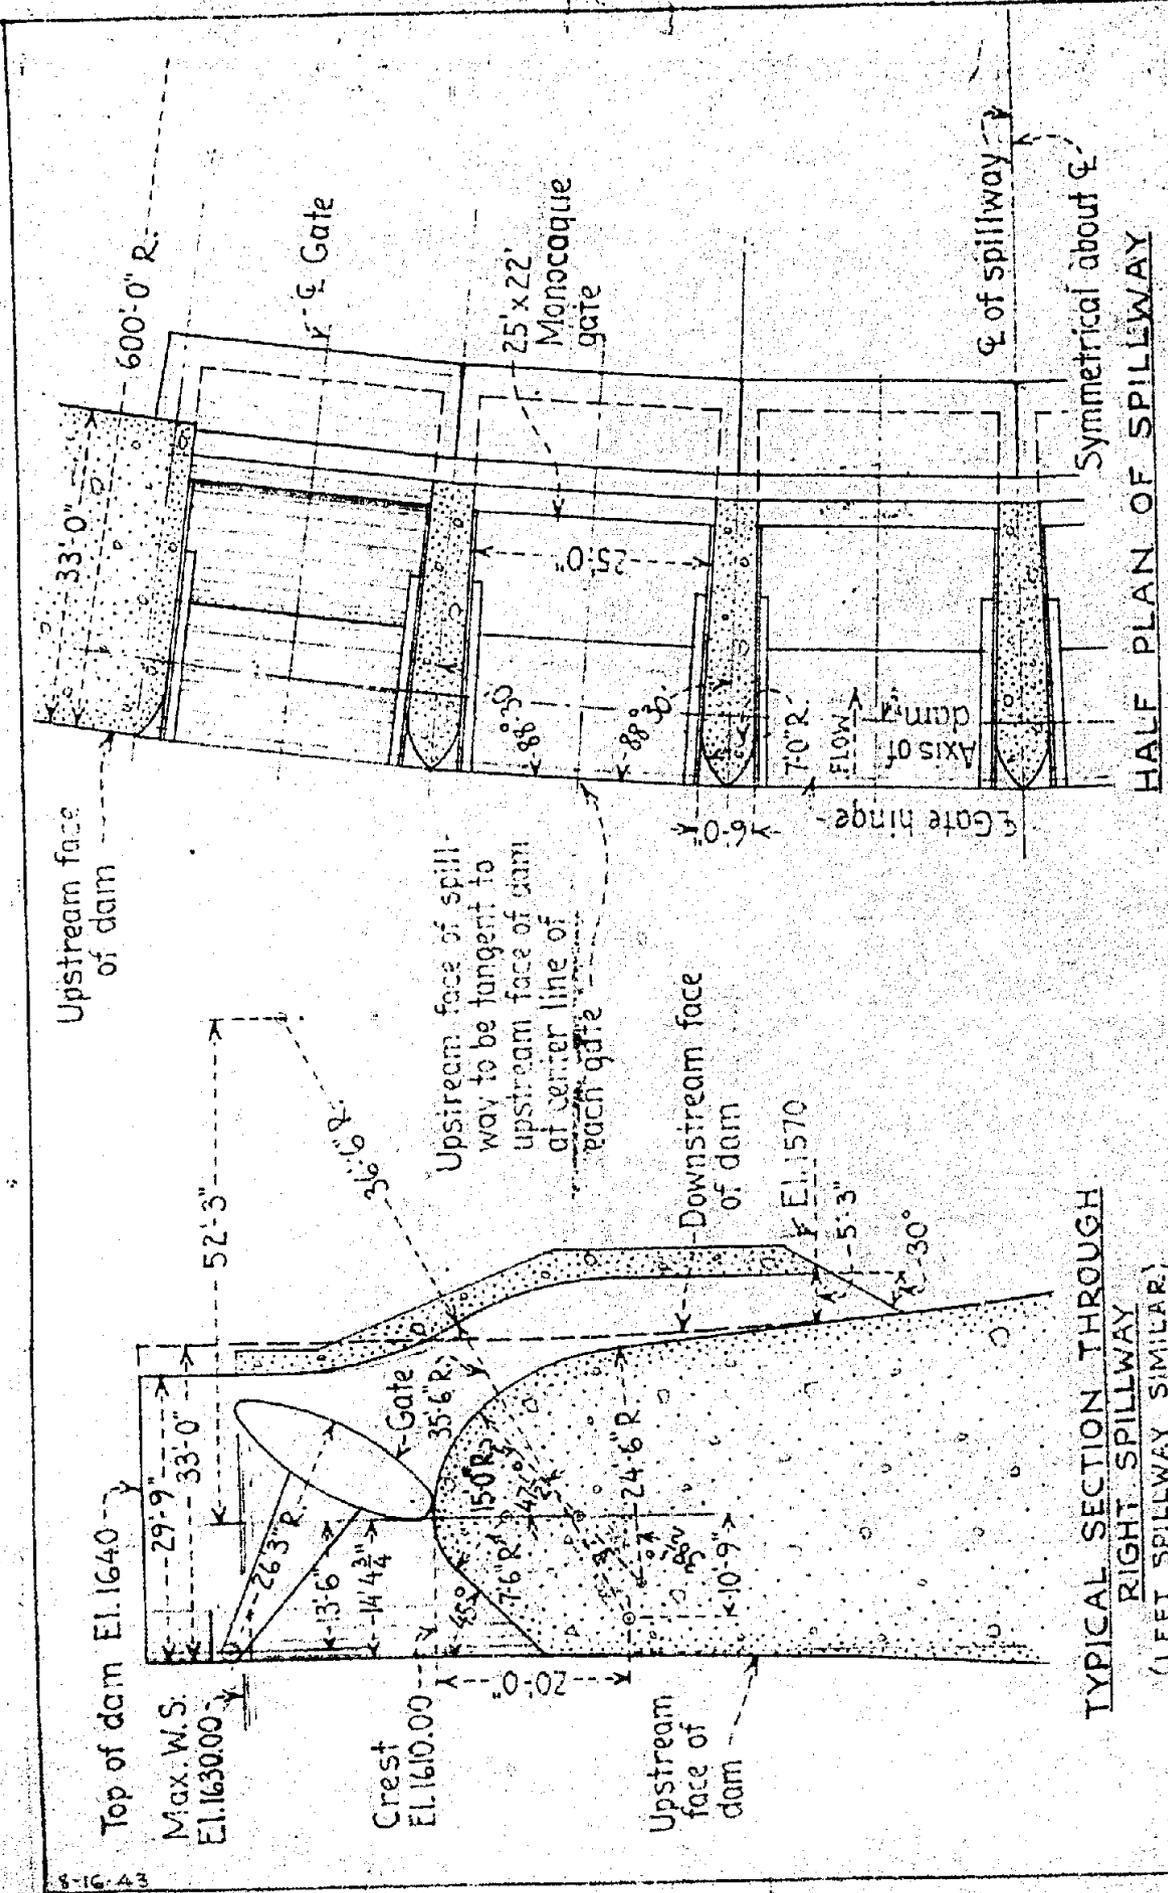
TYPICAL SECTION THROUGH RIGHT SPILLWAY
(LEFT SPILLWAY SIMILAR.)

ROSS DAM SPILLWAY OVERFLOW SECTION 5

9. Overflow section 5. Overflow section 5 (figure 11) was the same as overflow section 3 except for the addition of a deflector hood. The spillway consisted of six gates 25 feet in width and was designed for a maximum discharge of 35,000 second-feet with the reservoir at approximately elevation 1630. The resulting performance of this spillway was a decided improvement over the previous one. Flow conditions were excellent for the higher discharges, decreasing in desirability as the discharge was reduced. A dribbling action occurred from the end of the deflector hood at very low flows. The main jet of water maintained contact with the face of the overflow section and dam; thus the dribbling was primarily caused by fins adjacent to the piers. Photographs of overflow section 5 operating at a maximum discharge of 35,000 second-feet are shown on figure 10 A and C.

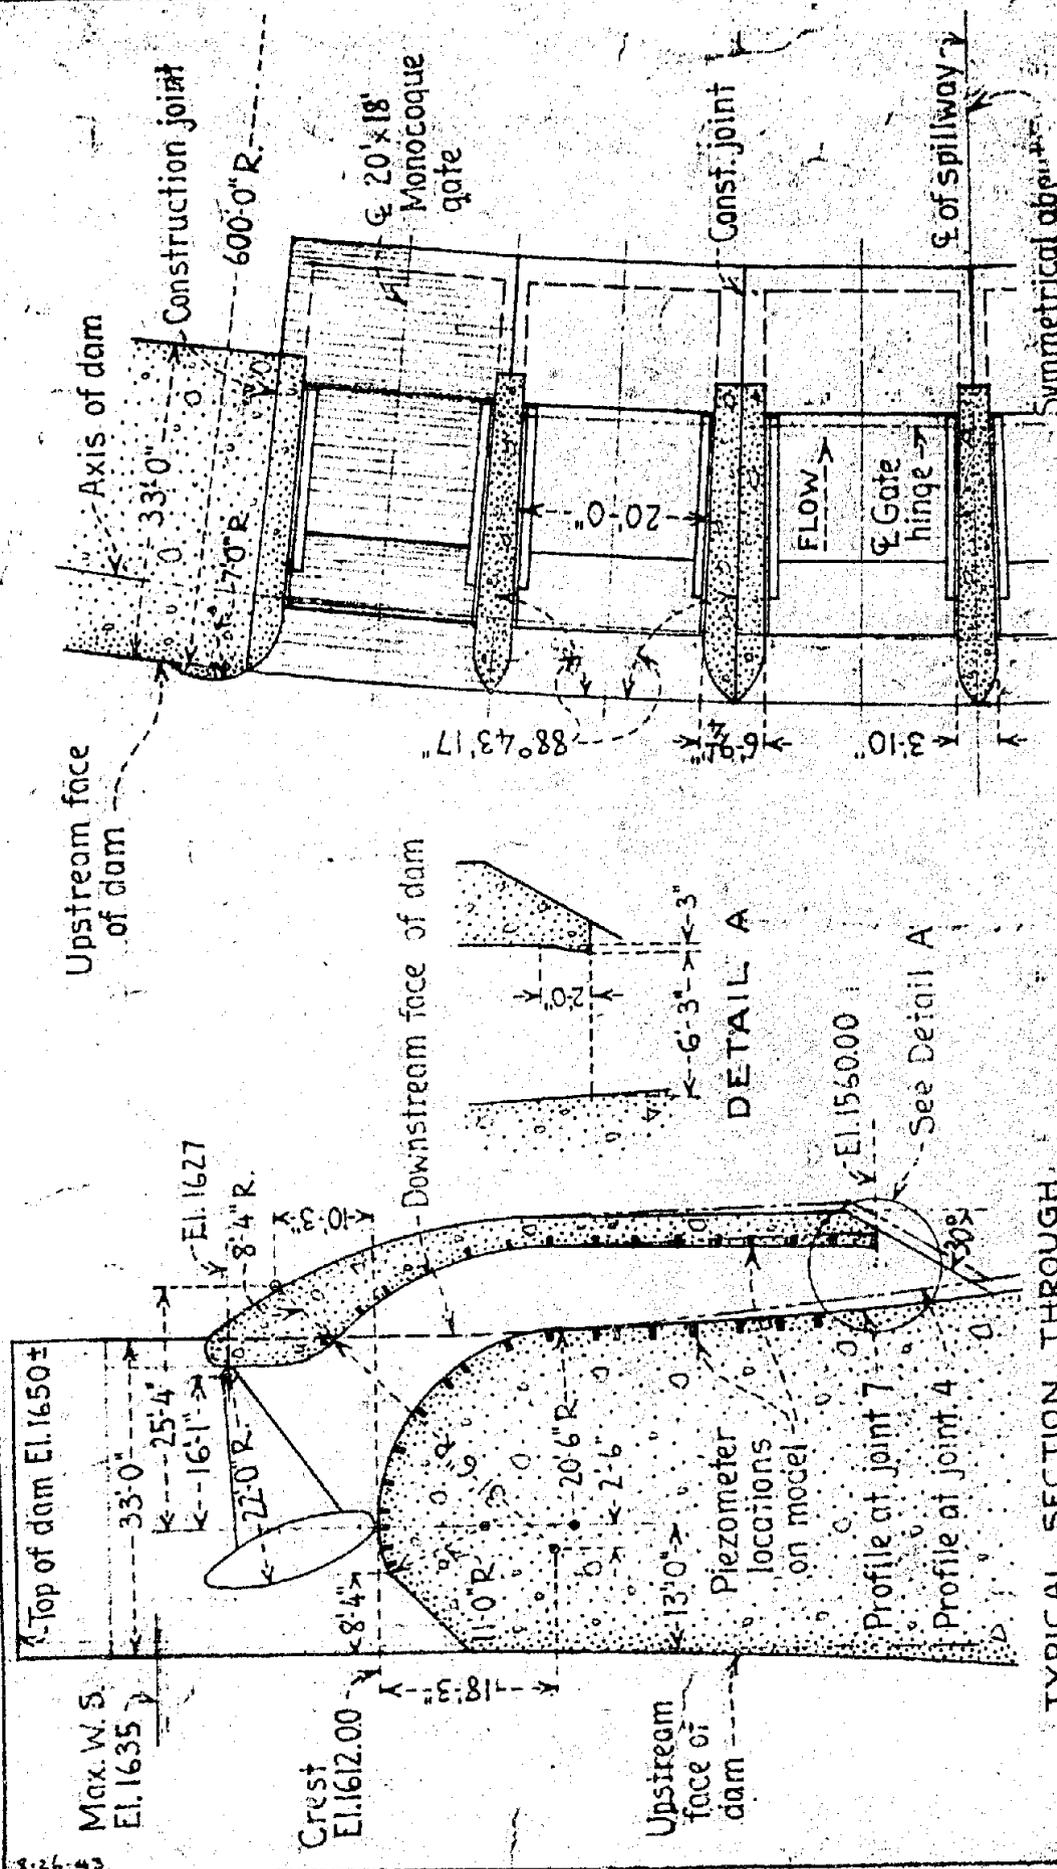
TYPICAL SECTION THROUGH
RIGHT SPILLWAY
(LEFT SPILLWAY SIMILAR)

HALF PLAN OF SPILLWAY

ROSS DAM SPILLWAY
OVERFLOW SECTION 7

11. Overflow section 7. Overflow section 7, shown on figure 14, was the same as section 6 except for the change of position and the dimensions of the deflector hood. The closed portion flowed full at a discharge of approximately 100,000 second-feet. A small lip was added to the lower end of the deflector hood to deflect the smaller discharges toward the dam face, thus reducing the dribbling previously experienced. Pressures on the overflow face and the deflector hood are plotted for overflow section 7 for free flow and also for gate operation on figure 15. The maximum negative pressure in this case is shown as 18 feet of water, which occurred at piezometer 9 for a discharge of 95,000 second-feet. The negative pressure decreased as the conduit flowed full at 100,000 second-feet. The maximum positive pressure on the deflector wall was reduced from 20 to 15 feet, but the decrease in discharge in the latter case was principally responsible for this reduction. Photographs of the 1:25 sectional spillway operating at 10,000, 40,000, 75,000, and 100,000 second-feet are shown on figure 16. The discharges as stated are based on twelve gates discharging at the same rate as the two shown. The dribbling can be seen in figure 16A with a discharge of 10,000 second-feet. As the discharge was increased, flow conditions continually improved until the ultimate desired flow condition was reached at 100,000 second-feet, at which point the conduit flowed full. The pressures on the face of the dam were positive throughout the entire discharge range.

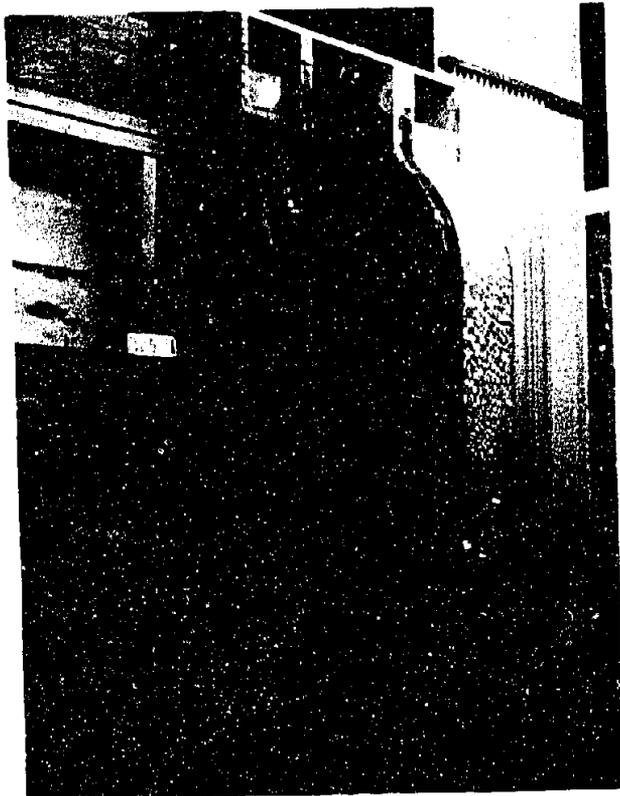
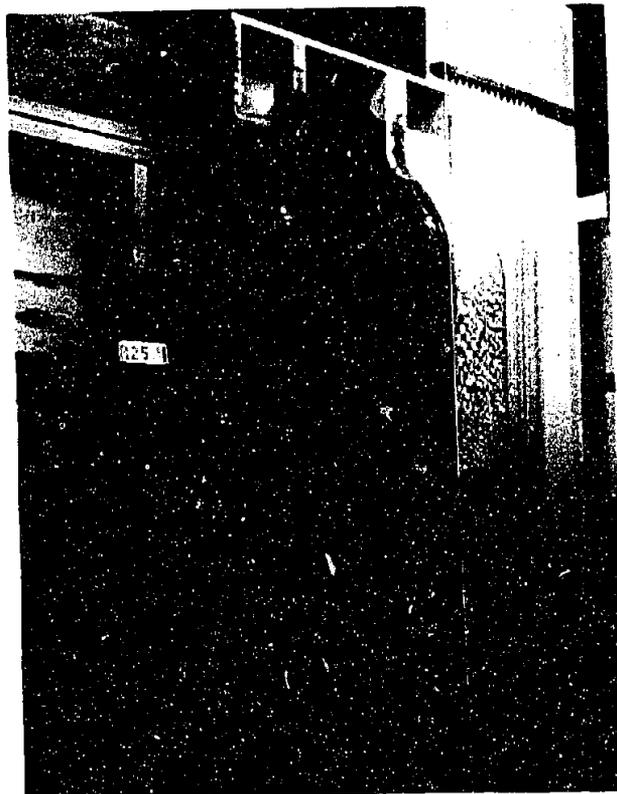
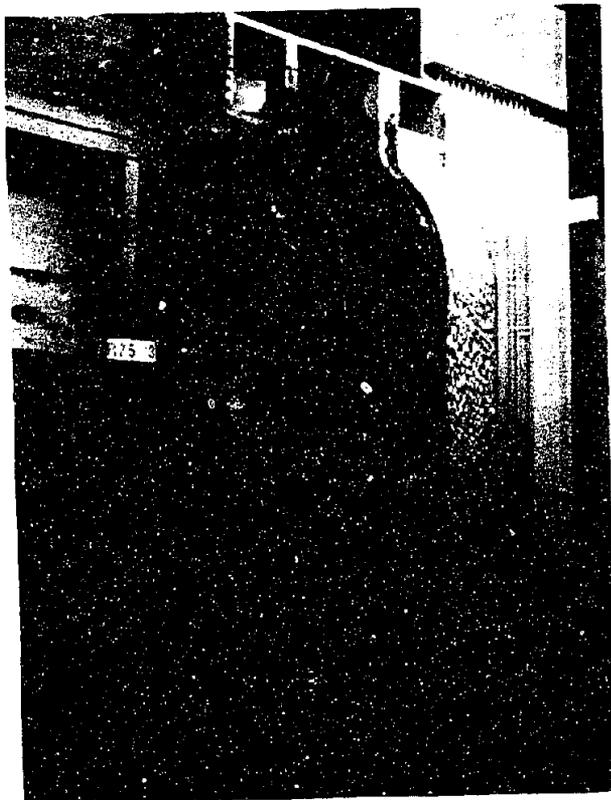
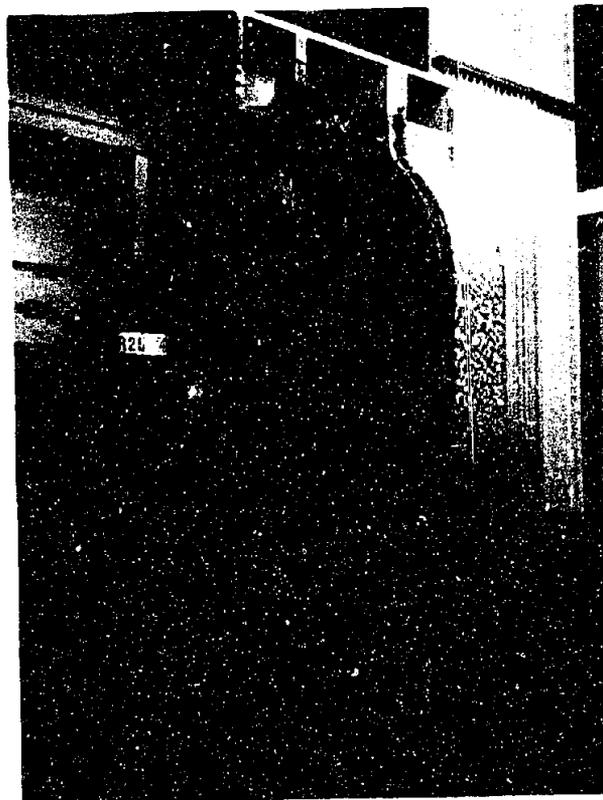
A- Discharge 10,000 Second-Feet

B- Discharge 40,000 Second-Feet

C- Discharge 75,000 Second-Feet

D- Discharge 100,000 Second-Feet

SECTIONAL MODEL ON 1:25 SCALE EMPLOYING TWO GATES
