* HYDRAULIC LABORATORY REPORT NO. 136
*
* - - -

* HYDRAULIC MODEL STUDIES FOR THE DESIGN
* OF
* ROSS DAM SPILLWAYS
* CITY OF SEATTLE, WASHINGTON
*
* - - -

* J. N. BRADLEY and C. J. HOFFMAN
*
* - - -

* Denver, Colorado,
* Oct. 12, 1943
*
* *****

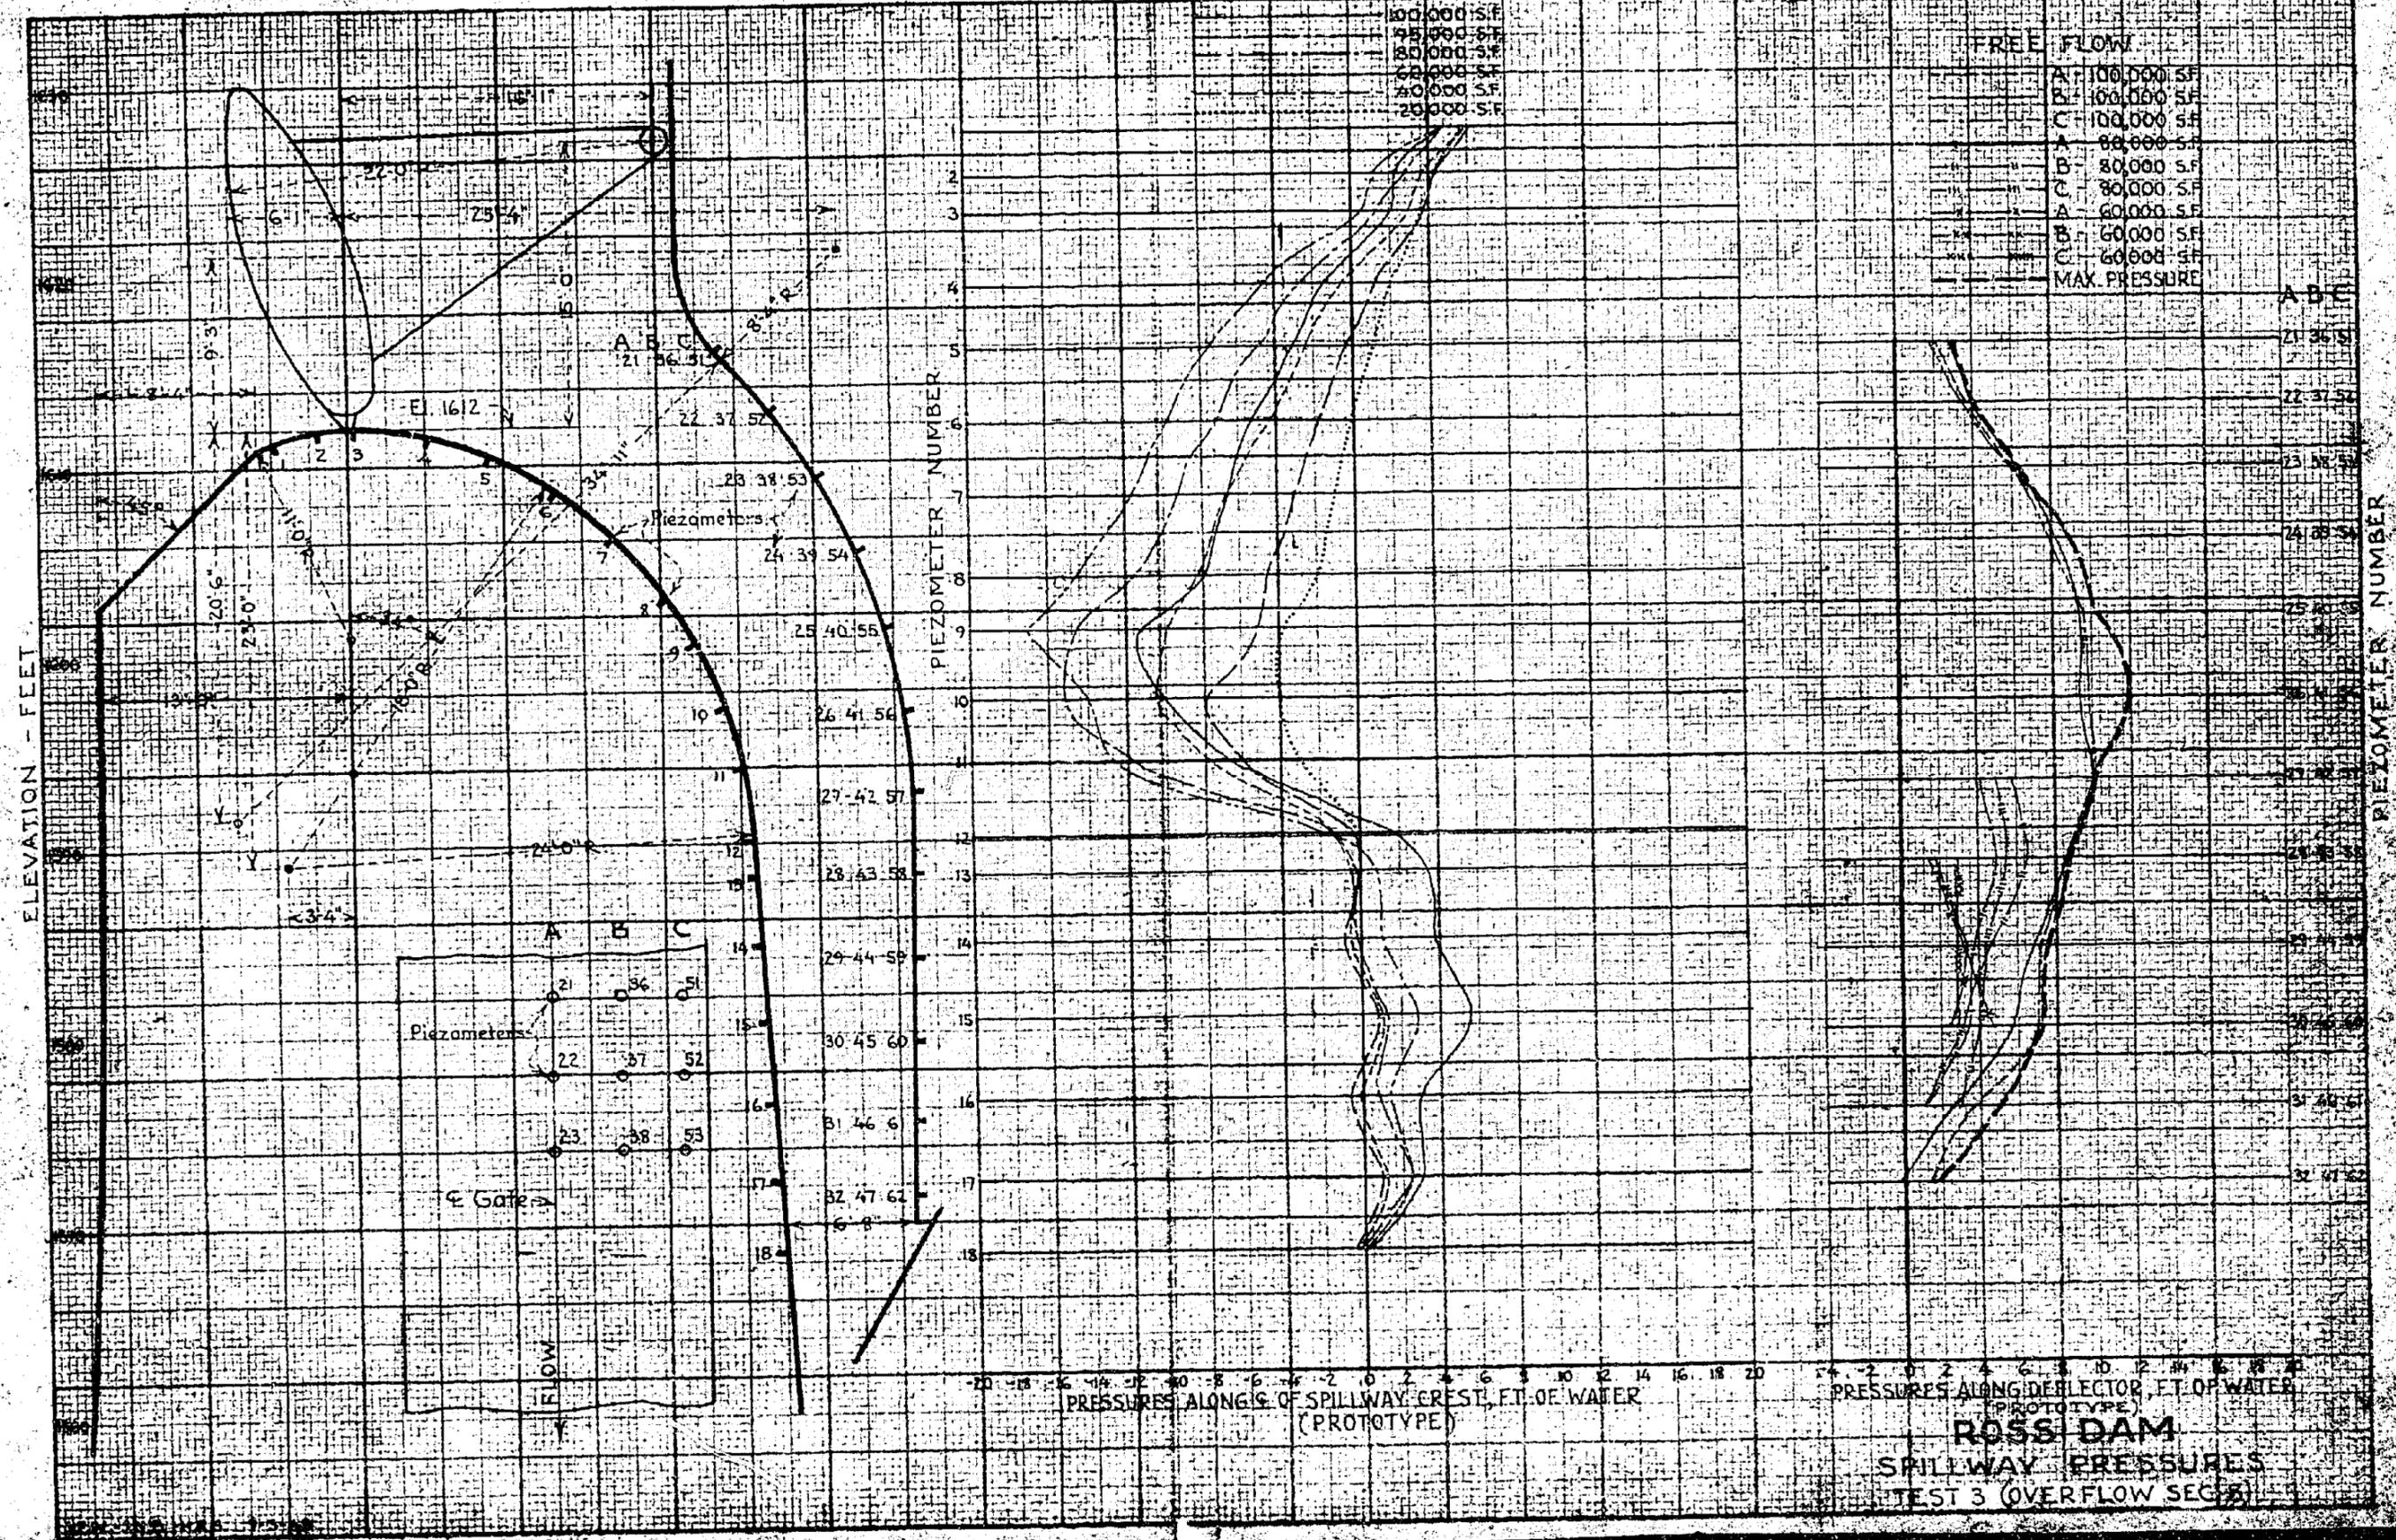
ROSS DAM
 SPILLWAY PRESSURES
 TEST 3 (OVERFLOW SECTION)

The 1,25 model consisted of one full gate with a half gate on each side and a short section of dam below them. Model results converted to prototype pressures are shown on figure 13 for overflow section 6 for free crest operation as well as for four gate positions. A maximum negative pressure on the overflow face of 20 feet of water is shown at piezometer 9 with a free discharge of 100,000 second-feet. The discharges as referred to on this model represent the corresponding flow for twelve gates, or the total for both spillways. As the discharge was increased above this value, a back pressure in the conduit produced by additional friction relieved the subatmospheric conditions to some extent. Figure 13 shows that the pressures were more severe for 100,000 second-feet than for discharges at partial gate openings with reservoir at elevation 1630, which was contrary to expectations. It was desired to limit the maximum negative pressure to one-half an atmosphere, or about 15 feet of water.

The maximum positive pressure on the deflector hood, on the other hand, is shown as 20 feet of water or 8.7 pounds per square inch for a flow of 125,000 second-feet. The heavy dash line on figure 13 represents the maximum positive pressure recorded on the hood for all conditions of operation. Discharge at partial gate openings defines this line in the vicinity of piezometers 30, 45, and 60.

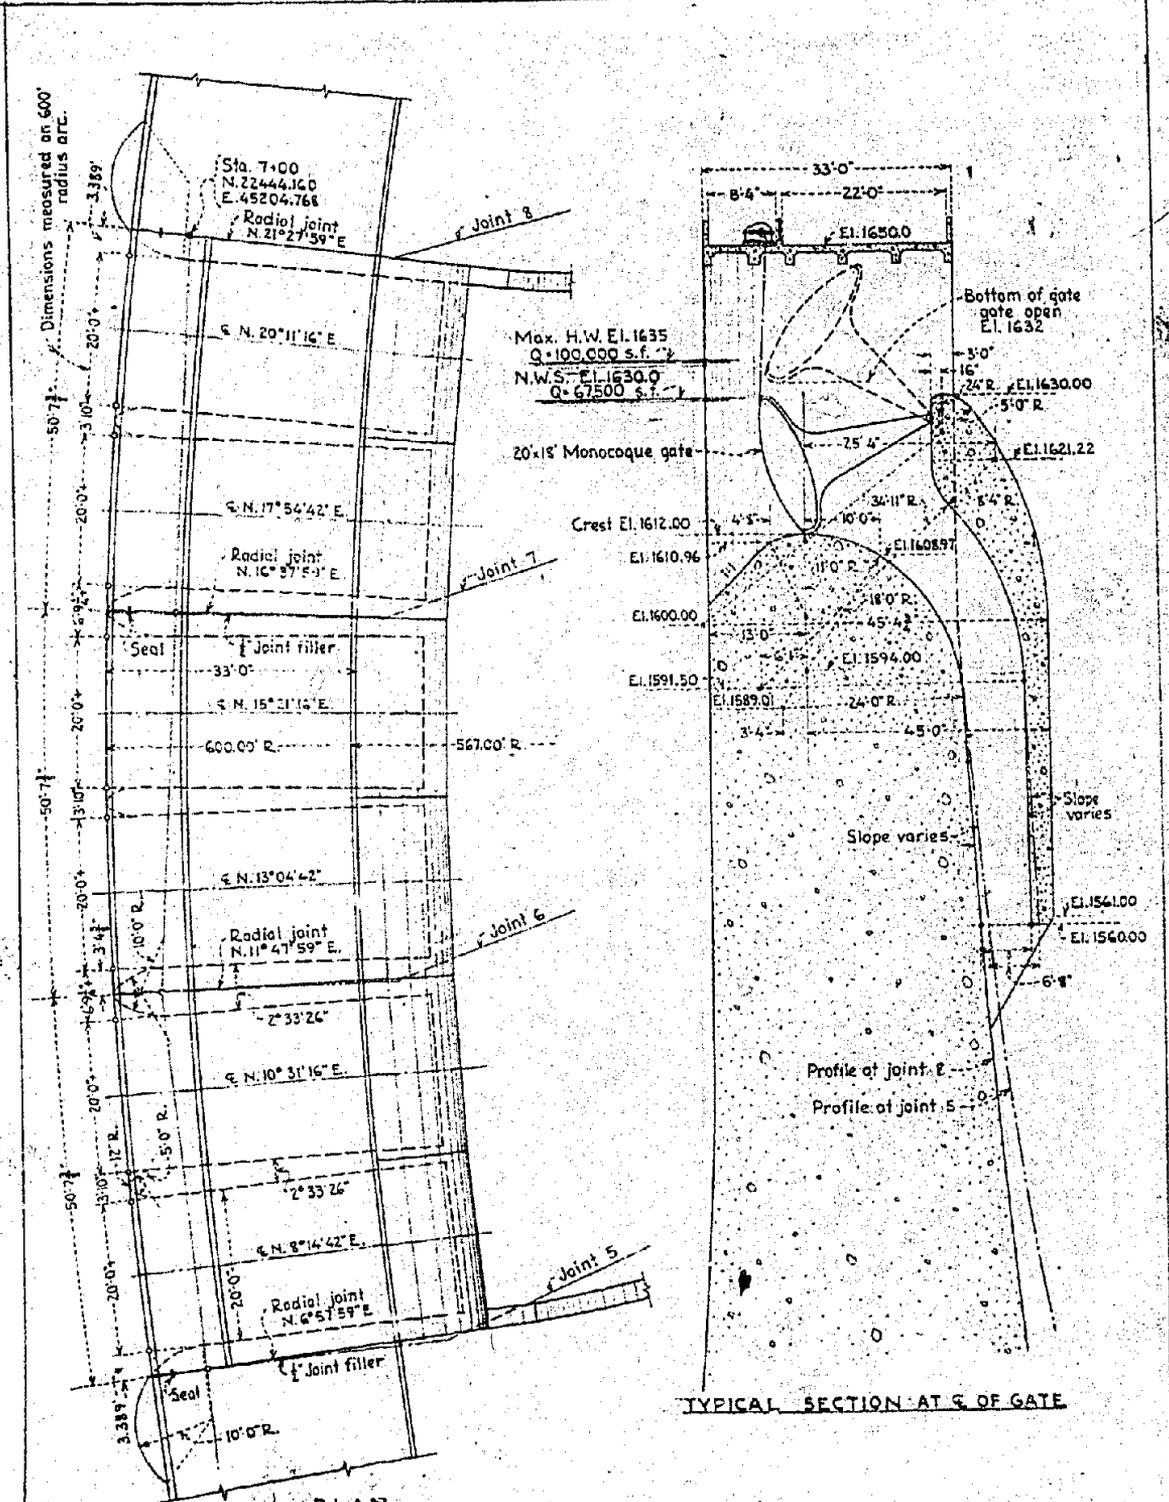
Dimensions measured on 500' radius arc.

PLAN
 RIGHT SPILLWAY AS SHOWN
 LEFT SPILLWAY OPPOSITE HAND

TYPICAL SECTION AT S. OF GATE

**ROSS DAM SPILLWAY
 OVERFLOW SECTION 8 - AS RECOMMENDED**

A study was made on the overflow section to determine the most economical elevation at which to terminate the downstream extremity of the deflector hood. Figure 18 shows a portion of the hood ending at elevation 1570 with the remainder at elevation 1560. Figures 18 A and B show flows of 40,000 and 100,000 second-feet, respectively. The photographs do not depict clearly the difference in flow encountered for the two hood elevations. The jet of water leaving the longer hood was forced closer to the dam face and therefore exhibited a more desirable appearance from a hydraulic standpoint than the shorter hood. Figures 18 C and D illustrate the point more clearly. The deflector hood extremities are at elevations 1570, 1580, and 1560, viewed from left to right. The jet of water overtopped the piers with the hood ending at elevation 1580. The same condition occurred to a lesser extent for the hood ending at elevation 1570. Figure 19 shows the variation of taper with the length of hood. From a hydraulic viewpoint the most economical point to end the hood is at elevation 1560. Although the tests on overflow section 8, figure 17, were made for a hood ending at elevation 1570, it is recommended that the final design be made to conform with the section shown on figure 19. The shapes are exactly

13. Final spillway design for dam to el. 1650. Upon conclusion of the above tests, overflow section 8 (figure 19) was installed at both ends of the arch on the 1:60 model and studies were commenced to determine the grades and wall positions for the channels downstream. The spillways were located as near the dam abutments as possible. The right spillway, as originally planned, was between section joints 4 and 7 and the left spillway between joints 20 and 23.

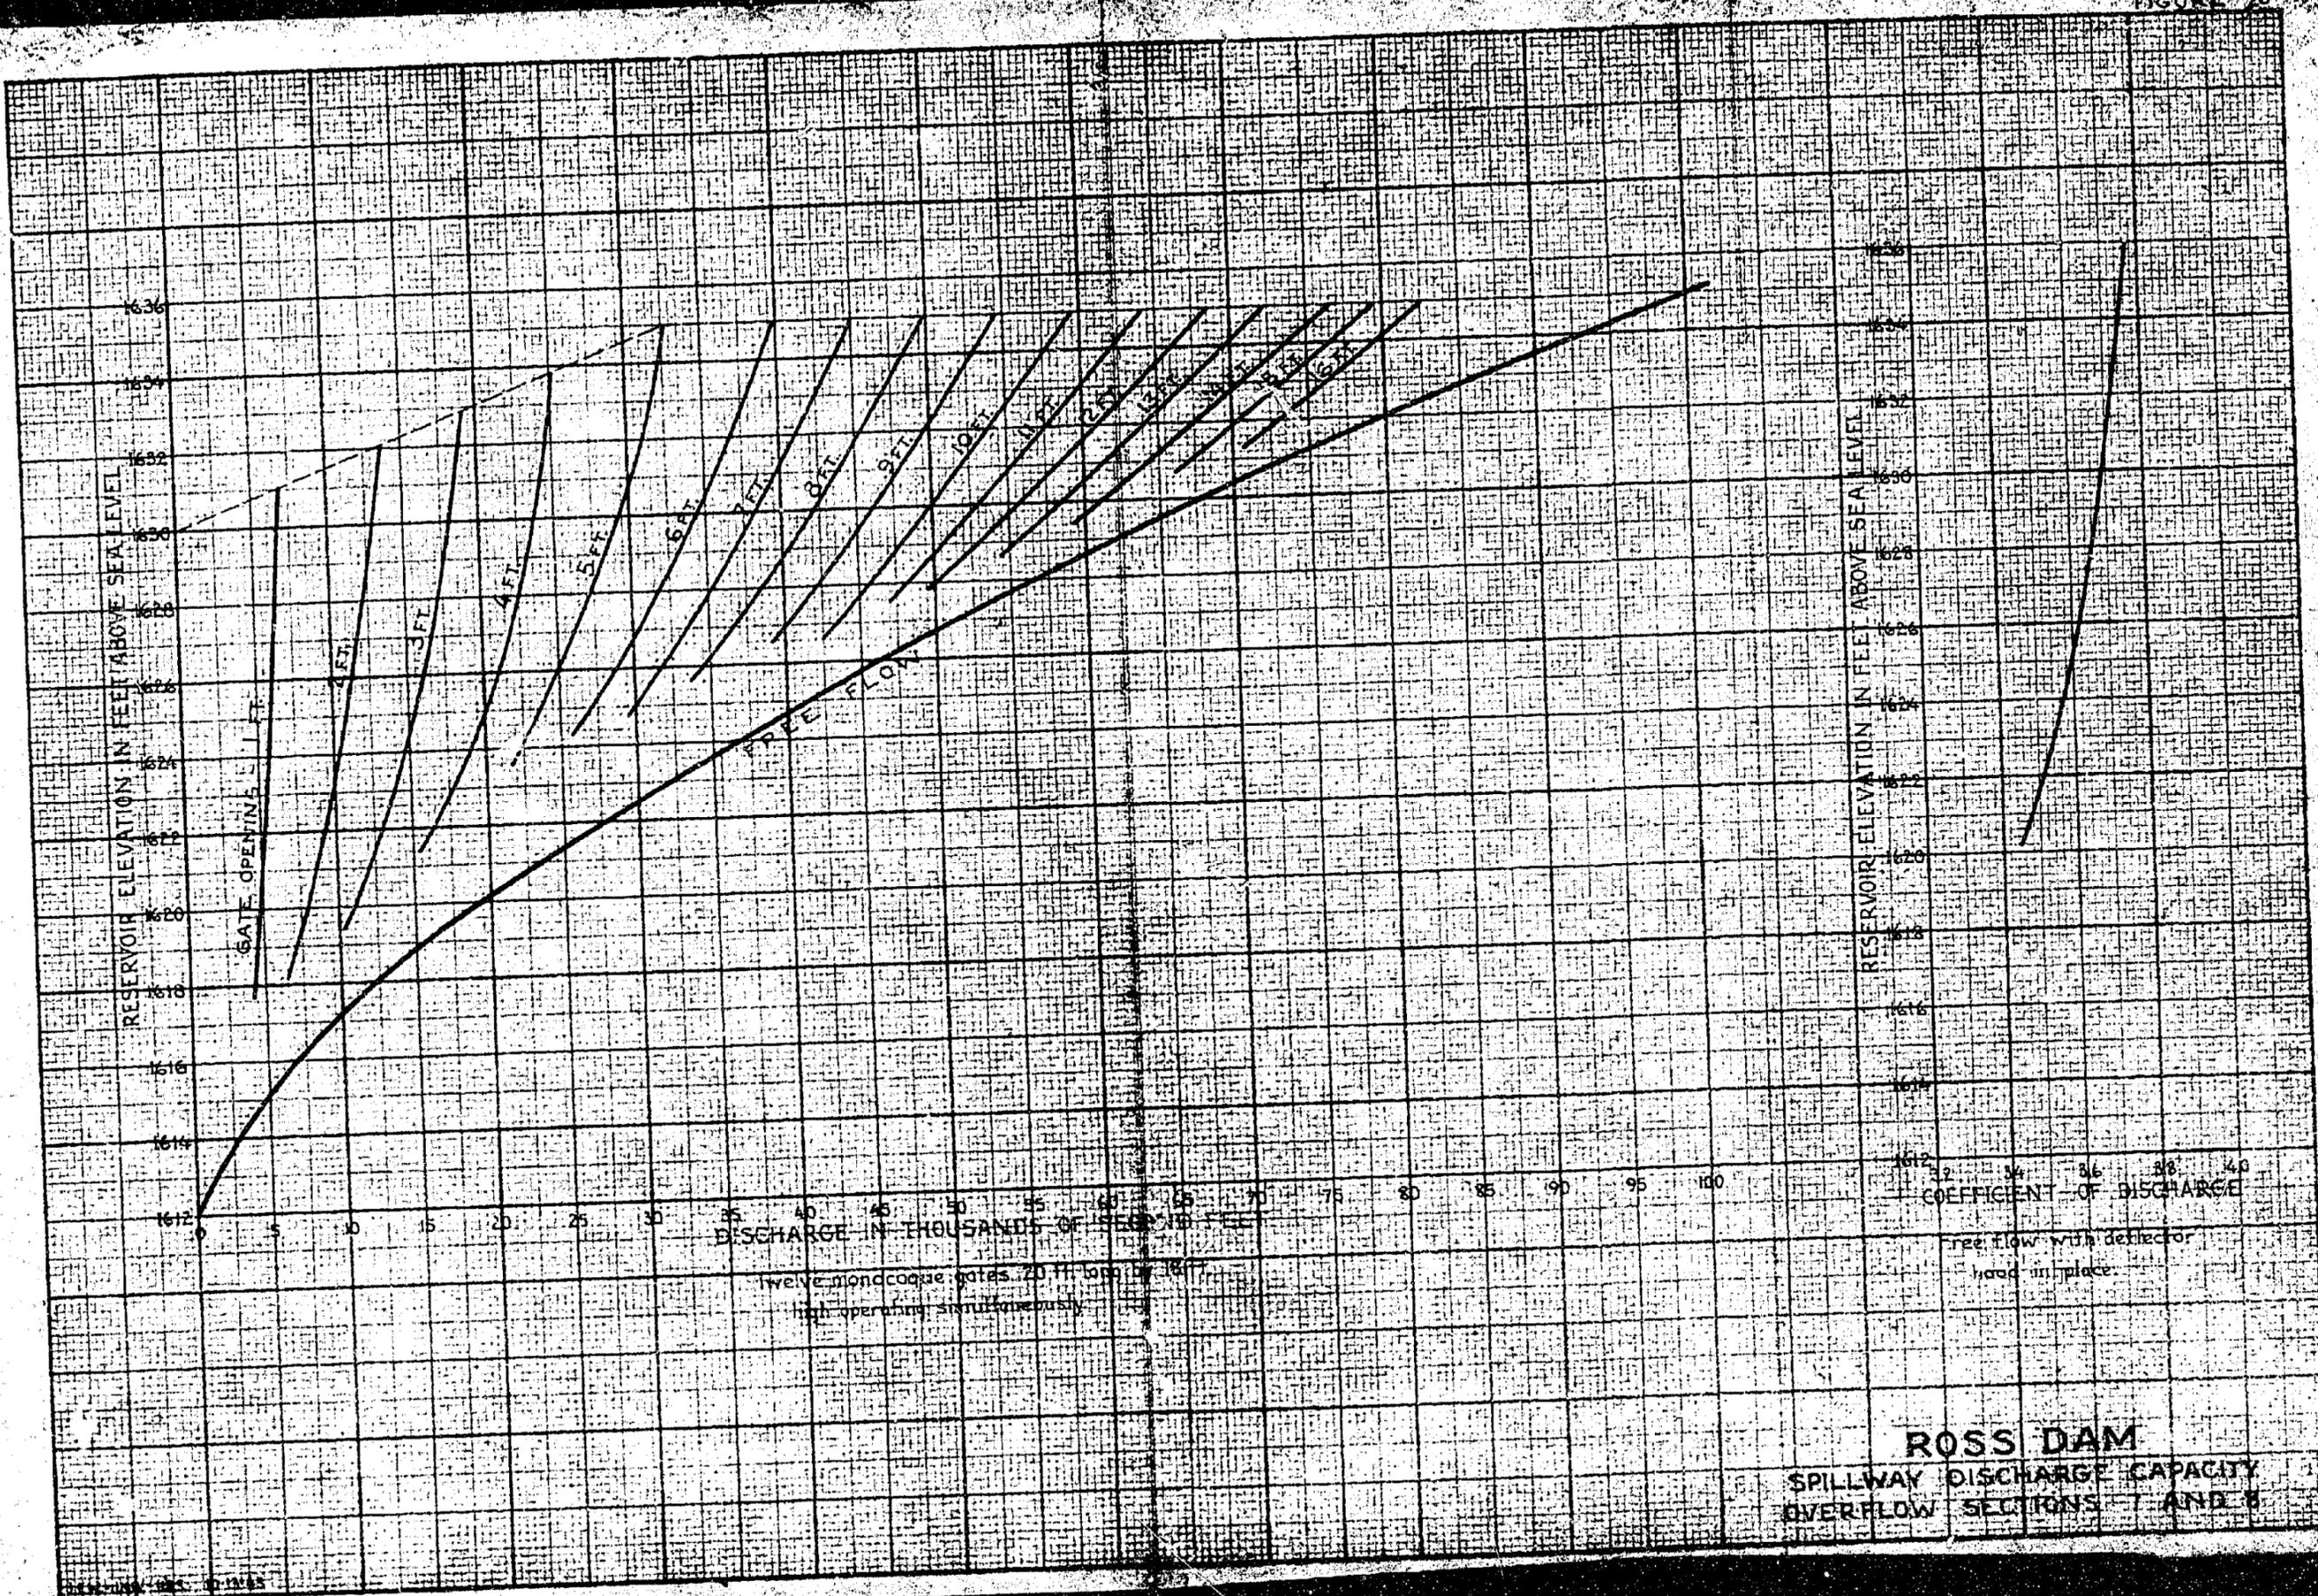
ROSS DAM
 SPILLWAY DISCHARGE CAPACITY
 OVERFLOW SECTIONS 7 AND 8

Head-discharge curves, obtained by calibrating one gate on the 1:25 model and multiplying the results by twelve, are shown on figure 20 for free flow and also for gate operation. The curves apply to both overflow sections 7 and 8. For free flow a discharge of 70,000 second-feet can be developed with reservoir elevation of 1630.5. To obtain 100,000 second-feet through the twelve gates requires a reservoir elevation of 1635.0. A head-discharge coefficient curve for free flow is also shown plotted on figure 20.

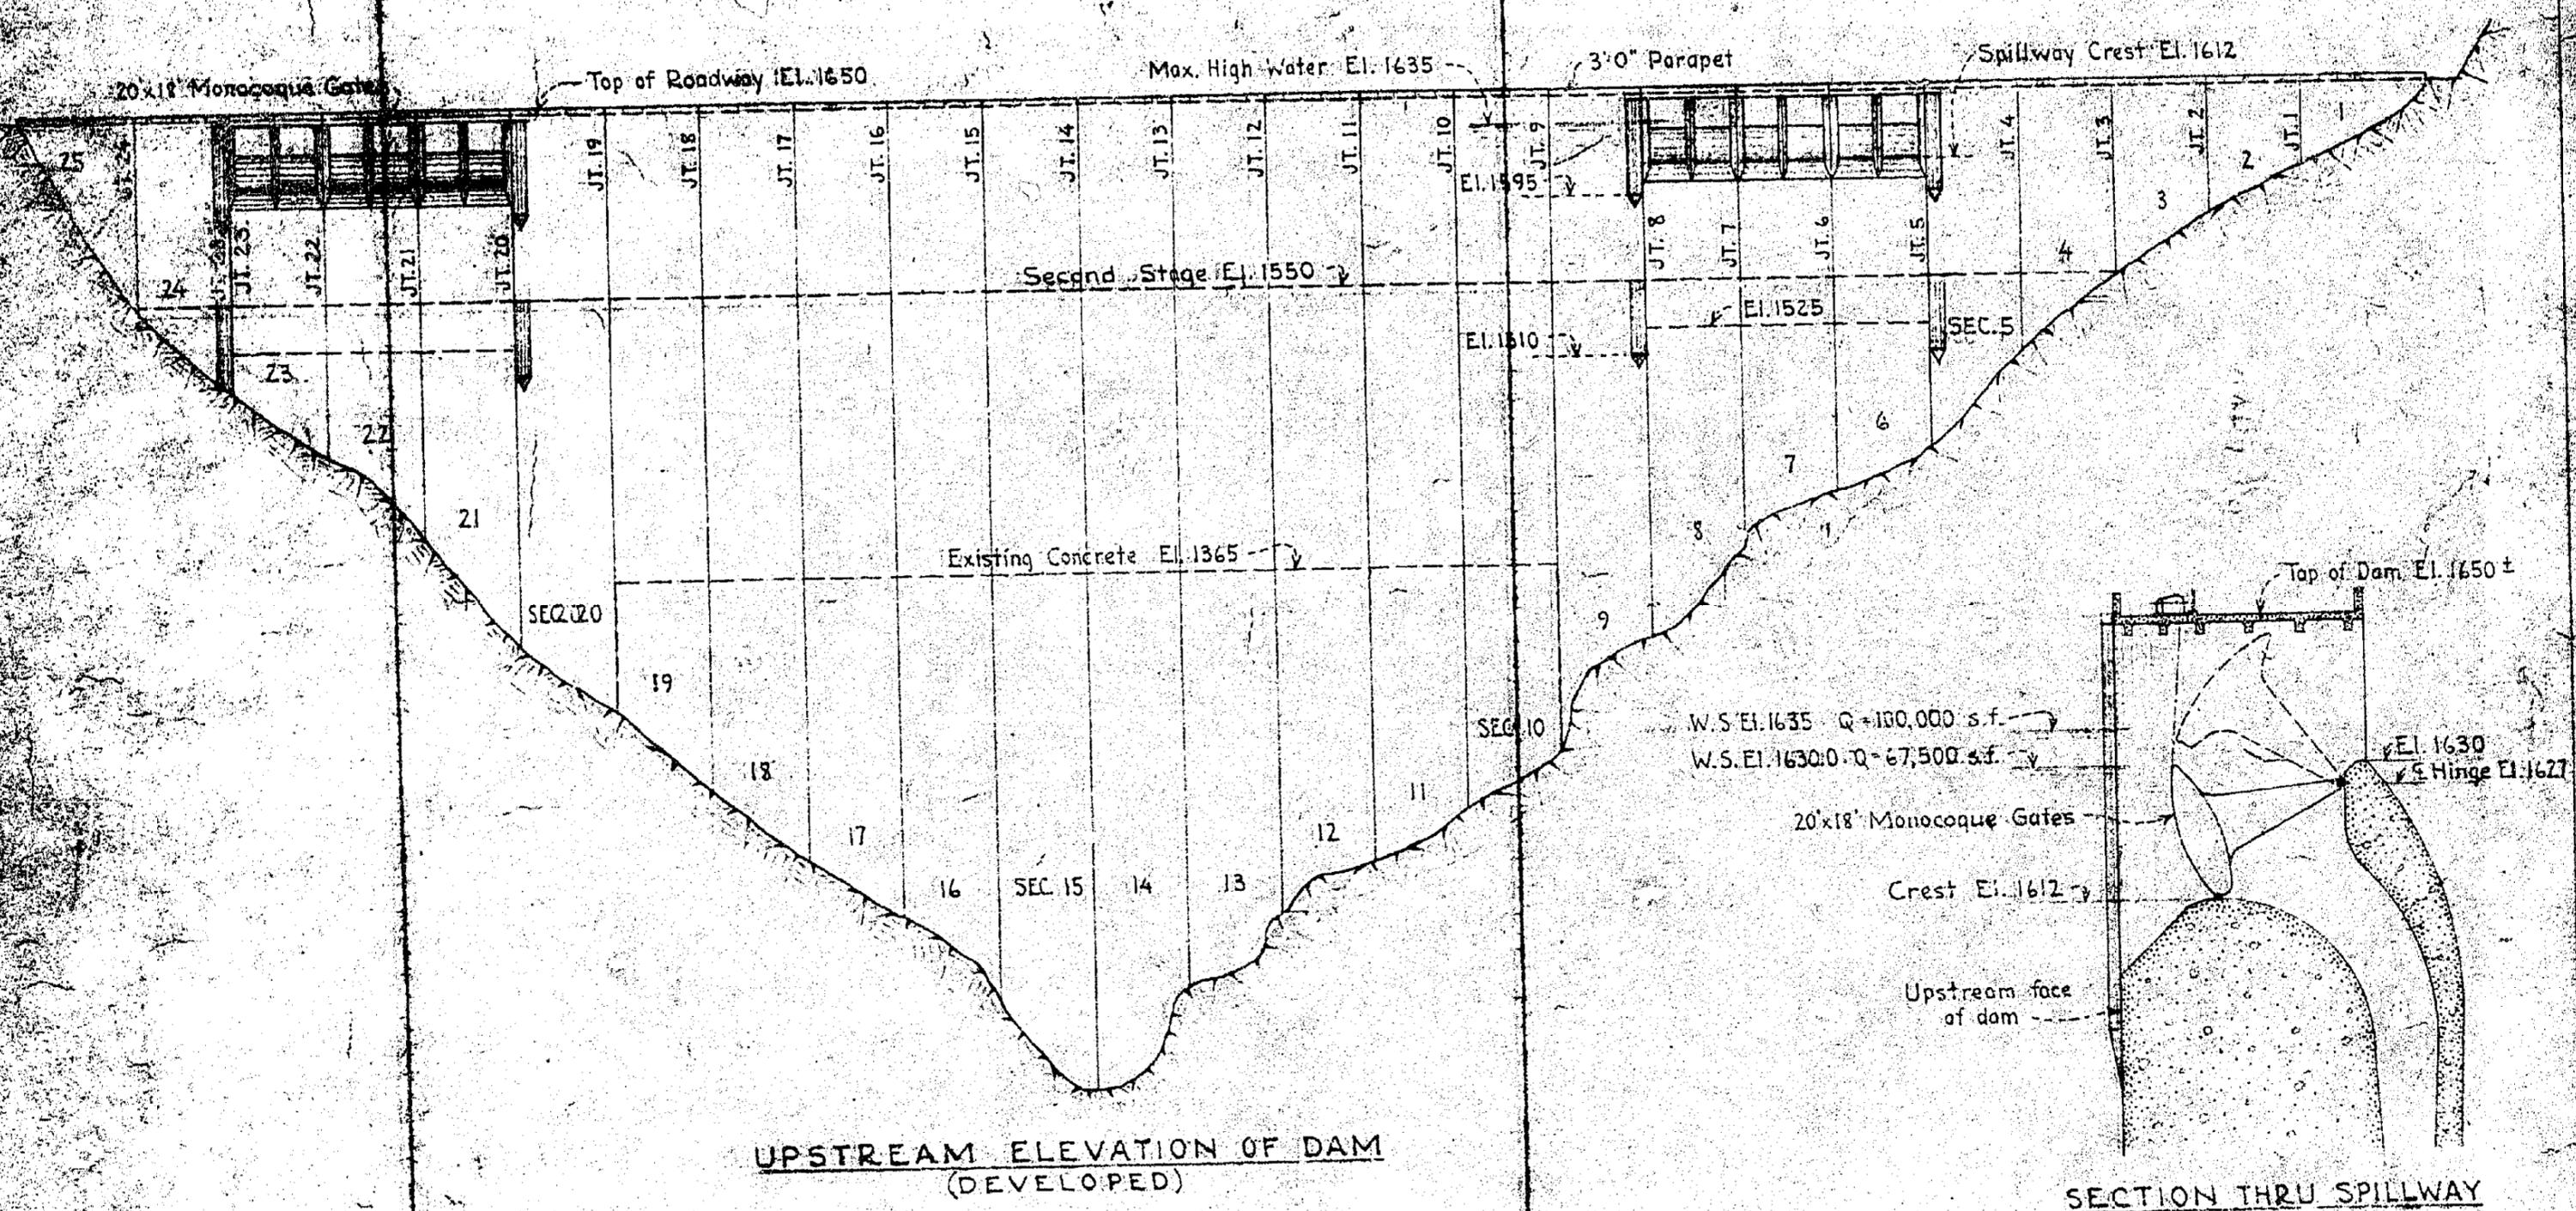
ROSS DAM
SPILLWAY LOCATIONS - EL. 1612

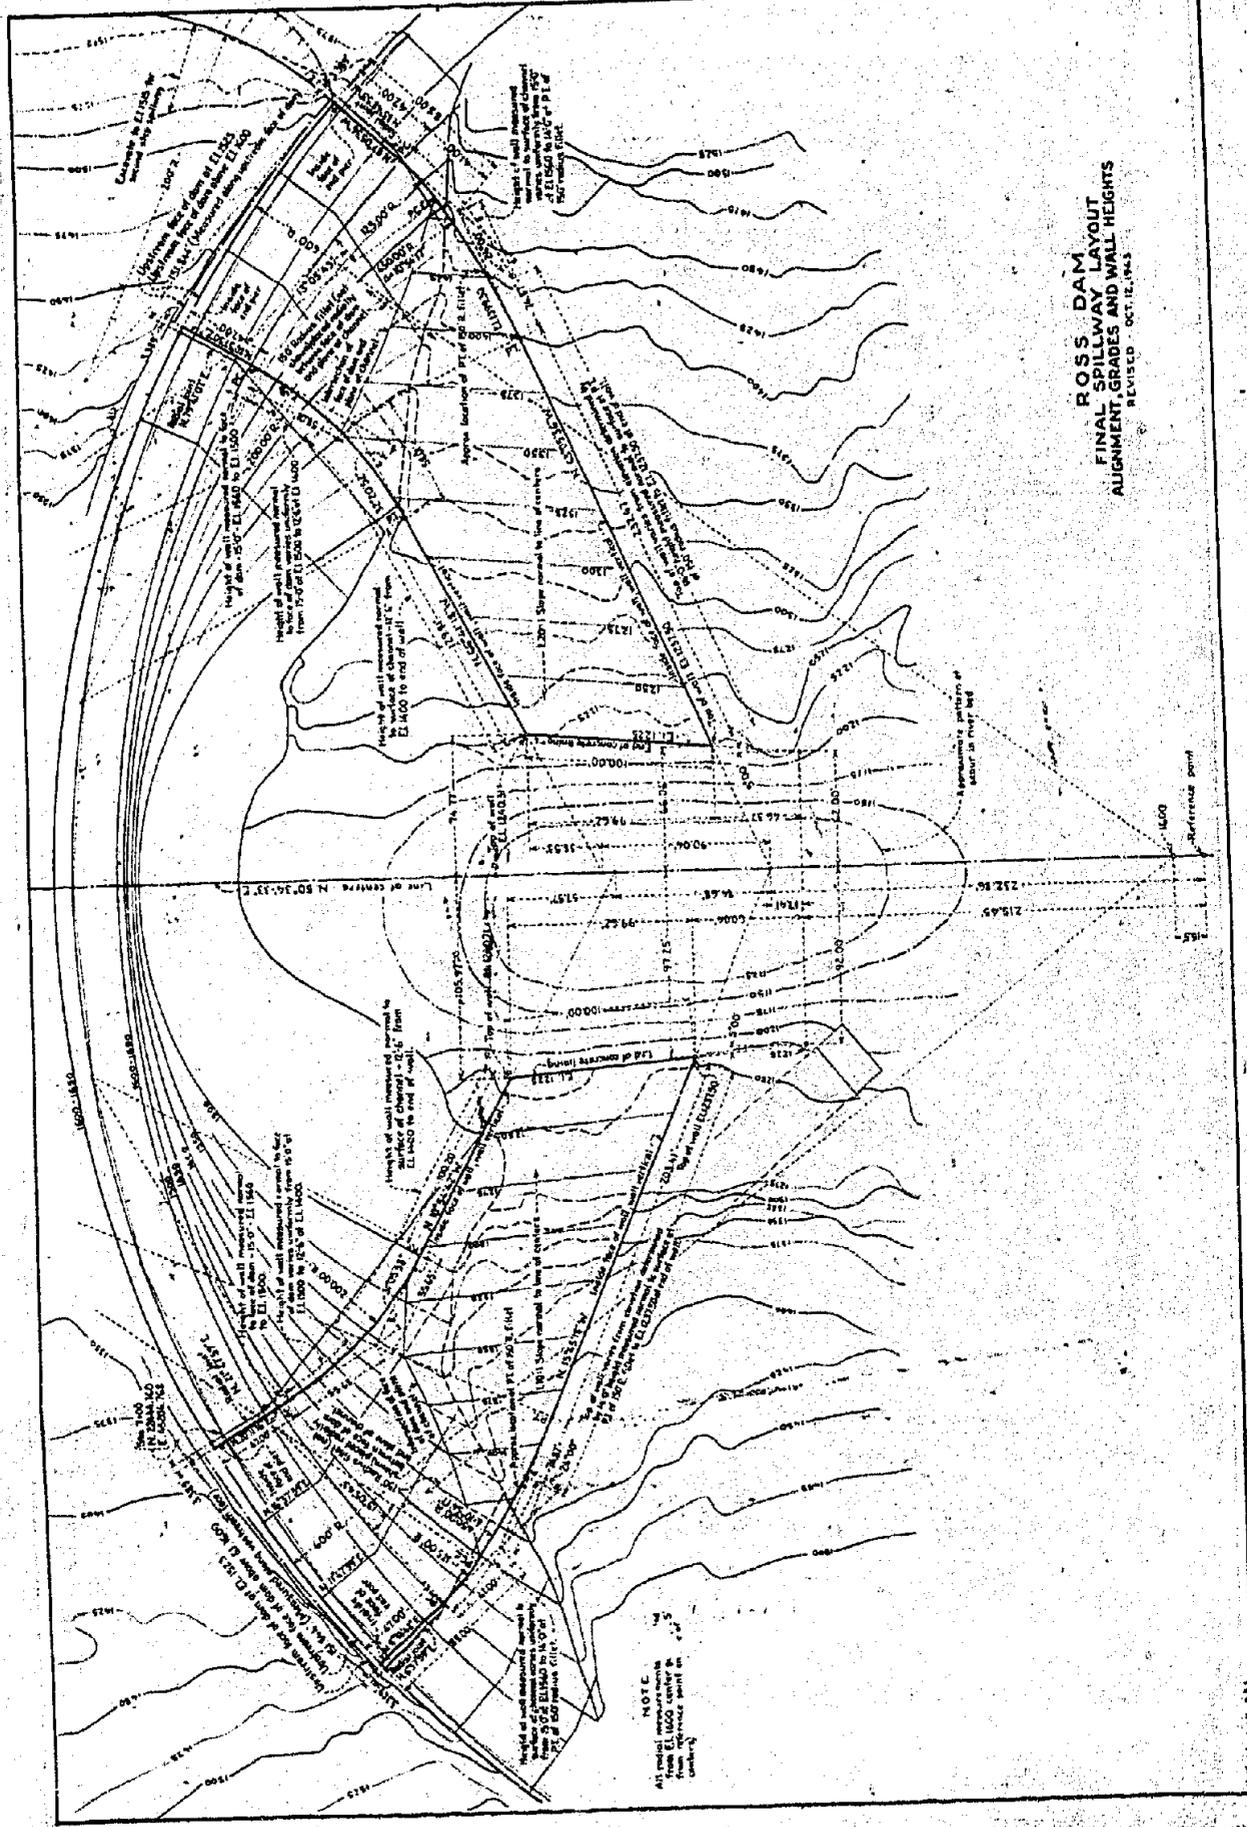
ROSS DAM
 FINAL SPILLWAY LAYOUT
 ALIGNMENT, GRADES AND WALL HEIGHTS
 REVISED - OCT. 12, 1943

With the above in mind, details of the spillway channels for the second step dam can also be obtained from figure 22. The approach depth to the right spillway for the second step construction is adequate since this spillway was shifted toward the center of the dam and no excavation is necessary on this side. To provide a uniform approach to the left spillway a bench was excavated to elevation 1615 on about a 200-foot radius, as shown on figure 22. Photographs of the topography upstream from the spillways are shown for the right and the left sides on figure 33 A and C, respectively. Figure 33 B and D depicts the flow approaching the right and the left spillways for a discharge of 37,500 second-feet per spillway.

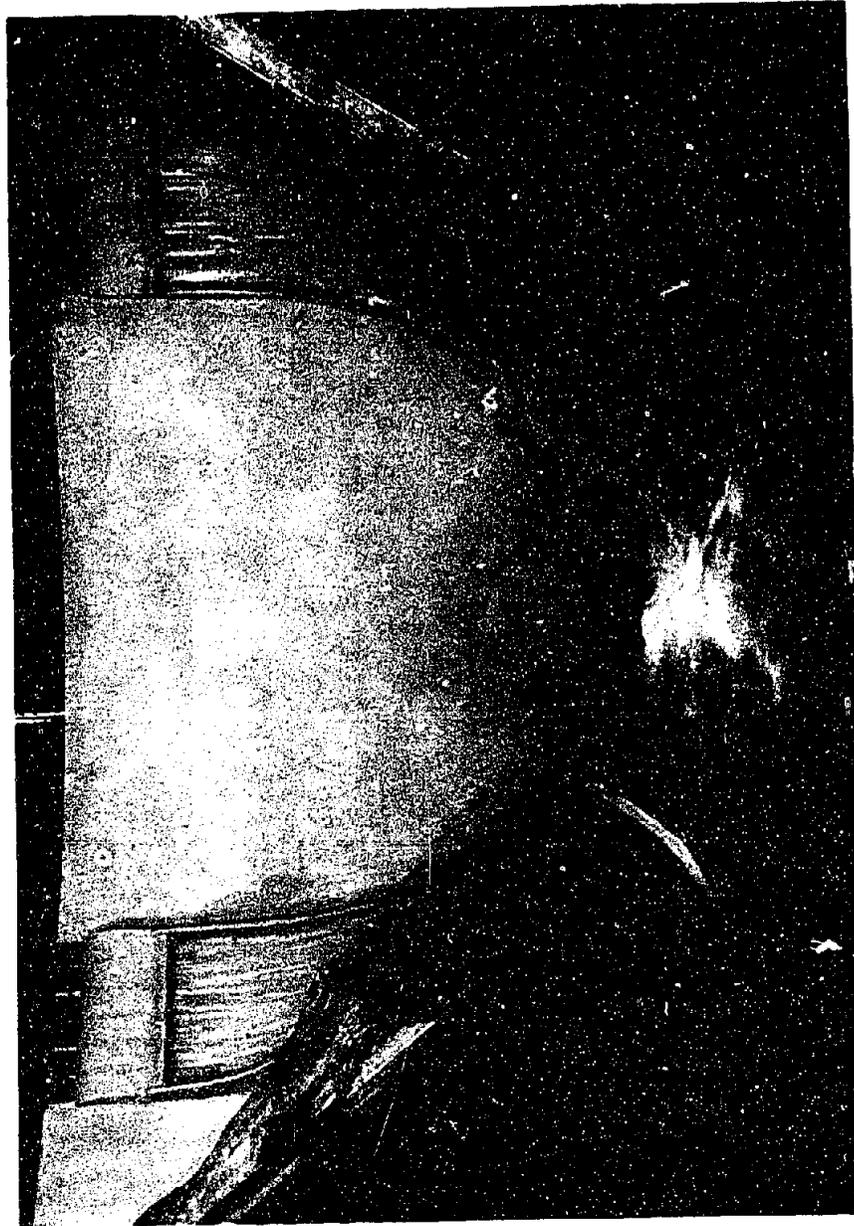
FIGURE 23

FINAL SPILLWAY DESIGN - DISCHARGE 75,000 SECOND-FOOT

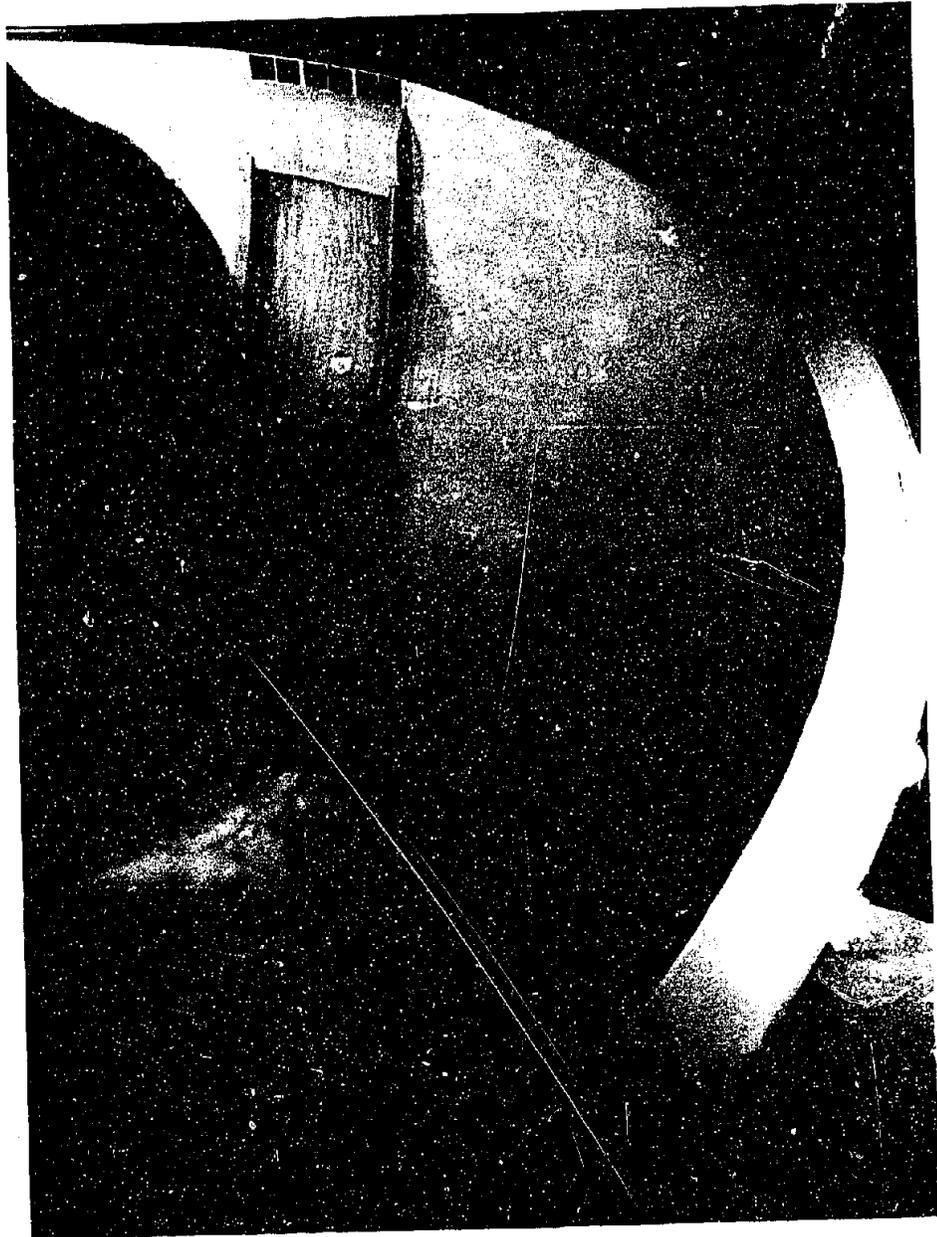
FIGURE 24

FINAL SPILLWAY DESIGN - TOTAL DISCHARGE 75,000 SECOND-FEET

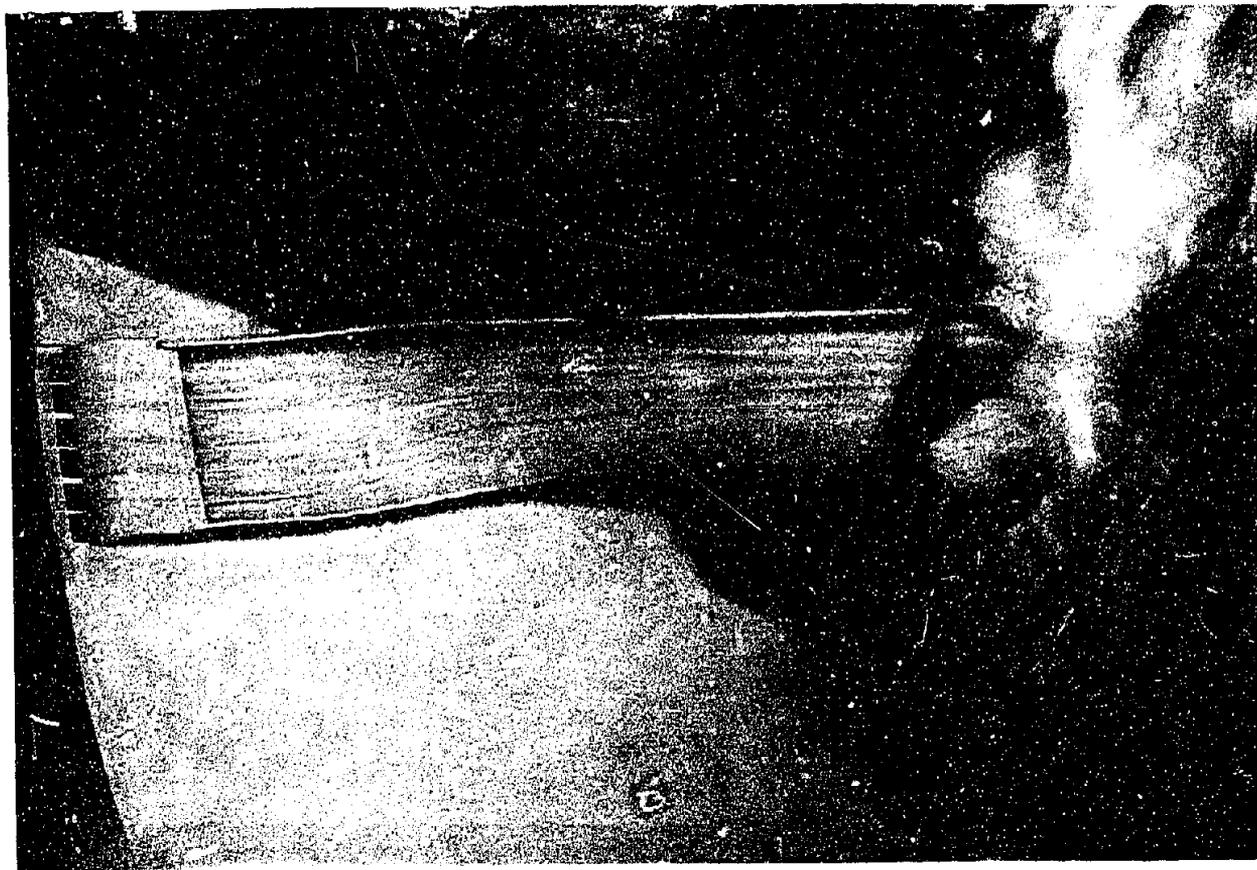
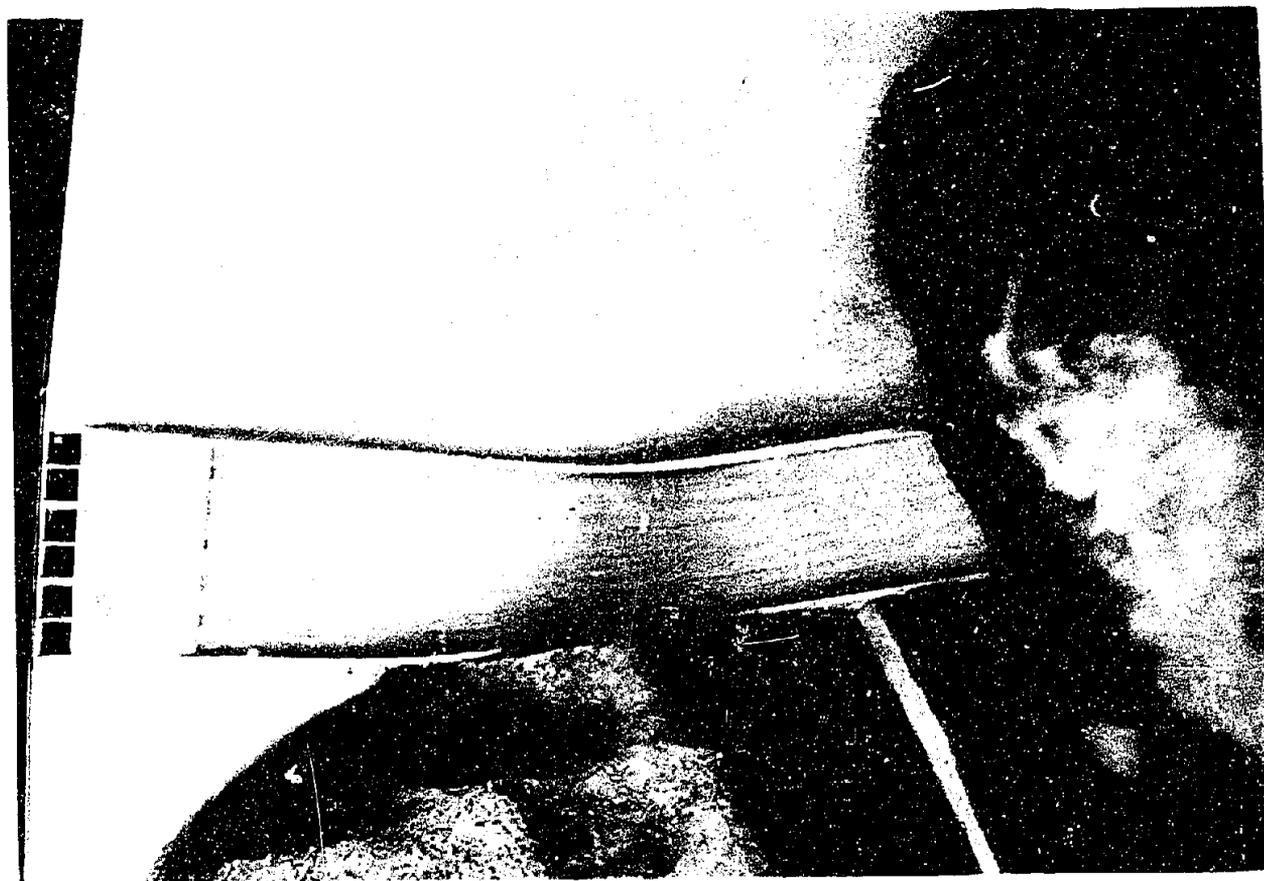
B- Left Spillway

A- Right Spillway

FINAL SPILLWAY DESIGN - DISCHARGE 37,500 SECOND-FOOT PER SPILLWAY

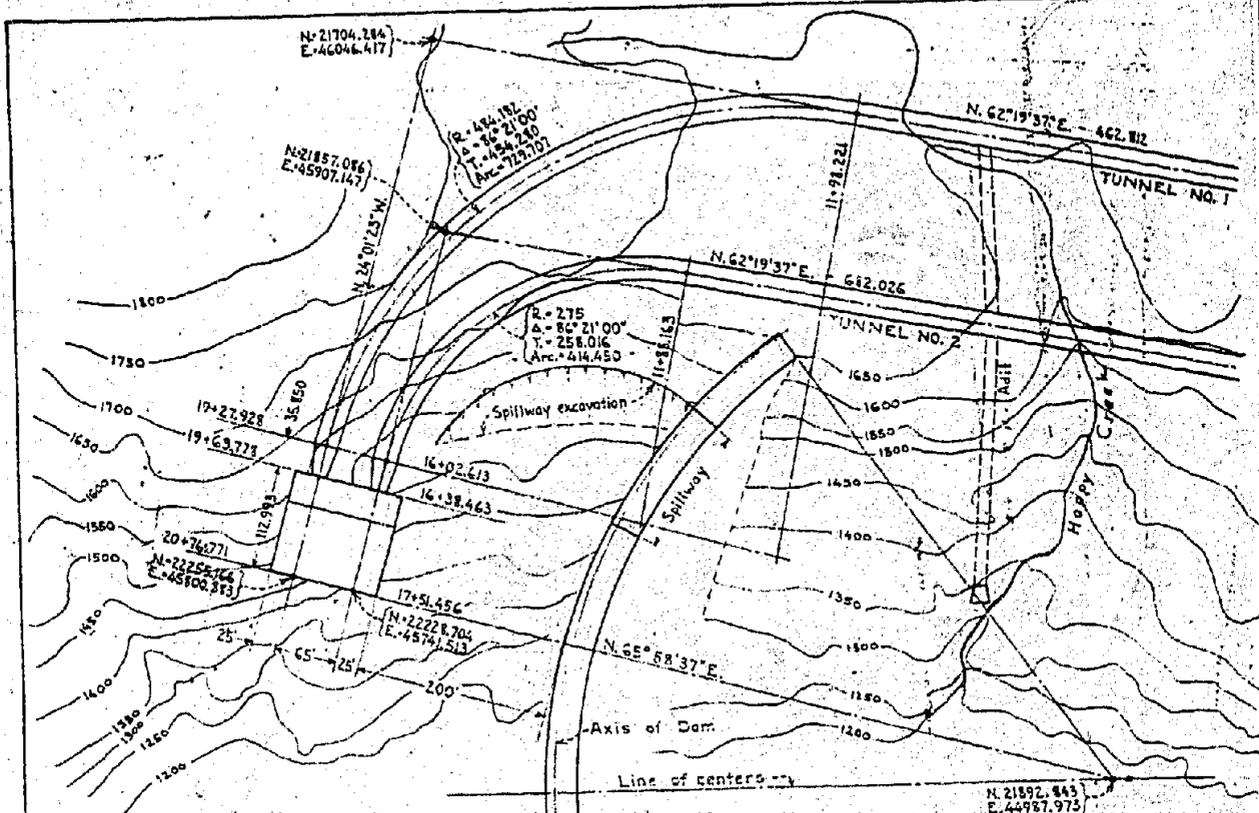
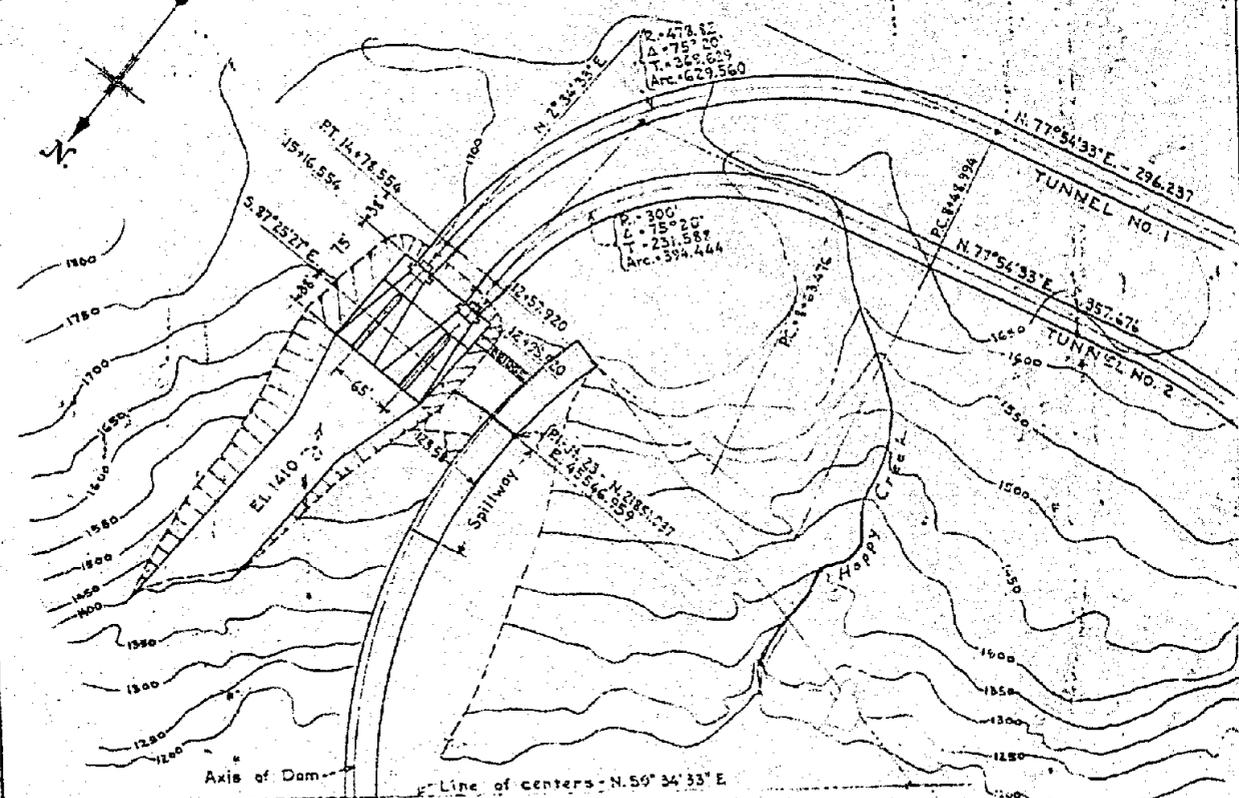
A. STUDY NO. 6

B. STUDY NO. 8

ROSS DAM
POWER INTAKE STRUCTURES
DESIGNS 6 AND 8

14. Location of power tunnel intakes. Of some eleven layouts made on the intake structures and tunnels leading to the powerhouse, three of the most desirable were installed in the model. The purpose was not to study flow through the intake structure but to observe the action of the water as it flowed past the structure when the left spillway was in operation. The extent of the intake structure so far as the model was concerned was merely a rack with side walls, where necessary, located as specified in the various studies. In no case did flow exist through the intake as the power tunnels were not completed. The intakes were incorporated in the model merely to make certain that adverse flow conditions would not exist in the vicinity of this structure during flood discharge over the spillway. The first intake investigated, study 6, is shown in plan on figure 26 A. Very little cut was required for this design as the intake structure projected out from the canyon as shown in photograph A, figure 27. The head box was of insufficient size to accommodate the entire rack structure; so only the portion that would fit in the box is shown. Figure 27 B depicts the flow in the vicinity of the intake for a discharge of 50,000 second-feet through the left spillway. Confetti is shown on the water surface to indicate the direction of flow. Incidentally, the flow currents are not correct in this case, due to the limitation in the size of the model head box. The photographs, however, do give some idea as to the appearance of the intake in this location.
