* HYDRAULIC LABORATORY REPORT NO. 136
*
* - - -

* HYDRAULIC MODEL STUDIES FOR THE DESIGN
* OF
* ROSS DAM SPILLWAYS
* CITY OF SEATTLE, WASHINGTON
*
* - - -

* J. N. BRADLEY and C. J. HOFFMAN
*
* - - -

* Denver, Colorado,
* Oct. 12, 1943
*
* *****

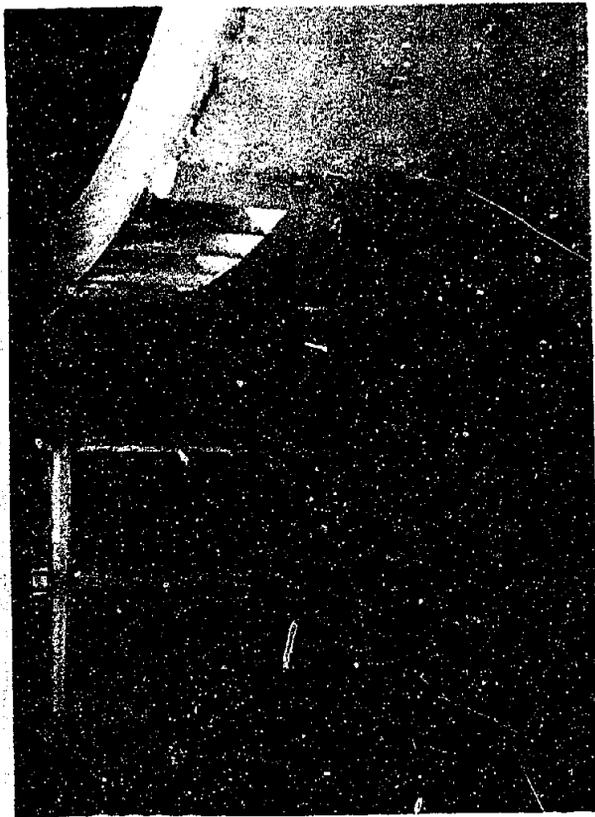
A- Intake Structure and Left Spillway

B- Discharge 25,000 Second-Feet through
Left Spillway

C- Discharge 50,000 Second-Feet through
Left Spillway

Study 8, figures 26 and 28, shows the intake structure located in a large cut in close proximity to the dam. Figure 28 B and C indicates excellent flow conditions for both discharges of 25,000 and 50,000 second-feet through the left spillway. The intake offered no obstruction to spillway flow, and it appeared that the spillway would in no way interfere with intake flow. Hydraulically speaking, this layout was excellent. From an economic standpoint the cut was excessive. Structurally, it was decided that the intake and the power tunnels were too close to the abutment of the dam.

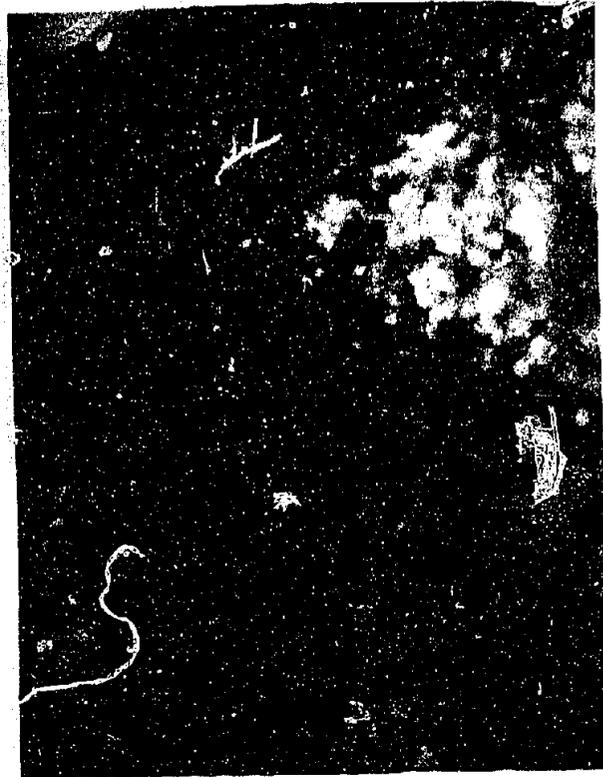
A- Intake Structure and Left Spillway

C- Discharge 50,000 Second-Feet through Left Spillway

B- Discharge 25,000 Second-Feet through Left Spillway

POWER TUNNEL INTAKE - STUDY 11

The third layout, study 11, was somewhat of a compromise between the two above schemes. The intake was moved upstream and set in a moderate cut in the canyon wall, as shown on figures 29 and 30 A. Flow conditions near the structure are shown for discharges of 25,000 and 50,000 second-feet through the left spillway on figure 30 B and C. Again, little or no interference between spillway flow and intake was discernible. Of the three intakes tested, design 11 proved the most desirable both from a structural and an hydraulic standpoint. Some doubt remained, however, as to the merits of design 6 as it was not fairly represented in the model.

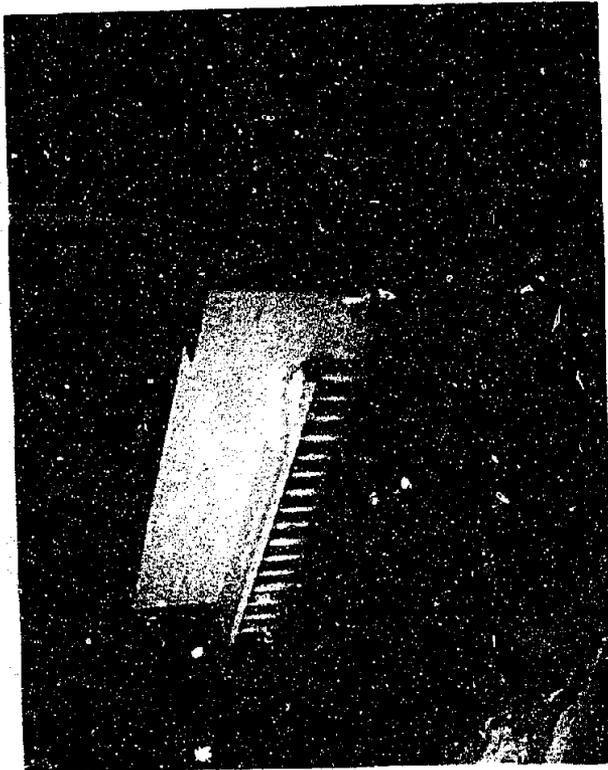
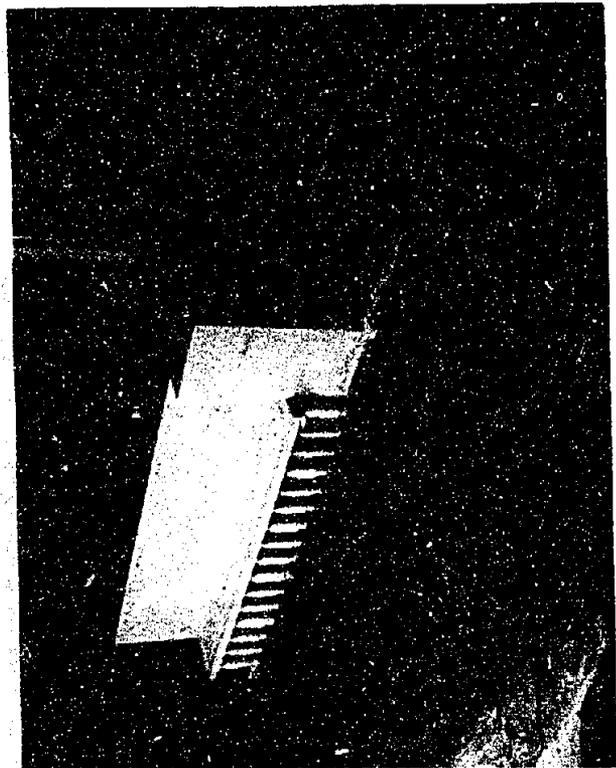
R- Discharge 75,000 Second-Feet

D- Discharge 25,000 Second-Feet

A- Discharge 100,000 Second-Feet

C- Discharge 50,000 Second-Feet

TAILRACE CONDITIONS AT POWERHOUSE

15. Tailrace conditions at powerhouse. As velocities were extremely high in the river for the larger spillway discharges, it was thought advisable to construct a model of the powerhouse to study tailrace conditions. The model powerhouse was located as for study 11, shown on figure 29. Although velocities in the river were high,

the water surface adjacent to the powerhouse was surprisingly quiet in comparison. For 100,000 second-feet of flow in the river, the waves, measured from crest to trough, were approximately 8 feet high along the front face of the powerhouse. The addition of a wall at the upstream end and a pier at the downstream end of the powerhouse improved tailrace conditions in general. The maximum wave height in this case was reduced to approximately five feet. The dimensions of the upstream wall and the additional downstream pier are shown on figure 29. Photographs of the tailrace for discharges of 100,000, 75,000, 50,000, and 25,000 second-feet in the river are shown on figure 31. Tailwater conditions for river discharges of 50,000 second-feet and less were extremely satisfactory. Even for discharges in excess of 75,000 second-feet no major difficulties in power generation should be encountered.

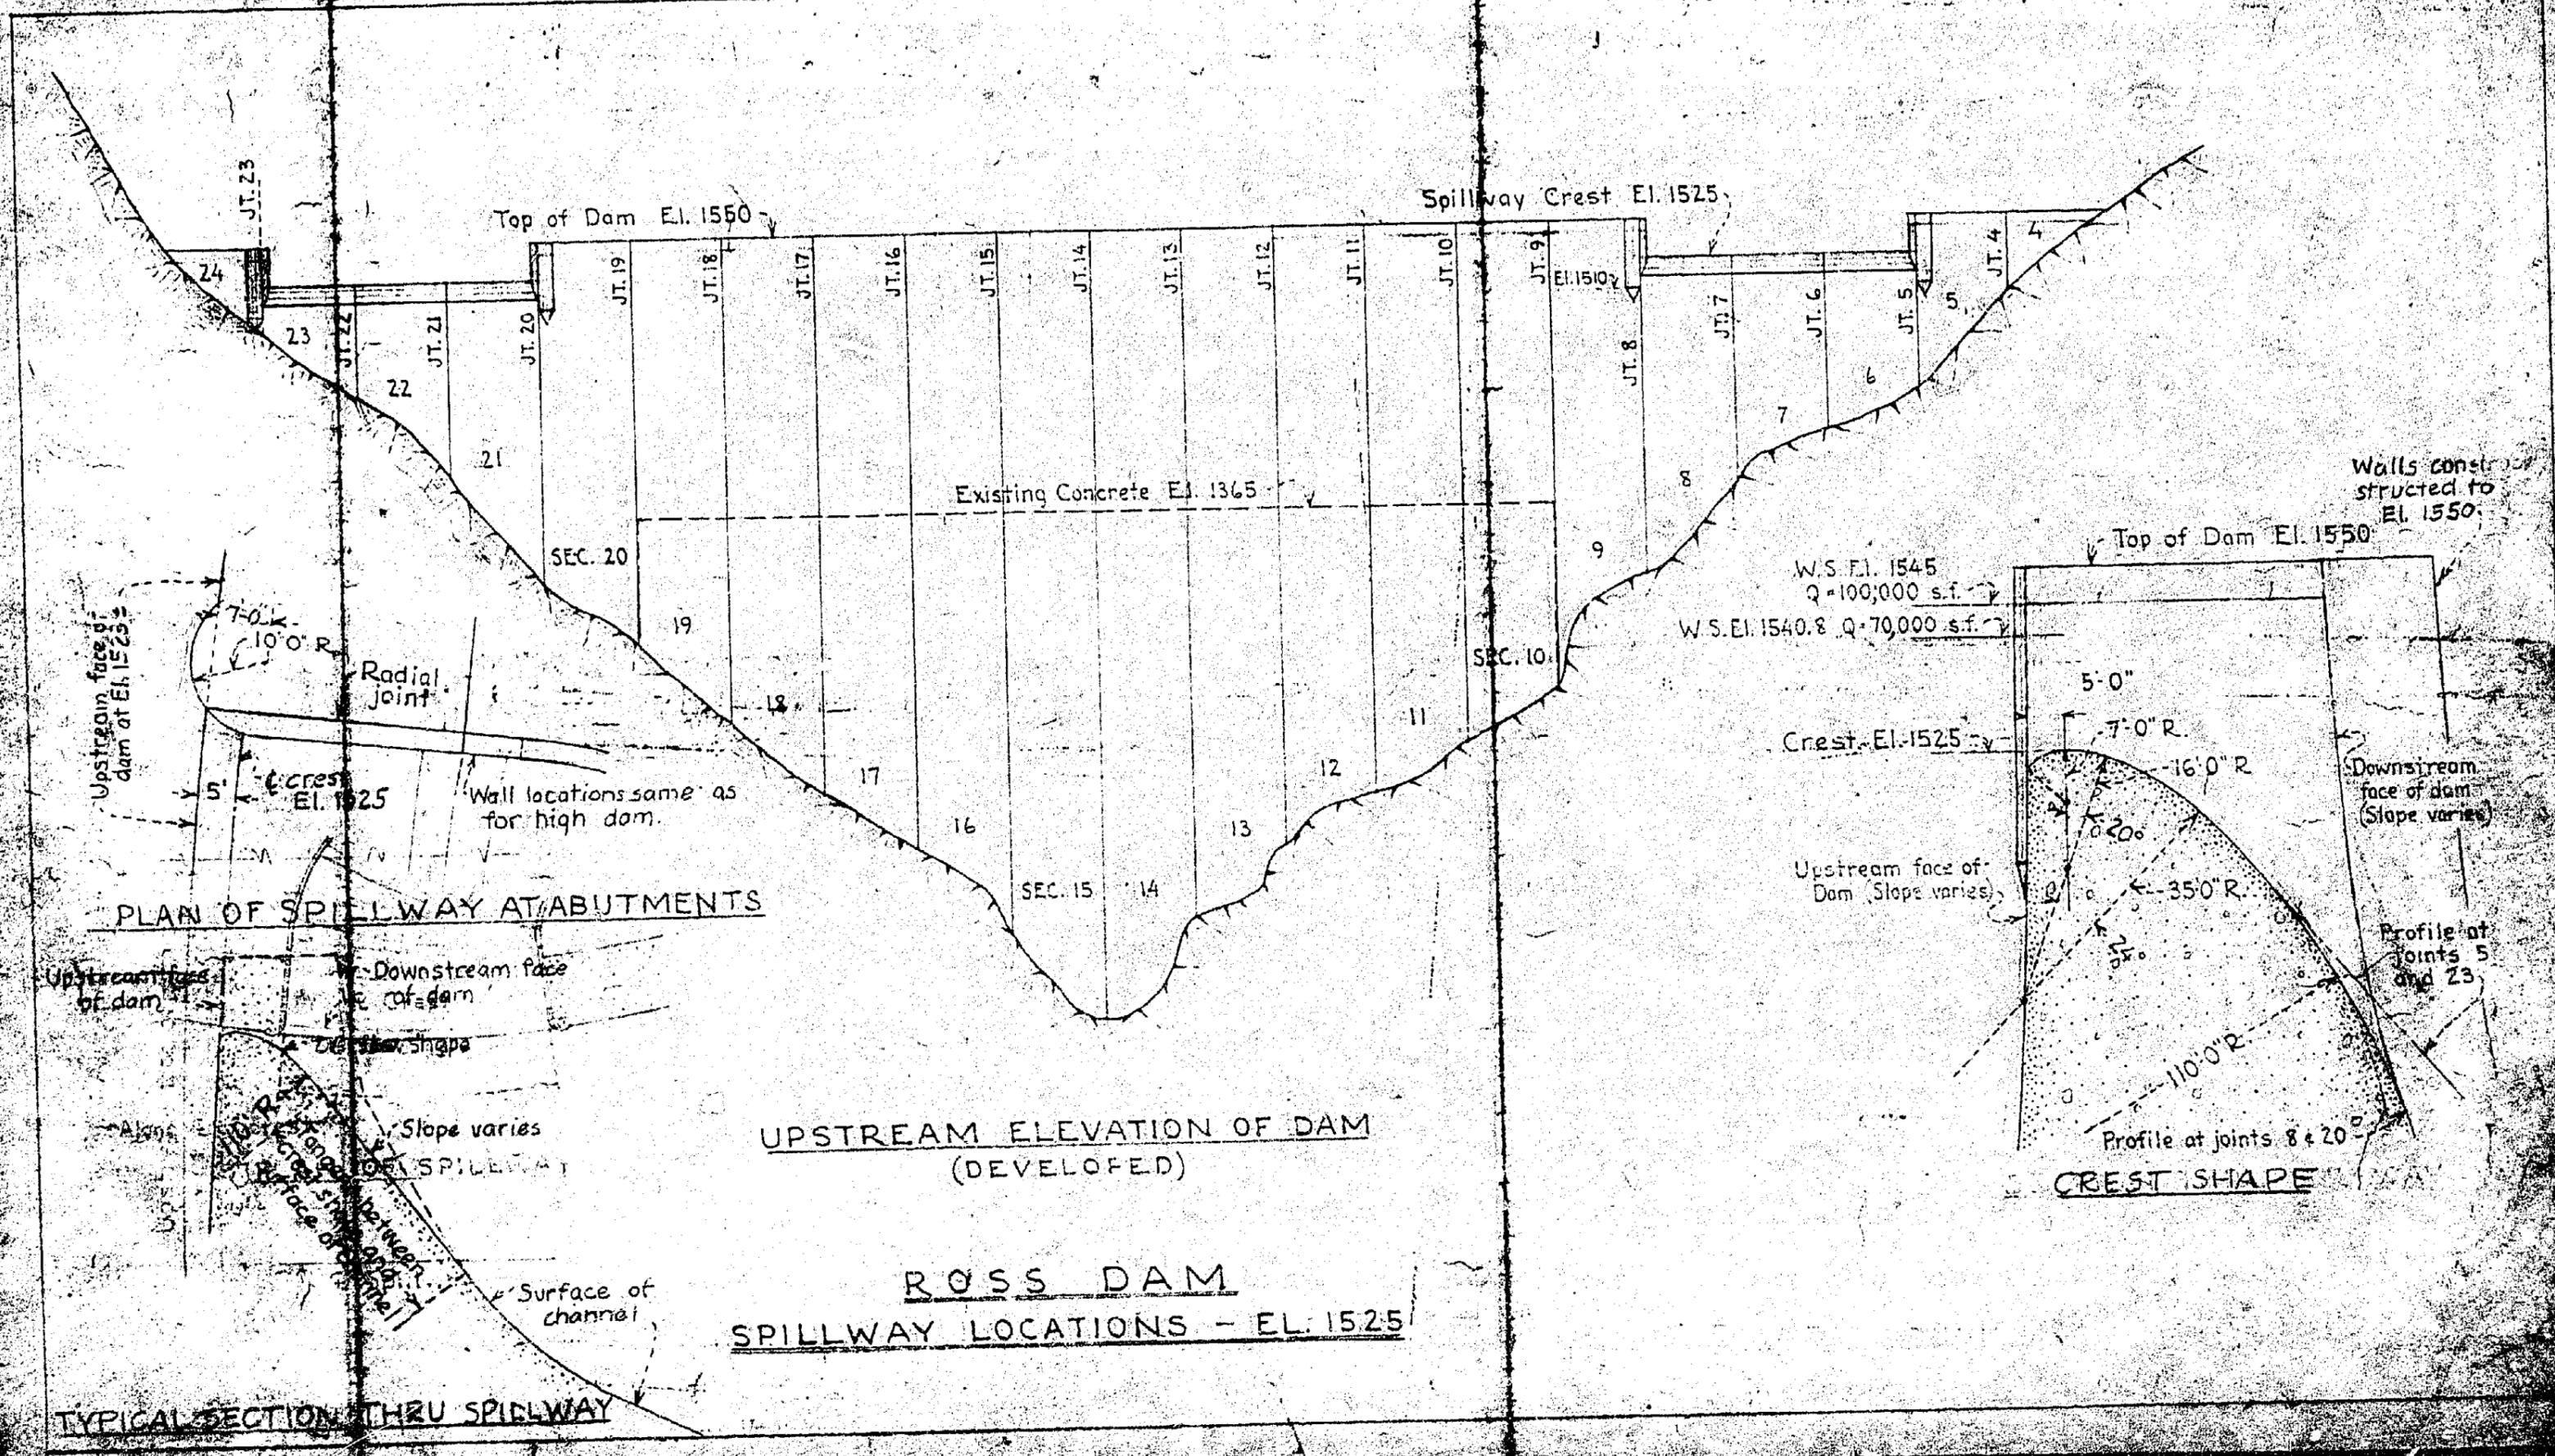
CREST SHAPE

PLAN OF SPILLWAY AT ABUTMENTS

UPSTREAM ELEVATION OF DAM (DEVELOPED)

ROSS DAM
SPILLWAY LOCATIONS - EL. 1525

TYPICAL SECTION THRU SPILLWAY

16. Spillways for second step dam. At the conclusion of the tests on the dam to elevation 1650, the model was revised to represent the second step dam. The overflow sections were projected vertically downward with crests at elevation 1525 so as to utilize the same channels for the second step spillways. Since the thickness of the dam at elevation 1525 was greater than at 1612, it was possible to design an overflow section with vacuumless profile for discharges up to 44,000 second-feet per spillway, which is shown dimensioned on figure 32. This shape was obtained from reliable, previously determined experimental data,¹ thus pressure measurements were omitted in these tests.

The overflow shapes were blended into the plane of each channel by a warped surface, the radial elements of which were tangents connecting the overflow profile and the channel slopes, as shown on figure 32. The warped surfaces will not be alike for the two spillways as the dam face and the channel downstream are both steeper on the right side. The overflow sections for the two spillways will be free crests, each 143 feet in length, without piers or gates. The channels downstream from the connecting warped surfaces will be the same as for the higher dam, with wall locations and wall heights identical for both stages of the dam.

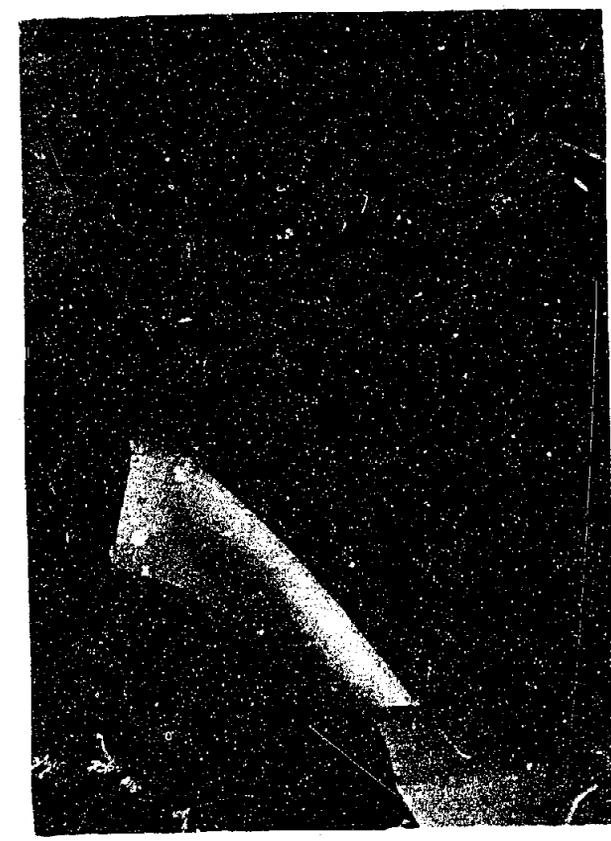
A- Approach Topography

B- Discharge 57,000 Second-Foot per Spillway

C- Approach Topography

D- Discharge 57,000 Second-Foot per Spillway

APPROACH CONDITIONS TO SECOND STEP SPILLWAYS

Flow conditions were generally satisfactory for both spillways for the lower flows but had a tendency to concentrate toward the downstream side of the channels as the flow increased. Flow conditions were better on the right spillway where the approach depth was greater and in all probability could be improved at the left spillway by increasing the approach excavation on that side.

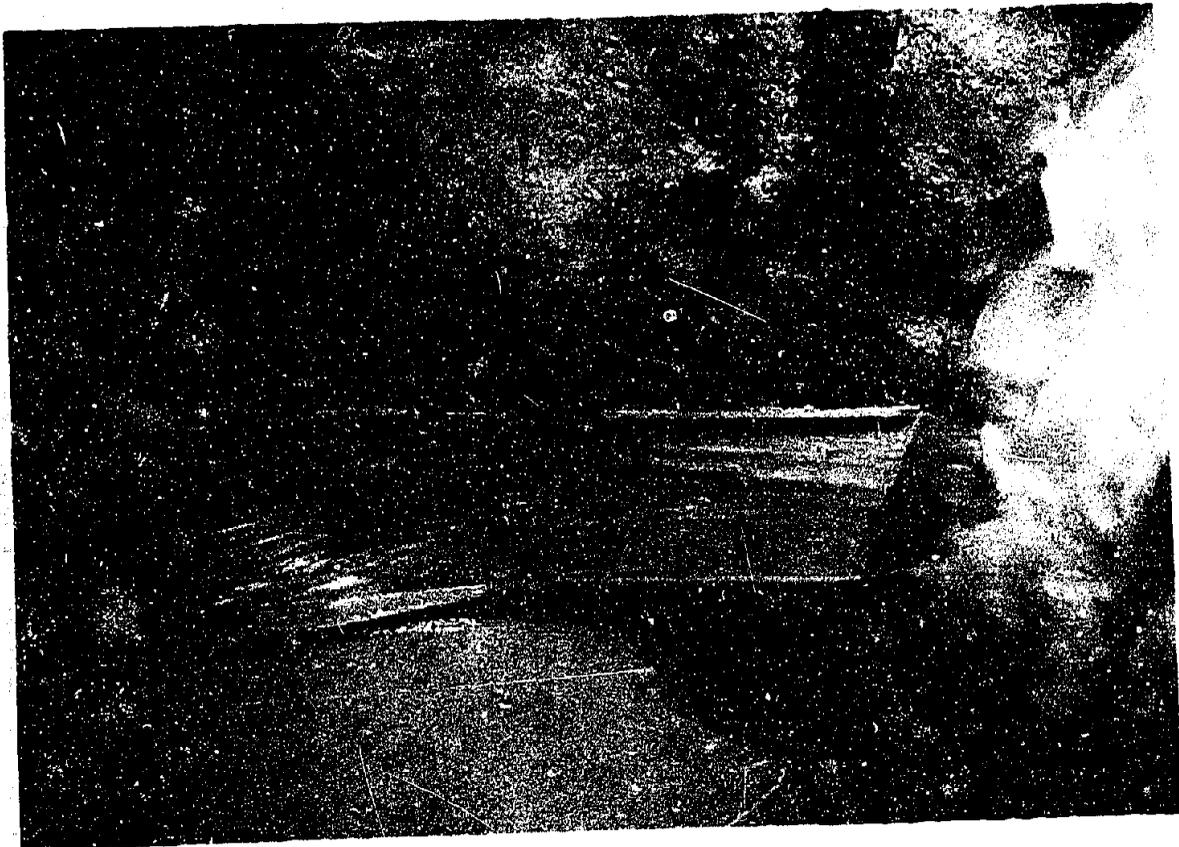
B- Left Spillway

A- Right Spillway

SPILLWAYS FOR SECOND STEP DAM - CRESTS AT ELEVATION 1525.0
DISCHARGE 37,500 SECOND-FOOT PER SPILLWAY

Photographs of the second step spillways, as recommended, are shown in operation for a discharge of 37,500 second-feet per side on figures 34 and 35. It was fortunate indeed that the same channels and walls could be utilized for the spillways on both stages when it is considered that the velocities involved were materially different for each stage.

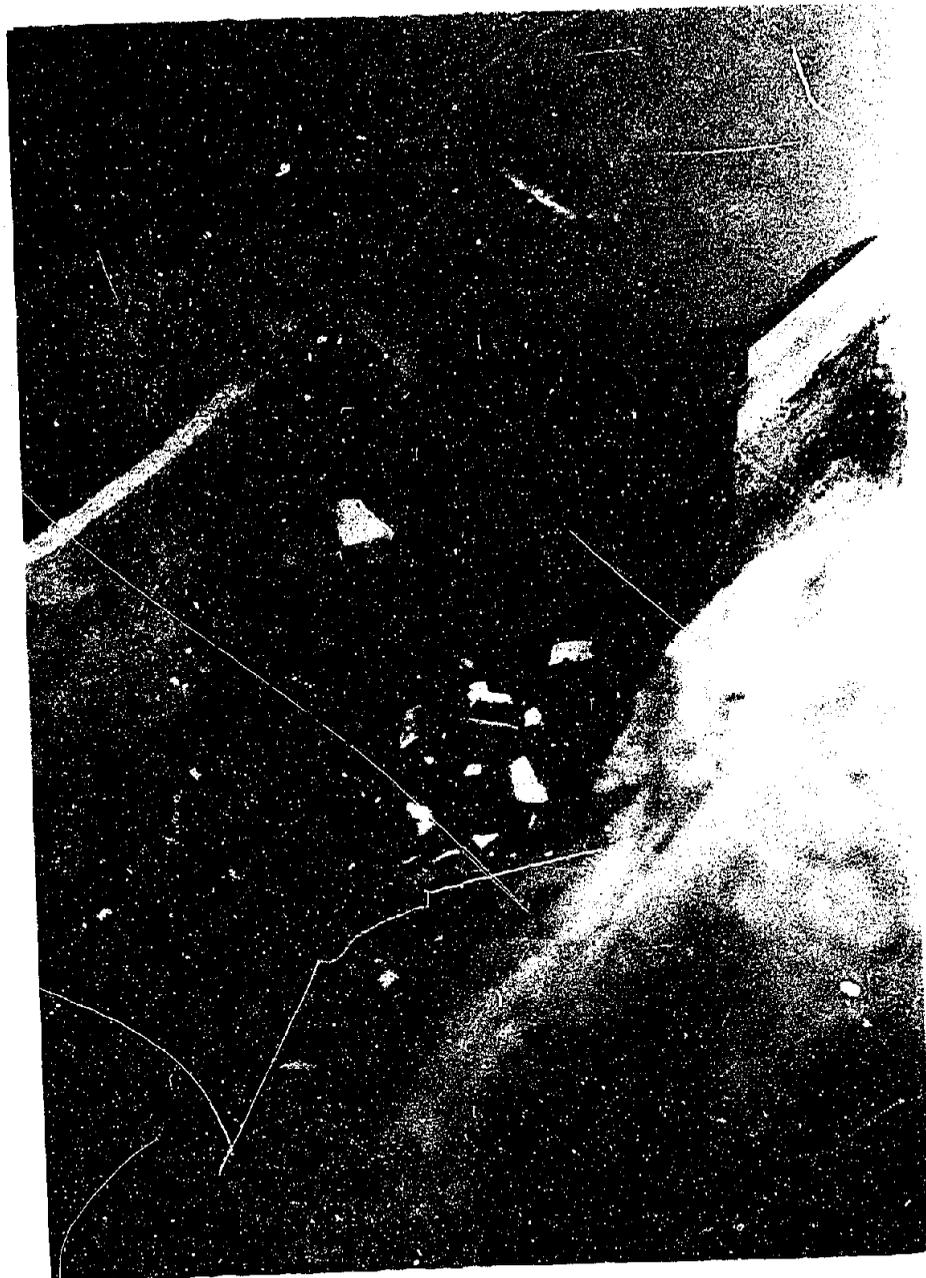
PATTERN OF SCOUR IN RIVER AFTER A TOTAL FLOW OF
100,000 SECOND-FEET

A photograph of the scour in the river produced by spillway operation is presented as figure 38. The depth of scour in this case was limited to elevation 1125, which was the elevation of the floor of the model. Some of the scoured material is shown in a more or less permanent deposit downstream while the loose material at the base of the dam remained undisturbed.

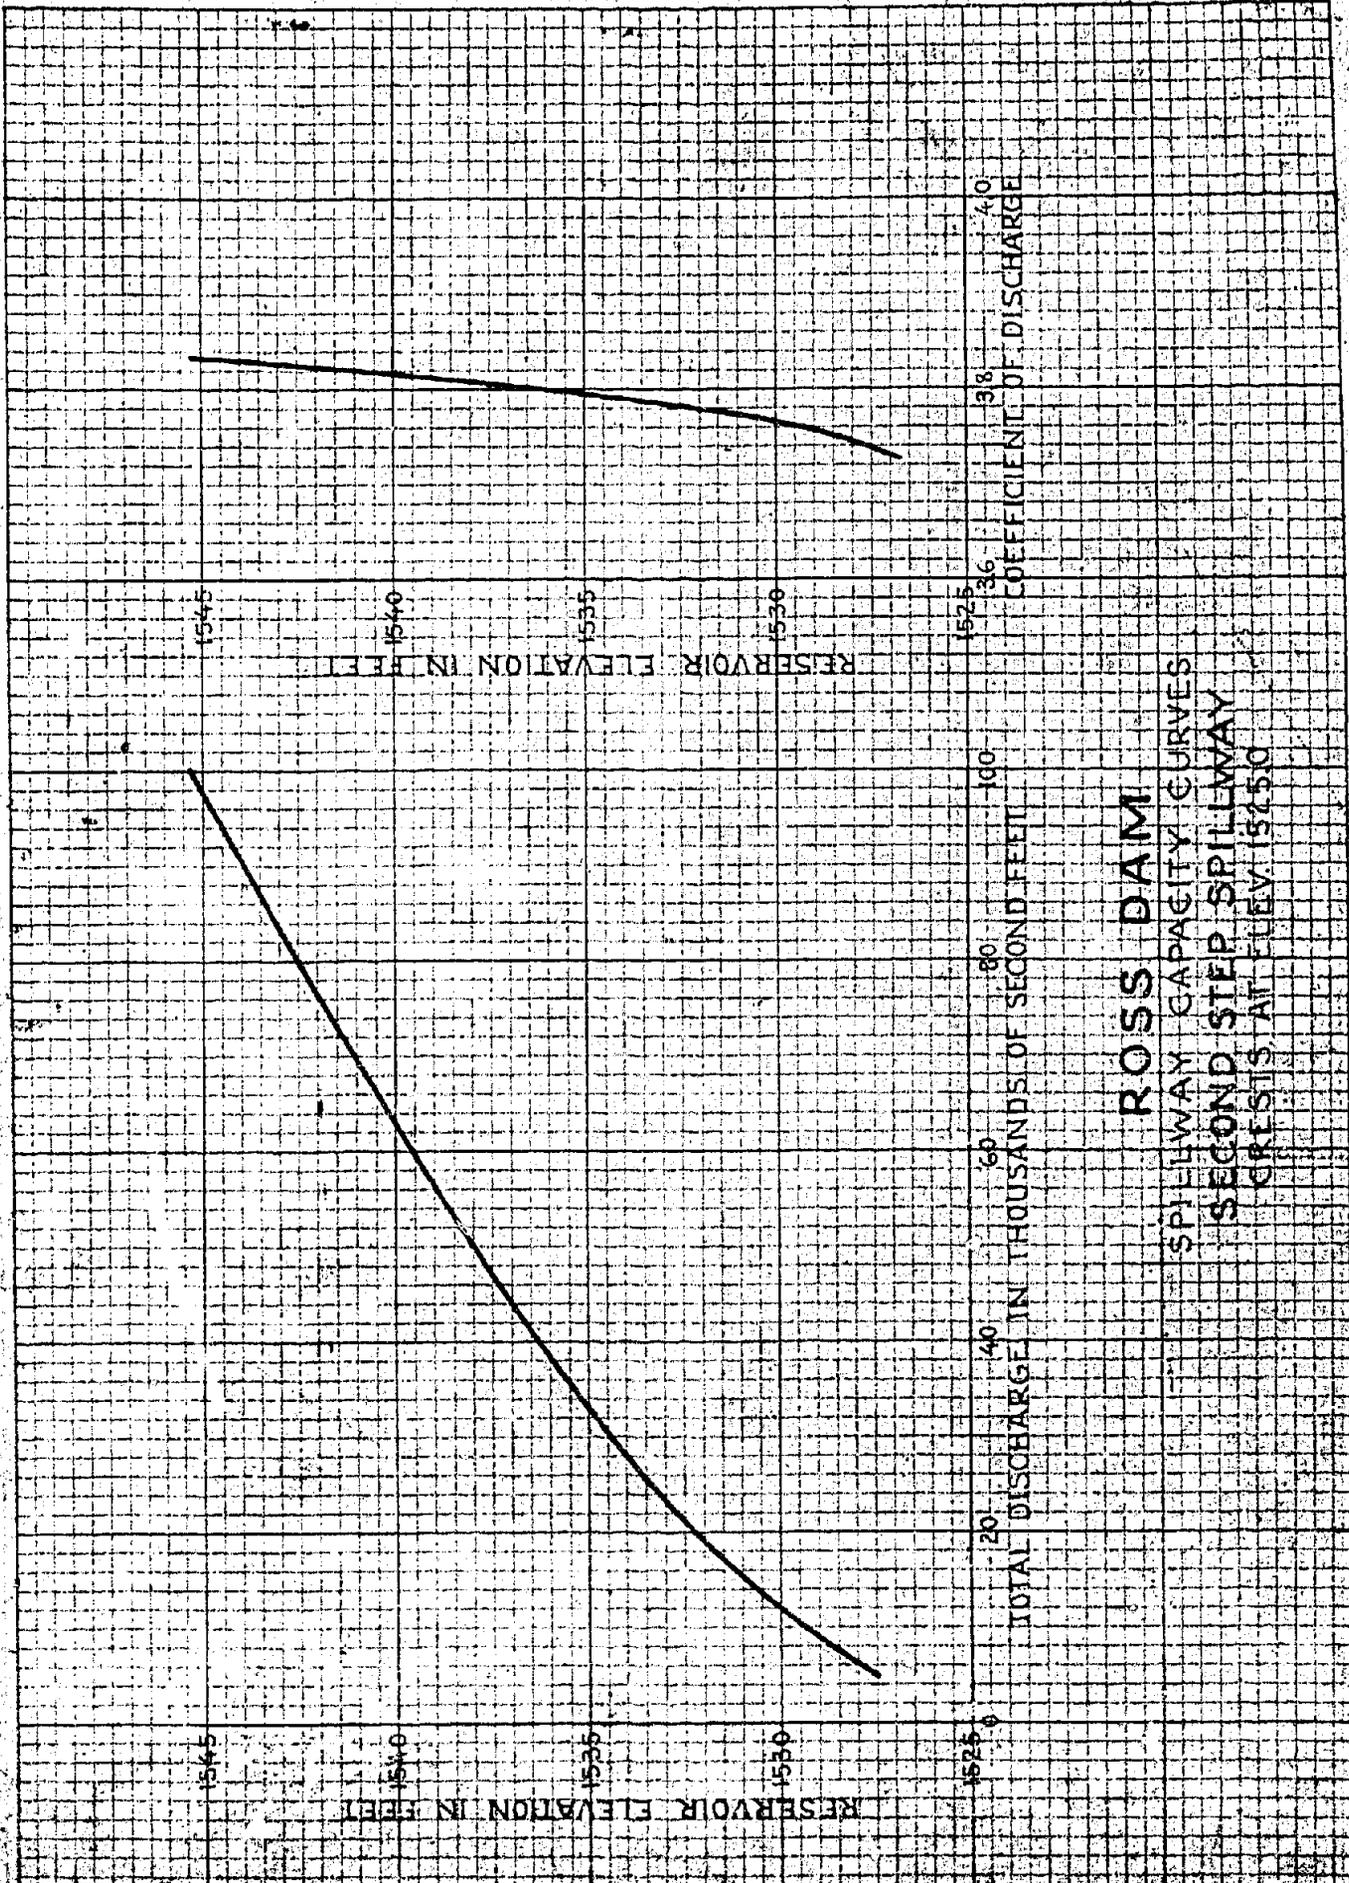
FIGURE 37

ROSS DAM

SPILLWAY CAPACITY CURVES
SECOND STEP SPILLWAY
CRESTS, AT ELEV. 15250

18. Spillway discharge curves for second step dam. Head-discharge and discharge coefficient curves for the second step free-crest spillway (figure 32) are shown plotted on figure 37.
