HYDRAULIC LABORATORY REPORT NO. HYD - 26.1

Technical Memorandum No. 556

HYDRAULIC MODEL EXPERIMENTS FOR THE  
DESIGN OF THE OUTLET WORKS AND SPILLWAY OF  
THE BULL LAKE DAM

Denver, Colorado  
July 15, 1937

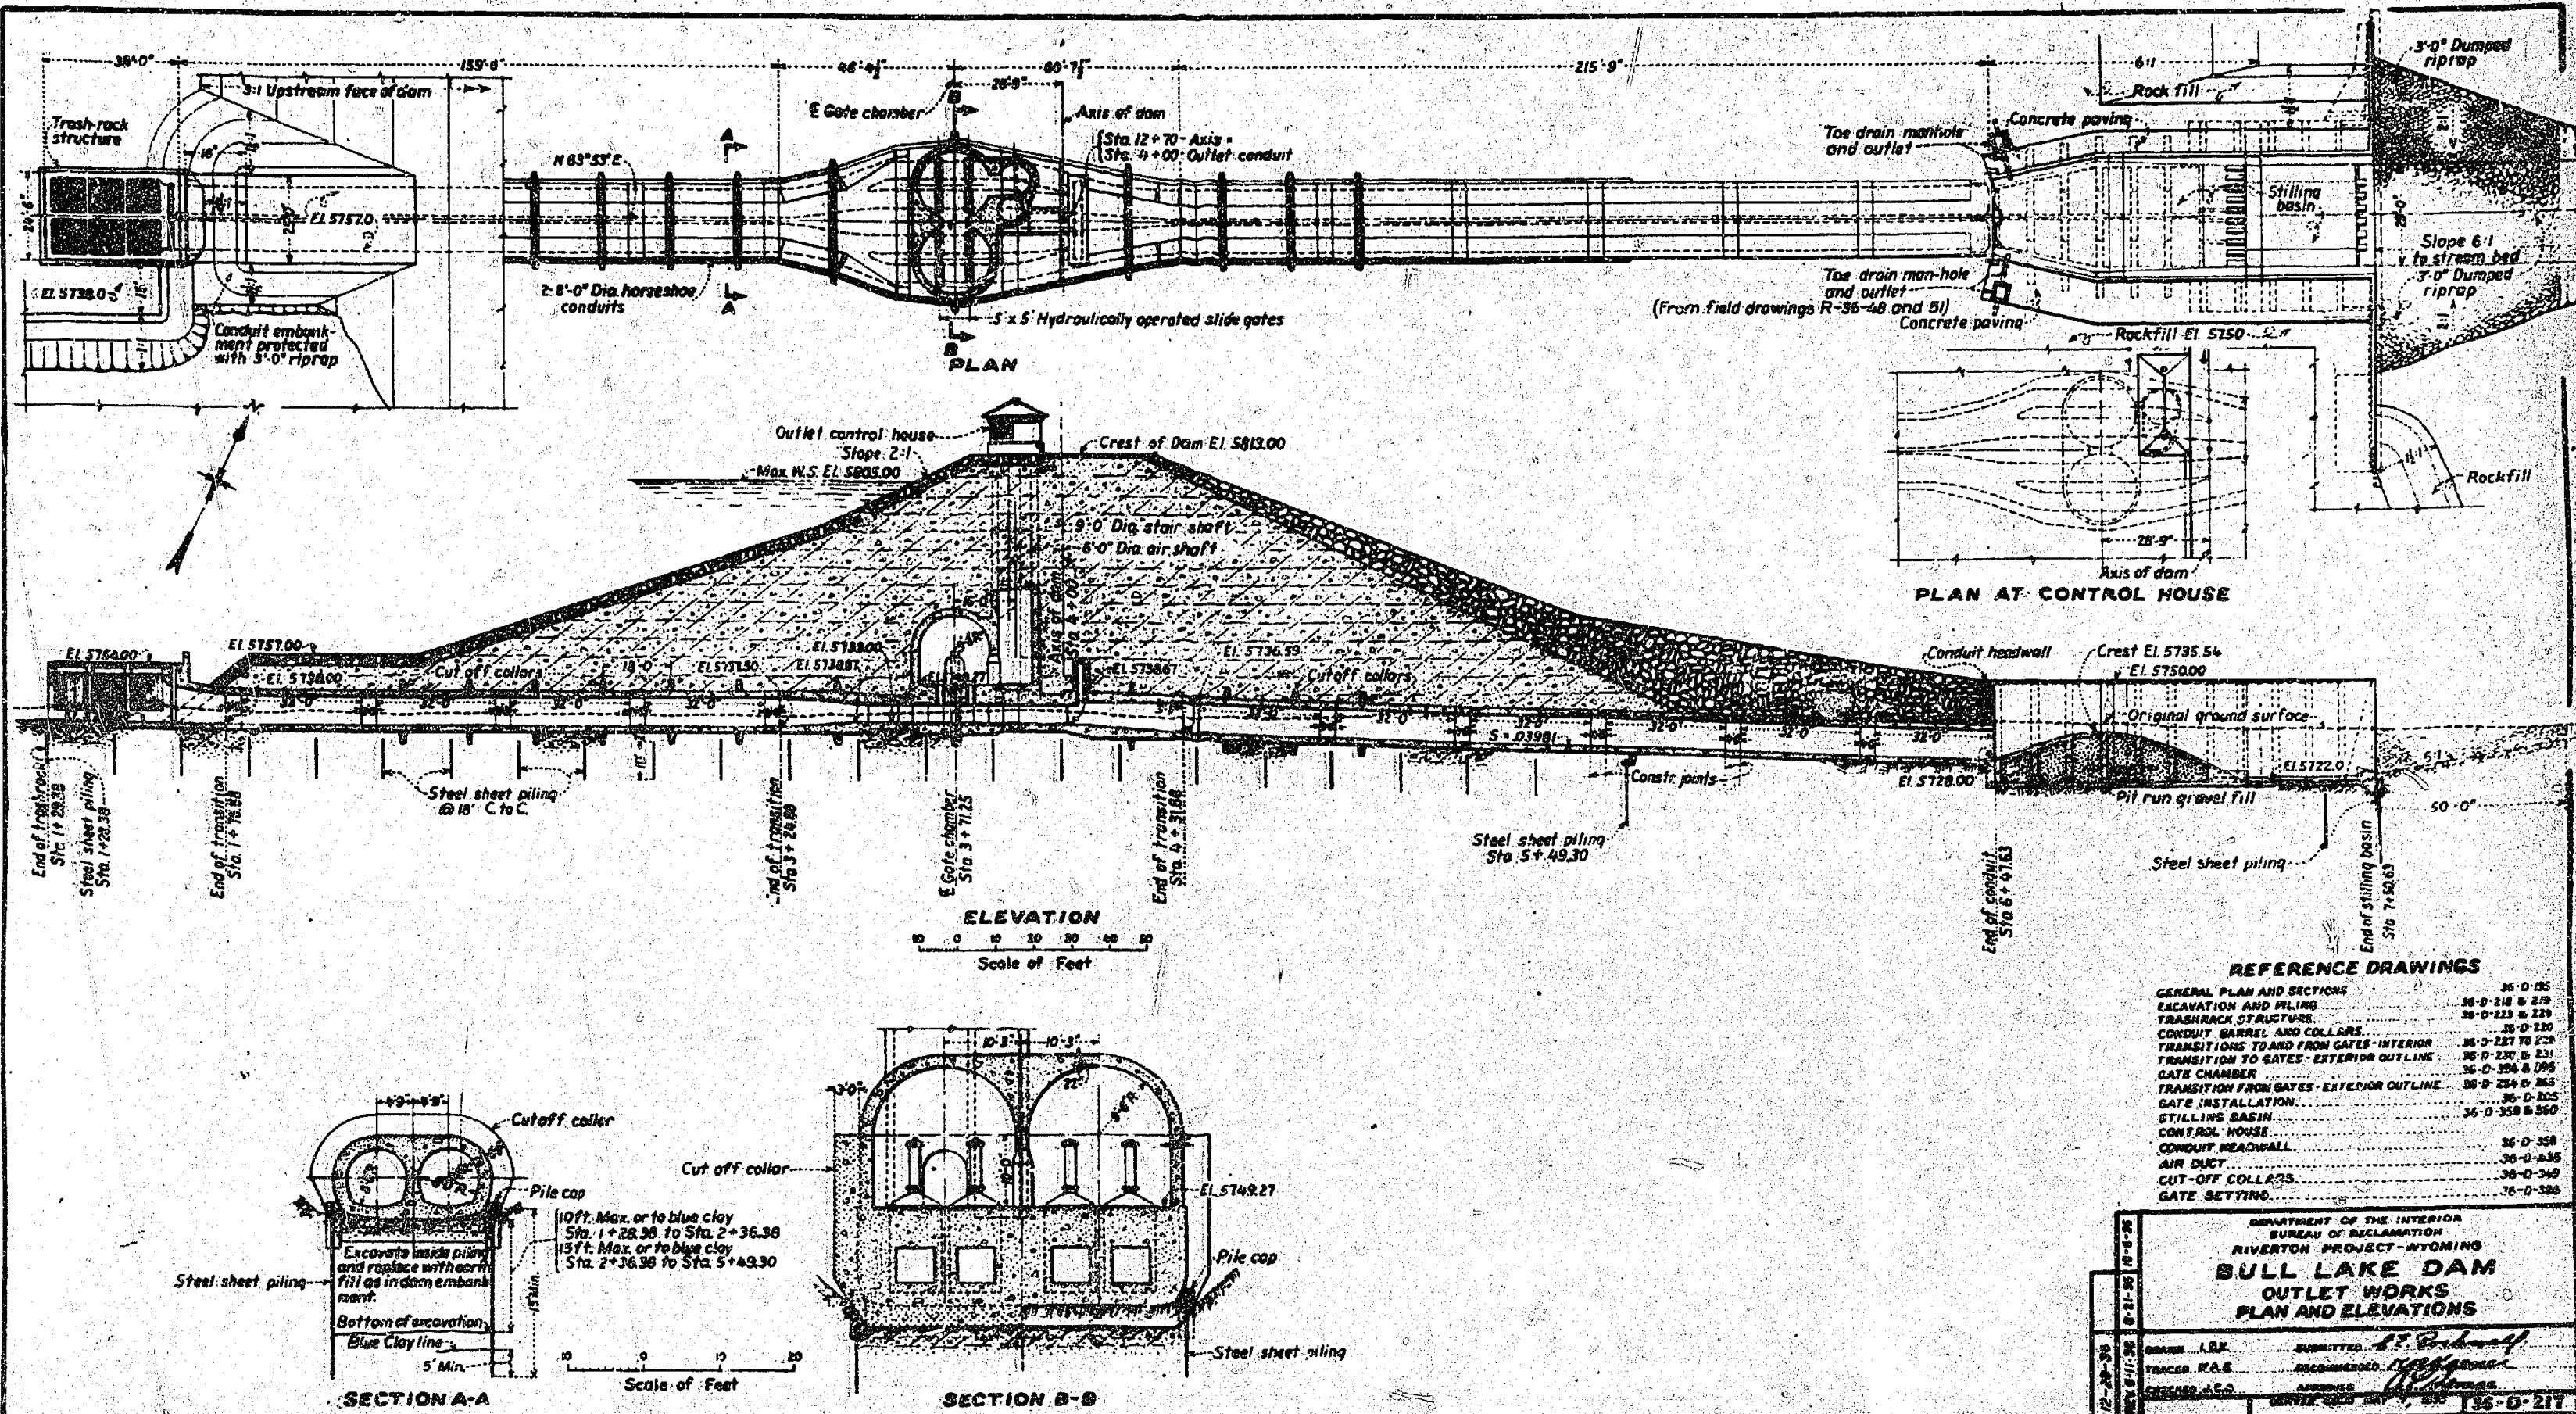
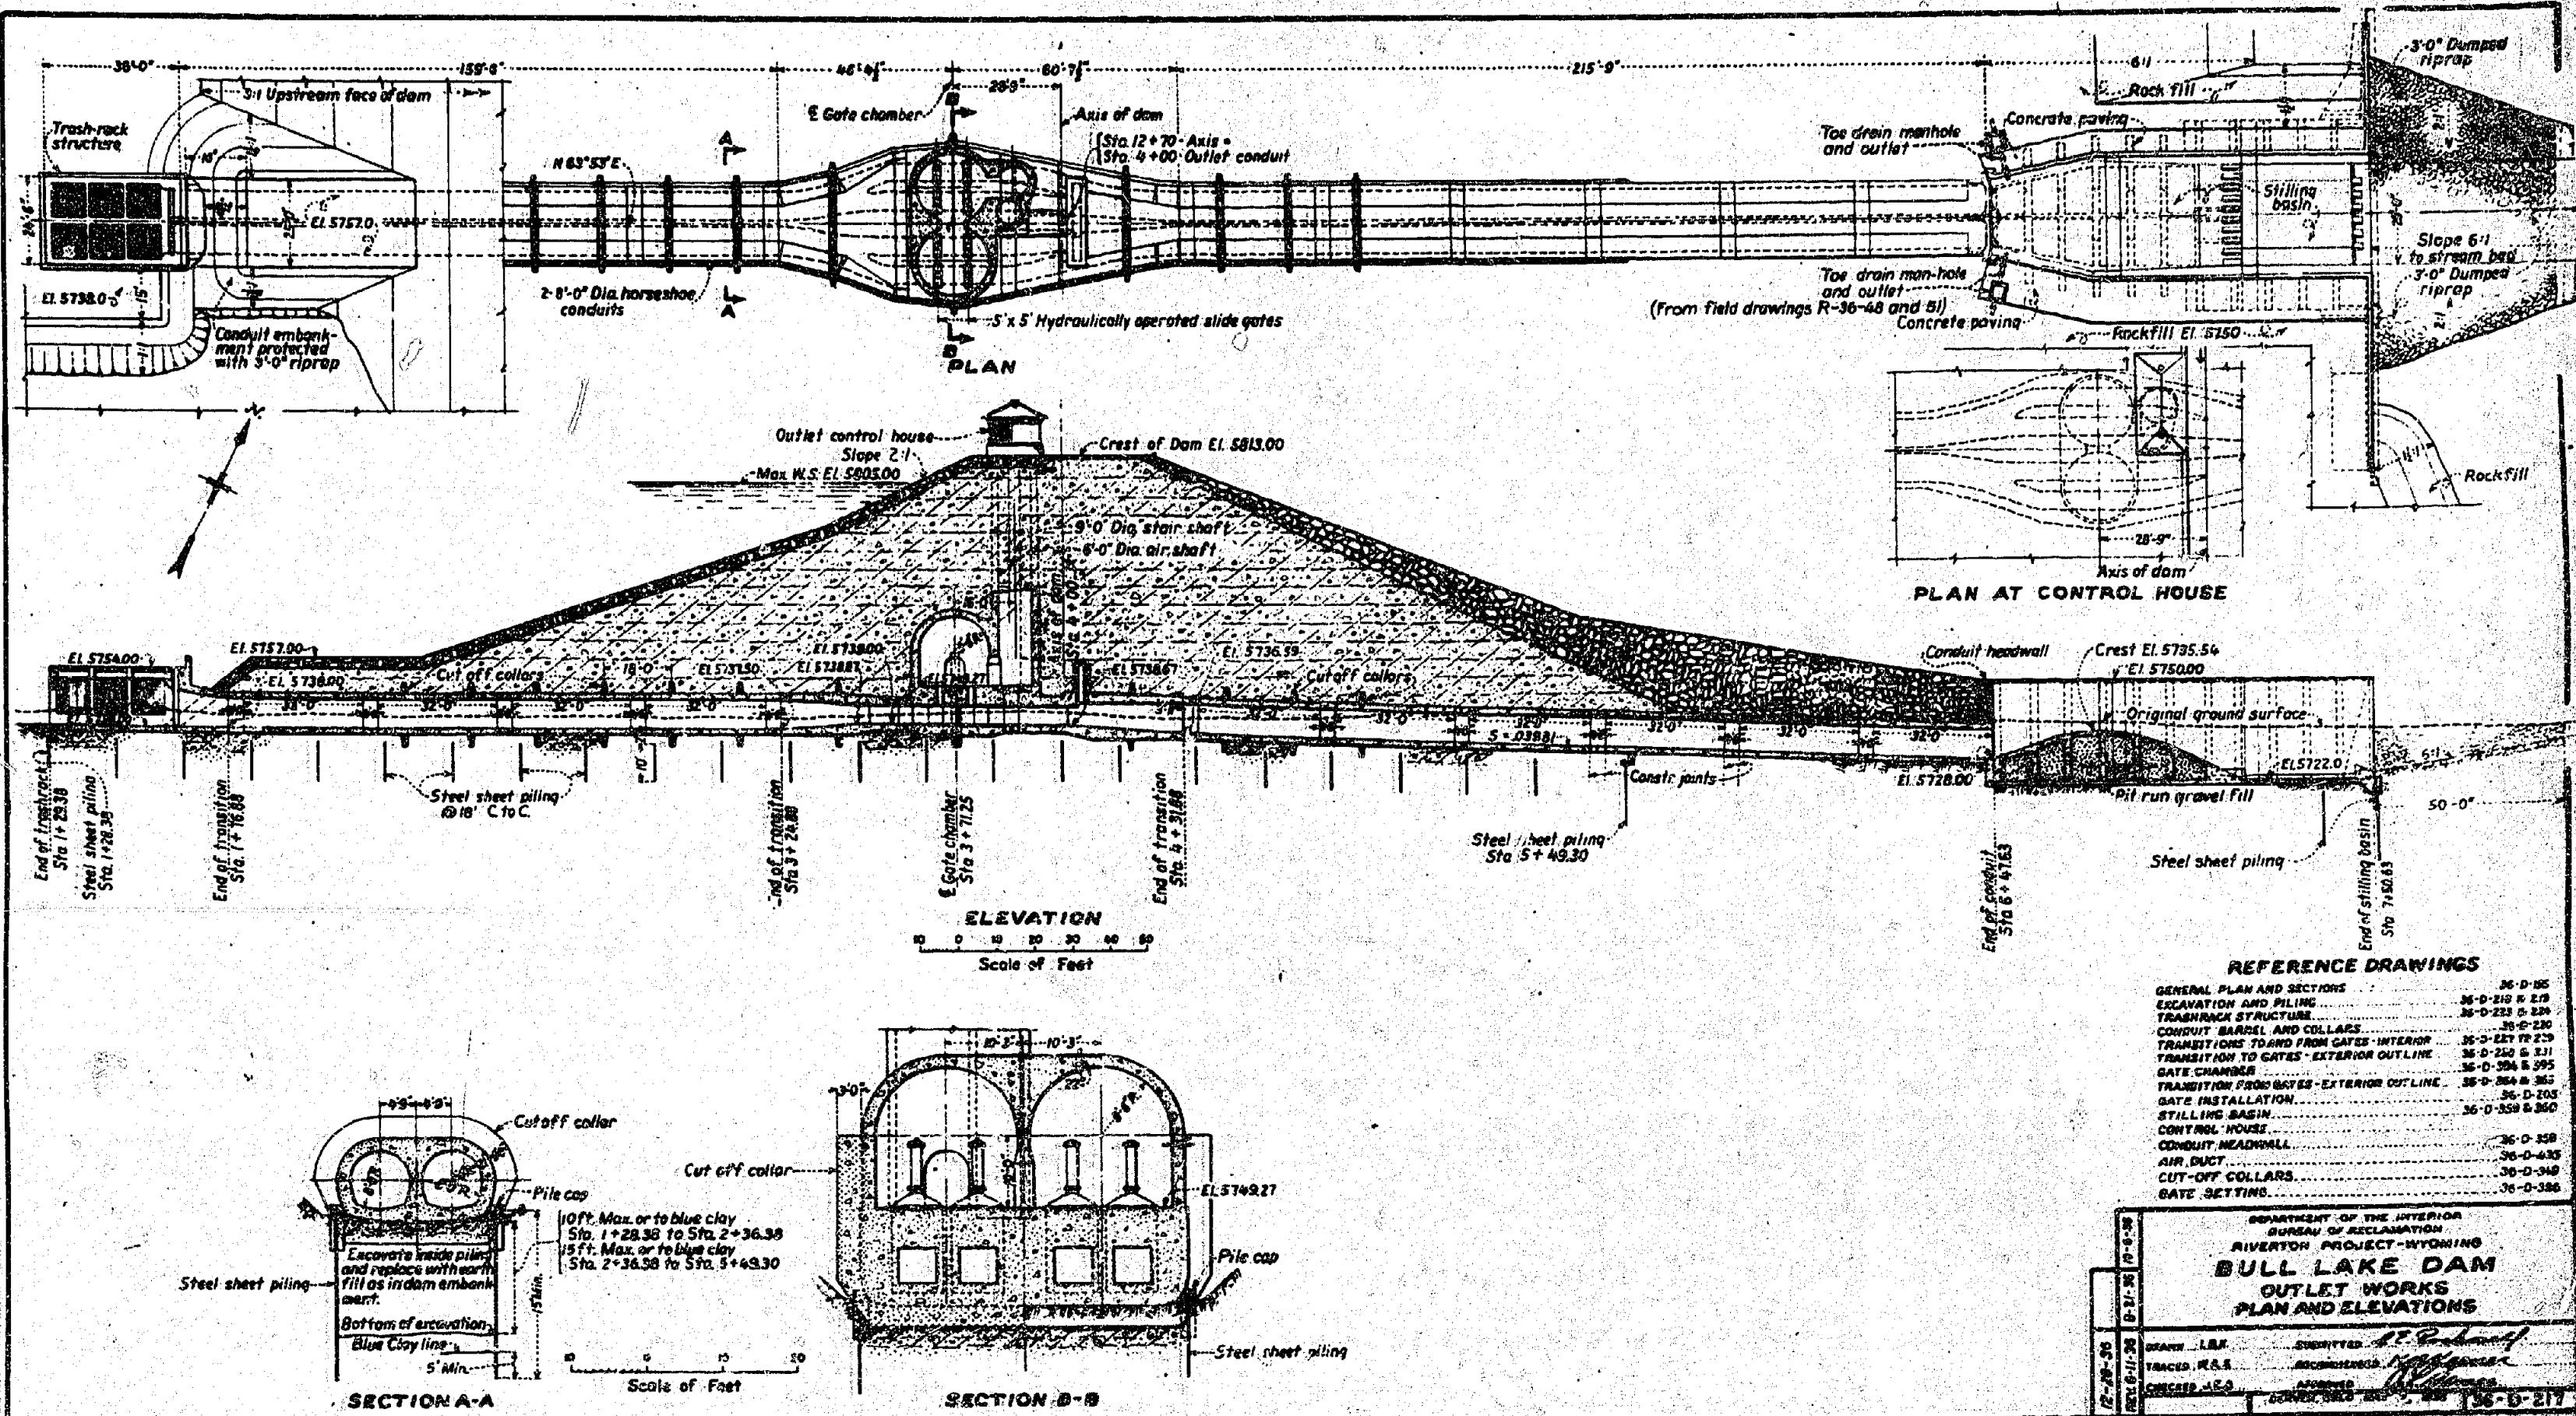
FIG. 3

The outlet works will consist of an intake and trash-rack structure connected to two 4-foot radius concrete horseshoe tunnels (fig. 3). Each tunnel will diverge into two rectangular control gate sections, having both a control gate and an emergency gate (fig. 4). An air vent located at the downstream end of the piers will supply air to the horseshoe tunnels to prevent the formation of a vacuum which would cause the tunnels to flow full intermittently. The section immediately downstream from the gates will converge into two 4-foot radius concrete horseshoe tunnels which will extend to the stilling pool. In the final design, the stilling pool (fig. 5) will have a hydraulic hump at the downstream end of the tunnels, a dentated step at the lower end of the slope, and a Rehbeck sill 35 feet 4 $\frac{1}{2}$  inches downstream from the dentated step. The stream bed will be riprapped on a slope of 6:1 from elevation 5723.25, at the downstream base of the sill, to elevation 5735.00. Riprap three feet thick will extend from the stream bed, on a 2:1 slope, to elevation 5735.00 on the left side of the stilling pool, and to elevation 5750.00 on the right side. The outlet works will have a capacity of 4,000 second-feet.

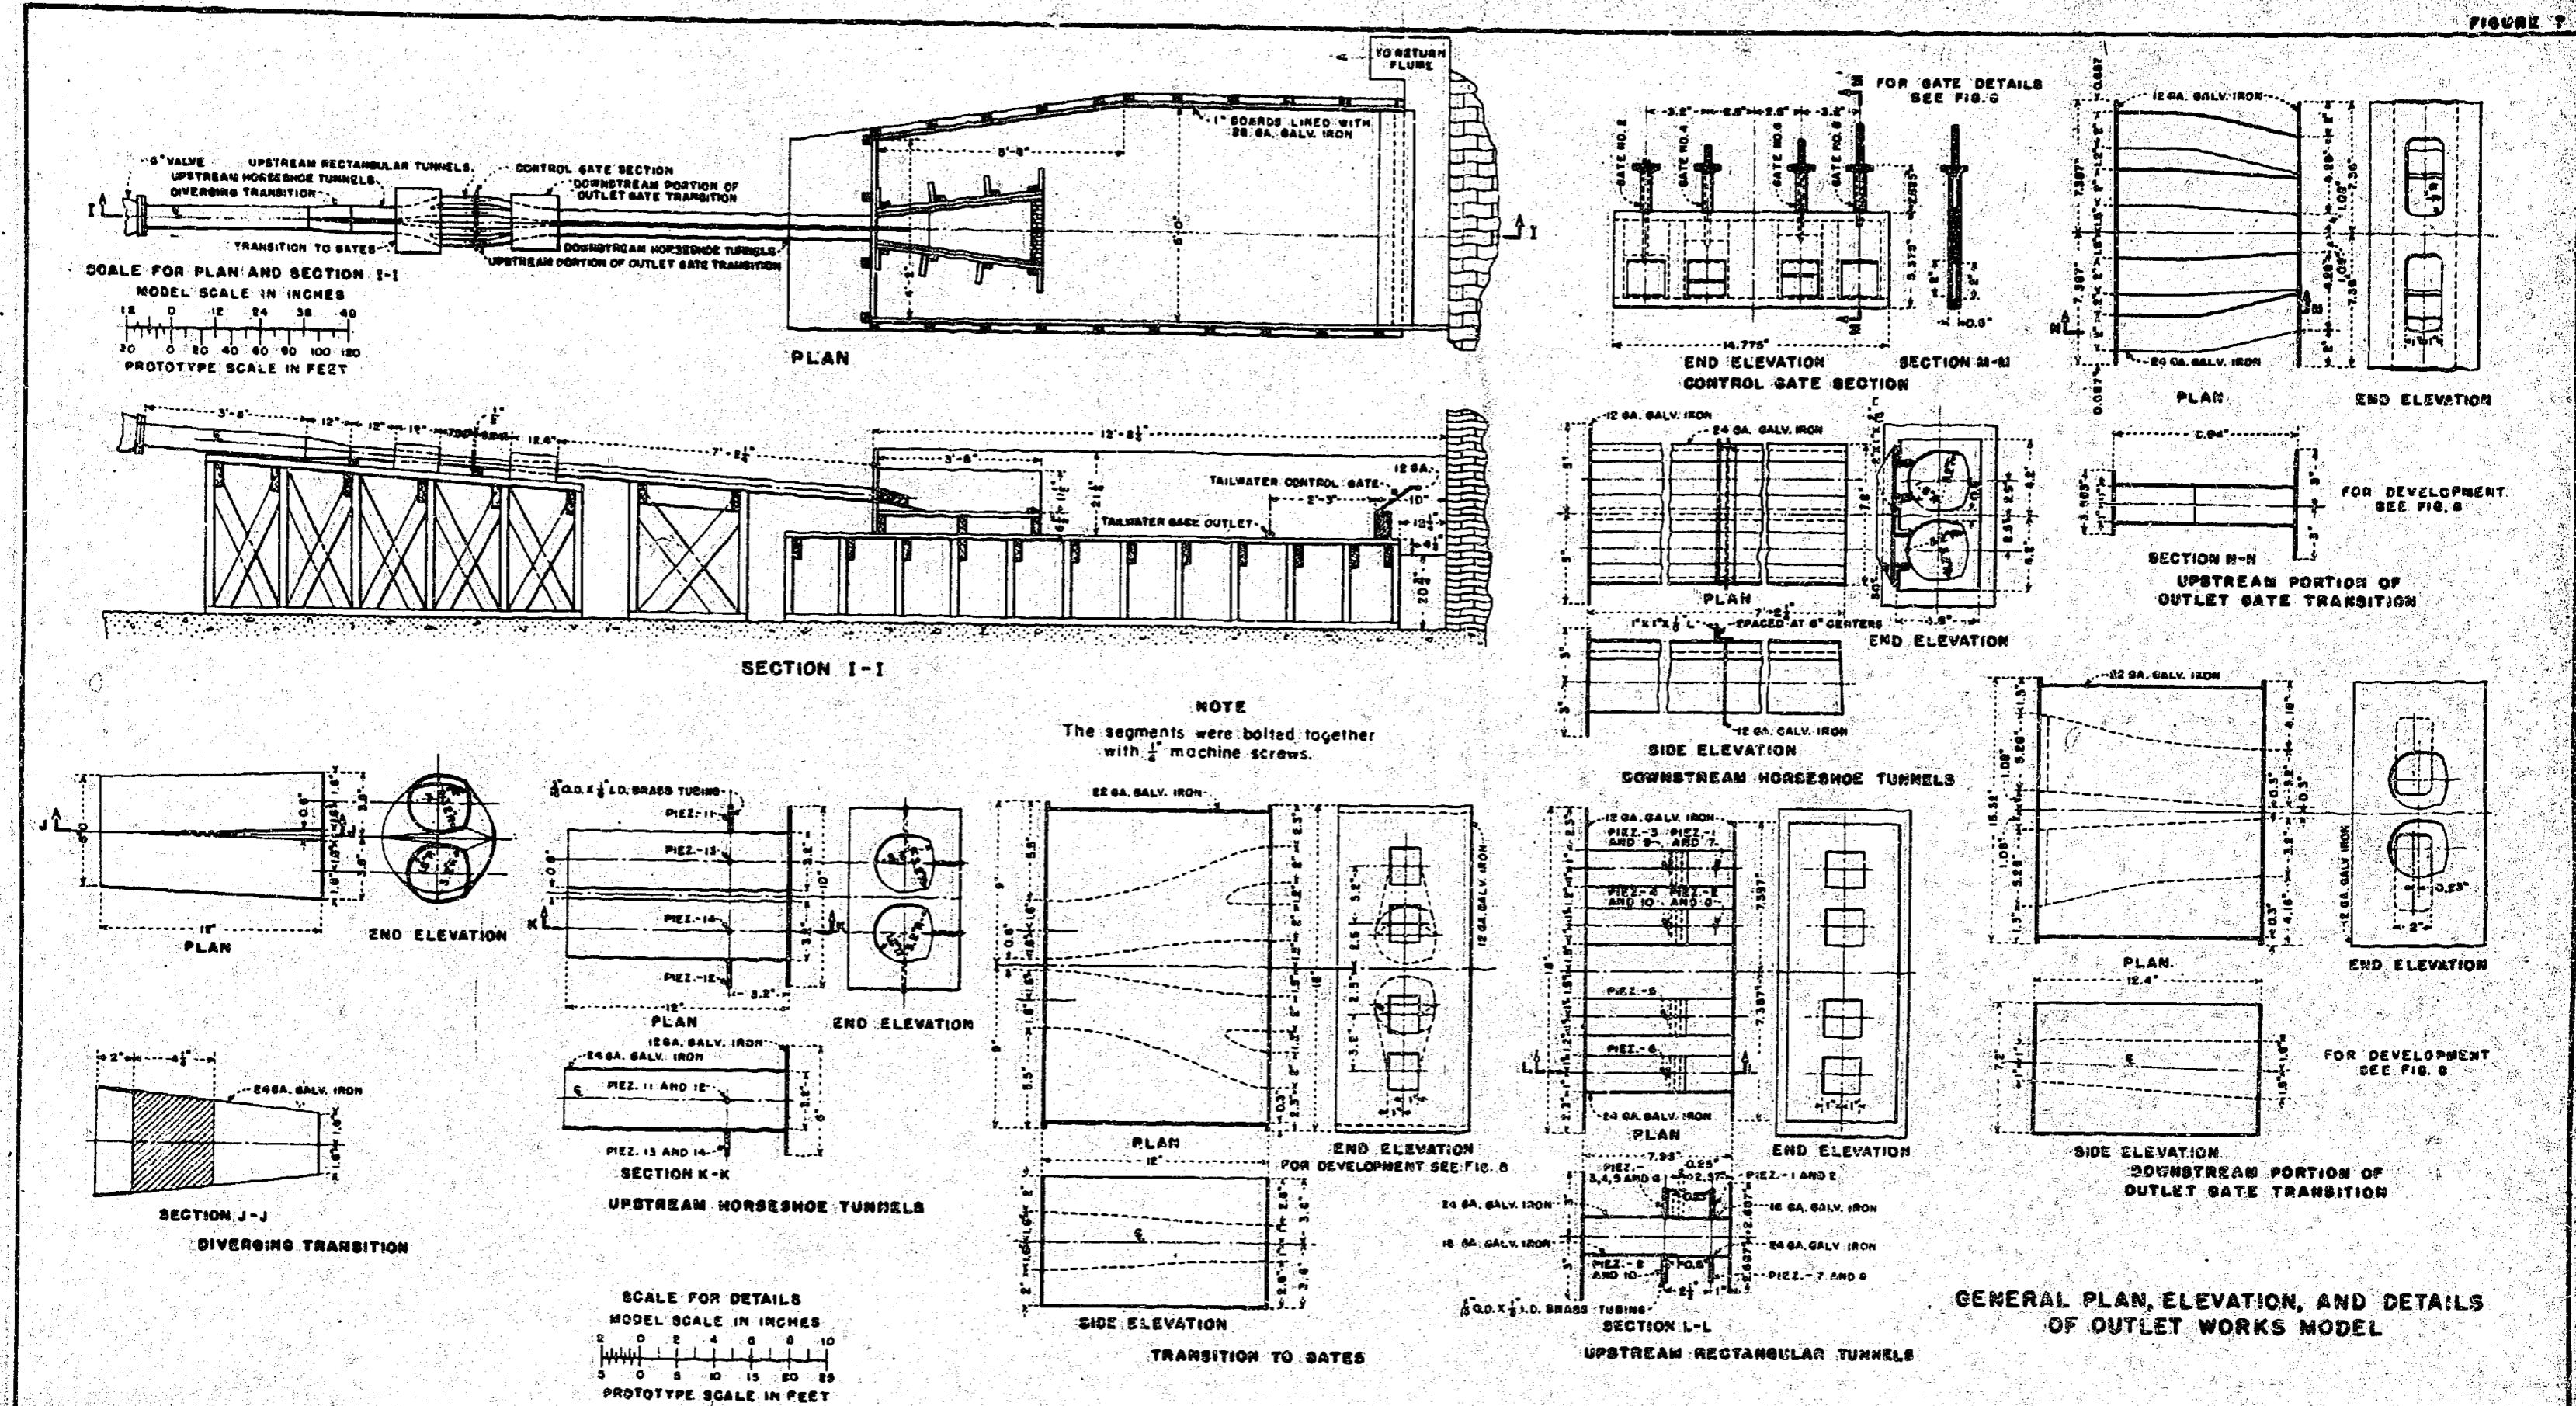
FIGURE 7

5. Model of outlet works. The model (fig. 7) was built on a scale of 1:30 in the Denver Hydraulic Laboratory. The water was supplied to the head tank by pump through a circulating system. A six-inch gate valve controlled the flow of water from the head tank to the model. The metal diverging transition split the discharge from the six-inch valve equally between the two metal horseshoe tunnels. Piezometers installed in the sides and bottom of the upstream horseshoe tunnels were connected to a manometer board to measure the head on the gates. The transition to the gates (figs. 7 & 8) was formed with plaster of paris between equally spaced templates cut to conform to the inside of the tunnels. The upstream rectangular tunnels were formed to represent the prototype section containing the emergency gates. These will be referred to as gates 1, 3, 5, and 7 numbered from left to right looking downstream. As these gates are not to be operated often, only the

gate sills were constructed (fig. 7). Piezometers were provided to measure the head in the rectangular tunnels immediately upstream from the gates. The operating gates, which will be referred to as gates 2, 4, 6, and 8 numbered from left to right looking downstream, were constructed of brass to simulate the 5-foot by 5-foot slide gates of the prototype (fig. 8).

The transition from the gates was constructed in two parts (fig. 8). The upstream portion consisted of four metal tunnels with  $\frac{1}{2}$ -inch radius leather fillets; the downstream portion was formed in a split mold with plaster of paris poured around two wooden cores. The mold was contained in a sheet-metal box to which were bolted the adjoining parts. Two metal horseshoe tunnels (fig. 7) were constructed with removable tops to permit observation of the flow. These extended from the transition to the stilling pool box.

8. Flow conditions. The upstream portion of the outlet gate transition (figs. 7 and 8) was added to the gate section, and

10. Flow conditions. The downstream portion of the transition (figs. 7 and 8) was added, and the top of the transition was removed to facilitate observation of the flow. The flow from the two center gate tunnels produced satisfactory flow conditions in the transition tunnel, but the flow from the two outside gate tunnels gave adverse flow conditions. Plate 2-A, -B, -C, and -D shows the flow conditions with all gates open an equal amount. Plate 2-E, -F, -G, and -H shows the flow with one side gate (gate 2) and one center gate (gate 6) set equally at various openings, the remaining two gates being closed.

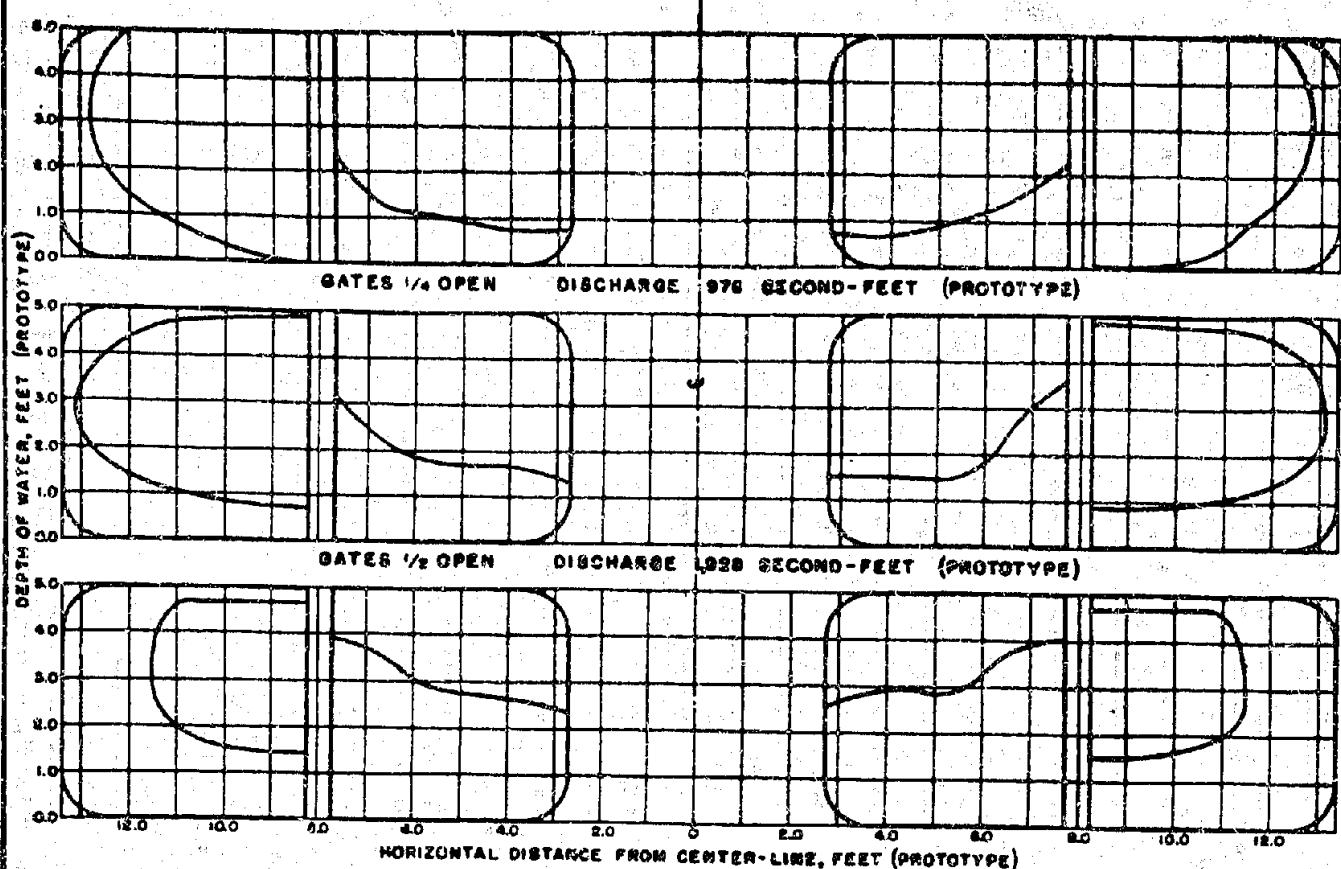
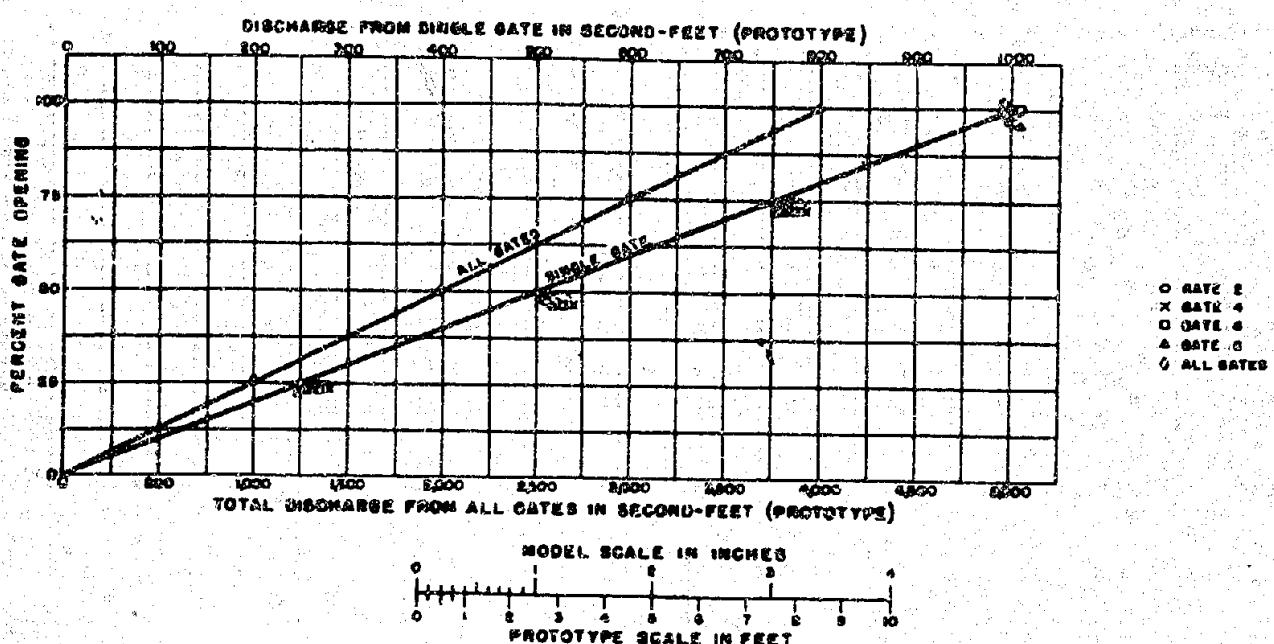
## FLOW THROUGH GATES AND TRANSITION

the hydraulic action was observed for different gate openings. As the gate opening was increased, the transition tunnels flowed free until a gate opening of 97 percent was reached. At this point the tunnels flowed full. Figure 9 shows the water surfaces at the downstream end of this portion of the transition for three different gate openings and for the tunnels flowing free. As the gates were closed, the tunnels flowed full until an opening of 36 percent was reached, after which the tunnels flowed free. Plate 1-E, -F, -G, and -H, shows the flow in the tunnels for different conditions of discharge and gate openings.

9. Effect of air vents. Air vents were placed immediately downstream from the gate section to aerate each transition tunnel. The use of several sleeves of telescope tubing provided a convenient method of varying the size of the air vent. It was found that a tube with an inside diameter of 3/16-inch was the smallest air vent that would allow the water in the tunnels to flow free with gates fully open. Plate 1-I and -J shows the effects of the air vents on the flow characteristics.

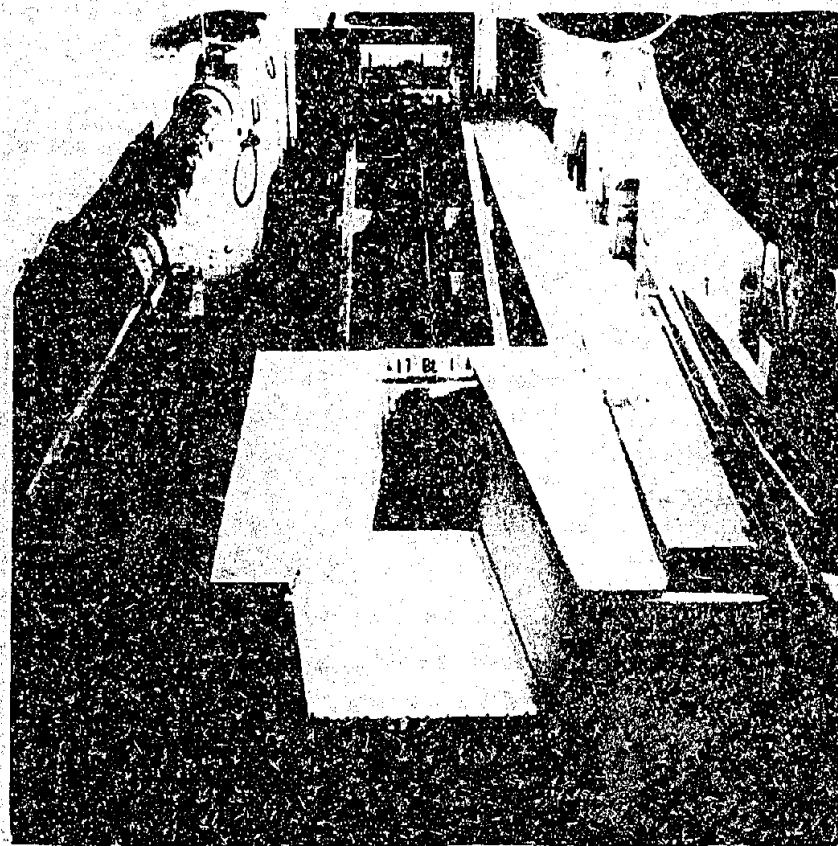
ORIGINAL DESIGN OF STILLING POOL

(1) The hydraulic jump formed inside the tunnels at maximum discharge when the tailwater (fig. 10) was five feet above normal (plate 4-A). This would be the tailwater condition for maximum discharge over the spillway. The forming of the jump in the tunnels caused them to flow full, and due to the increase in friction, the tunnels continued to flow full even after the tailwater was decreased. Aeration of the horseshoe tunnels did not remove this unfavorable characteristic.

(3) When the flow from the two tunnels was unbalanced, adverse flow conditions were produced in the stilling pool. This caused the hydraulic jump to form in the tunnel carrying the small discharge. Plate 4-B shows a discharge of 2,000 second-feet through the left tunnel. Different types of baffle piers failed to decrease the helical flow in the pool.

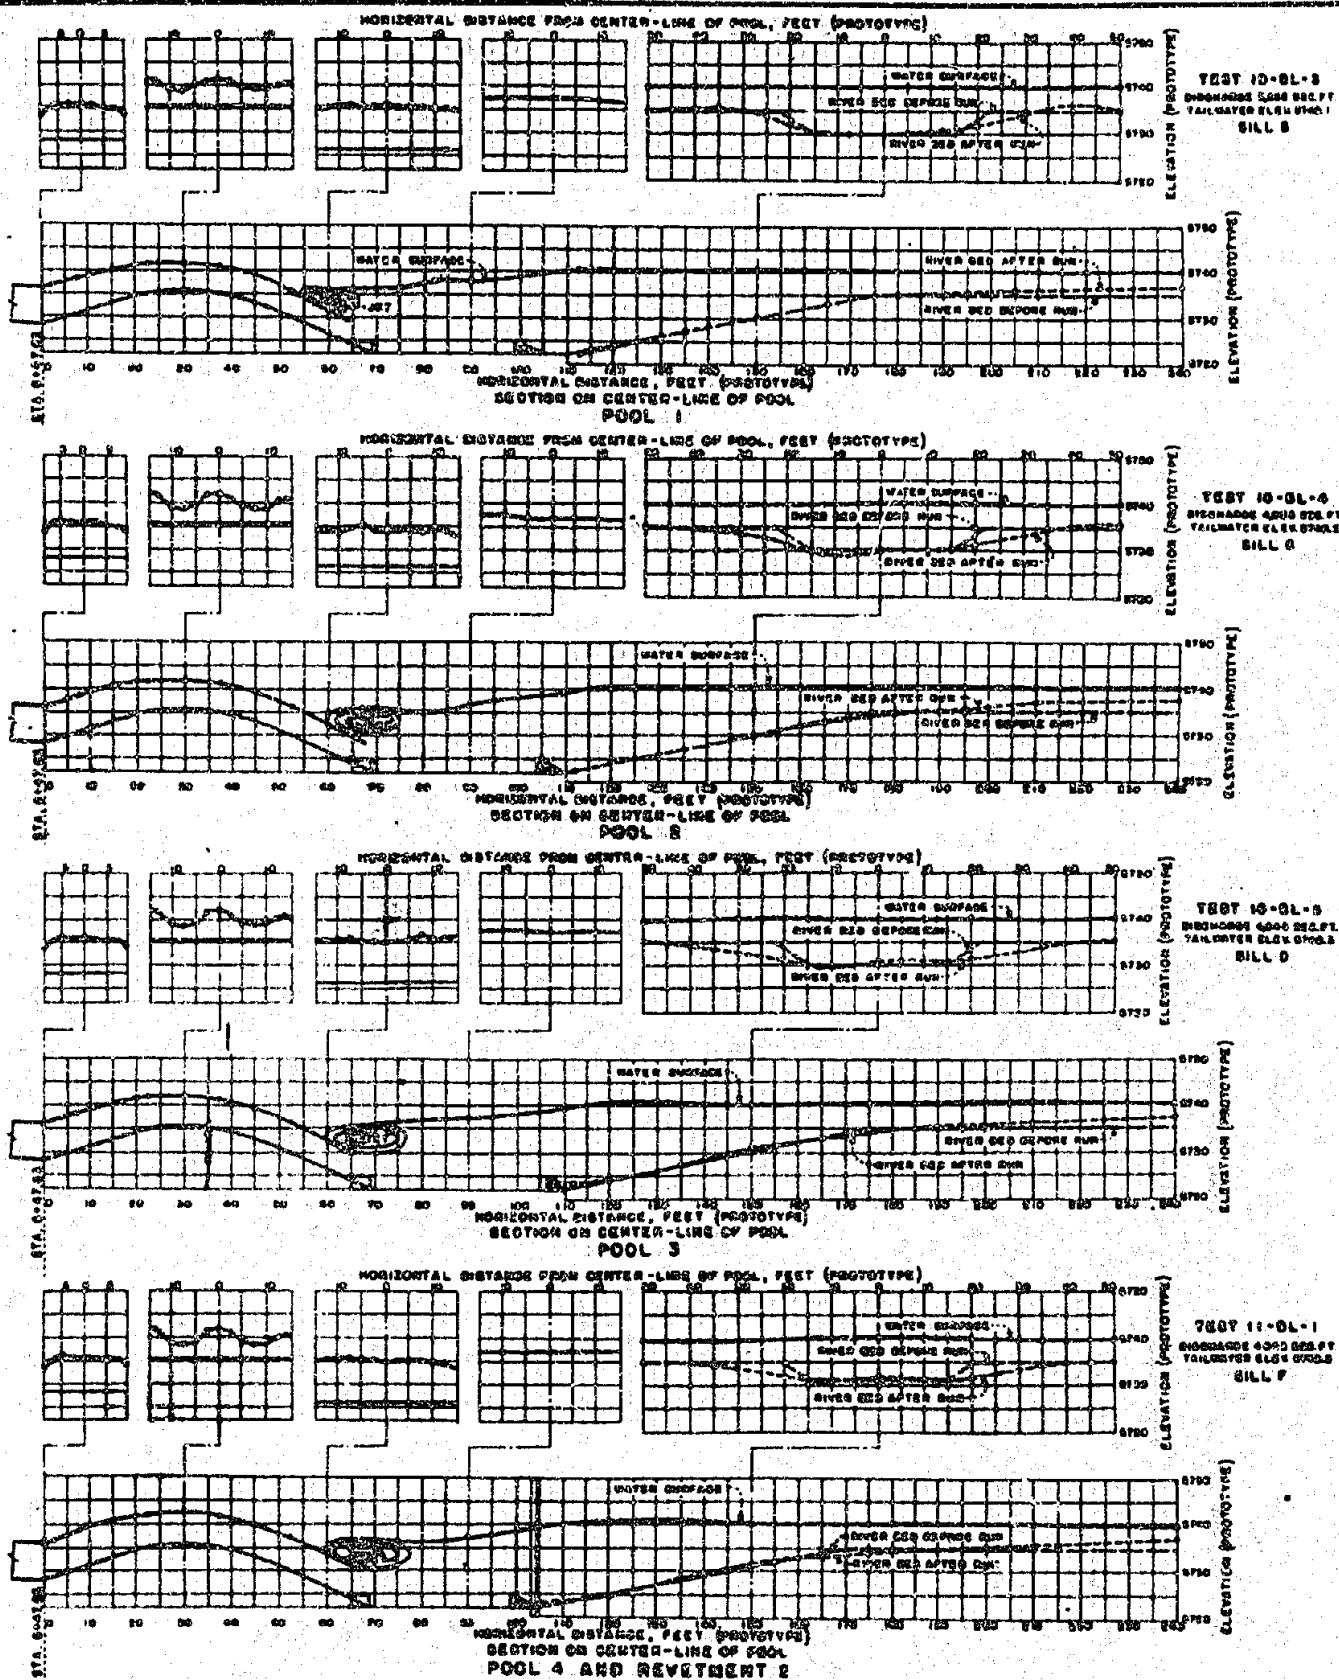
**WATER SURFACE PROFILE AND EROSION  
OF RIVER BED FOR POOLS 1,2,3 AND 4**

Sections are taken at downstream.  
Erosion of river bed after one  
hour. (Model).

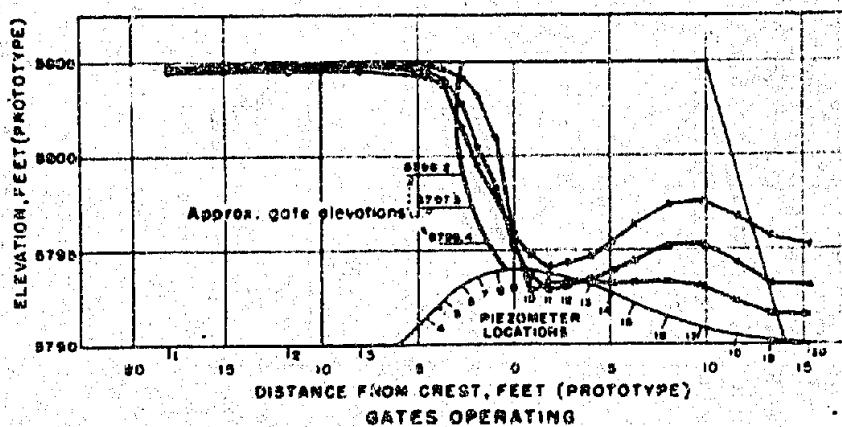
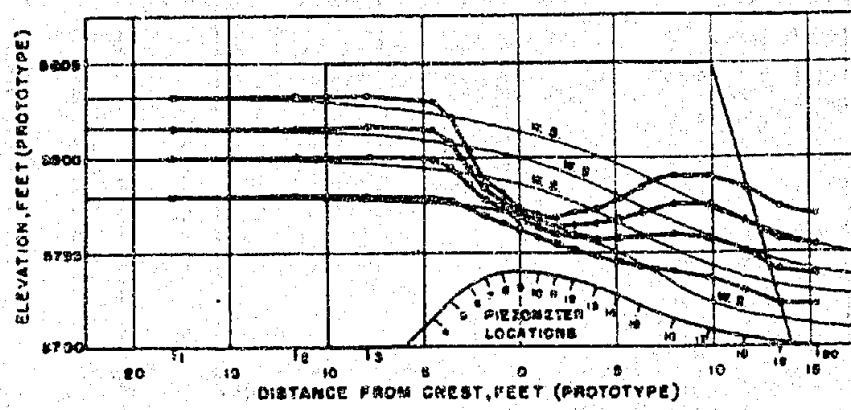
### WATER SURFACES AND PRESSURES OVER CREST

The pressure distribution (fig. 18) on the crest was measured both with and without the gates in operation. Slight negative pressures were noted for discharges of 2,500 and 5,000 second-feet with the reservoir water surface at elevation 5805.0 and with the gates in operation. Free flow over the crest gave positive pressures for all discharges. Water surface profiles (fig. 18) on the center line of the middle gate were also taken for various discharges.

- Pressures for discharge of 14,000 second feet.
- Pressures for discharge of 7,800 second feet.
- △ Pressures for discharge of 5,000 second feet.
- × Pressures for discharge of 3,000 second feet.

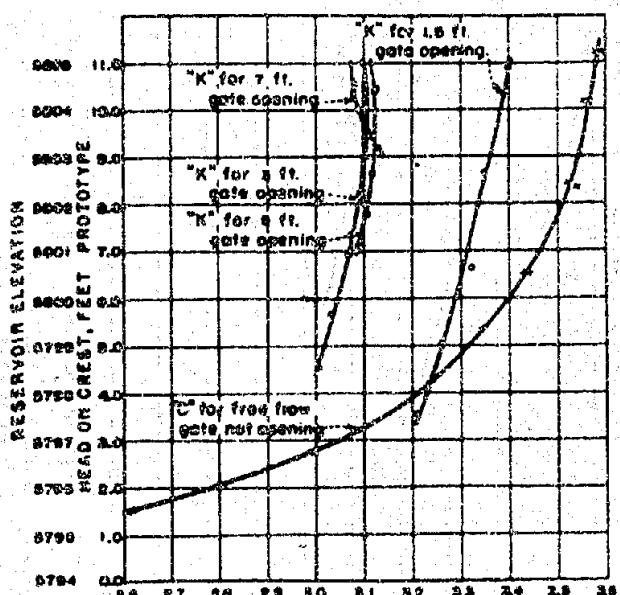
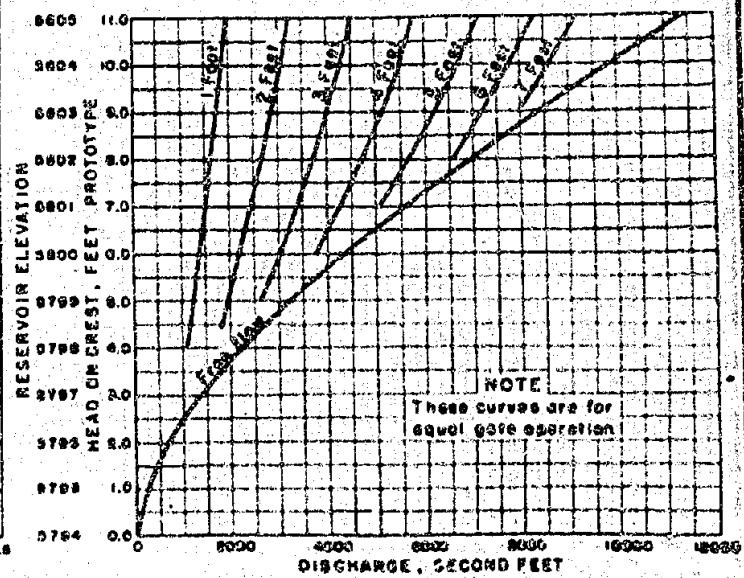
### SPILLWAY DISCHARGE CURVES

$$"C" \text{ IN DISCHARGE FORMULA } Q = C L H^{1/2}$$

$$"K" \text{ IN DISCHARGE FORMULA } Q = K L V E T [(H+C)^{1/2} - N^{1/2}]$$

#### DISCHARGE COEFFICIENTS OF RADIAL GATES

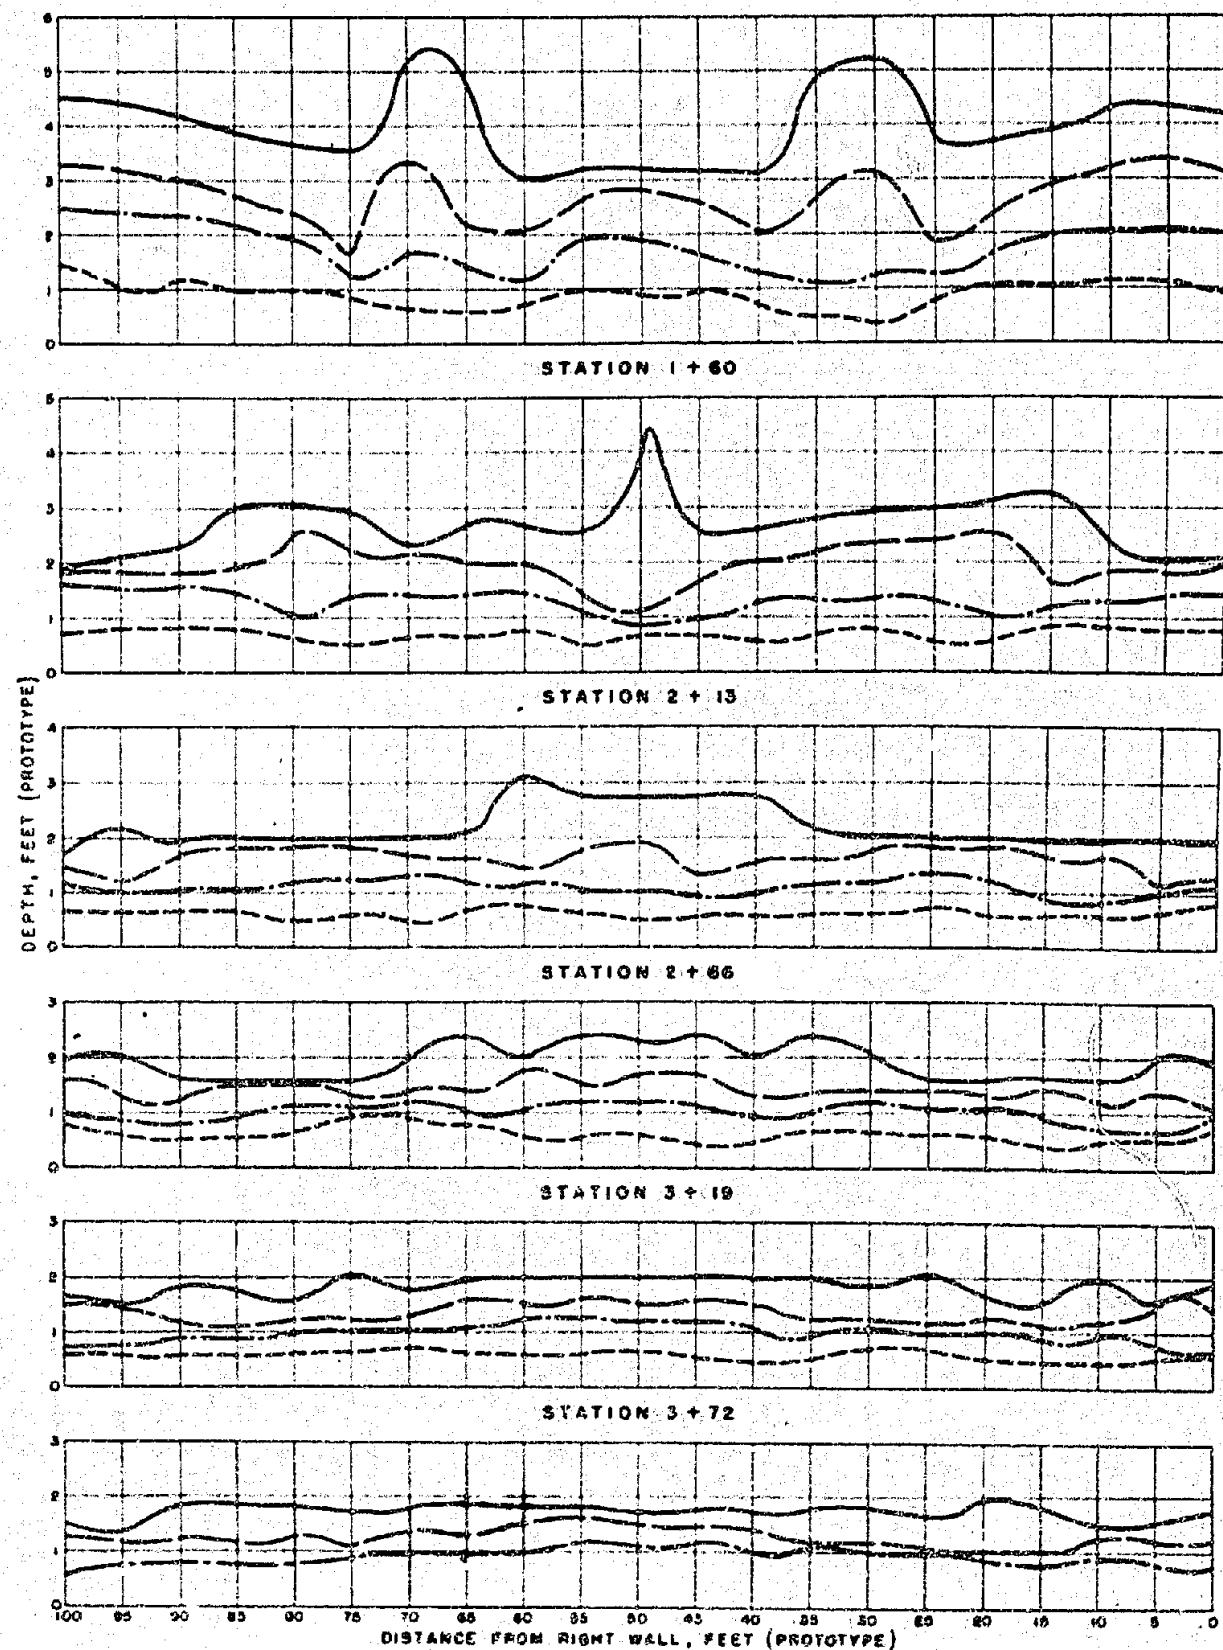
FIGURE 10

EXPLANATION  
SYMBOL      PROTOTYPE DISCHARGE  
—            10,000 SECOND-FEET  
—            7,000 SECOND-FEET  
—            5,000 SECOND-FEET  
—            2,000 SECOND-FEET

WATER SURFACE PROFILES  
ORIGINAL PIERS
