HYDRAULIC LABORATORY REPORT NO. HYD - 26.1

Technical Memorandum No. 556

HYDRAULIC MODEL EXPERIMENTS FOR THE  
DESIGN OF THE OUTLET WORKS AND SPILLWAY OF  
THE BULL LAKE DAM

Denver, Colorado  
July 15, 1937

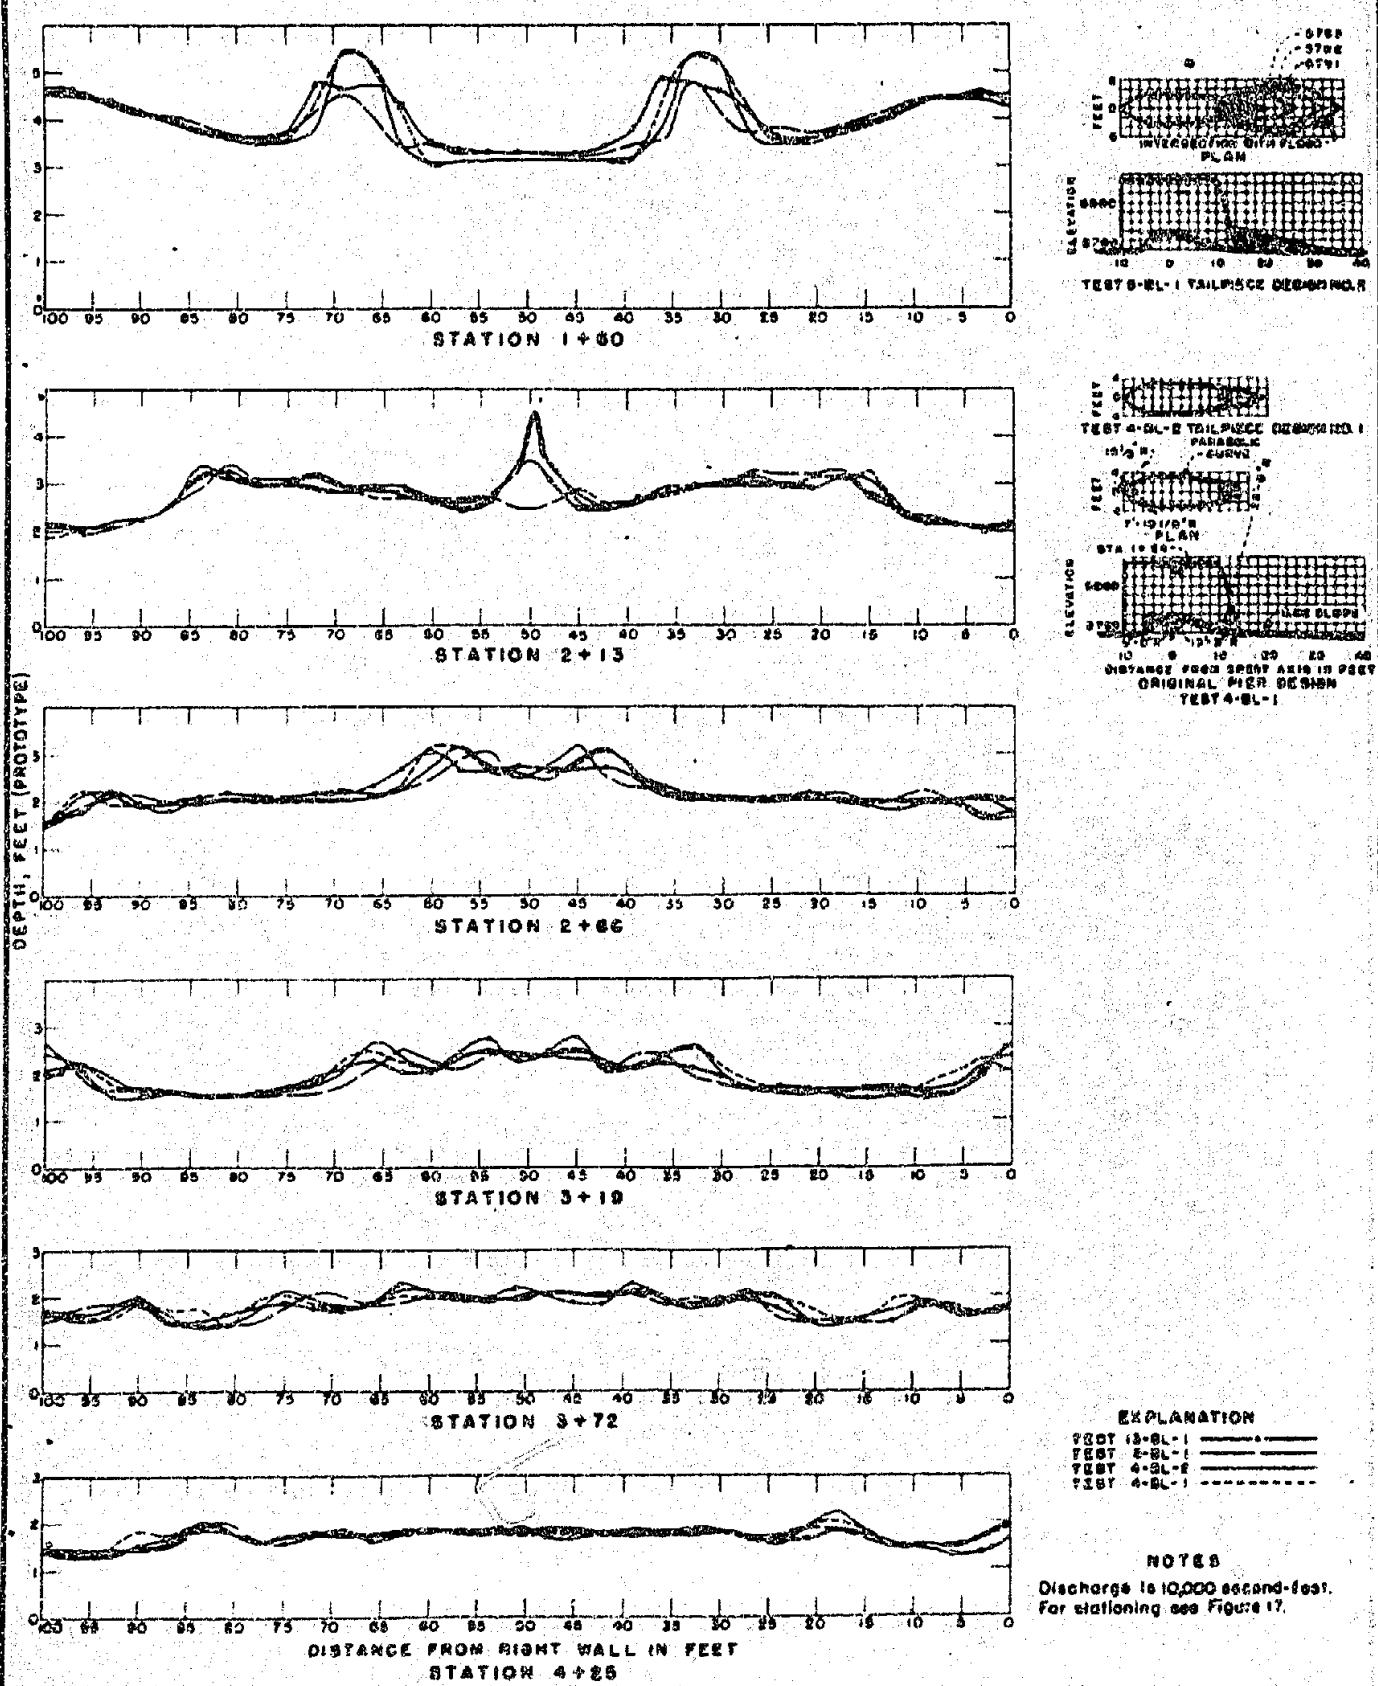
FIGURE 20

WATER SURFACE PROFILES - COMPARISON OF TAILPIECE DESIGNS  
USED ON ORIGINAL PIERS

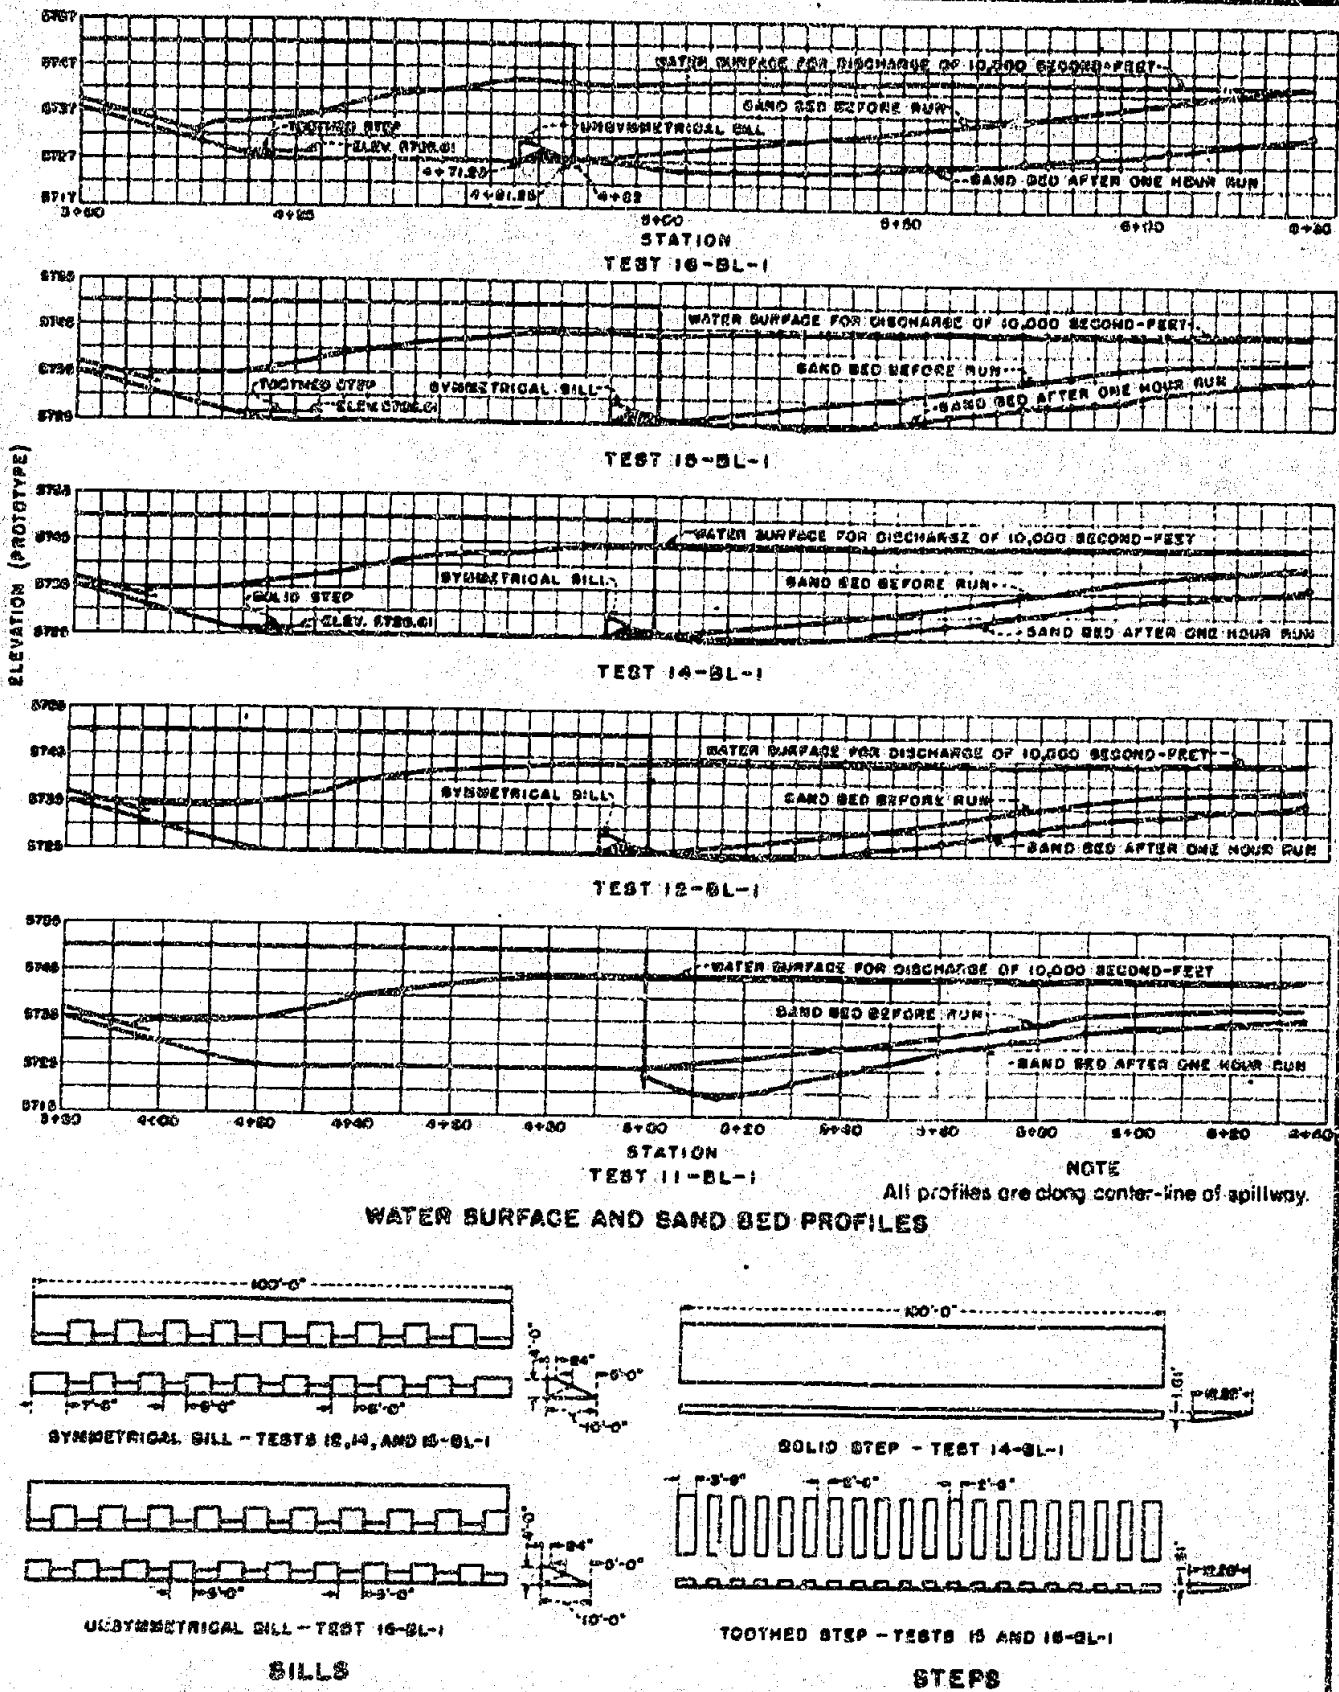
FIGURE 23

Four tests were made using sand downstream from the apron to study the effectiveness of the symmetrical sill, dentated step, and solid step (fig. 23) in preventing erosion of the stream bed. The results of these tests (fig. 23 and plate 11) showed that the symmetrical sill was very effective in preventing erosion of the river bed, and that neither the dentated step nor the solid step aided in scour prevention downstream from the apron. The tops of the brass rods in the pictures indicate the original sand bed. The steps were effective in holding the jump in the pool at tailwater elevations much lower than normal. As the foregoing test indicated ample tailwater depth as well as more than sufficient pool length, the apron was raised and the pool shortened.

24. Recommended design. The pool floor was raised two feet from elevation 5725.0 to elevation 5727.0 and the structure was shortened 18 feet, from station 5+00.0 to 4+82.0. A tentative recommended design had a dentated step at station 4+25.0 and an unsymmetrical sill (fig. 23) placed with its downstream edge at station 4+81.25. The step was used to keep the jump within the pool at abnormally shallow tailwaters and the unsymmetrical sill was used because it simplified the expansion-joint spacing. Test 16 on this arrangement was comparable to the erosion tests on the original pool, and the scour downstream from the apron was not serious (fig. 23).

In the final recommended design, the dentated step was omitted because it was found that a 50-foot strip of riprap downstream from the apron was equally effective in keeping the jump in the pool at abnormally low tailwater elevations. The unsymmetrical sill was also replaced by the symmetrical sill because the erosion was more severe downstream from the ends of the former.

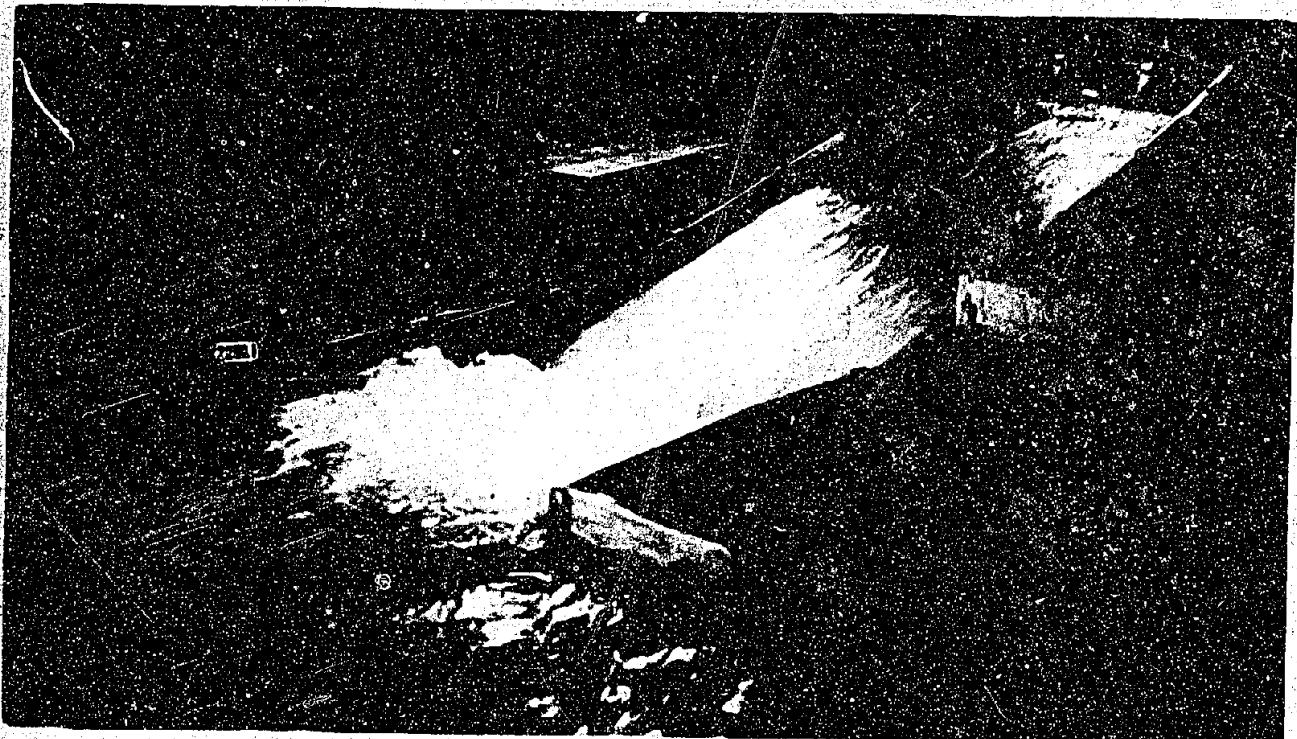
RECOMMENDED SPILLWAY DESIGN

NO FLOW

DISCHARGE 10,000 SEC/SEC

gate combinations failed to disclose any dangerous flow conditions in the pools, and only the worst conditions are shown on plate 13. Plate 14 shows the recommended design.
