HYDRAULIC MODEL STUDIES OF THE SPILLWAY AND
OUTLET WORKS OF ANCHOR DAM--OWL CREEK UNIT
MISSOURI RIVER BASIN PROJECT

Hydraulic Laboratory Report No. Hyd. 289

February 9, 1951

Subject: Hydraulic model studies of the spillway and outlet works of
Anchor Dam--Owl Creek Unit--Missouri River Basin Project.

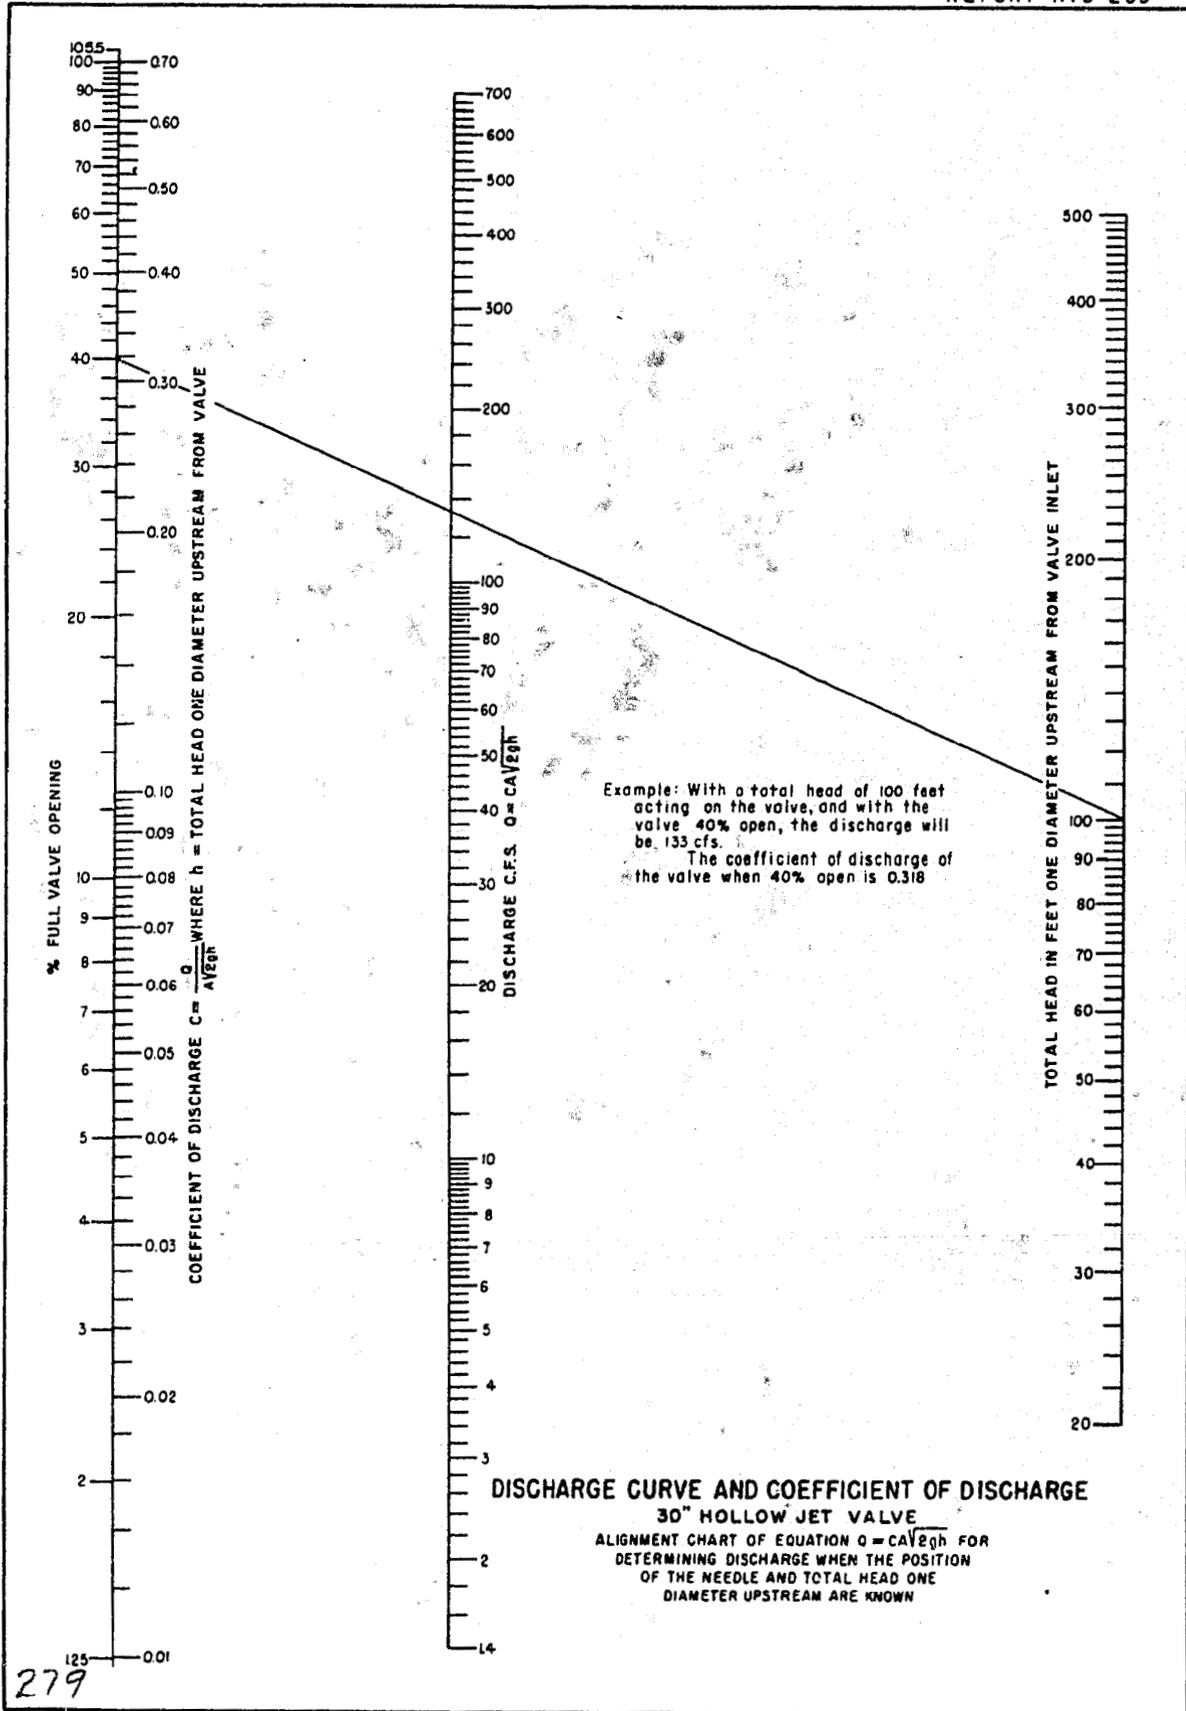
The rate of discharge for one of the two 30-inch hollow-jet outlet works valves is presented as an alignment chart of total head one diameter upstream from the valve inlet versus valve opening (Figure 15). The

relation of the discharge coefficient to the valve opening is also shown in this figure. The coefficient is based upon the total head on the valve centerline one diameter upstream from the valve inlet and upon the area of the conduit at the valve inlet. When both valves operate the total outlet works discharge may be obtained by adding the discharges of the valves.

13. An alignment chart showing the discharge for one of the two 30-inch hollow-jet valves of the outlet works is presented in Figure 15.
