SPILLWAYS AND ENERGY DISSIPATORS

Jacob E. Wernick, M. Am. Soc. C. E.,
Hydraulic Engineer, Bureau of Reclamation,
Denver, Colorado.

A paper to be presented by the author on June 14, 1939, before the Hydraulics Conference at Iowa City, Iowa, under the auspices of the Civil Engineering Division of the Society for the Promotion of Engineering Education and the Iowa Institute of Hydraulic Research.

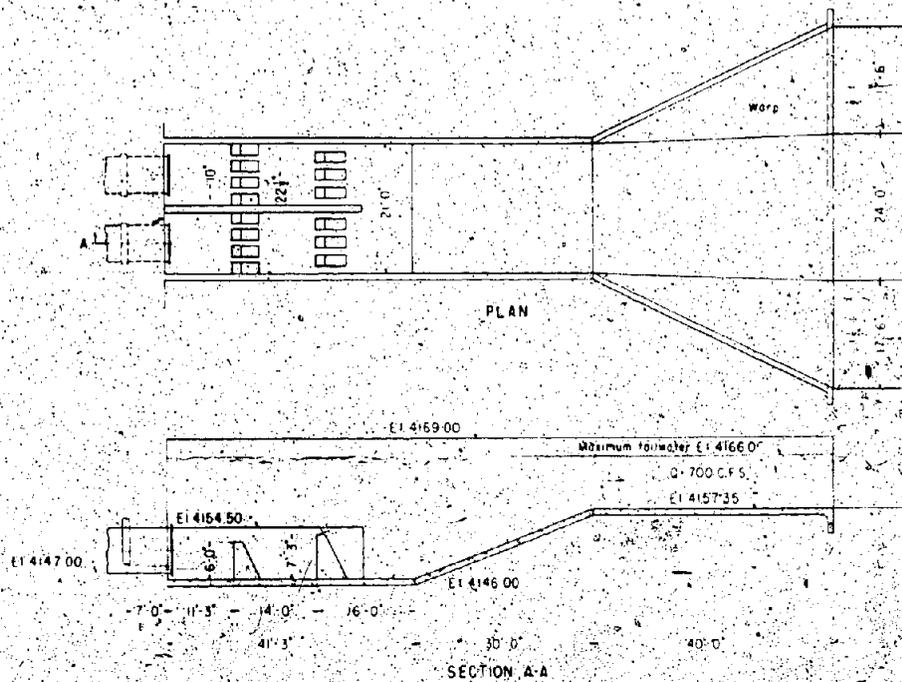
Figure 2, - Stilling Pool for Irrigation Outlet Works at Conchas Dam - Tucumcari Project.

very high, and since excessive tailwater prevents the formation of a hydraulic jump, baffle piers were located in the path of the high-velocity jet to disperse the velocity. The center training wall is necessary to prevent return eddies when one gate only is operating. The chief objection to impingement as an energy dissipator is the difficulty of inspection and maintenance of the impact surfaces. In this case, the pool can readily be unwatered during the winter months and necessary repairs made. The upstream face of the piers will be armored with standard 18-inch channels with the legs imbedded in the piers.

Direct impingement as a means of energy dissipation is not utilized except as a last resort when other methods fail. A recent study of a design for the Conchas Dam irrigation outlet works (figure 2) ended in impingement as a solution. Excessive tailwater caused by the bottom of the canal downstream from the outlets being located several feet above the conduits rendered a hydraulic jump or a roller design out of the question. Each of the two conduits will discharge 350 second-feet under a maximum

head of 64 feet, or one outlet may discharge 700 second-feet under the maximum head. With these conditions the exit velocity will be

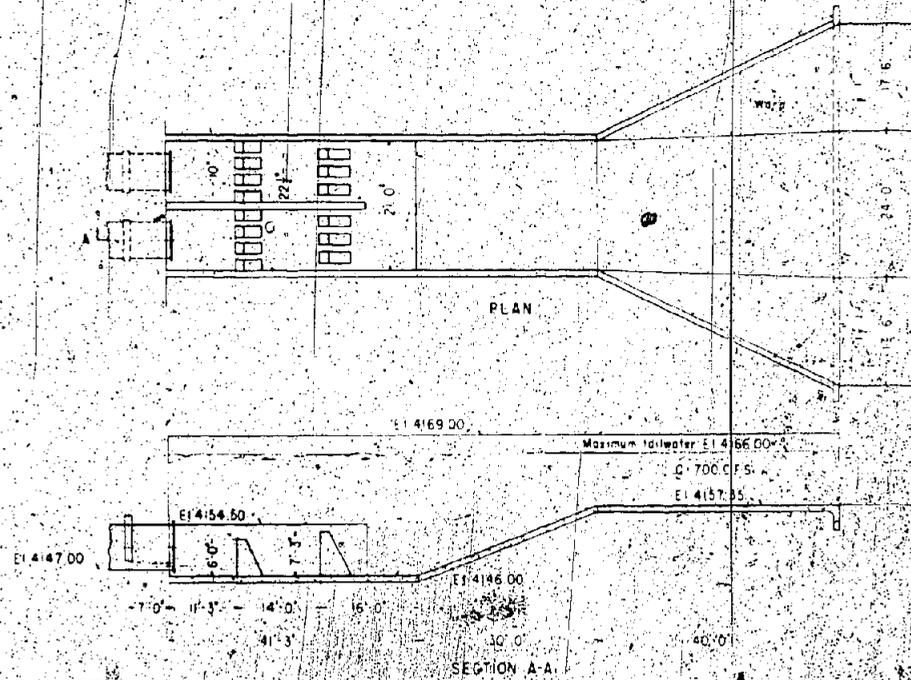
Figure 2 - Stilling Pool for Irrigation Outlet Works at Conchas Dam - Tucumcari Project.

very high, and since excessive tailwater prevents the formation of a hydraulic jump, baffle piers were located in the path of the high-velocity jet to disperse the velocity. The center training wall is necessary to prevent return eddies when one gate only is operating. The chief objection to impingement as an energy dissipator is the difficulty of inspection and maintenance of the impact surfaces. In this case, the pool can readily be unwatered during the winter months and necessary repairs made. The upstream face of the piers will be armored with standard 18-inch channels with the legs imbedded in the piers.

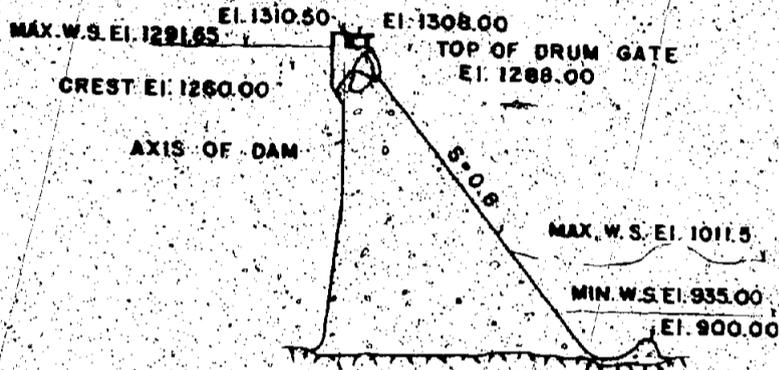
Figure 3 - Section Through Spillway of Grand Coulee Dam.

An example of a roller as a means of energy dissipation is the stilling pool designed for Grand Coulee Dam (figure 3). With a designed capacity of one million cubic feet per second and a difference in head of 230 feet, the energy to be dissipated will be 31,800,000 horsepower, or 19,300 horsepower per foot of gross

spillway crest length. An excess of tailwater depth made a hydraulic jump pool impracticable due to the enormous cost of a sloping apron whereby an agreement could be obtained between the tailwater curve and the jump-height curve. An apron curved in section (Figure 4) and placed at a very low elevation was developed. The final design of this curved apron, for a total length of 500 feet, was tangent to the 0.8 slope of the spillway face and to a 1:1 slope on the downstream portion.

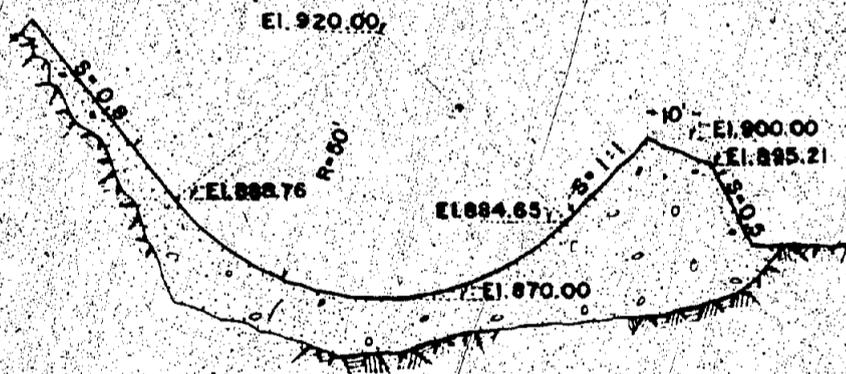
Figure 4 - Section Through Roller Stilling Pool.

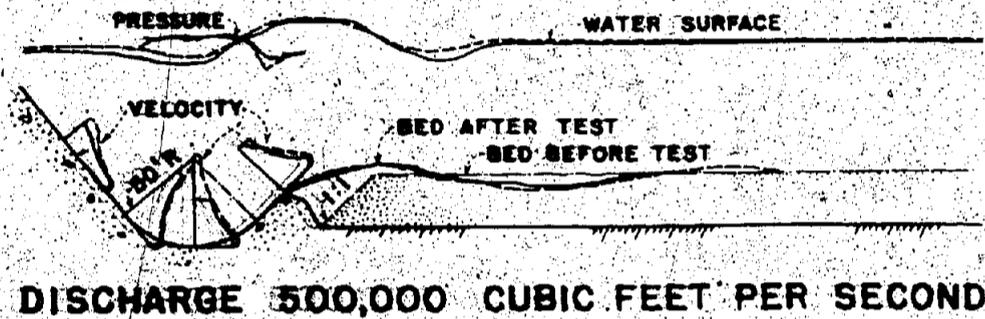
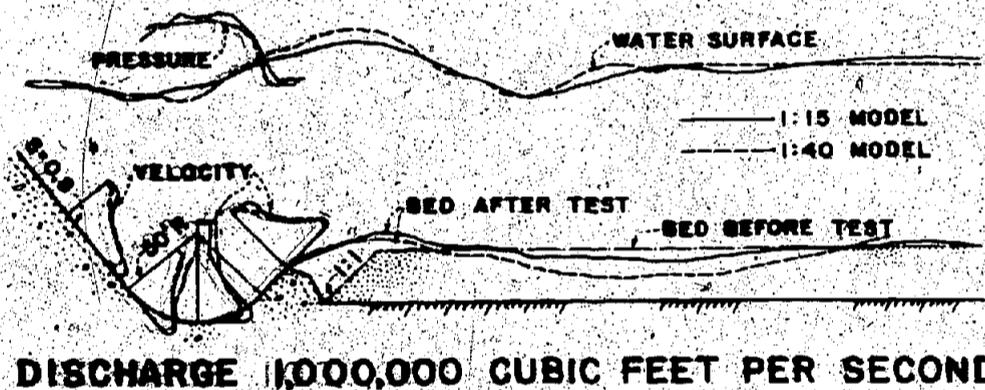
The behavior of the internal mechanism of the roller was clarified by velocity traverses (figure 5) within the bucket. As the descending sheet of water plunged into the tailwater, a large reduction of velocity occurred and the sheet diverged in the same fashion as in the transition zone of a hydraulic jump. After the stream entered the bucket proper, it was diverted with a practically constant velocity to the top at elevation 900.0. The effect of the

Figure 5.- Flow Characteristics in Grand Coulee Bucket.

lip is to divide the jet into two parts, one of which is deflected upward to form the elliptical surface with its major axis in a horizontal plane above the bucket; the other is turned downstream to form the ground roller.

The extent of velocity reduction, and hence energy dissipation, can be appreciated by an examination of the velocity traverses made in the stilling bucket. With a spillway discharge of 800,000 second-feet, the maximum velocity measured in the model at the point where the ascending sheet enters the pool and converted to prototype was 157.0 feet per second. This was a reasonable agreement with the calculated velocity of 141 feet per second. At the point of vanancy, the maximum measured velocity was 55 feet per second.

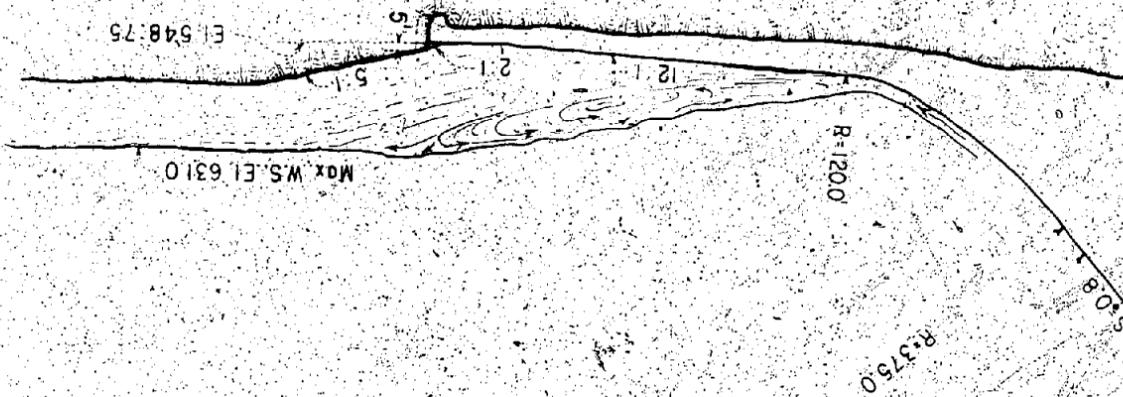
Figure 3 - Final Design of Stilling Pool for Shasta Dam.

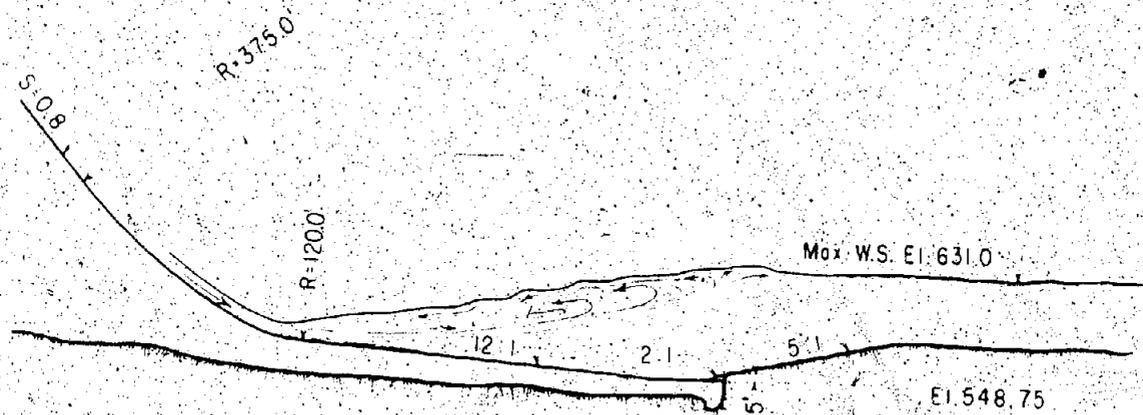
Figure 6 - Final Design of Stilling Pool for Shasta Dam.

An 8:1 sloping apron improved the action so that the jump could not be crowned on the model and the tailwater at which minimum velocity occurred could not be reached. Even so, the velocity at the end of the apron was equal to or less than the minimum for the original design. The jump-height curve obtained visually coincided with the natural tailwater curve for all flows except those near the maximum of 250,000 second-feet where five feet additional depth was found necessary to give satisfactory conditions.

A 12:1 apron, which deepened the pool at the upstream end, corrected this condition. The jump had an efficient appearance for all discharges and it was noted that any appreciable increase in tailwater depth for the maximum discharge gave a rougher pool surface. It was noted also that considerable reduction in tailwater depth gave rough but satisfactory conditions, thus creating a factor of safety.

The most widely used method of dissipation is the hydraulic jump stilling pool. Excellent examples of its application in recent years are the Norris Dam, constructed by the Tennessee Valley Authority; the Madden Dam, built by the Panama Canal Zone; and the Shasta Dam (figure 6) now under construction of the Bureau of Reclamation.

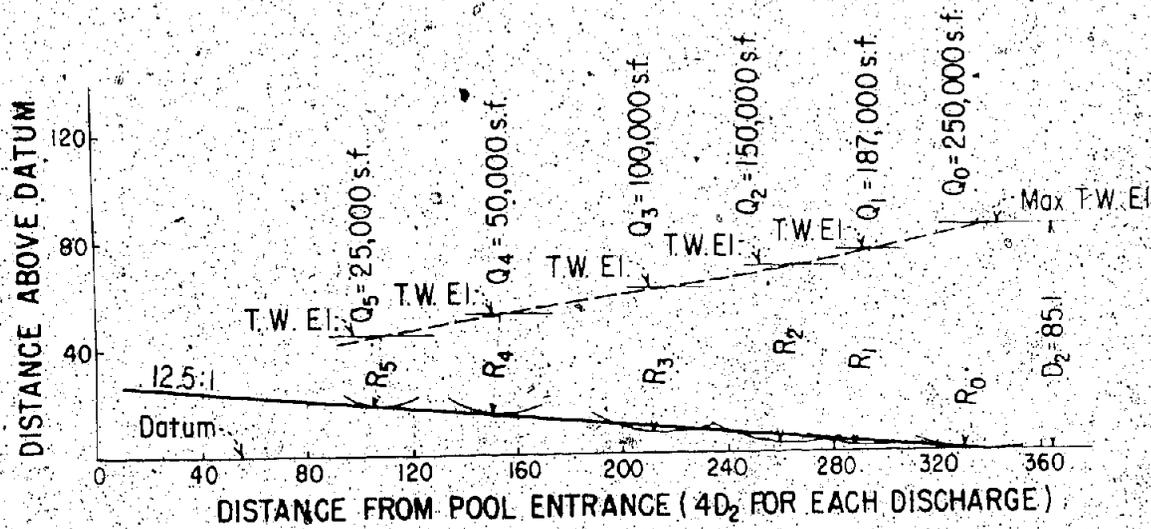
In the computation (figure 7) of the slope of the apron, the length of jump was conservatively assumed to be four times the depth downstream from the jump. Using the momentum formula for a

R_0, R_1, R_2, R_3, R_4 and R_5 are equal to the values of D_2 for the respective discharges, Q_0, Q_1 , etc.

Figure 7 - Design of Sloping Apron for Shasta Dam.

the values of D_2 for different discharges were computed. With the pool entrance as an origin, length of pool as abscissa, and elevation as ordinate, the tailwater elevation for each discharge was plotted a distance of $4 D_2$ from the origin. With these points as centers and radii equal to the respective D_2 , arcs were drawn below. A line tangent to these arcs is the profile of the stilling apron to be used. The slope of the Shasta apron computed by this method was 12.5:1. A slope of 12:1 had been previously determined by the model studies.

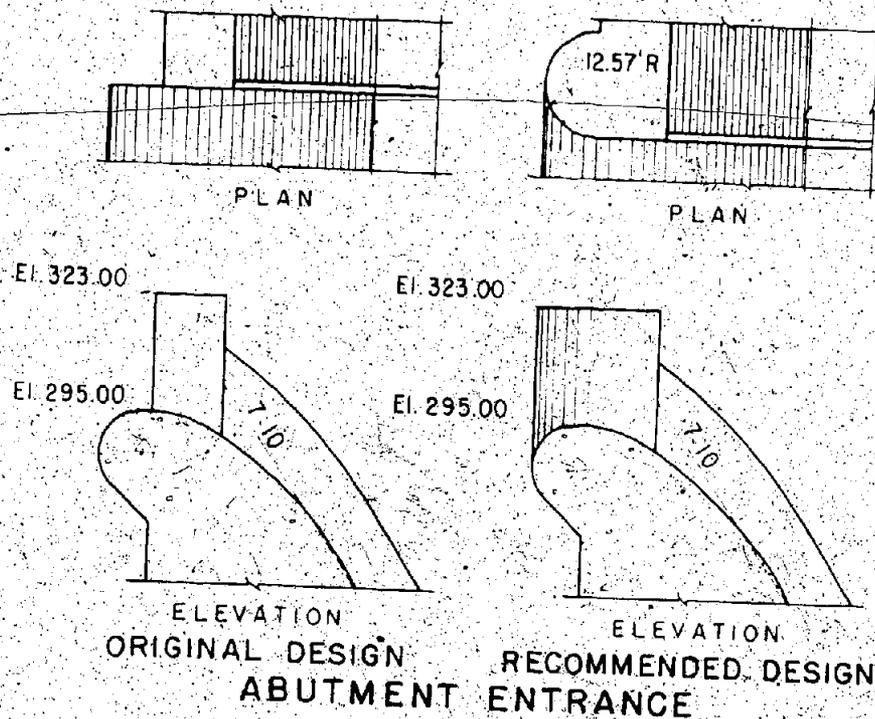
Figure 8 - Change of Entrance Conditions on Dos Bocas Dam.

Flow conditions for the maximum design discharge of 400,000 cfs. are satisfactory except for a small whirl on each side of the stilling pool.

In 1937, the problem of the spillway for the Dos Bocas Dam being constructed by the Rural Electrification Division of the Puerto Rico Reconstruction Administration was undertaken by the Bureau of Reclamation upon the recommendation of the consulting board. Operation with the original abutment entrance design was very unsatisfactory. The square entrances caused the sheet of water to spring free from the spillway sides, resulting in a much reduced flow at the side walls and a concentrated flow in the center of the stilling pool. This unbalanced condition caused a severe whirl on each side of the pool. These whirls caused disruption of the hydraulic jump formation. The introduction of a curved entrance at each abutment (figure 8) and the streamlining of the upstream nose of the bridge piers eliminated this undesirable condition. As the studies progressed, a position of the stilling floor was developed which produced

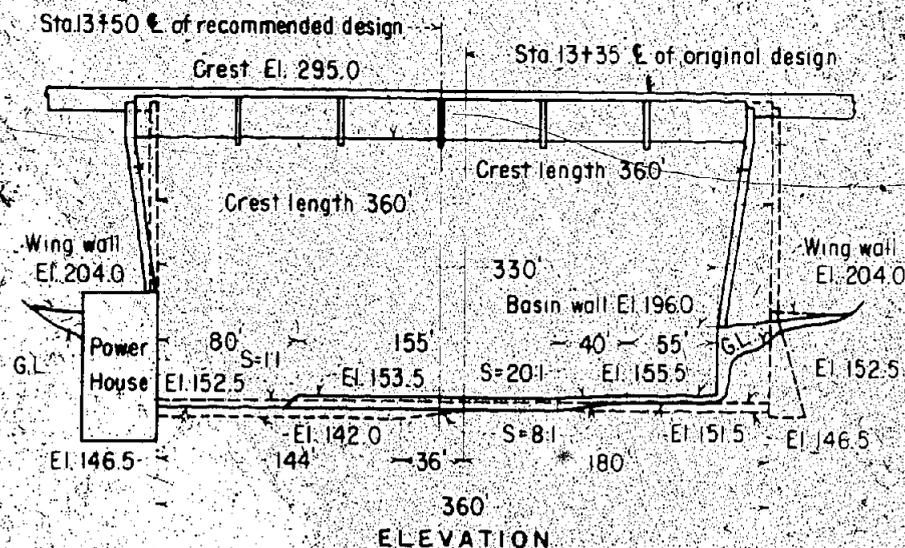
Figure 9 - Downstream Elevation of Dos Bocas Spillway, Showing Original and Recommended Design.

The first cause of this whirl was that even with the change of design on the bridge piers and abutment entrance there was still some lack of uniform distribution of flow over the extreme ends of the spillway. Secondly, at flows of less than 75,000 second-feet, the topography downstream on the left side acted as a control forcing the stream over into the main channel. As a result, a "dead" area was formed from which water flowed back into the jump area, disrupting the jump and forming the whirl. Sills, dentates and variations of the apron elevation did little toward elimination of the whirl. The final solution (figure 9 and figure 10) consisted of shifting the entire spillway crest fifteen feet to the right and converging the spillway and stilling pool wall toward the downstream end of the apron. The step by step analysis of this change is as follows: By rotating the left wall about its intersection with the crest line so that the downstream end

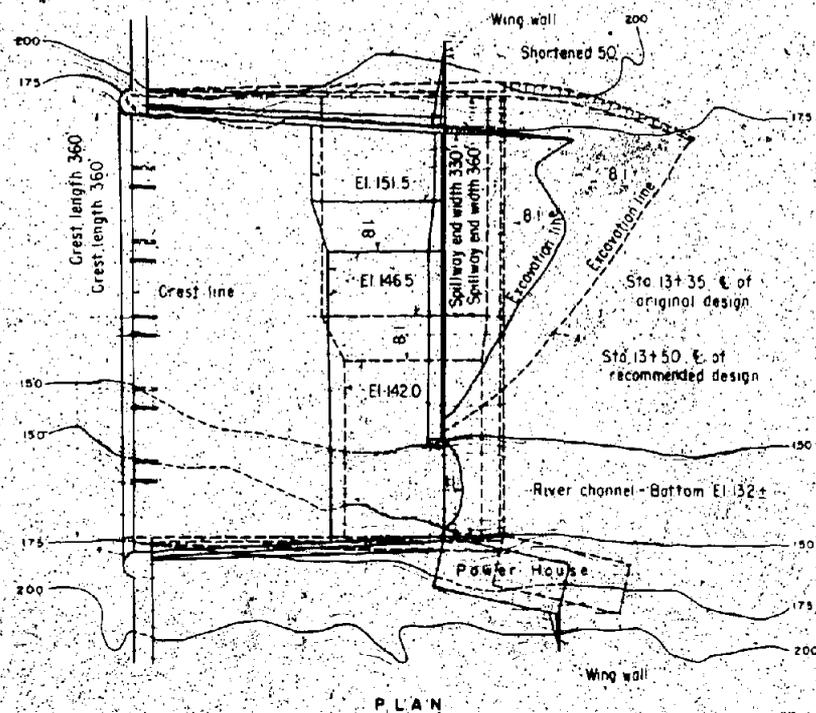
Figure 10 - Plan of Dos Bocas Spillway Showing Original and Recommended Designs.

which the whirl formed was eliminated. To establish symmetry of design again the right wall was rotated a similar amount to the left. No adverse effect was noted in the flow conditions; in fact, there was some improvement despite the fact that the downstream end of the apron had been constricted a total of thirty feet. However, the rotation of the right wall moved it fifteen feet out into the river channel. To bring it back to its original position, which was more desirable from a structural standpoint, the entire crest was shifted to the right a distance of fifteen feet, which in effect moved the downstream end of the left training wall thirty feet to the right. This change of position not only appreciably improved the hydraulic conditions in the stilling pool but produced a decided economy by reducing the deep rock excavation on the left side. The depth of excavation at the downstream end of the left training wall was reduced from 45 to 20 feet.

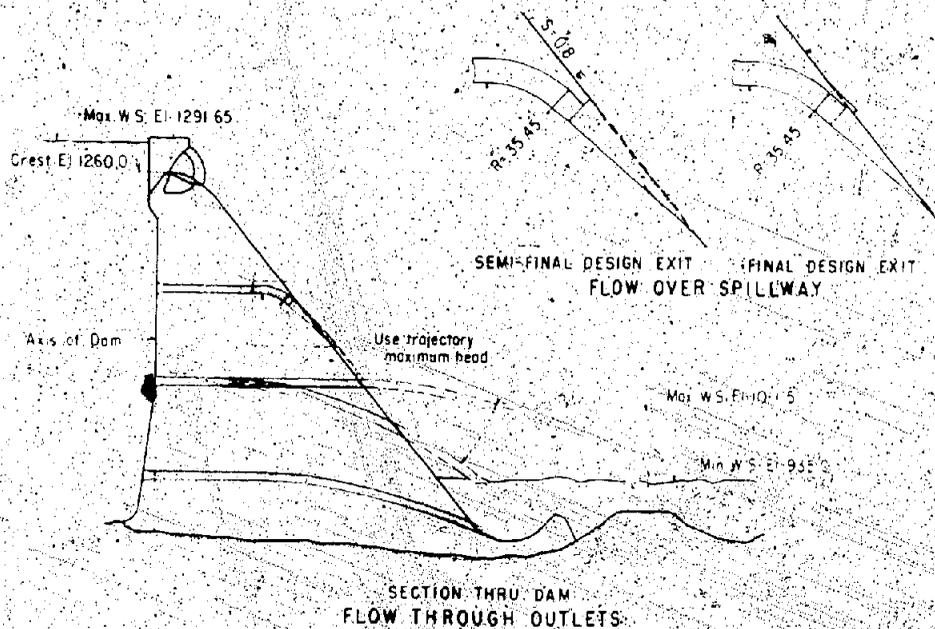
Figure 11 - Design of River Outlets for Grand Coulee Dam.

In the original design of these conduits, they were placed horizontally so that the jet would plunge into the tailwater downstream from the stilling pool. The model showed extreme scour conditions, particularly along the riprapped banks of the powerhouse tailraces. In the next design, the conduits were placed on a parabola through the dam so that the jet would plunge into the spillway stilling pool. The dissipation of energy in the flow from the upper tier was satisfactory, but with a high tailwater the jet from the middle tier was diverted

An important problem in recent developments is the provision of discharge capacity to release water in excess of the power demand. At Grand Coulee Dam (figure 11) three tiers of twenty 8-foot 6-inch outlets are being provided to release 225,000 second-feet, and at Shasta Dam, a total of seventeen outlets of the same size will be provided in three tiers to release a flow of 63,000 second-feet. The two installations have been studied practically as one problem so that the tentative design for Shasta Dam is identical to that of the upper tier at Grand Coulee Dam. Certain last minute changes could not be included at Grand Coulee because of the construction progress.

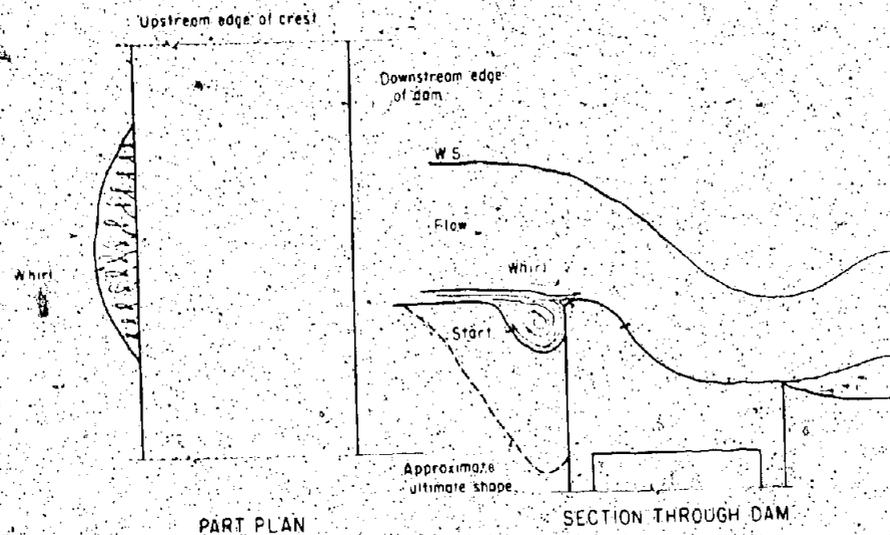
UPSTREAM EROSION
 Figure 1. - Erosion Upstream From Crest of Salt River
 Power Canal Diversion Dam.

The river above the dam carries a heavy bed load and during a flood bars form across the dam completely covering it for short intervals. In the clear water of the model, it could be seen that holes were scoured, to a depth of 12 cent, along the upstream face of the spillway crest. The velocity of approach was high due to the shallow channel and as the water passed over the crest an eddy was formed below the spillway. This eddy picked up bed material from the upstream face of the dam and carried it downstream. The pocket increased in size until the intensity of the eddy was decreased and it could no longer pick up material. The hole was then filled up from the material being moved along the spillway. As a particular hole was filled another would be formed elsewhere (Figure 13). As a hole became filled, the cycle would be repeated. Examination of the portions of the original dam remaining in place disclosed scours to a depth sufficient to explain the observations in the model.

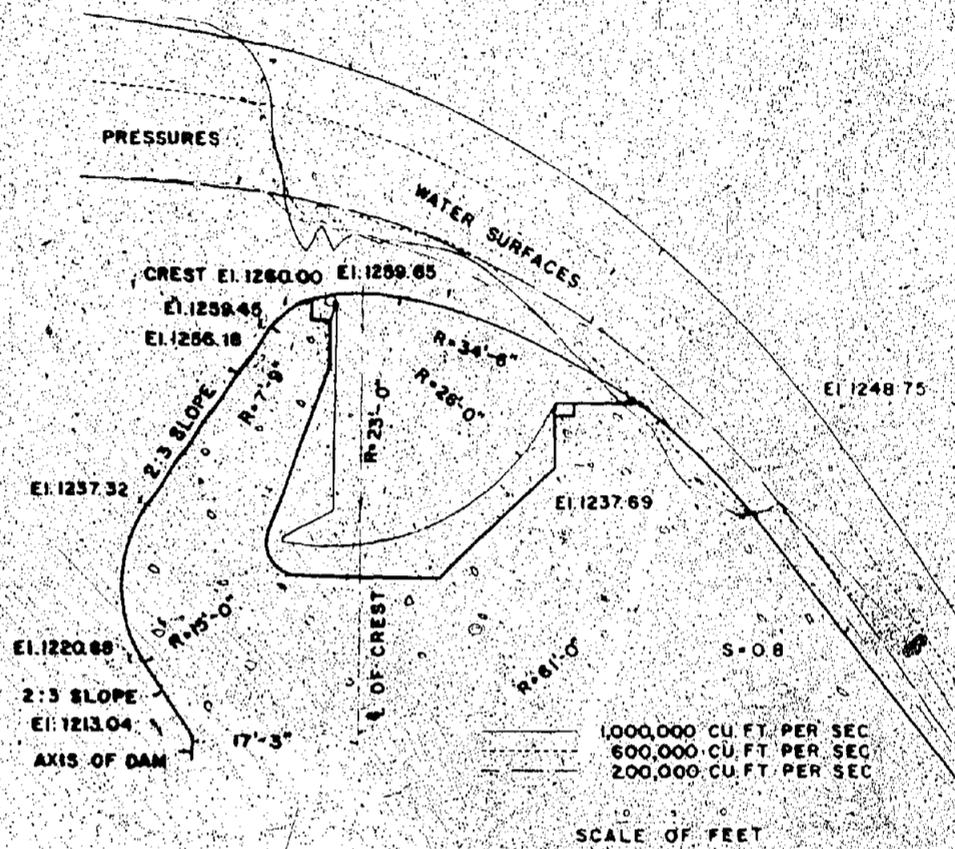
A region of negative pressure at all flow conditions occurred with this design. The indications were that the curvature of the crest was too sharp near the downstream edge of the drum gate. To eliminate this low pressure region, the radius of the large curve was lengthened (figure 18), the axis of the crest moved upstream, and a parabolic curve introduced to connect the simple curve to the 0.8 slope of the downstream face of the spillway. The tests on this section showed that the low pressure zone had been eliminated.

Figure 15 - Original Design of Grand Coulee Spillway One

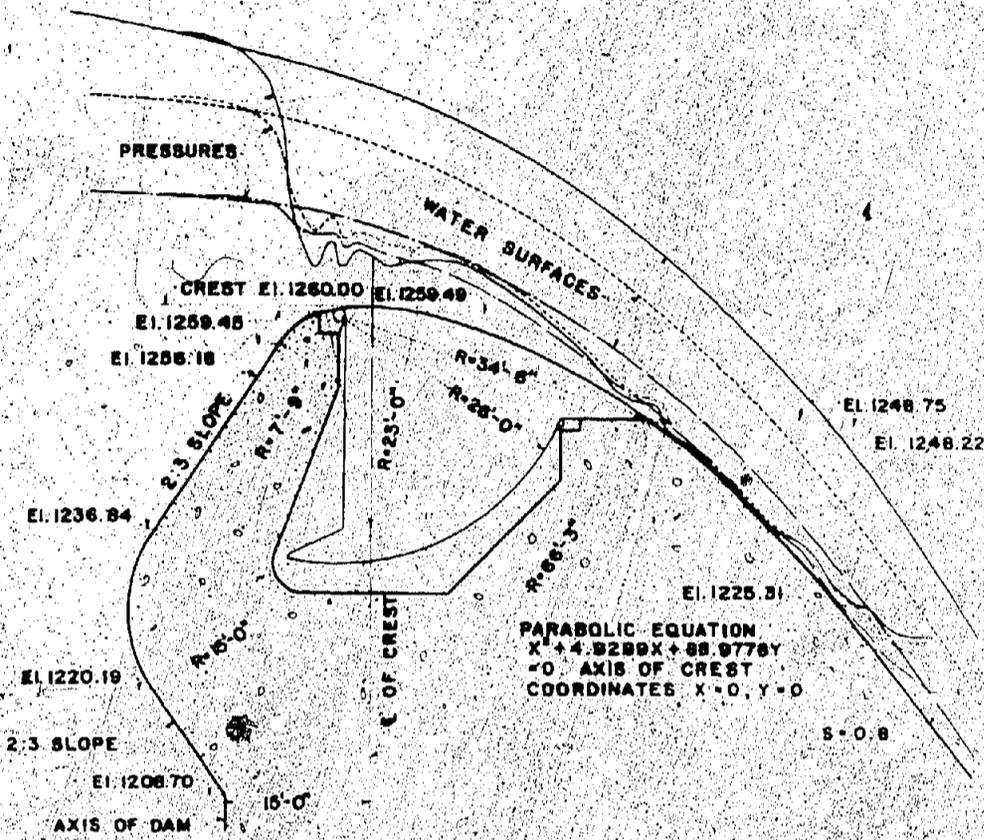
Figure 16 - Final Design of Grand Coulee Spillway Crest.
