Projecting Economic Consequences of Urban Canal Breaches

Adapting risk management techniques for dams to canals

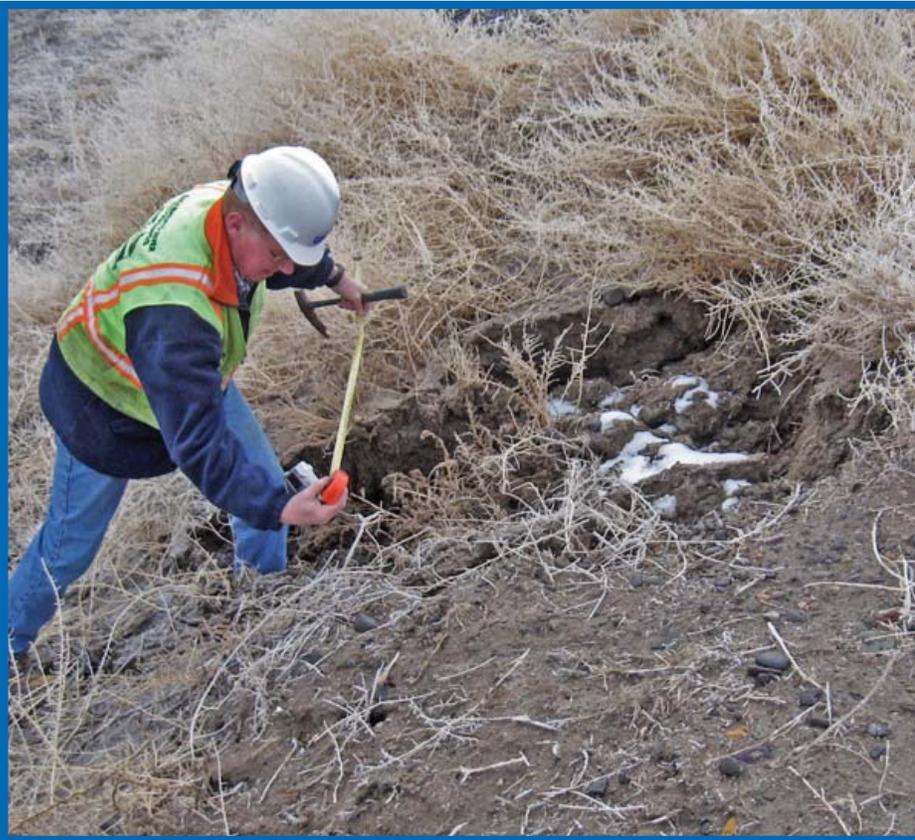
Landside, left canal bank, about 240 feet downstream from canal breach. Collapse feature associated with downhill sediment transport. Three muskrat burrows on the canal side of the embankment near high water line. Photo by M. McCulla, 01-13-2008.

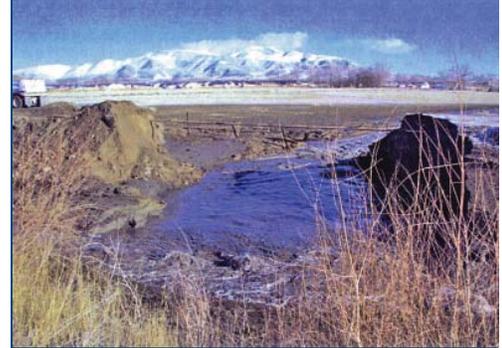
Canal Breach Example

At approximately 4:30 a.m. on Saturday, January 5, 2008, a breach occurred in the Truckee Canal, a Newlands Project facility in northern Nevada, owned by Reclamation and operated and maintained by the Truckee Carson Irrigation District. As a result of the breach, an uncontrolled release of water flowed into irrigated lands and a portion of the City of Fernley, located some 30 miles east of Reno. About 590 homes were flooded.
