Upper Clark Fork Aquatic Restoration Strategy II

December 2016

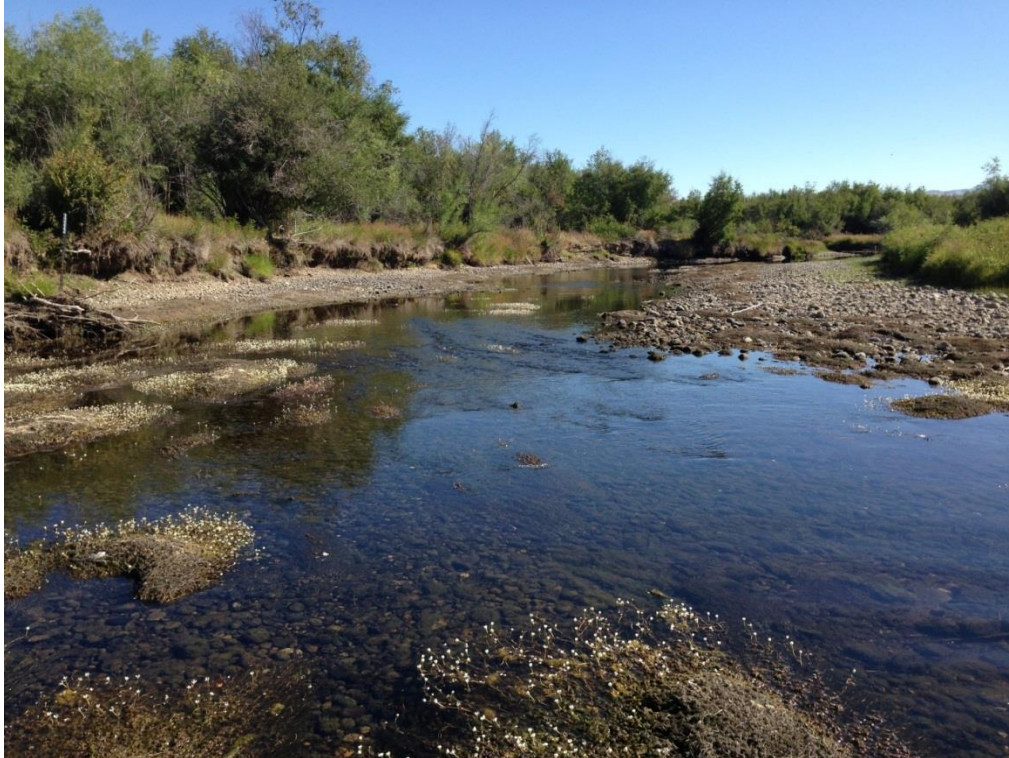
Figure 21- Clark Fork River near Gemback Bridge (near Racetrack), 2.6 cfs, 8/4/2016. Photo Credit: Clark Fork Coalition.

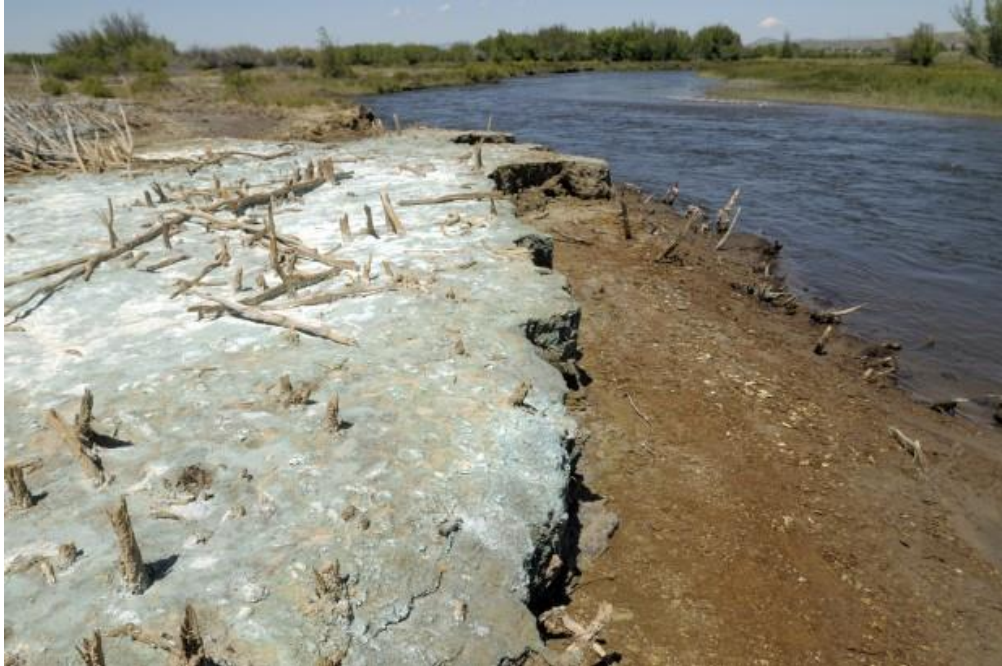
Figure 23- A “slicken” of toxic waste deposited on the riverbank of the Upper Clark Fork River near Racetrack. Photo source: Tom Bauer of the *Missoulian*. These dense, toxic mats of contaminated soil have inhibited plant growth for more than 100 years and continue to leach heavy metals into the river.

flood of record for the valley in 1908) transported and deposited these mining wastes in the floodplain of the Upper Clark Fork basin from Butte to 120 miles downstream near Missoula. The toxic “slickens” that were deposited suppress plant growth along portions of the streambank, and when they erode into the river, cause increases in metals-loading in the water column – negatively impacting aquatic and terrestrial ecosystems (Figure 23).

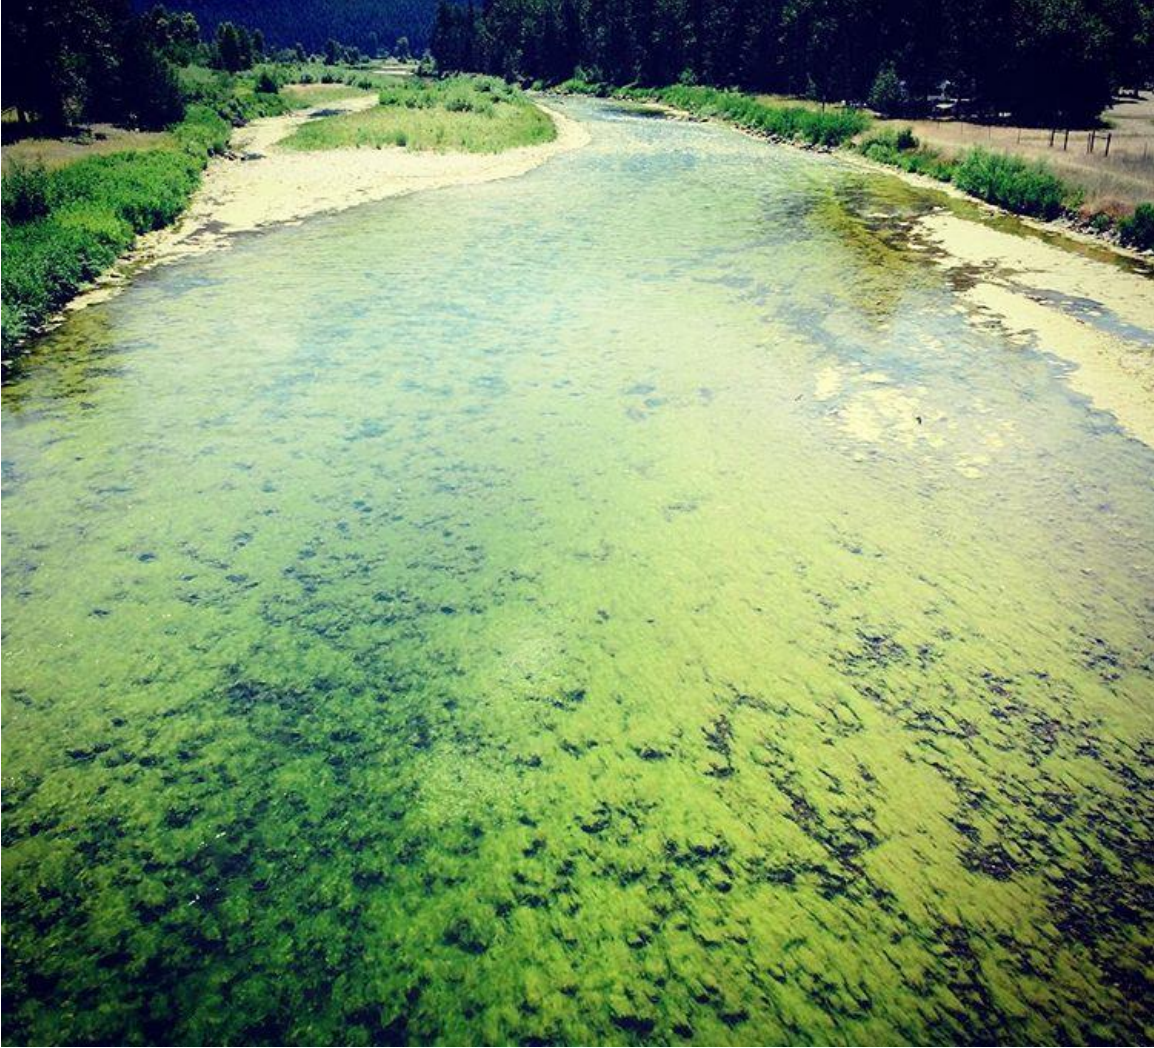
Figure 26- *Cladophora* bloom on the Clark Fork River near Clinton, MT in July 2016.

Although algae species such as *Cladophora* are native to the UCF, anthropogenic inputs of nutrients such as nitrogen stimulate excessive algae growth relative to baseline conditions in nearby waters (Lohman & Priscu, 1992). Nutrient loads in the UCF originate from both point sources (i.e. Butte and Deer Lodge wastewater treatment plants) and non-point sources, such as fertilizer, animal wastes, and subsurface septic systems associated with residential development (USGS, 2014; Figure 28).

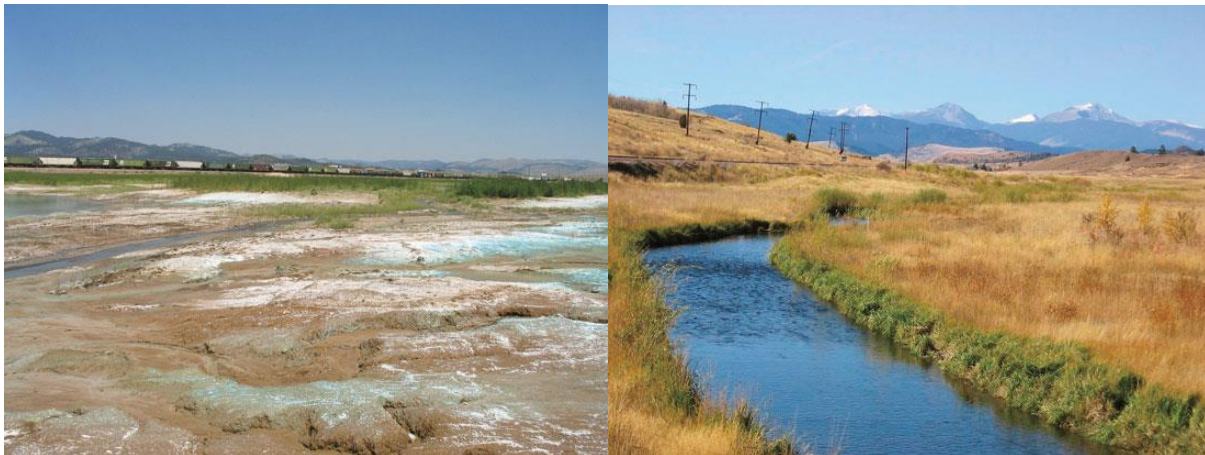
Figure 34- Silver Bow Creek floodplain pollution before cleanup (left) and post cleanup (right).

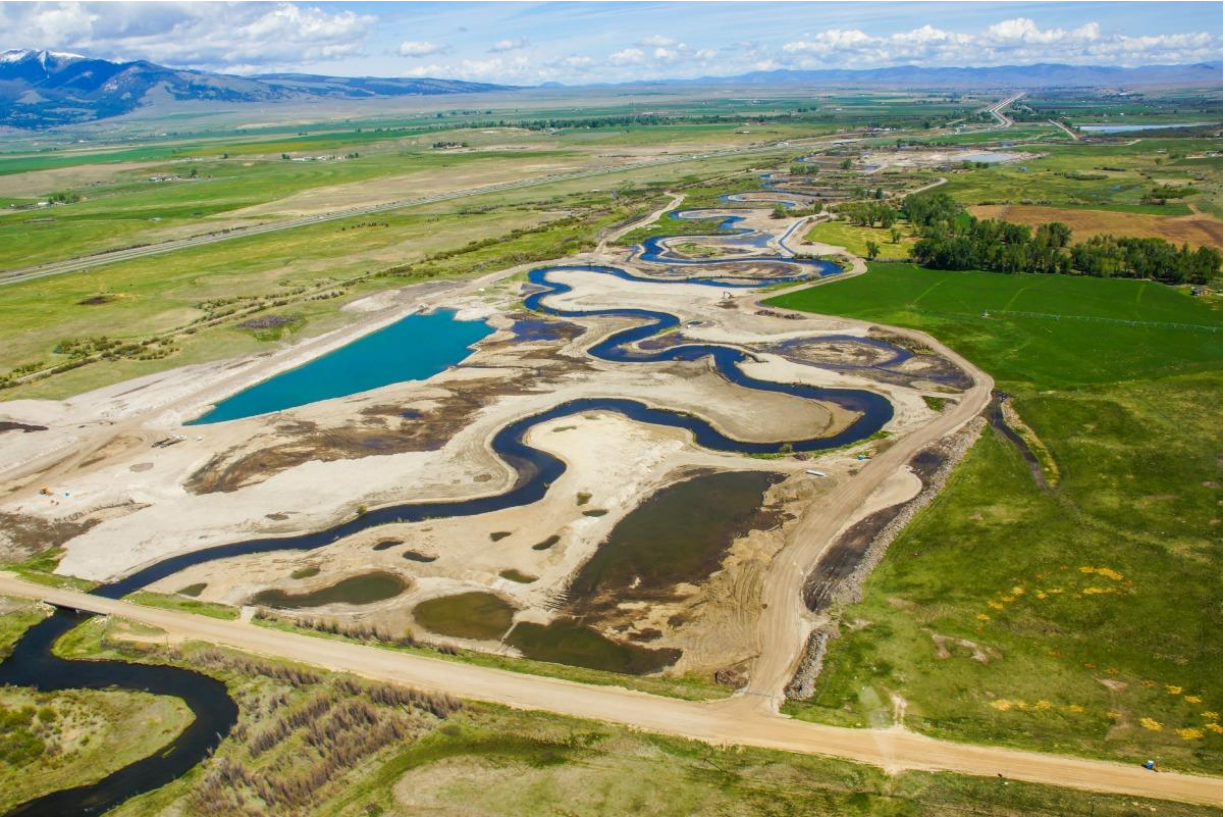
Figure 36- Aerial photo of the remediation and restoration of Phases 5 and 6 (part of the Upper Clark Fork River Reach A). This photo is facing due south from Galen Road (at the bottom of the picture) near the Dry Cottonwood Creek Ranch which is operated and owned (part owners) by the Clark Fork Coalition. White patches indicate where contaminated soil has been removed and hauled away. No remediation was carried out *in* the river (just banks and floodplain), and its natural course was left intact. The light blue “pond” is where source gravels were removed to help rebuild parts of the floodplain. Smaller potholes in the foreground were added as wetland features to help improve habitat diversity in the recovering floodplain. In 2016 hundreds of migrating snow geese were observed using these features.
