# Safe Then; Safe Now

## A Summary of Pueblo Dam's History

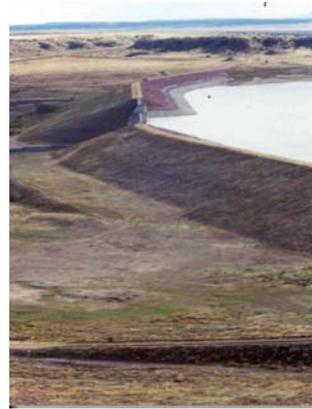
*The long earthen embankment at Pueblo Dam.*

Pueblo is an earthen embankment dam, with a center concrete section that supports a large spillway. The spillway is designed to *safely* pass floodwaters that would otherwise overflow the dam. When filled to the spillway crest, Pueblo Reservoir holds 349,940 acre feet of water.

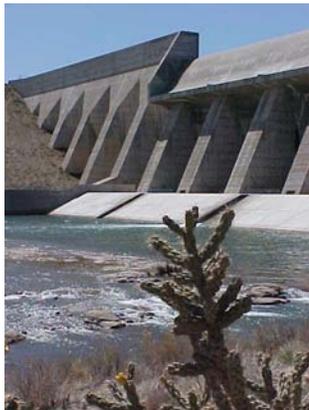
*The concrete spillway at Pueblo Dam*

In 1997, a review of Pueblo Dam identified a slight possibility that the concrete spillway section of the dam could slide under high loading conditions—a lot of pressure behind the dam. Actions were taken to prevent the possibility of sliding. Those actions included:

- Filling a portion of the stilling basin with roller-compacted concrete (RCC)
- Installing rock bolts through the toe block and the foundation layers to further anchor the concrete section.

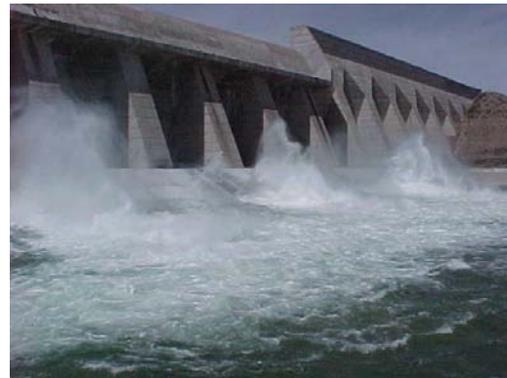
*Full releases from Pueblo Dam to the Arkansas River following the completion of SOD work in 2000.*

The modification work has had the anticipated effect and successfully addressed the sliding potential.

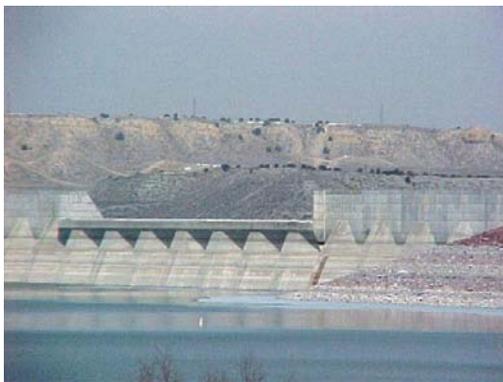
*The concrete spillway section on the upstream side of Pueblo Dam.*
