Windy Gap Firming Project

Visual Assessment Technical Report

**U.S. Department of the Interior
Bureau of Reclamation
Great Plains Region**

July 2008

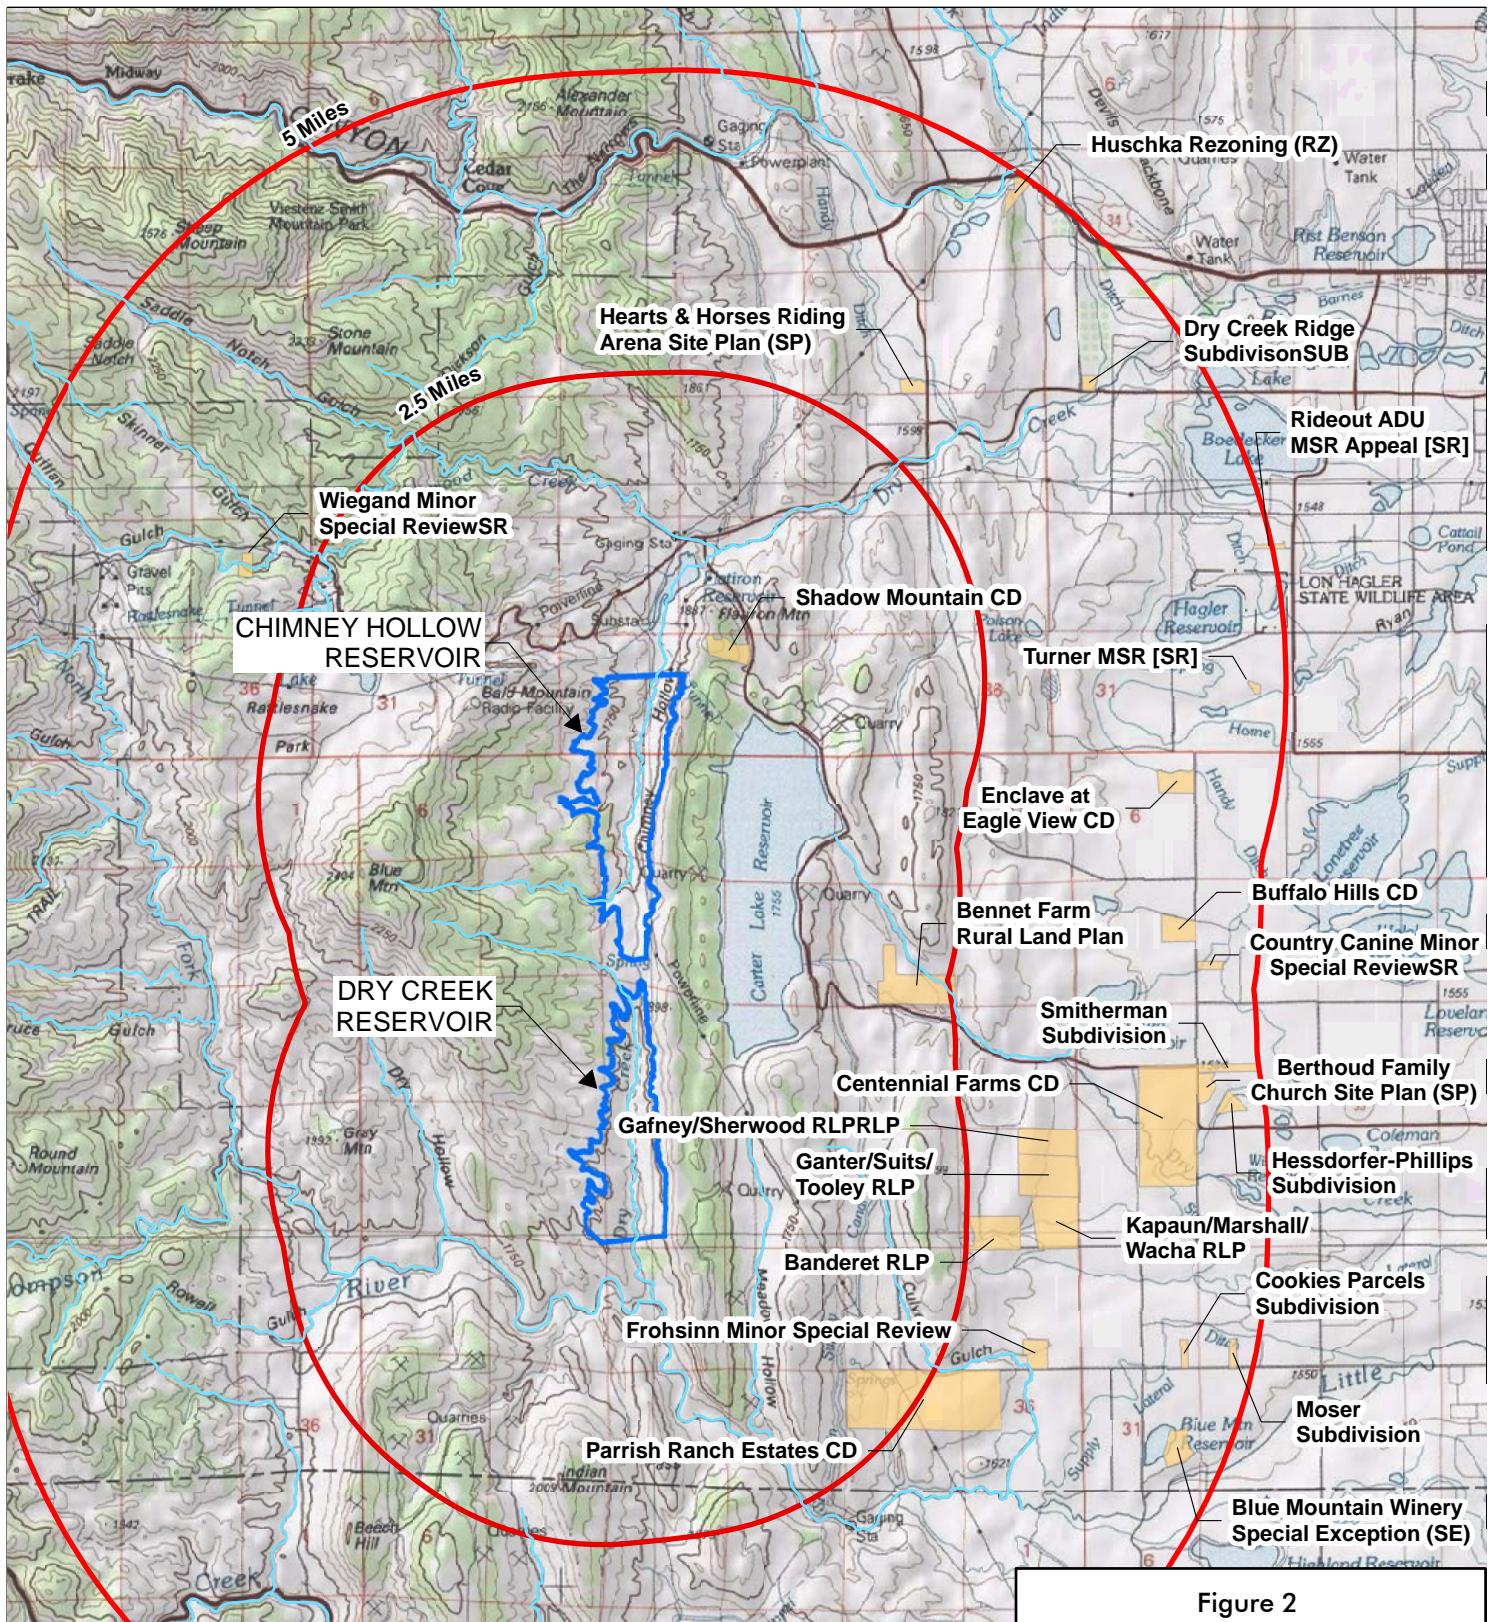
Figure 2
WINDY GAP FIRMING PROJECT

Reasonably Foreseeable Future Land Development Near Potential East Slope WGFP Reservoir Sites
W:\workspace\2390windygap\GIS\dev

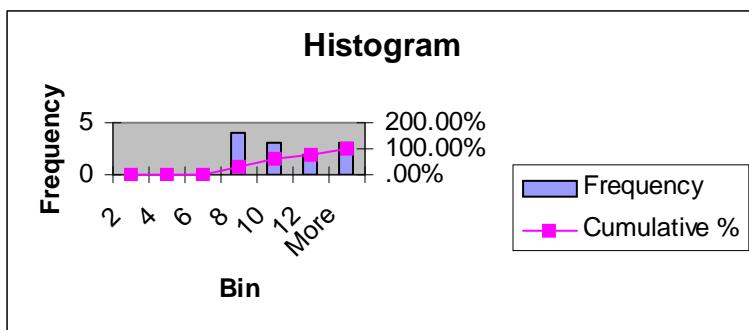
Table B-5. Jasper East Scenic Quality Histogram

Bin	Frequency	Cumulative %
2	0	.00%
4	0	.00%
6	0	.00%
8	4	33.33%
10	3	58.33%
12	2	75.00%
More	3	100.00%

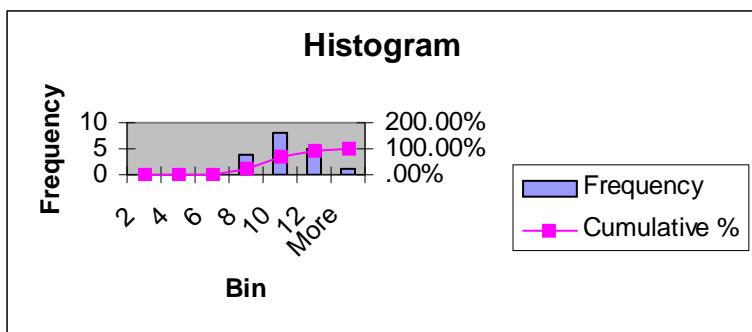
Table C-5. Rockwell/Mueller Creek Scenic Quality Histogram

Bin	Frequency	Cumulative %
2	0	.00%
4	0	.00%
6	0	.00%
8	4	22.22%
10	8	66.67%
12	5	94.44%
More	1	100.00%

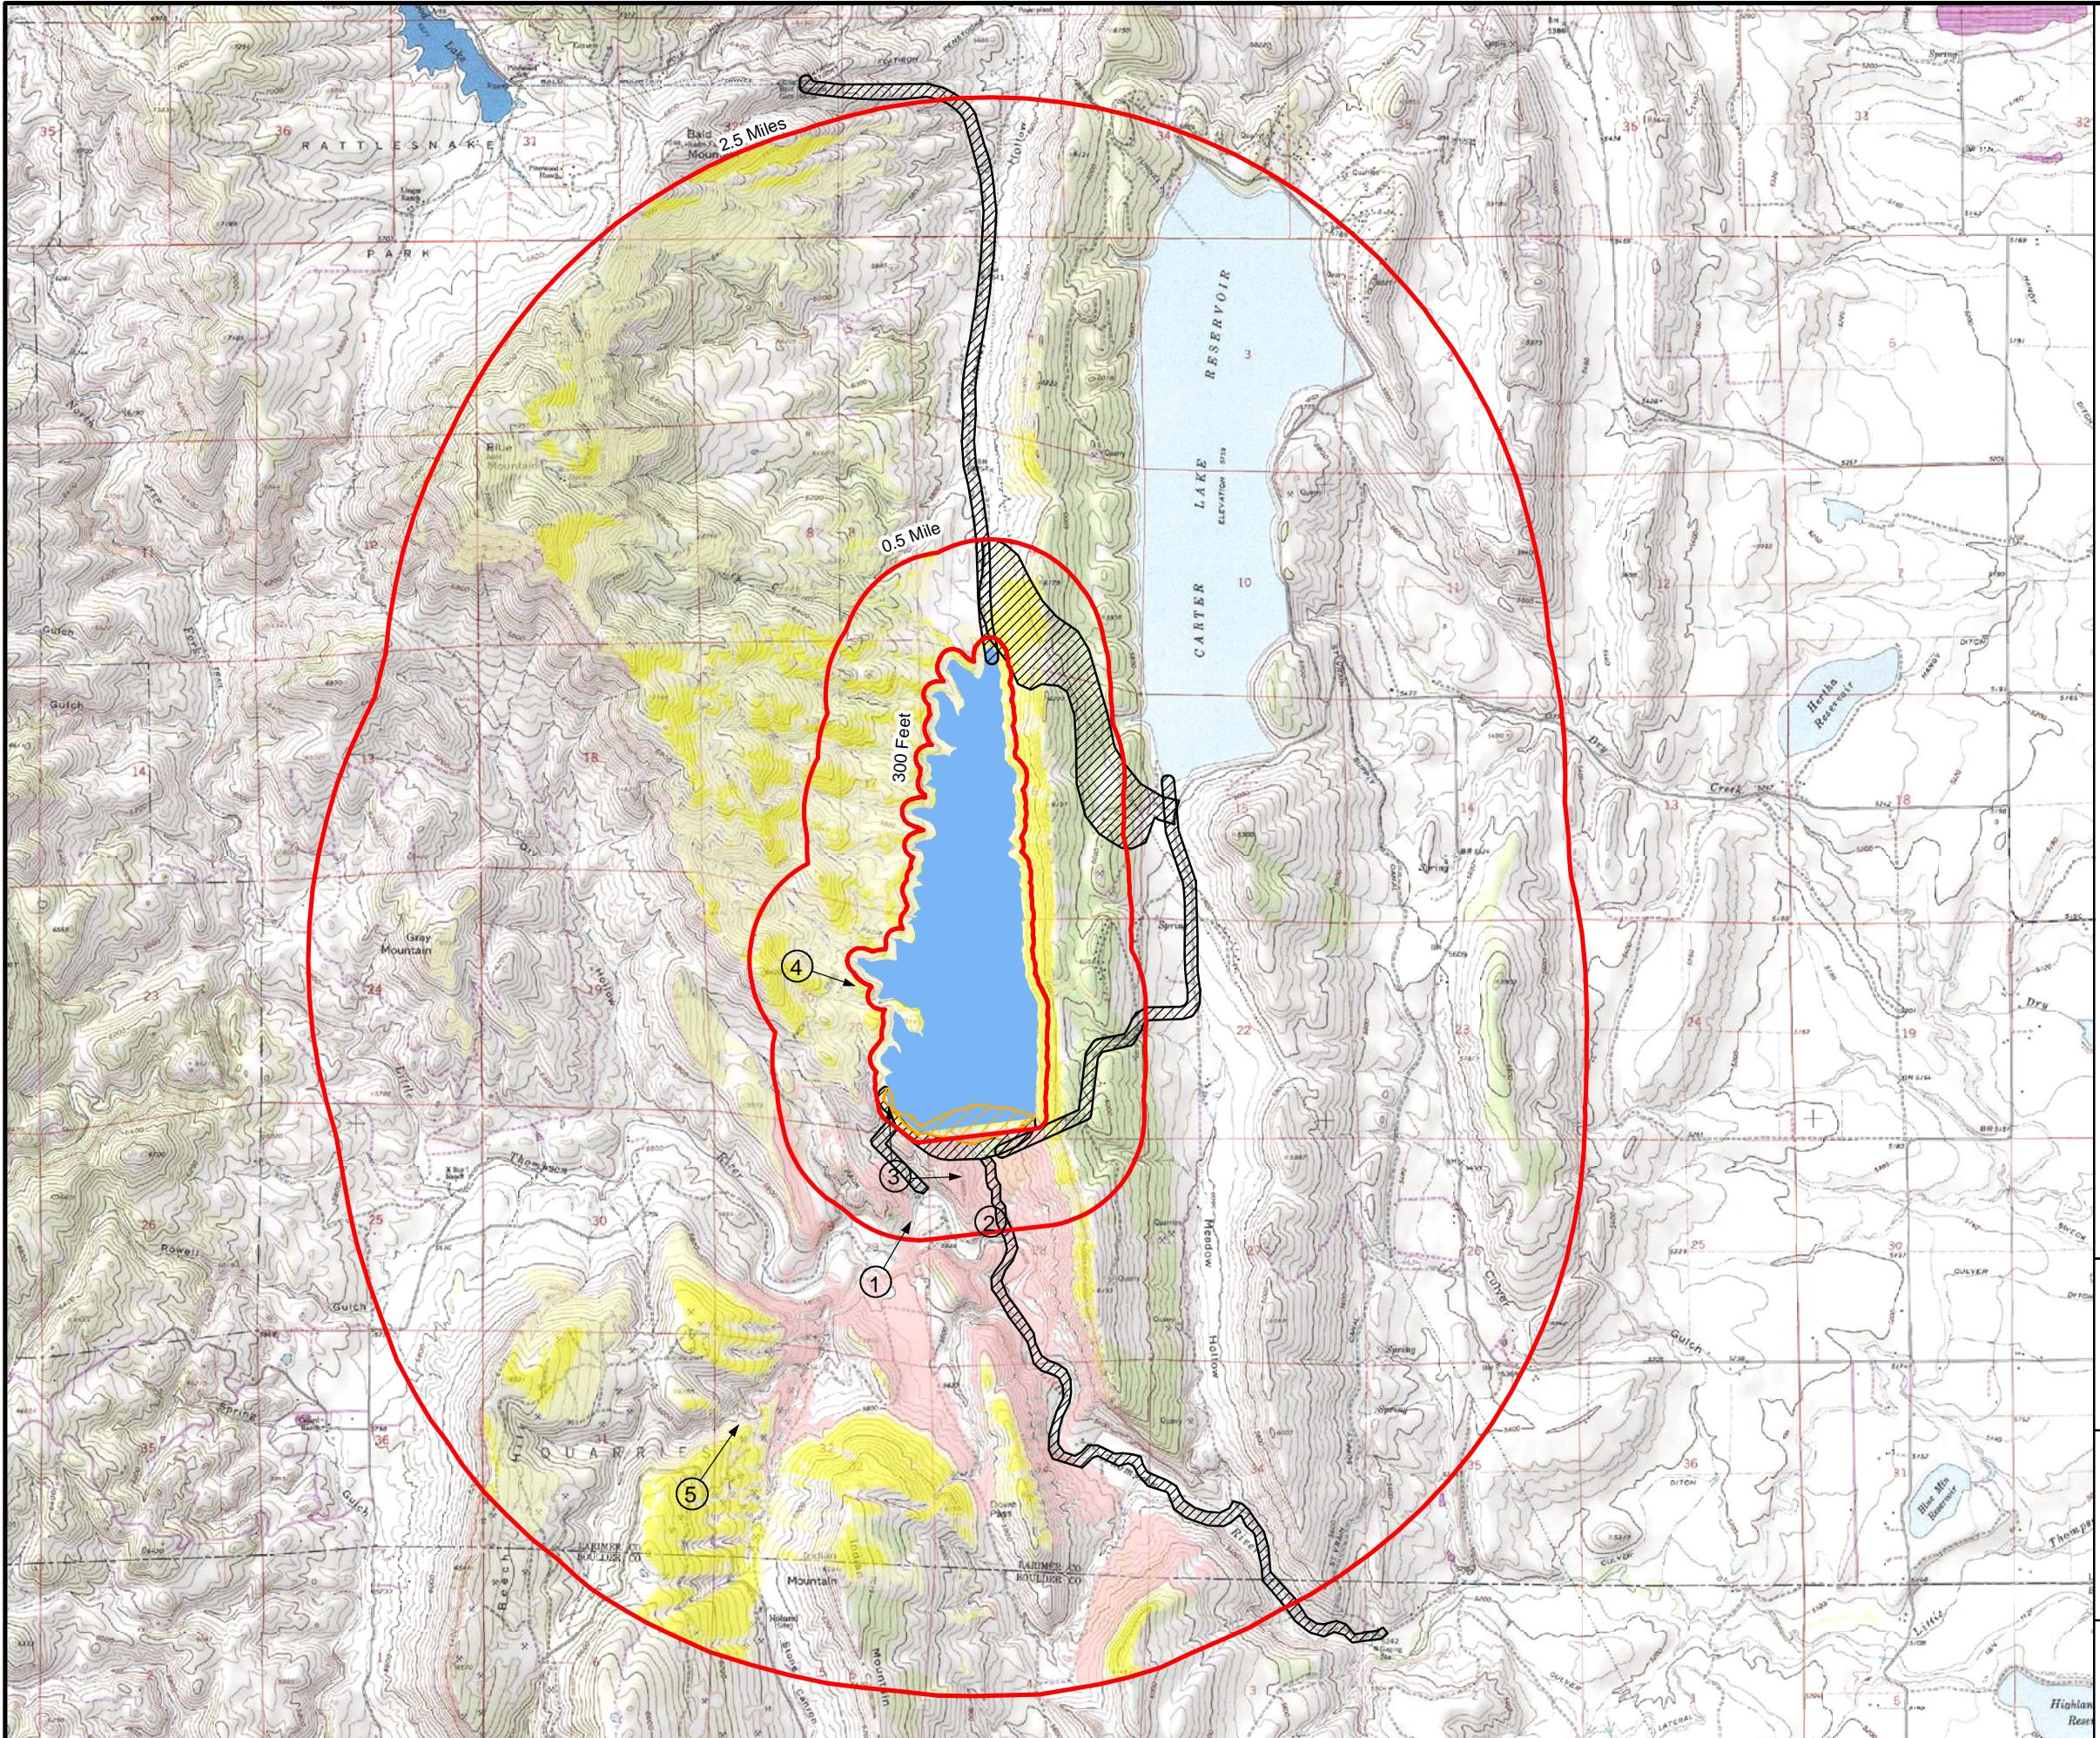
Figure D-1
Dry Creek Reservoir
Visibility Study

- Legend:**
- Proposed Dry Creek Reservoir
 - Proposed Disturbed Area
 - Proposed Dry Creek Dam
 - Key Observation Point (KOP)
 - KOP with Direction of Photograph
 - Distance Zones from Proposed Reservoir

Areas where the dam and reservoir are not visible
Areas where 50% or less of the dam and reservoir are visible
Areas where 50% or more of the dam and reservoir are visible
Areas where only the dam is visible

KOP 2 (Figure D-1) has moderate to high scenic quality. Views of the horizon edges and some land form variations and rock forms are partially obscured by hills and vegetation. Additionally, artificial forms of the gravel road, an abandoned corral with outbuildings, and a deteriorated pond dam dominate the foreground of the views of the alternative reservoir site.

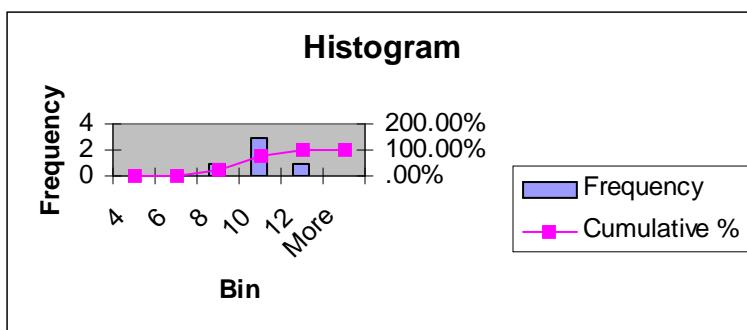
Table D-5. Dry Creek Scenic Quality Histogram

Bin	Frequency	Cumulative %
4	0	.00%
6	0	.00%
8	1	20.00%
10	3	80.00%
12	1	100.00%
More	0	100.00%

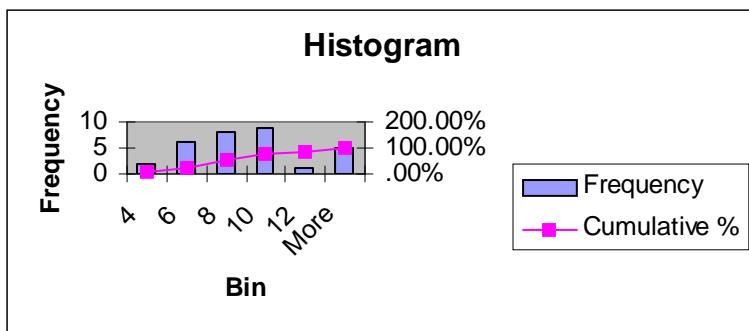
Table E-5. Chimney Hollow Scenic Quality Histogram

Bin	Frequency	Cumulative %
4	2	6.45%
6	6	25.81%
8	8	51.61%
10	9	80.65%
12	1	83.87%
More	5	100.00%
