Test Results of Intralox Traveling Screen Material

**U.S. Department of Interior
Bureau of Reclamation
Technical Service Center
Denver, CO**

May 2003

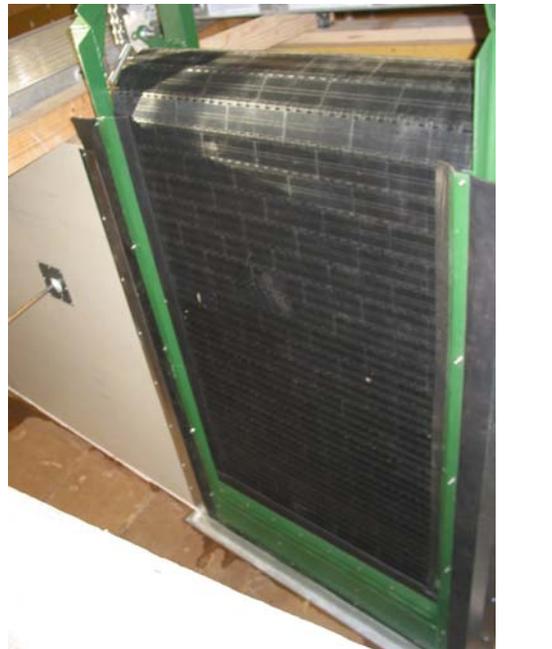
Figure 2. - Traveling screen installed in the WRRL recirculating flow facility. The screen shown in the right photo is mounted vertically on a 10 degree converging wall between the two walkways spanning the facility.

The traveling screen was installed in a straight section of the 10 degree converging wall about 10.5 ft downstream from the bend, figure 2. The frame is mounted directly on the floor and in a 2 x 6 stud and plywood support wall. The seal arrangement caused the face of the screen to be offset 1.5 in behind the support wall and screen frame. The open area of the screen began 12.5 in up from the floor.

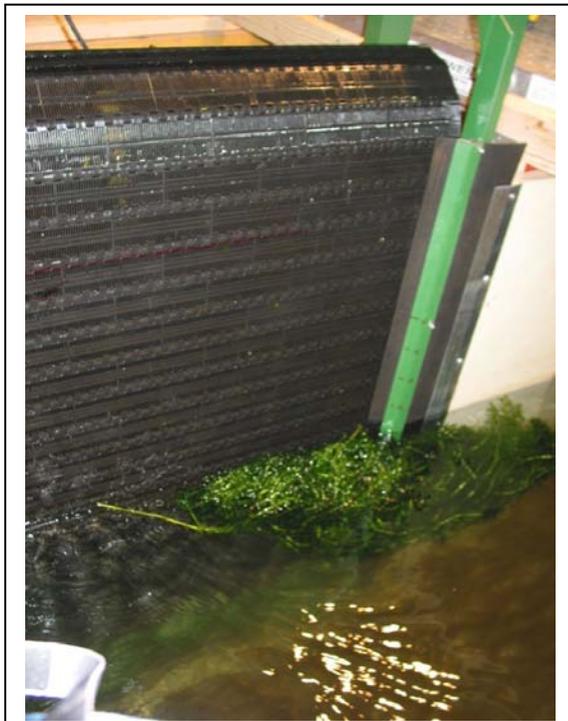
Figure 7. - Egaria weed was released upstream from the screen and “balled up” near the downstream end of the bypass before being swept downstream to the bypass. No egaria was captured by the original traveling screen.

Original Screen Configuration - The original traveling screen installed vertically on the 10 degree angled wall was tested with debris first. The same 0.45 ft/s approach and initial sweeping velocity of about 0.75 ft/s were set in the flume. A five gallon bucket was filled with egaria and gradually released upstream in the sweeping flow. The smooth surface of the screen and the sweeping velocity did not allow the screen to pick up any of the egaria. The weeds essentially balled up at the downstream end of the screen against the frame (figure 7) until it was swept downstream by the sweeping velocity.

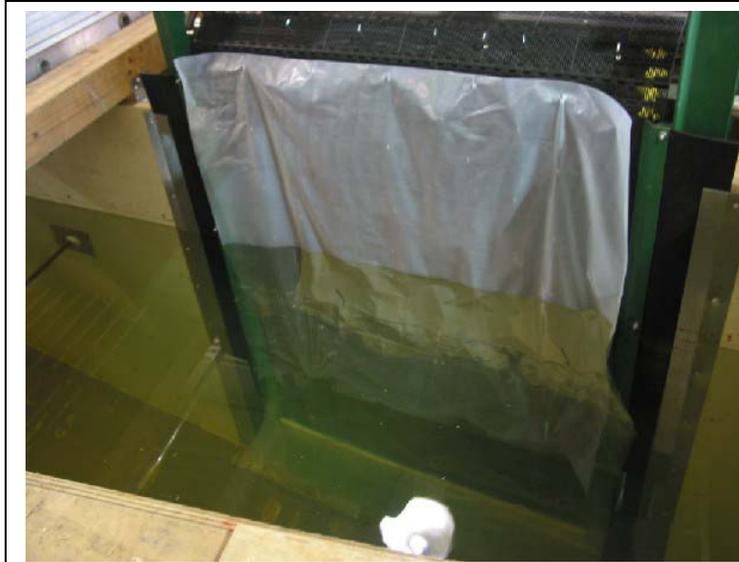
Figure 13. - A double thickness of plastic sheeting was attached to some of the hooks on the face of the screen to hold it in place over the screen and seals for a loading test simulating a debris clogged screen.

A sheet of plastic was attached to the hooks and covered the face of the screen including the seals, figure 13. The model was filled with water to a depth of 4 feet on both sides of the screen. A valve was then opened on the diversion side or behind the screen to lower the water level and produce the differential. Unfortunately, the center wall of the model was designed for equal loading on both sides and failed during two separate attempts to

produce a 2 ft differential. The most differential that was obtained was about 8 inches. The model was then drained, the plastic removed, the screen and seals inspected and the motor turned on to see if screen would travel correctly after experiencing this load.

The screen material, gears, and seals looked in good condition after the test. There were no discontinuities or bulges in the screen material and it traveled without difficulty.

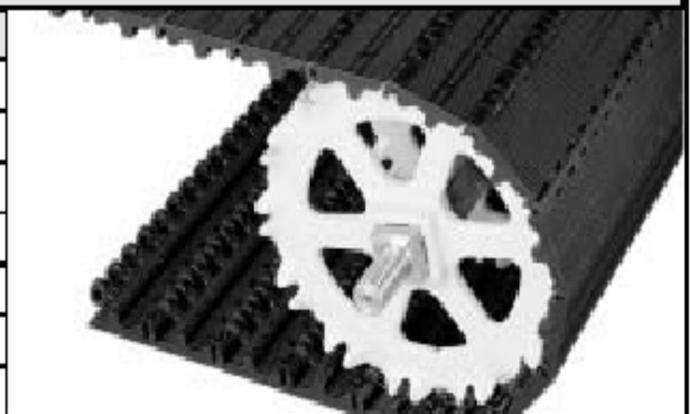
Mesh Top

in.	mm
Pitch	2.50	63.5
Minimum Width	5.00	127.0
Width Increments	1.00	25.4
Opening Size (approximate)	0.068 x 0.75	1.7 x 19.1
Open Area	32%	
Hinge Style	Open	
Drive Method	Center-driven

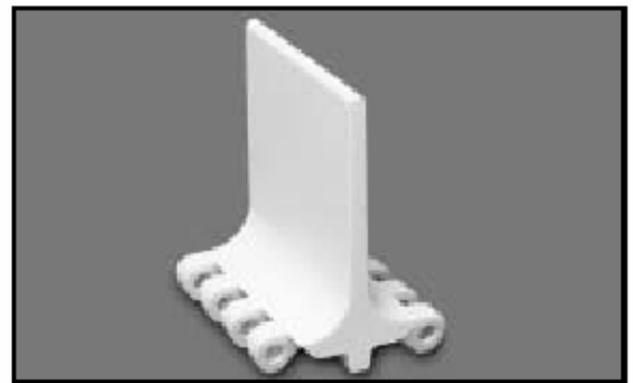
Impact Resistant Flights

Available Flight Height		Available Materials
in.	mm	
4.0	102	Polypropylene, Polyethylene, Acetal

Note: Each flight rises out of the center of its supporting module, molded as an integral part. No fasteners are required.
