Redrock Canyon Fish Barrier Feasibility Investigations

Final Report for Central Arizona Project Fund Transfer Program Task 4-46

December 2006

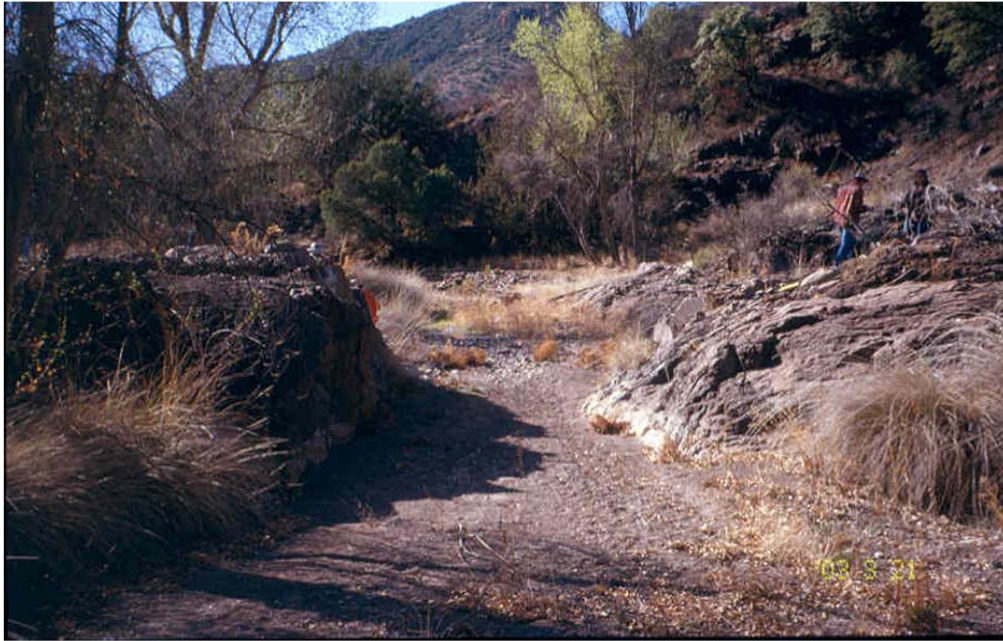
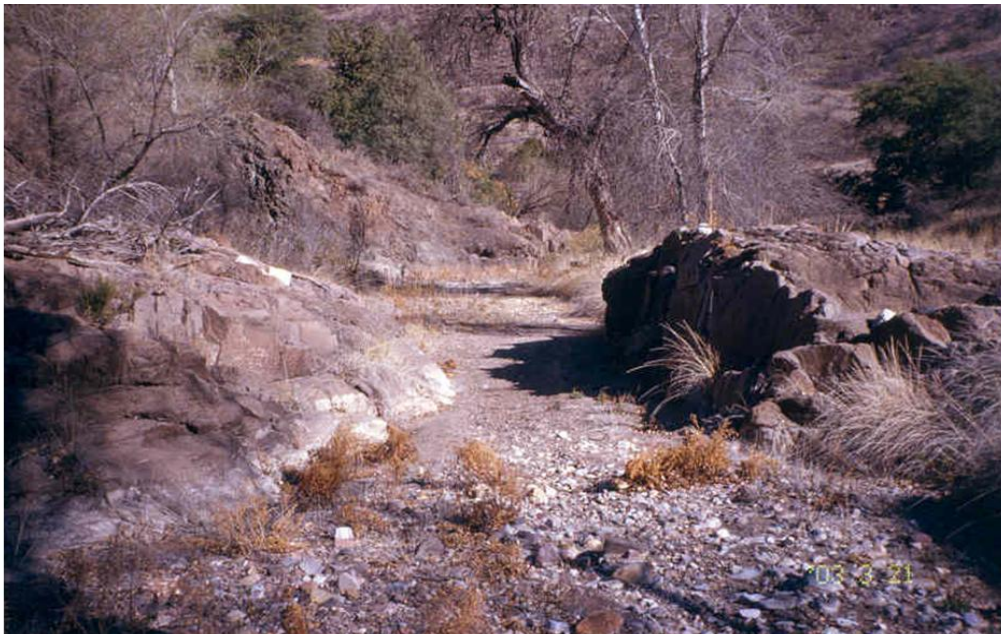
A rock outcrop channels the stream through a 9-foot wide gap, providing an excellent fish barrier site (Figures 3 and 4). There is a perennial reach about 20 yards upstream of the proposed barrier that maintains a trickling flow even during extremely dry periods.

Figure 3. Photographs of the proposed Redrock Canyon fish barrier site looking upstream (top) and downstream (lower).

B. Geology - The stream channel is 9 feet wide measured at the top of the alluvium. The rock walls widen to 18 feet at the top of rock, about 6 feet above the alluvium.

Basalt forms both abutments and is expected to underlie the alluvium that presently fills the channel. The basalt is reddish brown to dark gray, and hard and moderately weathered. A prominent joint set strikes sub-perpendicular to the stream channel, dips near vertical and is spaced about 1-foot apart.

The right abutment is formed from a steeply dipping joint that strikes N15°W and dips 80°W. The right abutment consists of hard, reddish brown to gray basalt. The basalt is moderately fractured (fractures spaced 0.3 to 1.0 foot apart) and mostly slightly weathered (rock rings when struck with a hammer). Localized surface areas are moderately hard and moderately weathered (dull sound when struck by a hammer). The left abutment is similar to the right, but includes areas of intensely fractured rock (fractures spaced approximately 0.1 to 0.3 feet apart) especially at the rock surface.
