## Zebra & Quagga Mussel Research Program

### RESEARCH NOTE

#### *Quagga Mussel Control for Pipes using Water Jetting*

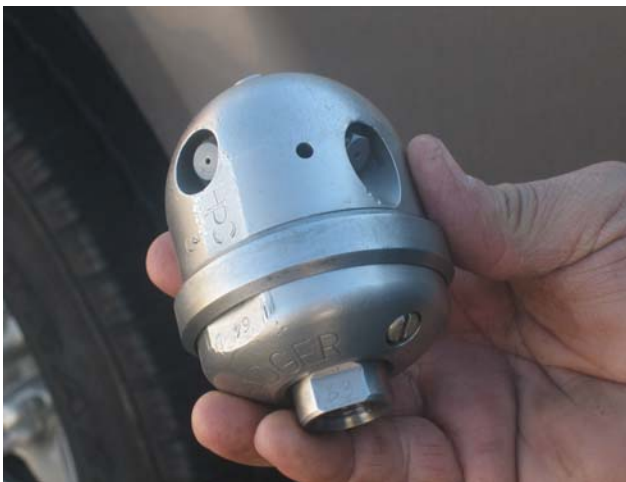
**Figure 1.** High pressure water jetting nozzle.

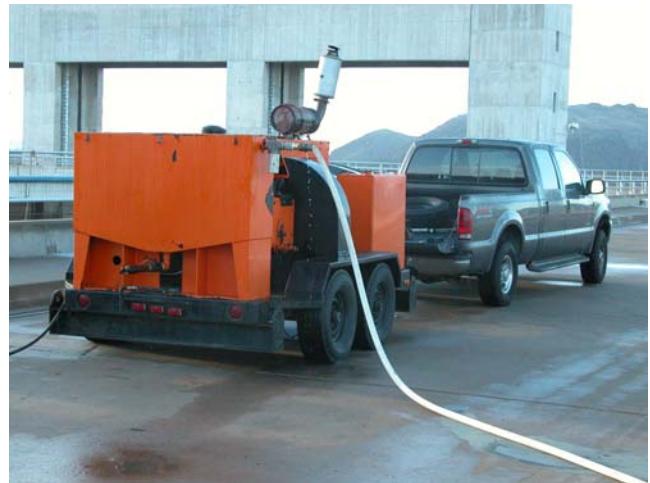
Prior to water jetting, a camera was inserted into the 10-in-diameter pipe to observe pre-cleanout condition. Heavy mussel settlement, biofouling, and rust nodules were observed over the 105-ft length of pipe. The water jetting system (Fig. 2) consisted of a pumped arrangement that delivered pressures ranging from 5,000-10,000 psi to the nozzle. For this demo, a 10,000 psi pressure setting was used.

**Figure 2.** High pressure water jetting pump.

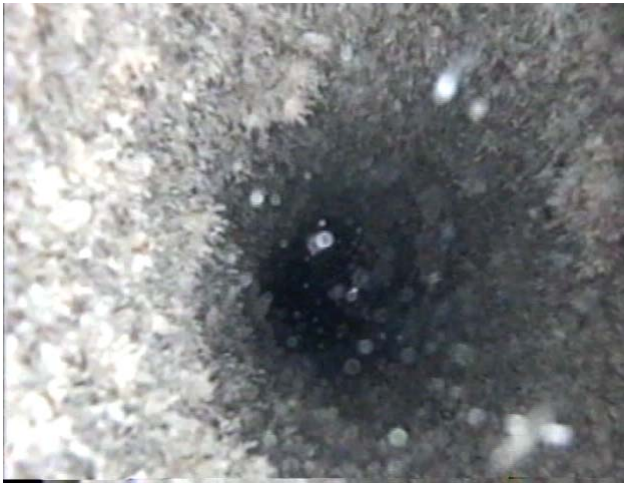
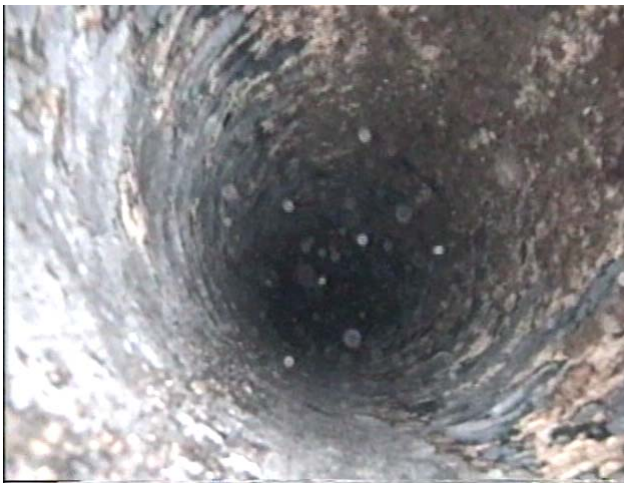
Following water jetting, the pipeline was again inspected (video documentation is available for both pre- and post-cleanout inspections). Figure 3 shows before and after images captured from the video. The results demonstrated this system is highly effective for removal of mussels and other biogrowth. However, there were areas where rust nodules and some minimal biofouling remained. Furthermore, some coating removal was also observed (although it

should be noted that coating failures pre-existed as evident from observed pre-test rust nodules). Nonuniform cleaning and coating removal was observed and is presumably due to nozzle head insertion along the bottom of the pipe rather than along the centerline. A crawler is recommended for use when possible to overcome these deficiencies. Reduced operating pressures may also prevent or limit coatings removal.

**Figure 3.** 10-in domestic water line before and after water jetting.
