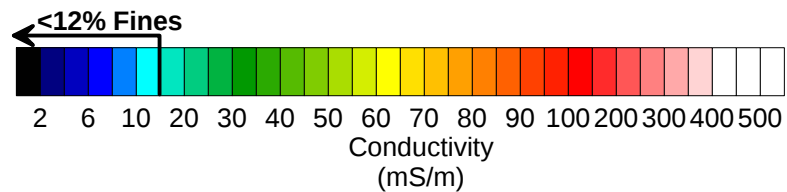
Figure 68. Gila-Land-1 (West)  
conductivity cross-sections
