## Modifications to Bypass System Operations to Improve Hydraulics at the Tracy Fish Collection Facility

### Volume 47

# Tracy Fish Facility Studies California

April 2011

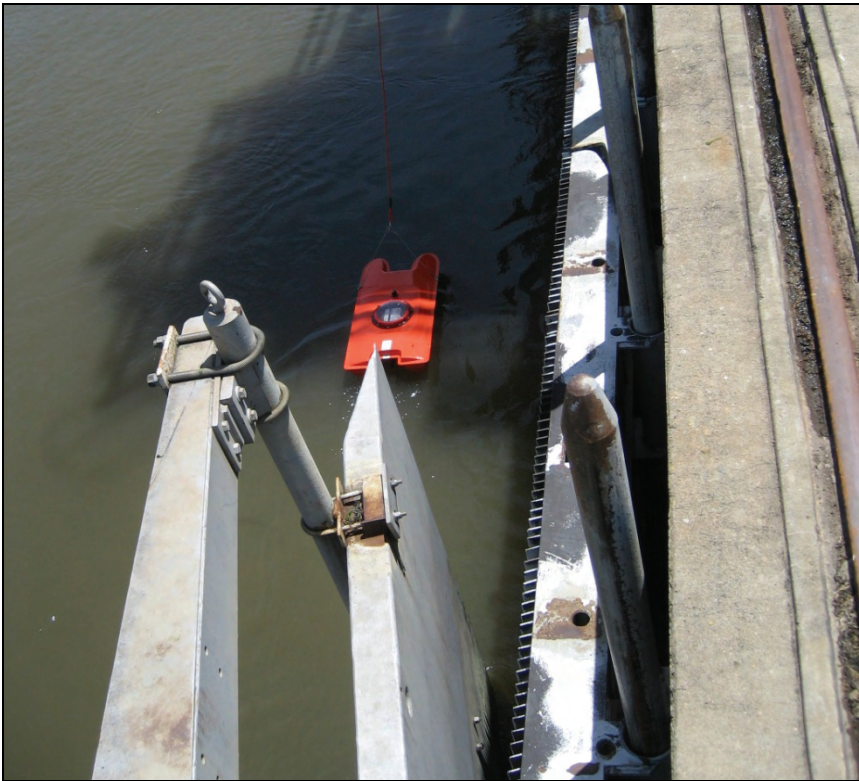
Figure 4.—OTT Qliner current profiler floating upstream of a bypass intake.

During field tests in 2005, primary bypass ratios needed to be raised above 1.0 to evaluate the performance of the replacement bypass intakes (DeMoyer 2007). Up to three bypasses were closed to increase bypass ratios above 1.0. In order to identify changes in velocity fields due to bypass closures, velocity data were collected inside the primary bypass intakes with a SonTek acoustic Doppler velocity meter (ADV) (SonTek/YSI, Inc., San Diego, California) and 4.6 m (15 ft) upstream of the primary bypass intakes with an OTT Qliner ADCP. The ADV was affixed to the louver panel in the mouth of the bypass intake. The ADCP was attached to a rope and floated upstream of a bypass intake as in Figure 4. Single plane, narrow beams provided accurate data close to the primary louver line.

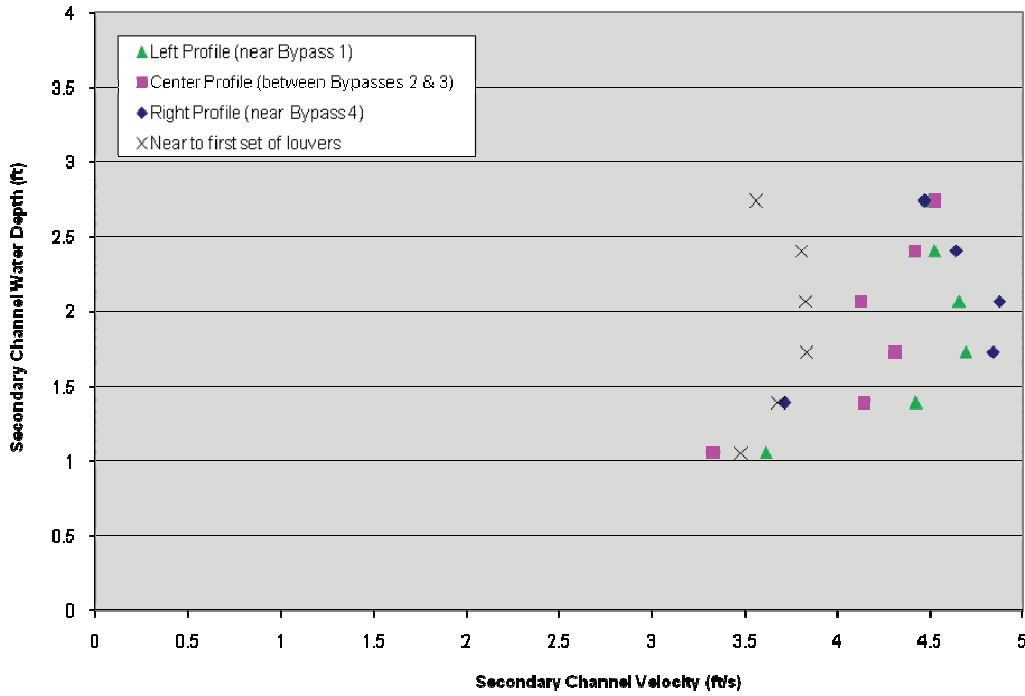
Figure 5.—Data collected at three lateral locations across the secondary channel and directly upstream of the secondary louver line while all bypasses are open (DeMoyer 2004). Metric equivalent: 1 m = 3.28 ft.

Secondary channel velocity data were collected with all four primary bypasses open and then during operations with one or two primary bypass pipes closed in Figures 5–8 (DeMoyer 2004). Results show that closing primary bypasses does not skew the flow approaching the secondary louvers; therefore closing bypasses should not affect the ability of fish to gain entrance to the secondary fish bypass.

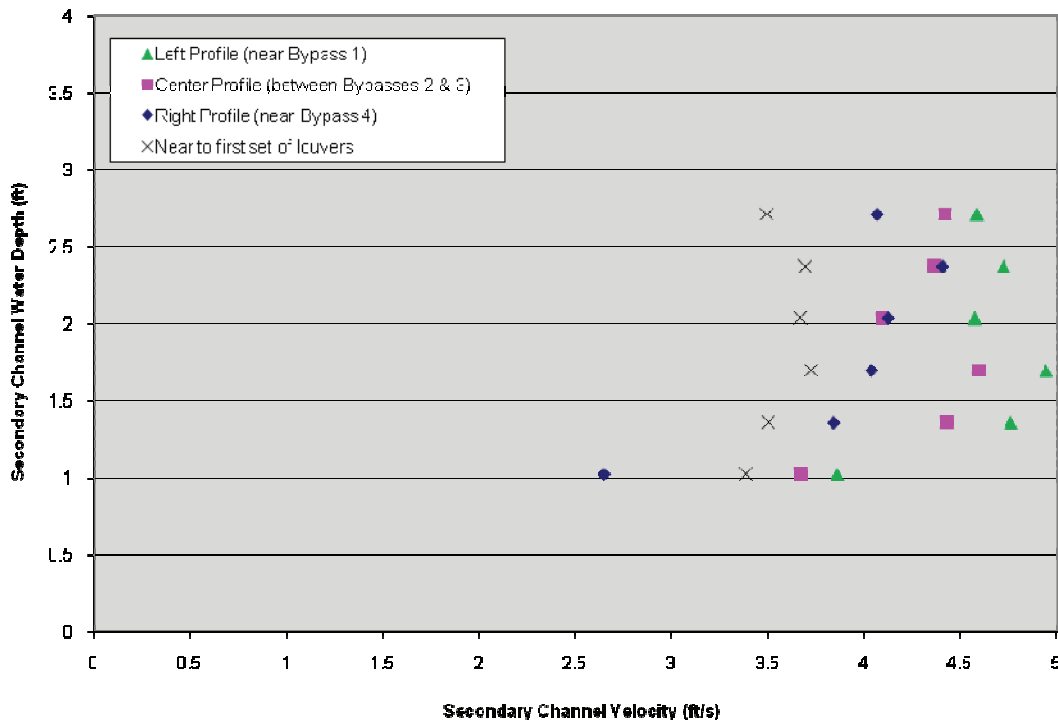
Figure 6.—Data collected at three lateral locations across the secondary channel and directly upstream of the secondary louver line while bypass 1 is closed (DeMoyer 2004). Metric equivalent: 1 m = 3.28 ft.

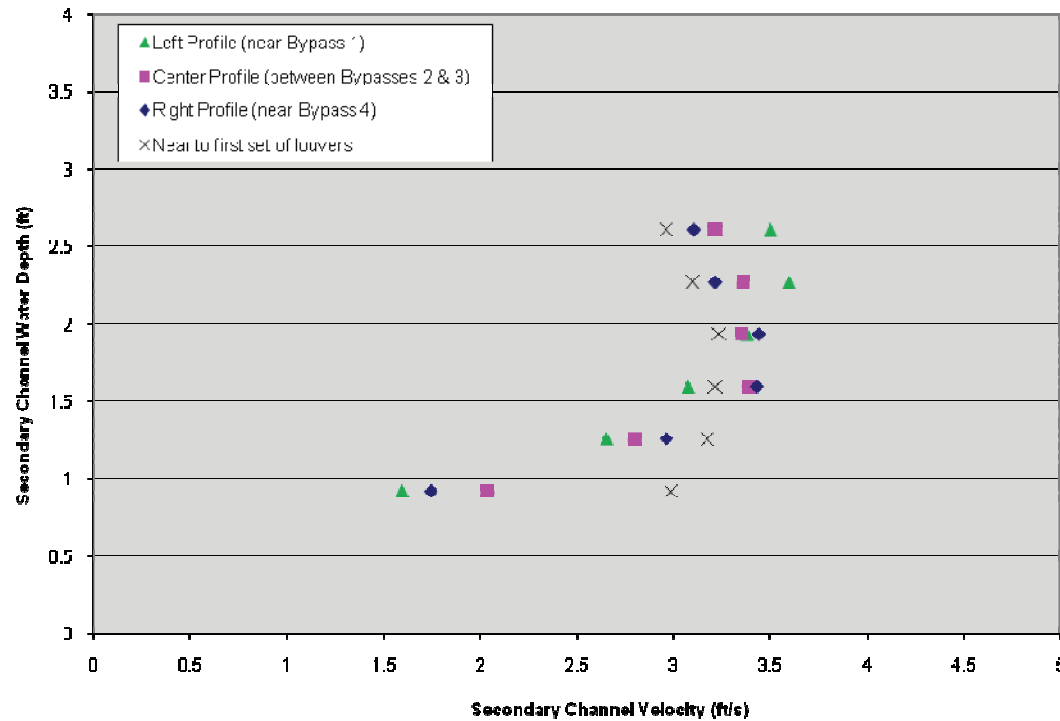
Figure 8.—Data collected at three lateral locations across the secondary channel and directly upstream of the secondary louver line while bypass 1 and 2 are closed (DeMoyer 2004). Metric equivalent: 1 m = 3.28 ft.
