Evaluation of Fish Behavior Upstream and Downstream of the Mitten Crab Traveling Screen at the Tracy Fish Collection Facility

Tracy Technical Bulletin 2015-2

**U.S. Department of the Interior
Bureau of Reclamation
Mid-Pacific Region and
Denver Technical Service Center**

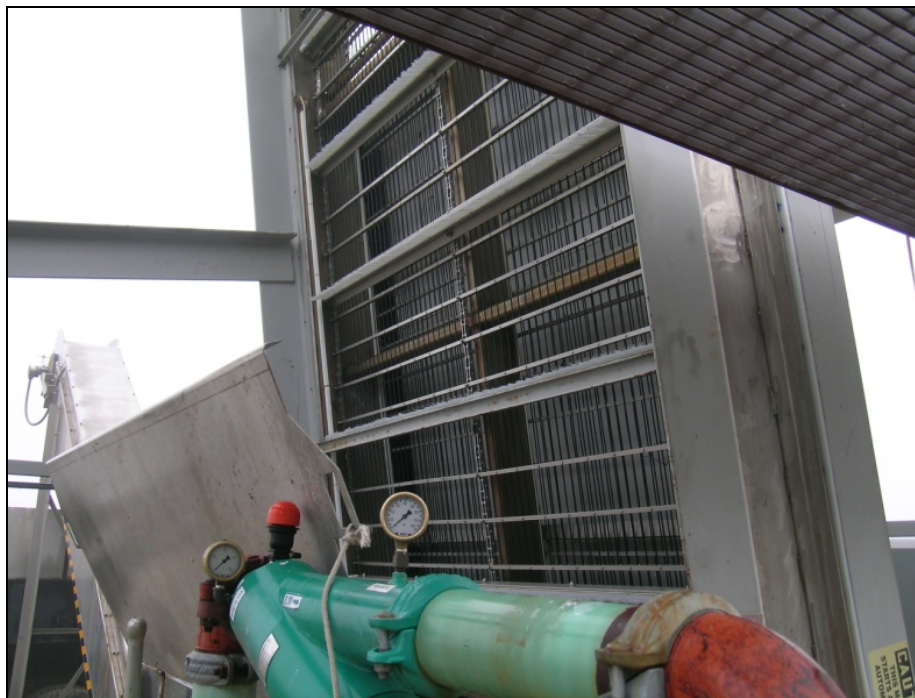
Figure 2a.—Vertical traveling screen out of the water (control condition).

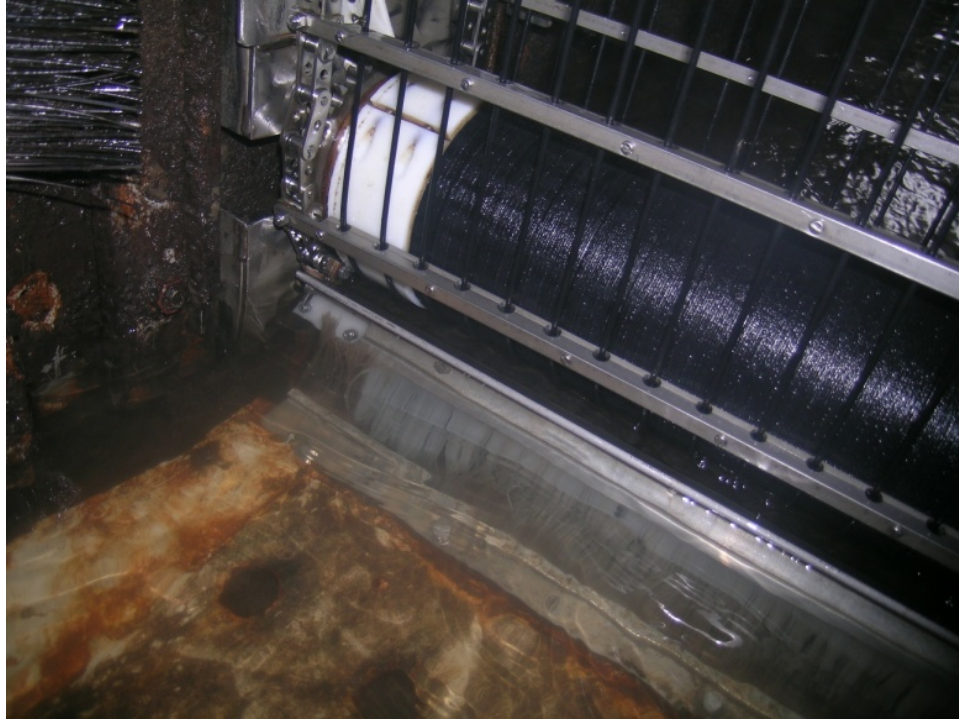
Figure 2b.—Vertical traveling screen all the way down, steel plate flat (plant condition).

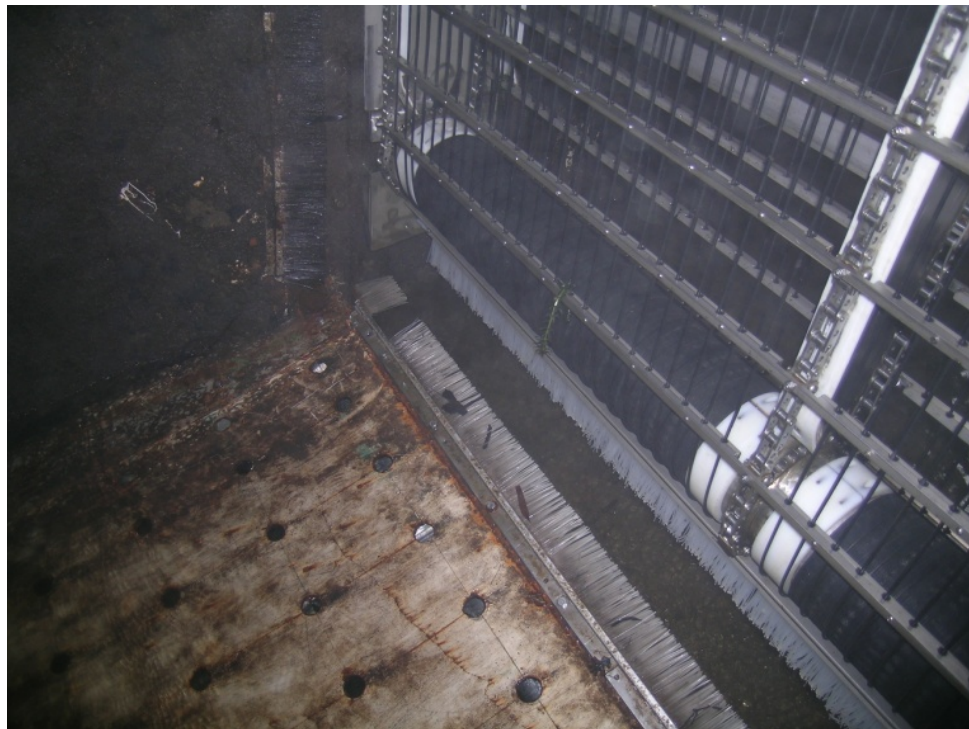
Figure 2c.—Vertical traveling screen 30.5 cm off the secondary channel, floor-steel plate inclined 33.0 cm (crab condition). Note 7.6 cm gap between 2 sets of brushes.

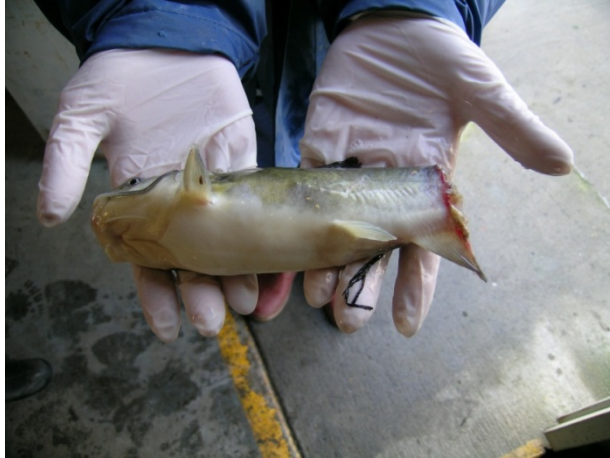
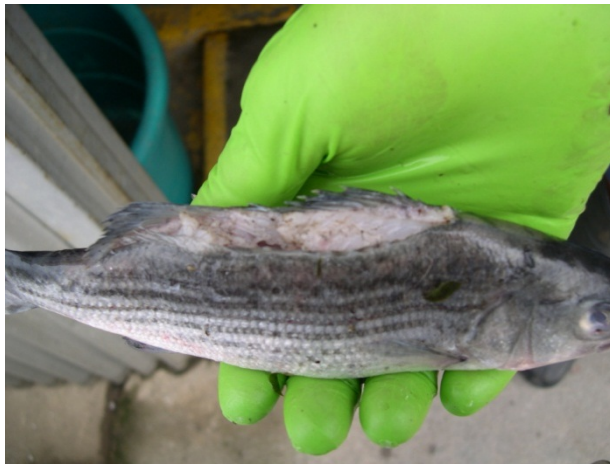
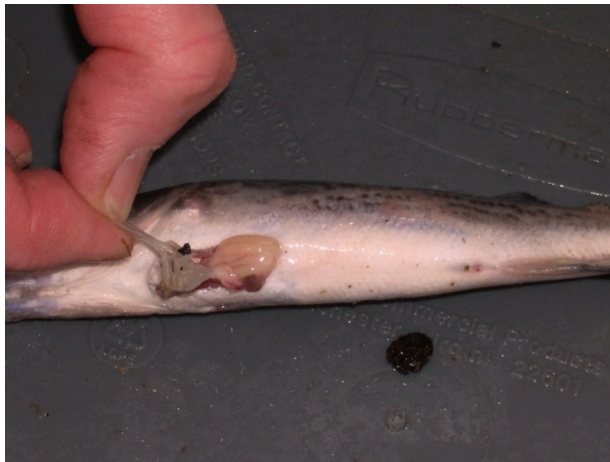
Figure 3.—External injuries observed in traveling screen experiments.

Up to 95.8 percent of the experimental fish were not recovered in the experiments (about 43 percent per release; Table 1). The high proportion of nonparticipation was not statistically different among screen conditions (Kruskal-Wallis, $P = 0.285$), nor when channel velocity was relatively higher (> 0.7 m/s, 2.3 ft/s; Wilcoxon Rank Sum Test, $P = 0.053$). The high proportion of missing experimental fish, even during tests when the traveling screen was out of the water and channel velocity was high (0.9 m/s, [3.0 ft/s]), suggests that some form of fish crowding may be beneficial in the primary bypass pipes and secondary channel. For example, flushing of the primary bypasses and netting in the secondary channel following one set of releases yielded 93.5 percent of the missing fish for those experiments. No experimental fish were removed by the screen. No mitten crabs were observed during the experiments. Three wild fish were noted to have injuries, possibly caused by the screen rotation or placement of the steel plate (Figure 3).
