Hydraulic Laboratory Report HL-2011-10

Physical Hydraulic Modeling of Secondary Louver Replacement at the Tracy Fish Collection Facility

U.S. Department of the Interior
Bureau of Reclamation
Technical Service Center
Hydraulic Investigations and Laboratory Services Group
Denver, Colorado

December 2011

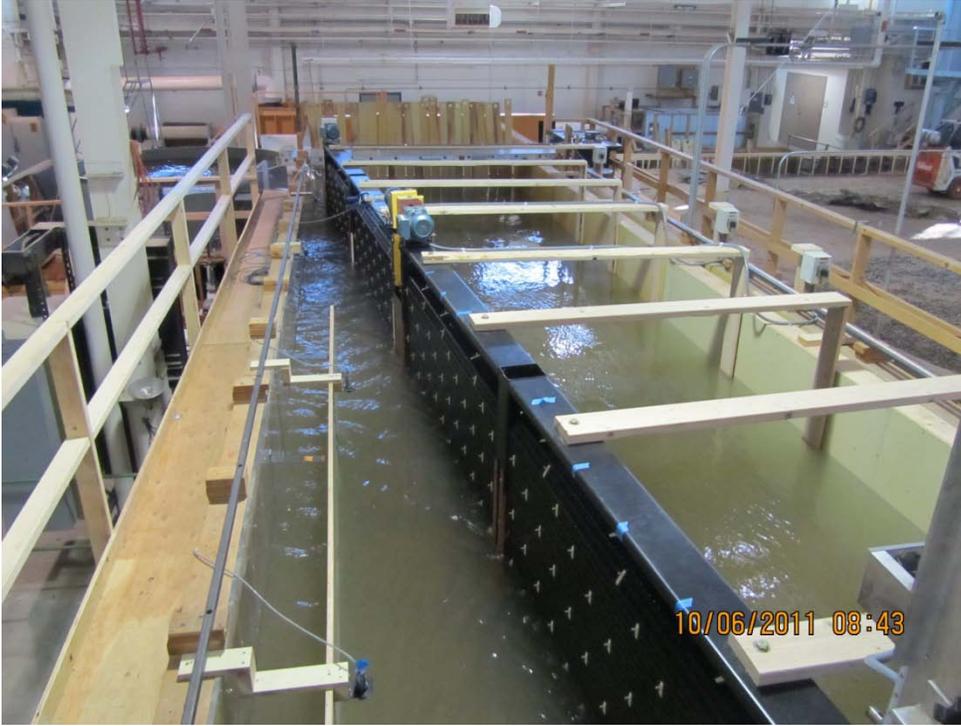
Figure A-1 - Close up overview of model (flow from bottom to top)

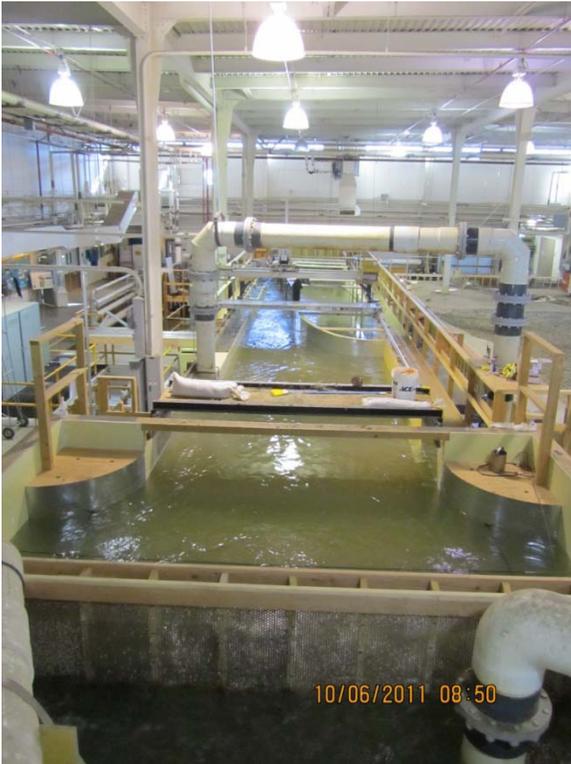
Figure A-2 - Overview of model (flow from bottom to top)

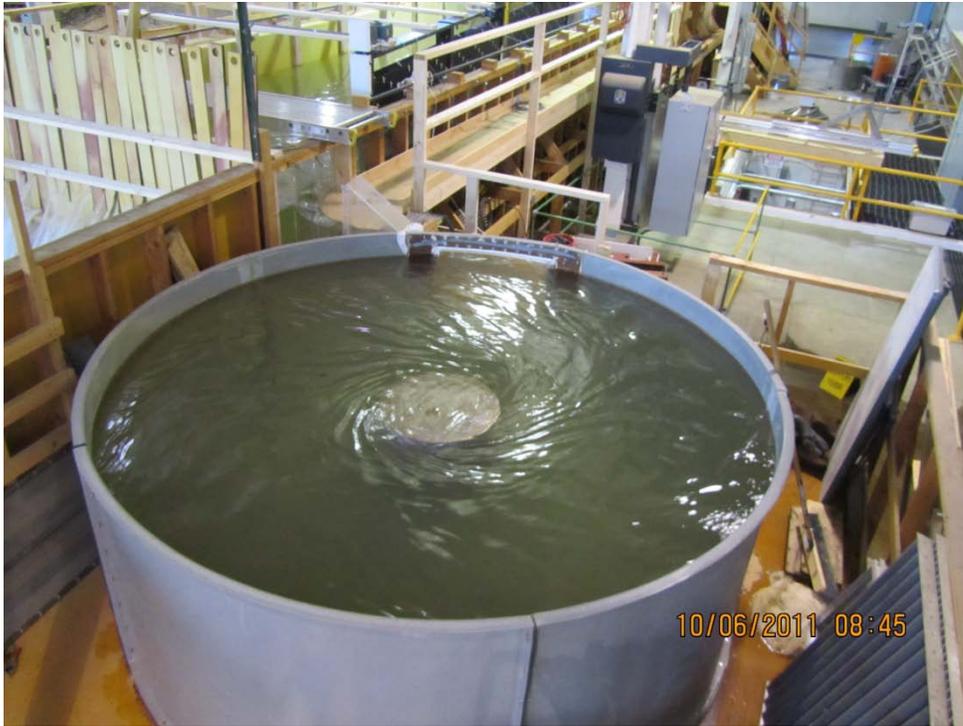
Figure A-3 - Holding tank during a test (flow entering the tank from the top)

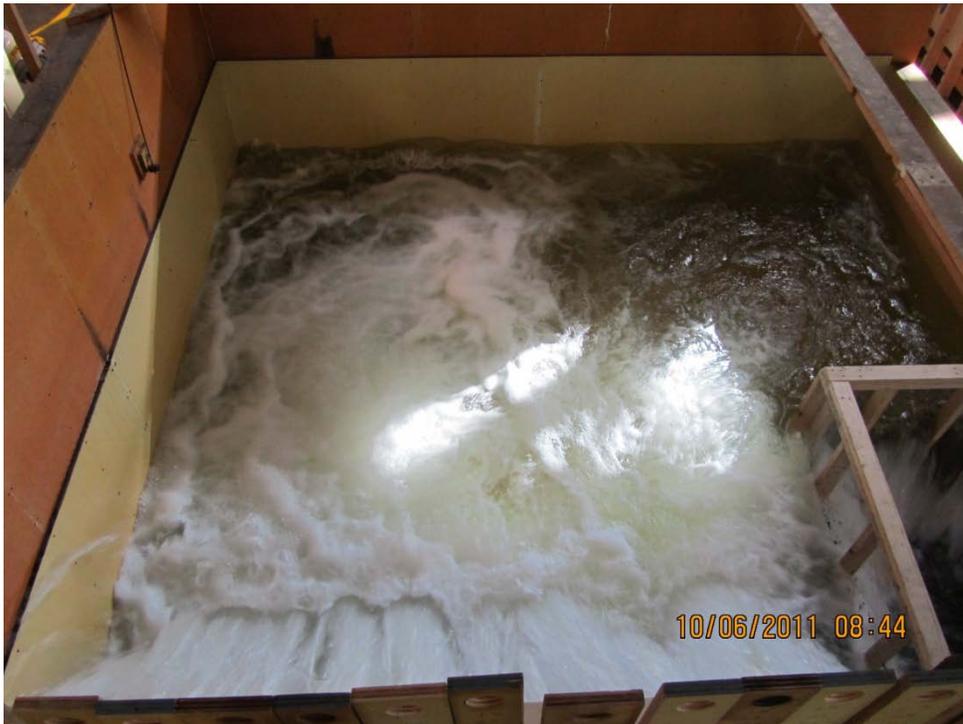
Figure A-4 - Tailbox during a test (flow from bottom to top)

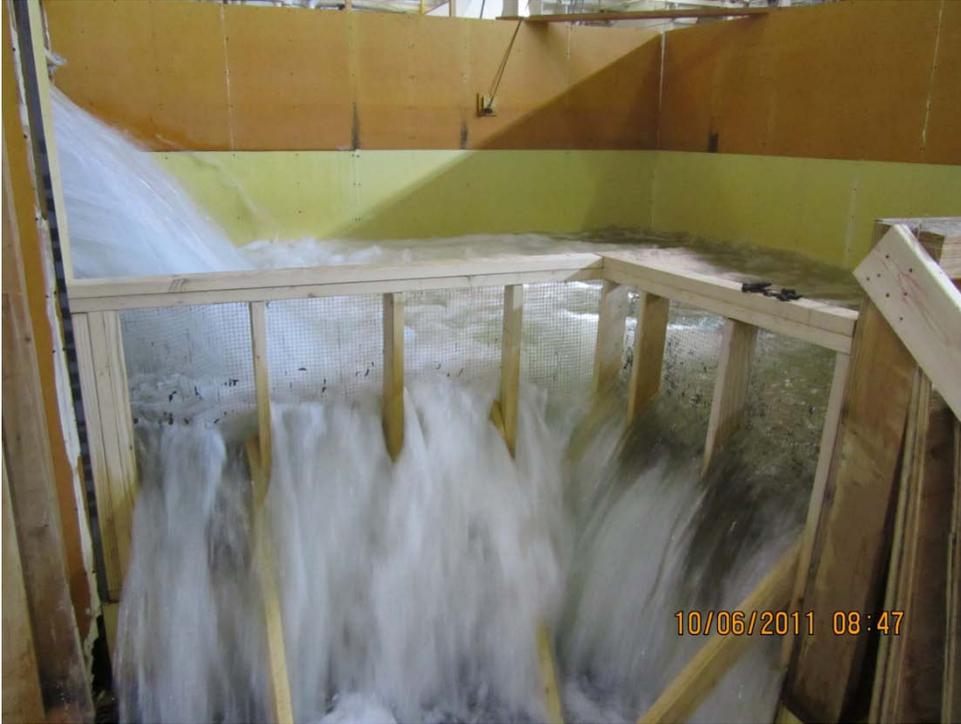
Figure A-5 - Tailbox during a test (flow towards reader)

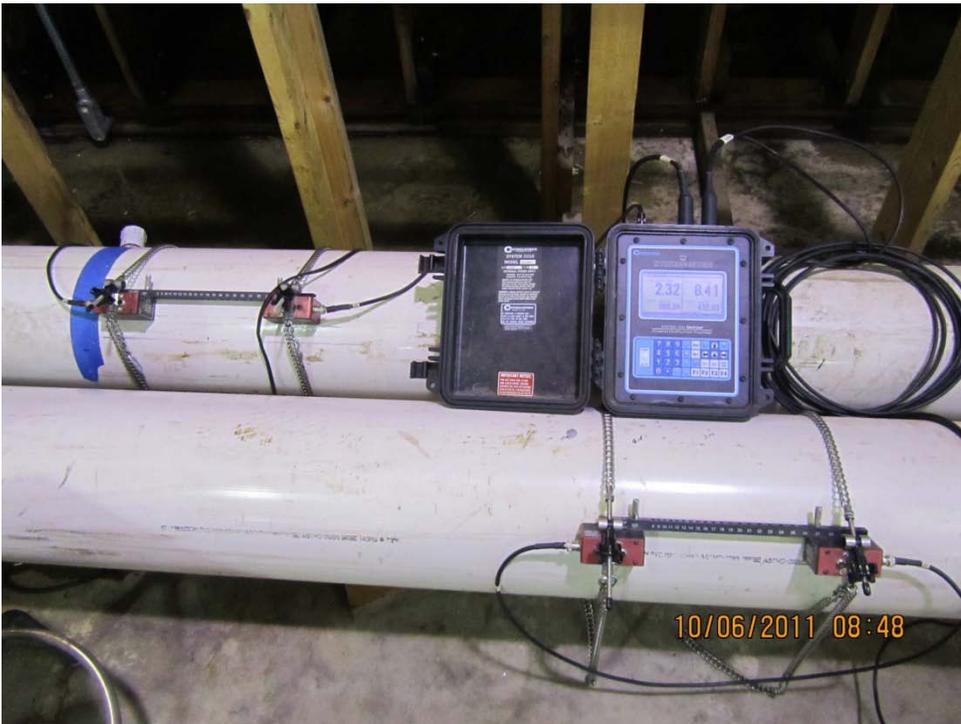
Figure A-6 - Ultrasonic flow meter on two inflow pipes (flow from right to left)

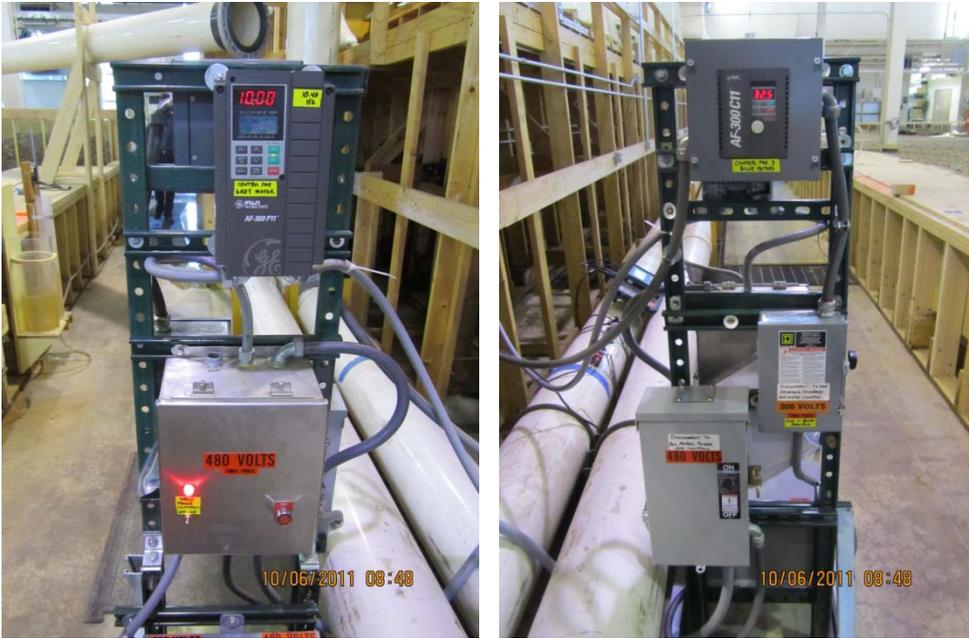
Figure A-7 - Variable frequency drive for screens

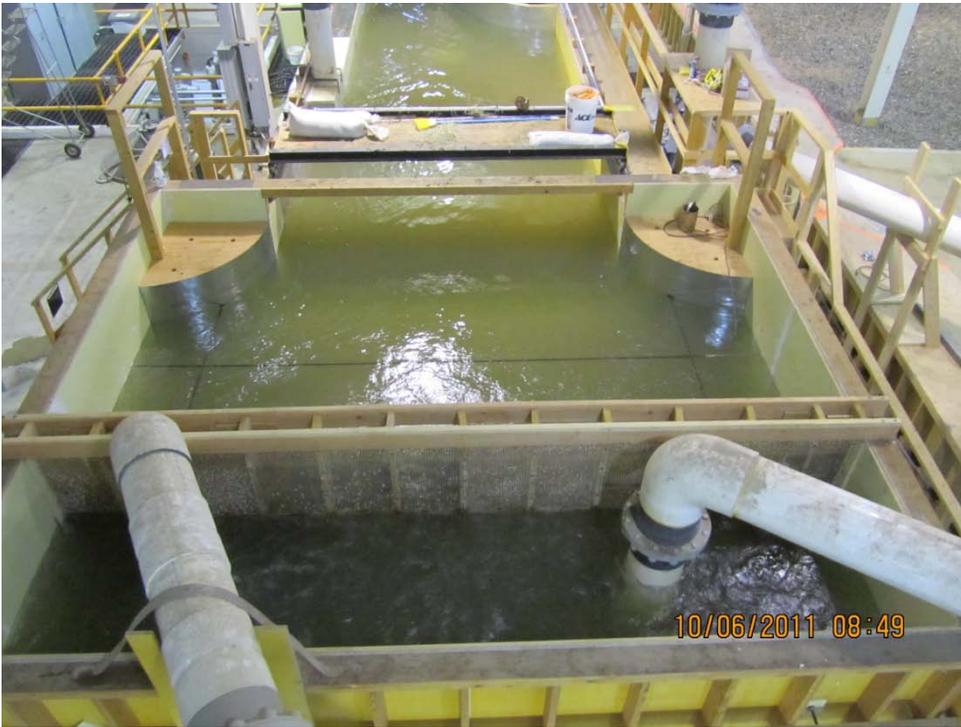
Figure A-8 - Headbox and inflow pipes 1 and 2 (flow from bottom to top)

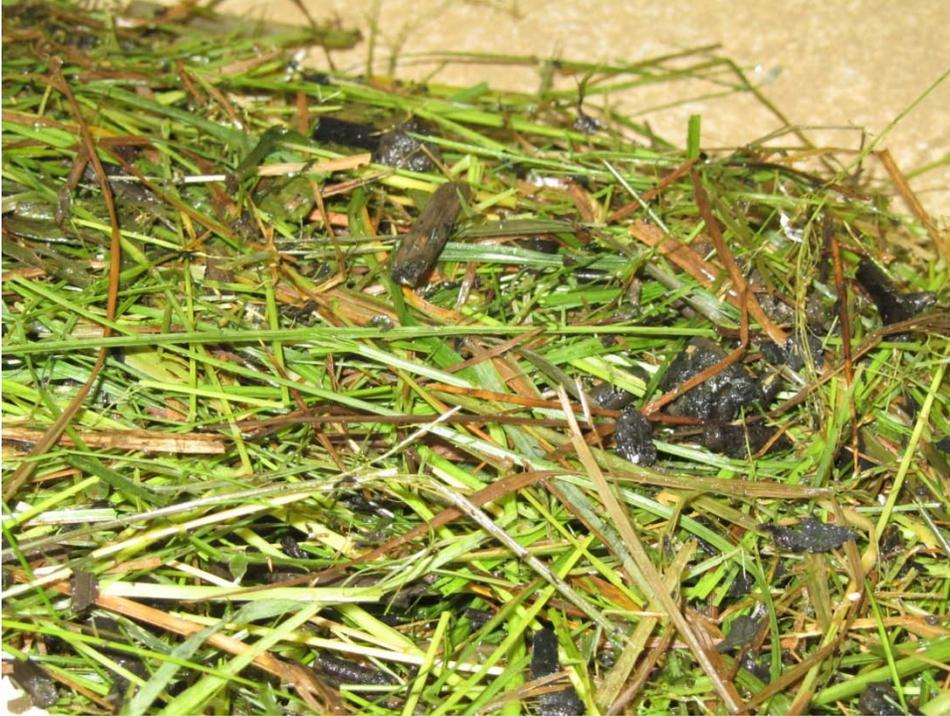
Figure A-9 - Close up of hay and woody debris collected downstream of the traveling screens

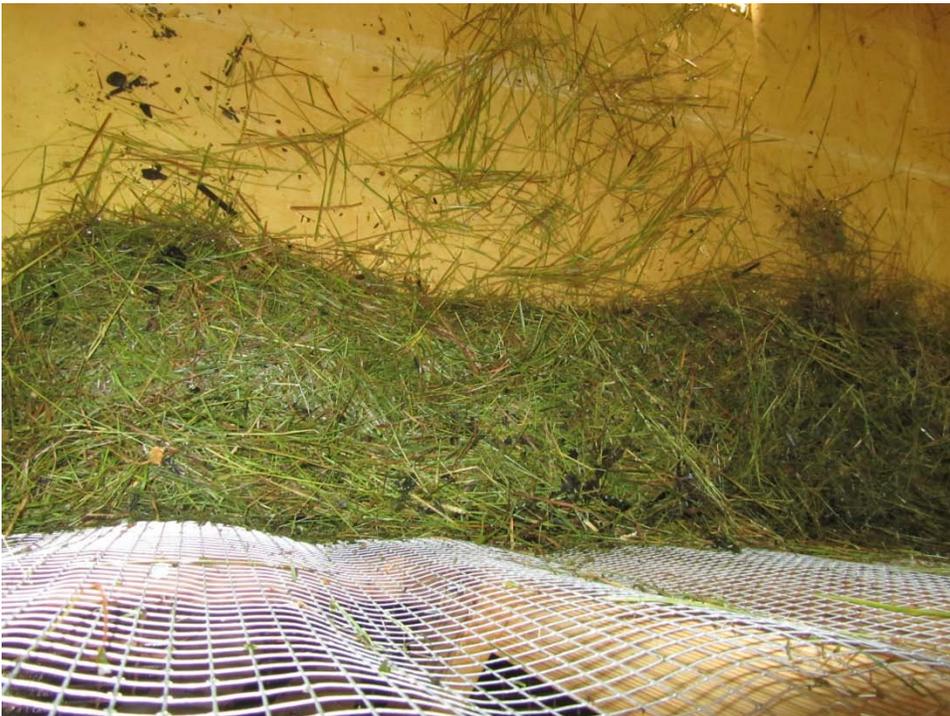
Figure A-10 - Collection of hay and woody debris in the tailbox downstream of the traveling screens

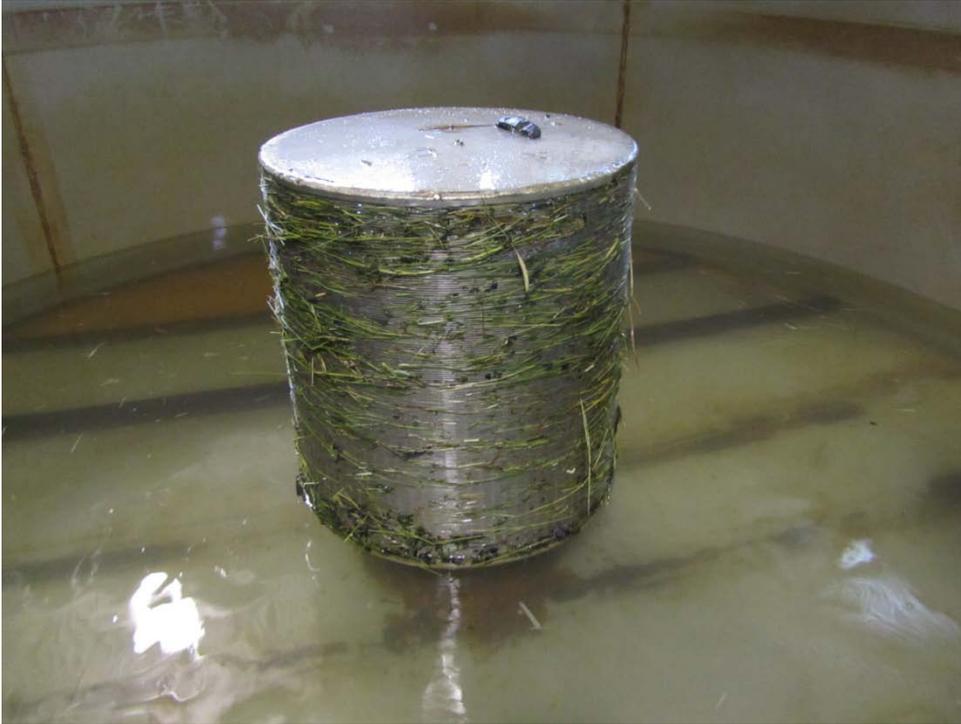
Figure A-11 - Hay and woody debris in the holding tank after a test is complete.

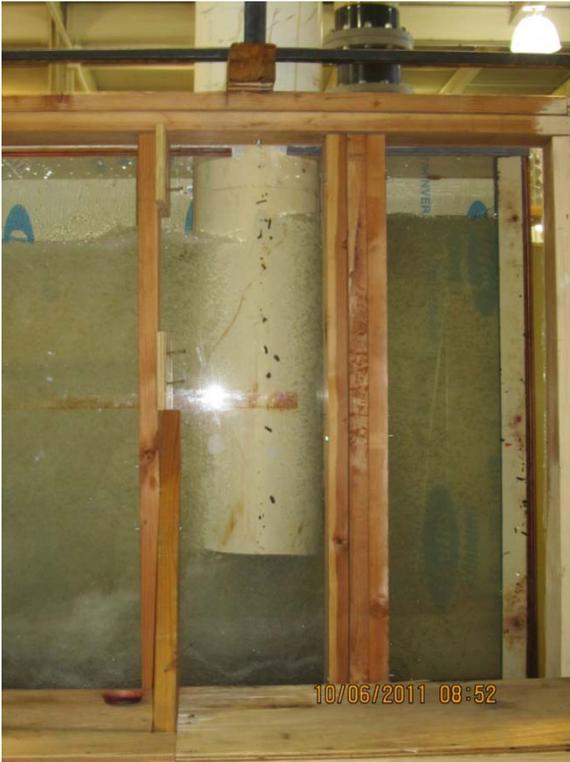
Figure A-12 - Inflow 4 into the clean water bypass (flow from right to left)

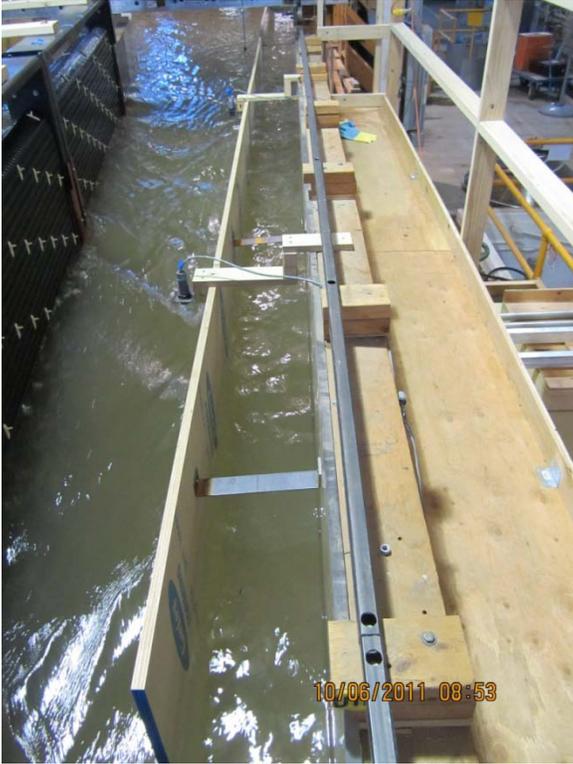
Figure A-13 - Clean water bypass (flow from top to bottom)

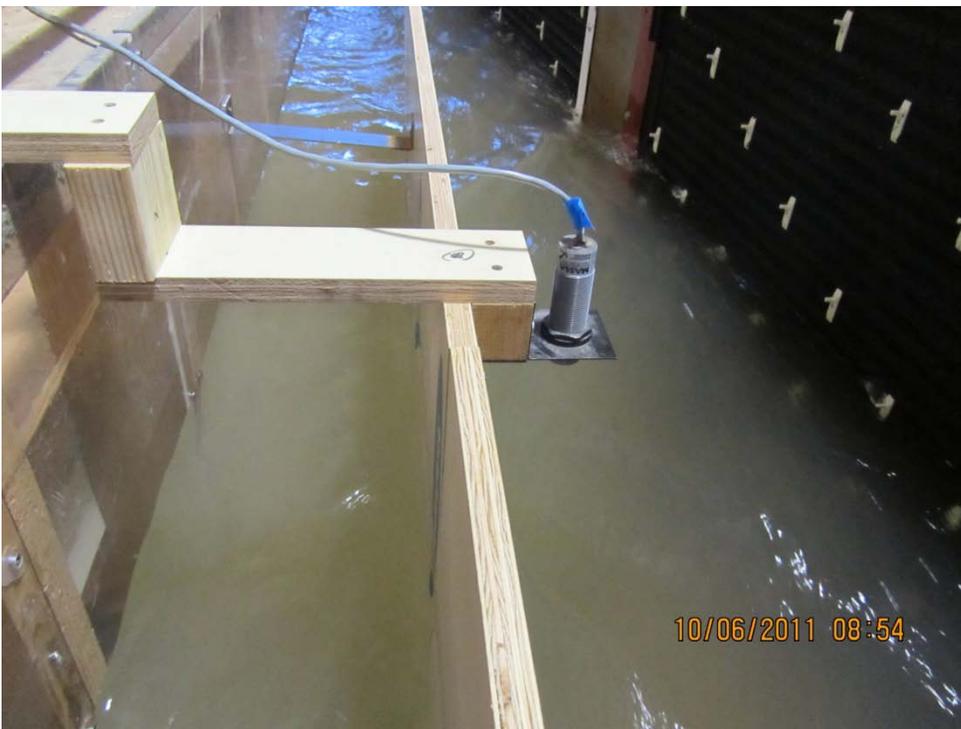
Figure A-14 - Ultrasonic downlooker to determine flow depth (1 of many)

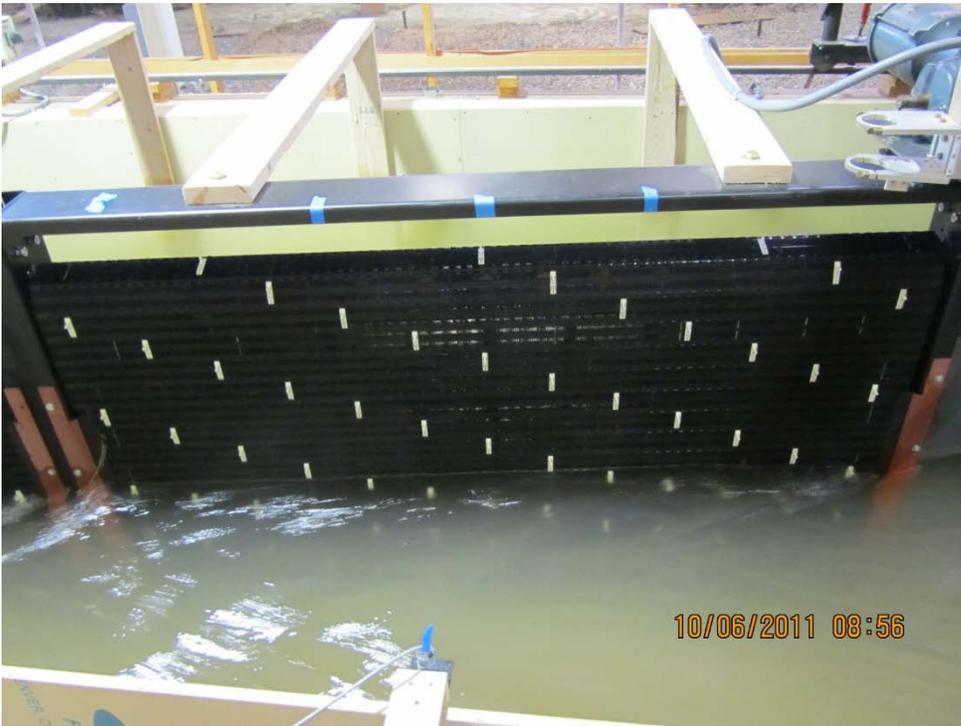
Figure A-16 - Debris peg layout on upstream side of screen (flow from right to left)

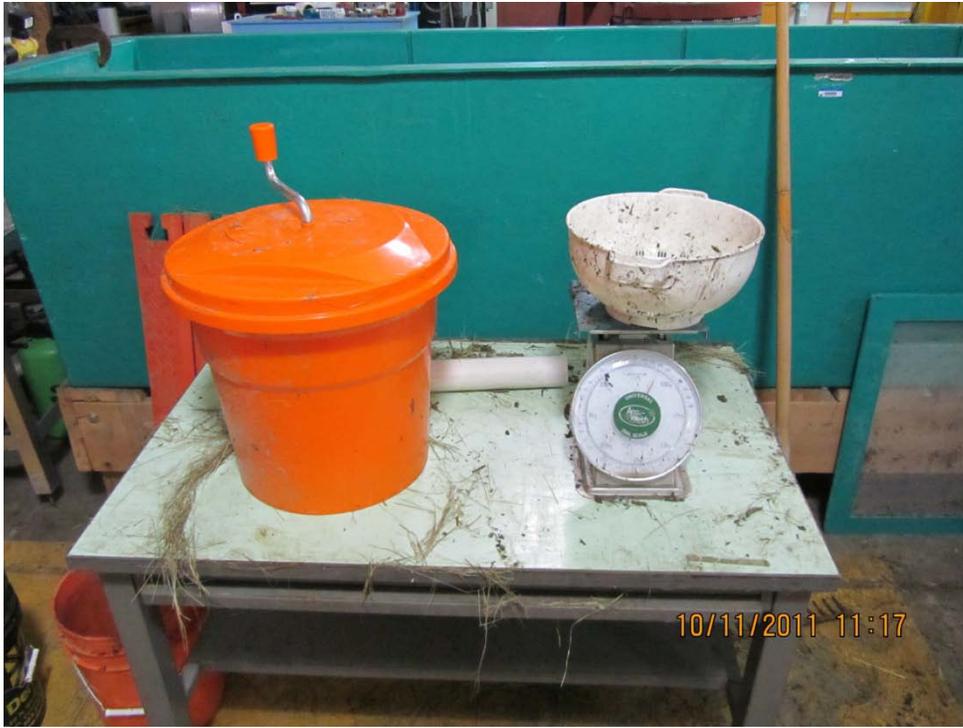
Figure A-17 - Debris weigh station
