# Tracy Fish Facility Studies California

## Evaluation of a New Technique to Remove Debris from Holding Tanks at the Tracy Fish Collection Facility

Tracy Series Volume 50

**April 2014**

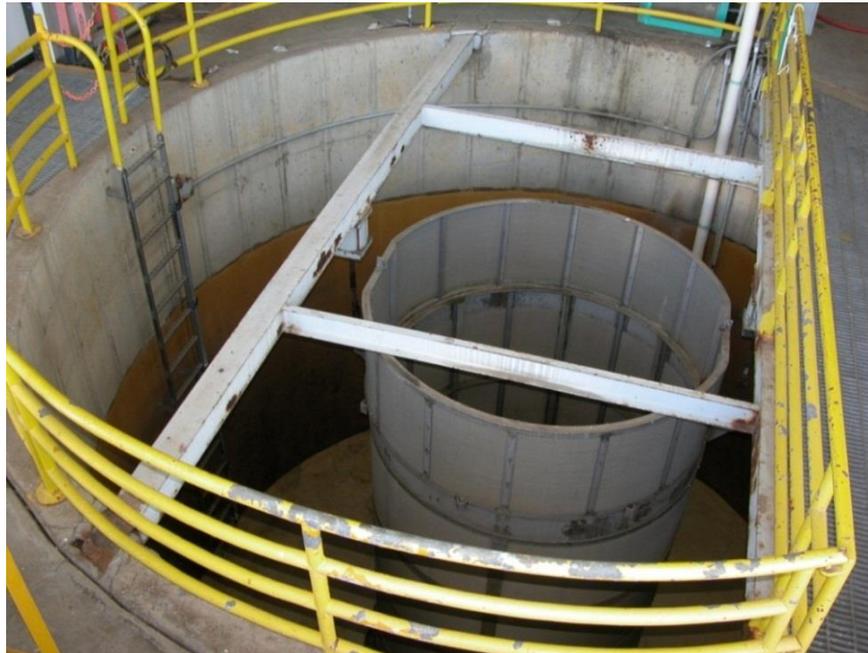
Figure 1.—Flow-through, open-end, conical-bottom, concrete holding tank at the Tracy Fish Collection Facility.

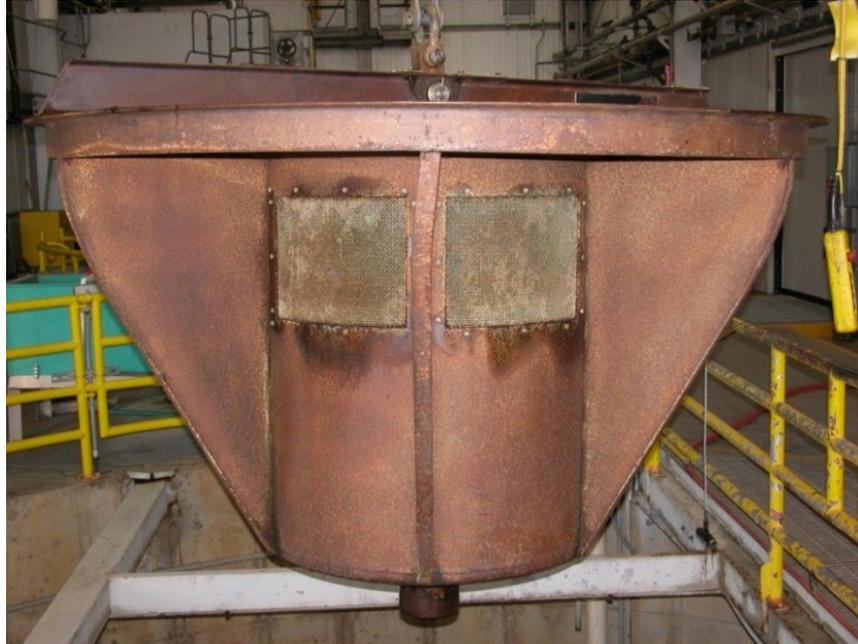
Figure 2.—Fish-count bucket (343-L) used to transfer fish from holding tanks to the fish-count station during salvage counts at the Tracy Fish Collection Facility.

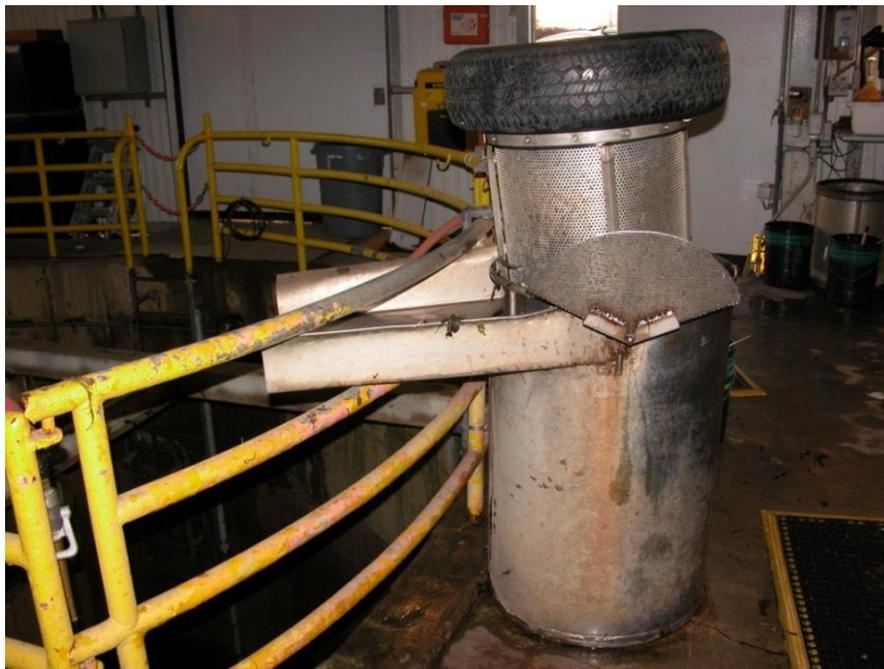
Figure 3.—Fish-count station (23-L) where salvage samples are processed every 2 h at the Tracy Fish Collection Facility.

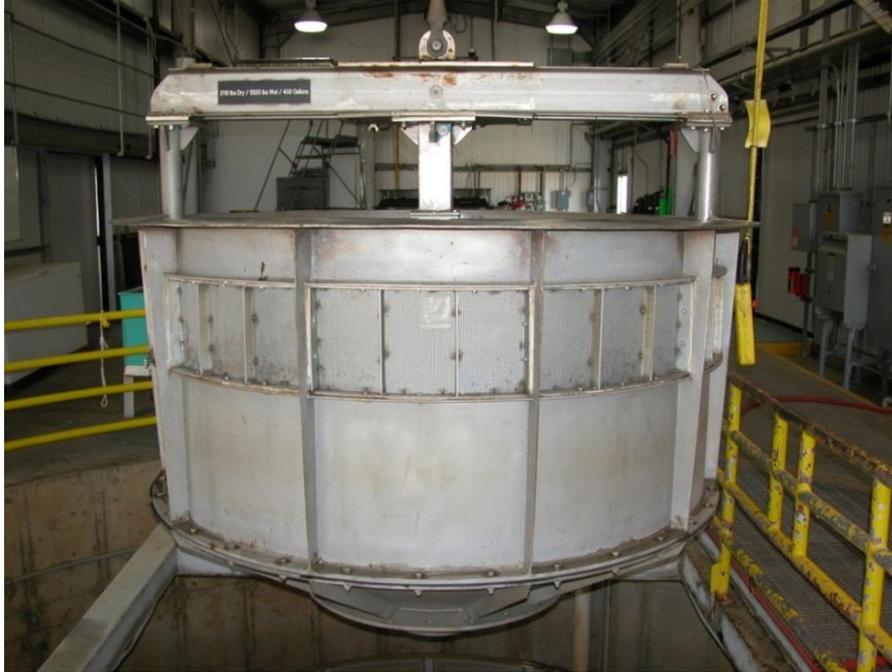
Figure 4.—Haul-out bucket (1544-L) used to transfer fish from holding tanks to the fish-haul truck during the haul-out process at the Tracy Fish Collection Facility.

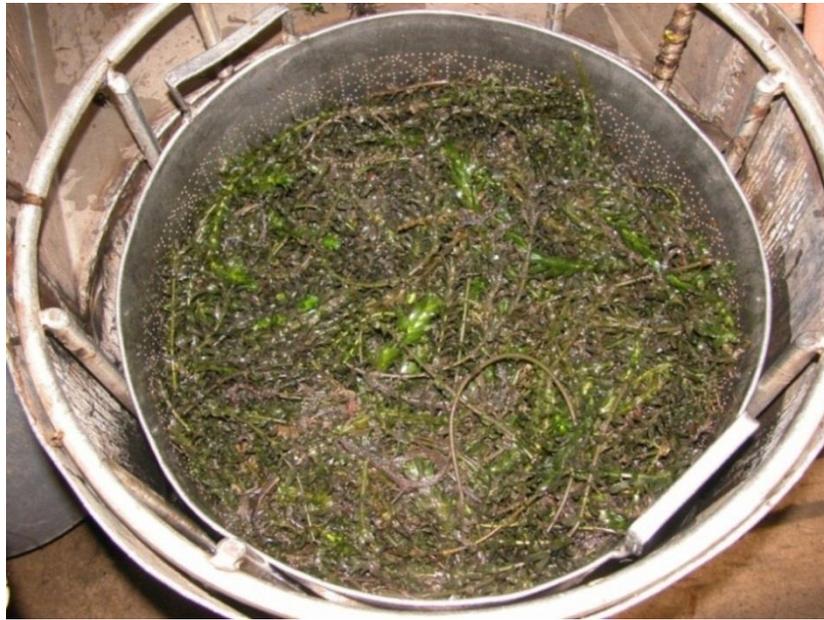
Figure 5.—Example of green debris encountered during the salvage process at the Tracy Fish Collection Facility. Green debris consisted almost entirely of Brazilian elodea during the Holding Tank Screen Lift evaluation.

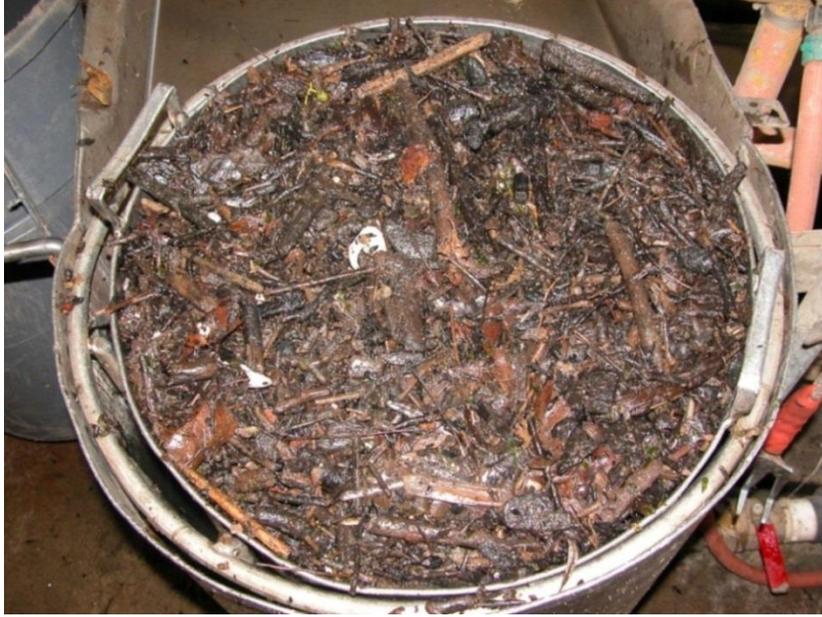
Figure 6.—Example of woody debris encountered during the salvage process at the Tracy Fish Collection Facility. Woody debris consisted mostly of sticks, twigs, roots, bark, seeds and peat during the Holding Tank Screen Lift evaluation.

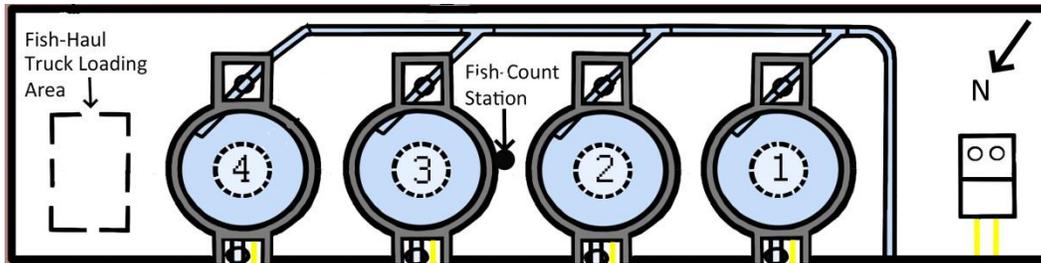
Figure 7.—Schematic of the holding tank building at the Tracy Fish Collection Facility showing numbering of holding tanks as well as locations of the fish-count station and fish-haul truck loading area.

Holding tank #2 was chosen as a starting point for time trials with the fish-count bucket since fish-counts typically start at this location. The time it took to hoist the empty fish-count bucket from holding tank #2 drain pit to the fish-count station (seated on the fish-count station) and back to holding tank #2 drain pit was recorded (n = 6; Figure 7).

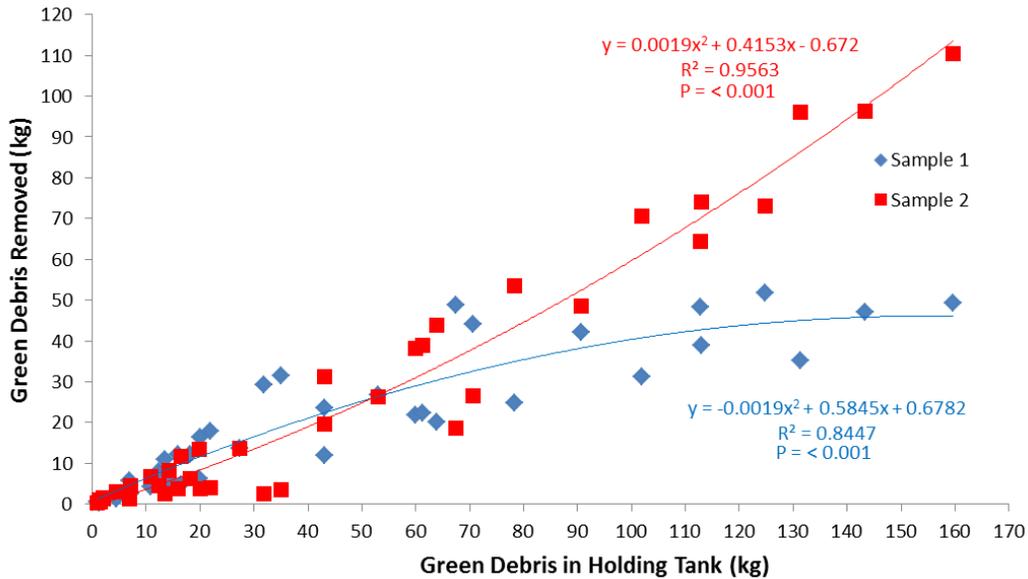
Figure 8.—Green debris in Sample #1 and #2 relative to the total amount of green debris in the holding tank (n = 38).

removal efficiency continued to decline as more debris was added. The amount of green debris removed in Sample #1 was dependent on the total amount of green debris in the holding tank (Regression,  $P = < 0.001$ ), although the HTSL could only remove approximately 50 kg of green debris regardless of how much was in the tank (Figure 8).

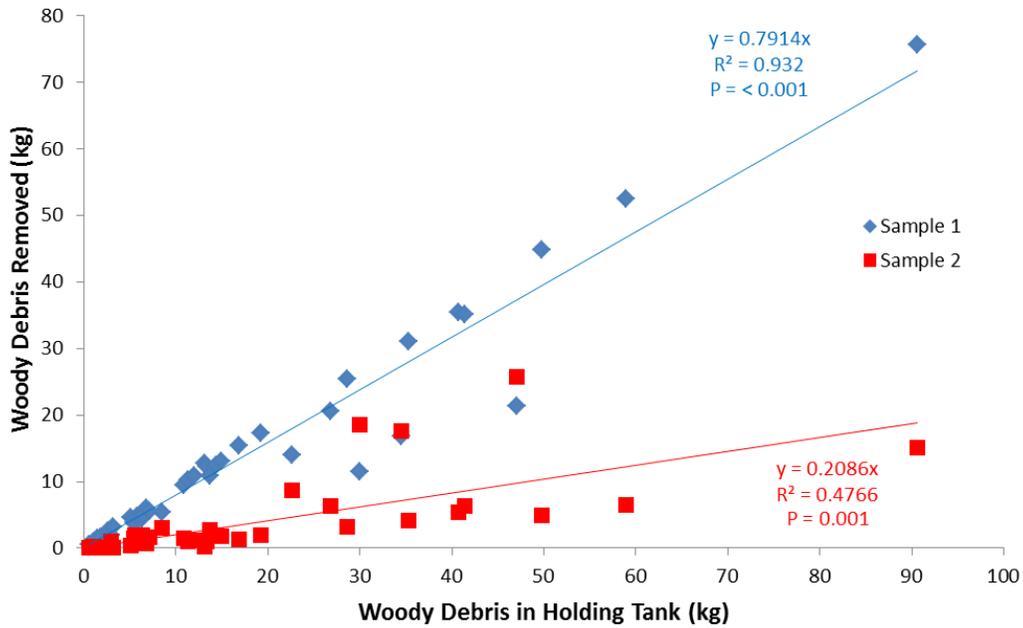
Figure 9.—Woody debris in Sample #1 and #2 relative to the total amount of woody debris in the holding tank (n = 40).

Unlike green debris, woody debris pieces were generally short and dense, sank to the bottom faster, and concentrated around the holding tank screen, resulting in greater debris removal in Sample #1. When performing the HTSL with woody debris, a maximum threshold of debris removed in Sample #1 was not encountered over the range of debris loads tested, as with green debris. Instead, removal efficiency was a constant fraction of the initial amount in the holding tank (Regression,  $P = < 0.001$ ; Figure 9). This suggests that performing the HTSL with woody debris was equally effective over all debris loads tested and more predictable than with green debris. Despite this, bucket capacity will eventually limit the amount of woody debris that the HTSL is able to remove. Additional sampling is needed with extreme woody debris loads to determine the debris removal capacity of the fish-count and haul-out buckets.

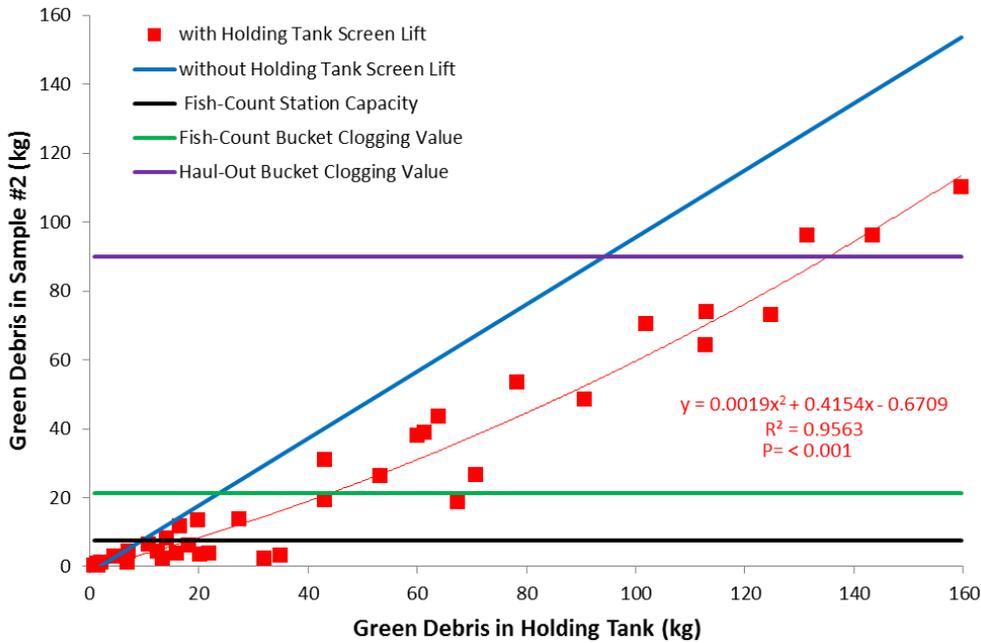
Figure 10.—Green debris in Sample #2 relative to the total amount of green debris in the holding tank. The blue line (without Holding Tank Screen Lift) is for reference to illustrate how much debris would be in the sample if not removed. The black, green and purple horizontal lines are referencing the clogging values of the fish-count station, fish-count bucket and haul-out bucket, respectively.

The HTSL prevented the fish-count station from filling when the tank had approximately 20 kg of green debris and 125 kg of woody debris, or less (Figures 10 and 11). The HTSL prevented the fish-count and haul-out bucket discharge pipes from clogging when there was up to 43 kg and 135 kg of green debris in the holding tank, respectively. This process prevented the fish-count and haul-out bucket discharge pipes from clogging with woody debris up to the maximum amount tested (91 kg); therefore, it was not possible to estimate ranges in woody debris loads in which performing the HTSL will likely benefit the salvage process by preventing clogging of the buckets.

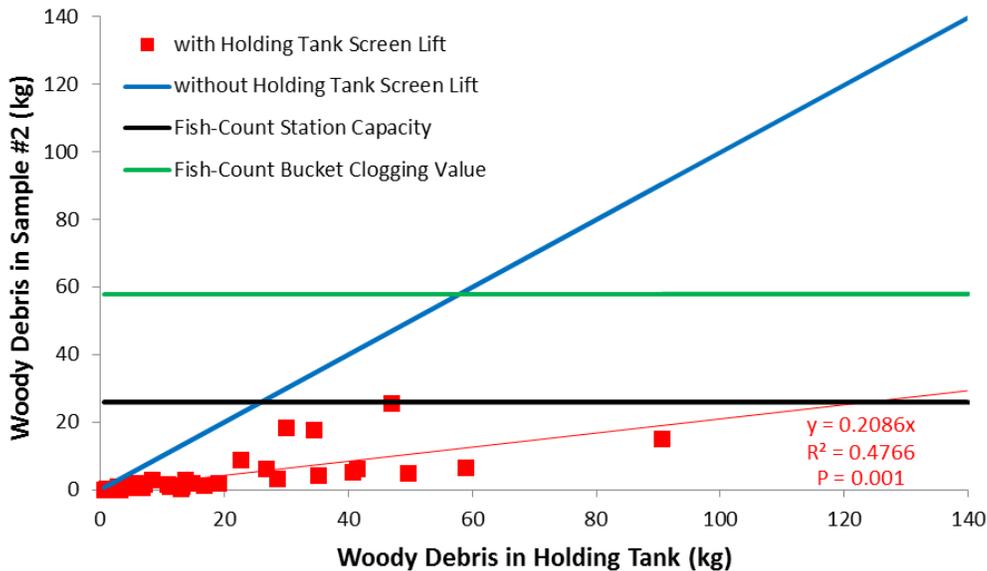
Figure 11.—Woody debris in Sample #2 relative to the total amount of woody debris in the holding tank. The blue line (without Holding Tank Screen Lift) is for reference to illustrate how much debris would be in the sample if not removed. The black and green horizontal lines are referencing the clogging values of the fish-count station and fish-count bucket, respectively.

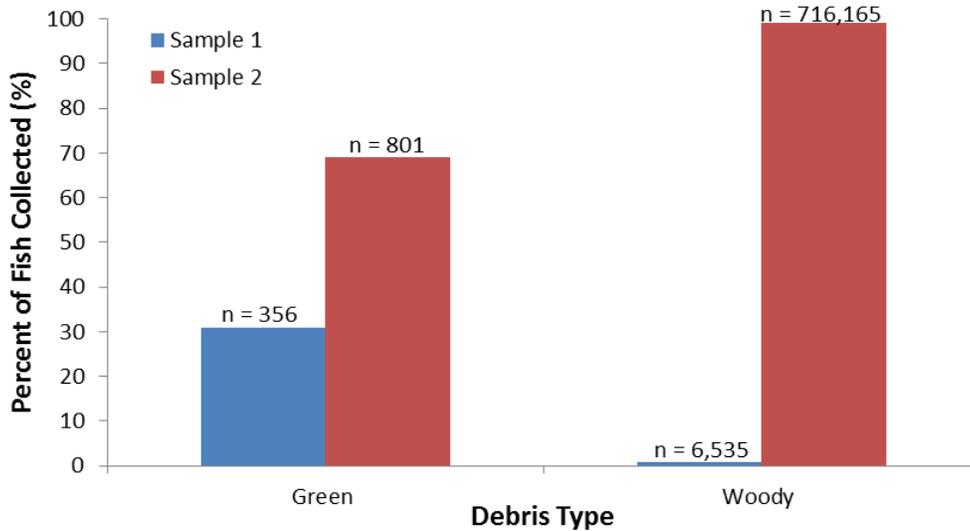
Figure 12.—Percentage of all fish combined in each sample for each debris type when using the Holding Tank Screen Lift. The number of fish collected in each sample for each debris type is represented by “n”.

When combining all fish species together (wild and artificially added), fish loss in Sample #1 was 31 percent and 1 percent when the HTSL was used with green and woody debris, respectively (Figure 12). However, these results were influenced by the most abundant species. In Figure 12, Sacramento splittail and common carp were largely responsible for woody debris results, while white catfish, Sacramento splittail, threadfin shad and Chinook salmon all had nearly equal representation in green debris replicates. The loss of fish in Sample #1 suggests it will not be reasonable to immediately dispose of debris removed in Sample #1 without additional processing.

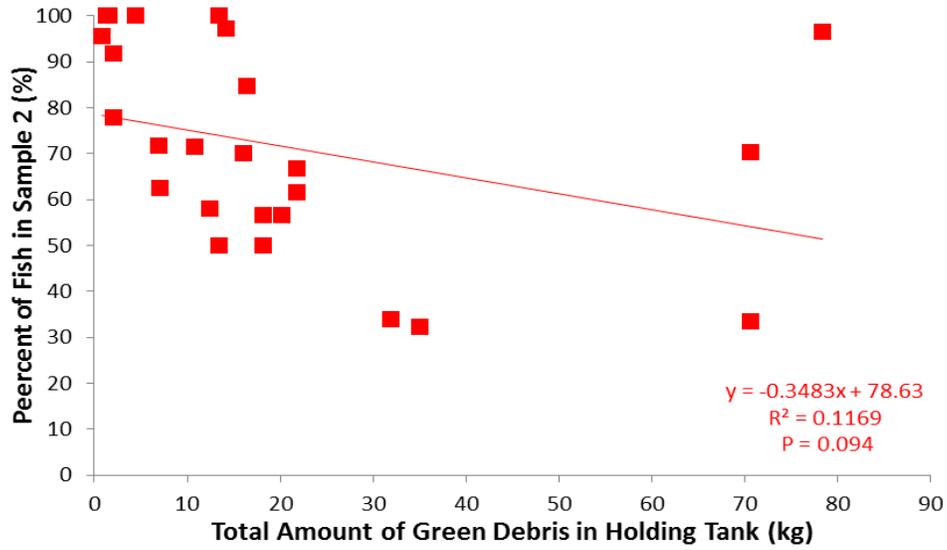
Figure 13.—Percentage of fish recovered in Sample #2 relative to the total amount of green debris in the holding tank.

The percentage of fish recovered in Sample #2 was generally not influenced by quantity of debris in the holding tank for both debris types. However, percentage of fish collected in Sample #2 during green debris replicates was more dependent on amount of debris in the holding tank (Regression,  $P = 0.094$ ; Figure 13) than during woody debris replicates (Regression,  $P = 0.698$ ; Figure 14). If the 2 extreme values above 70 kg of green debris were removed from Figure 13, there would be an inverse relationship between recovered fish and debris load. This trend should be further evaluated.

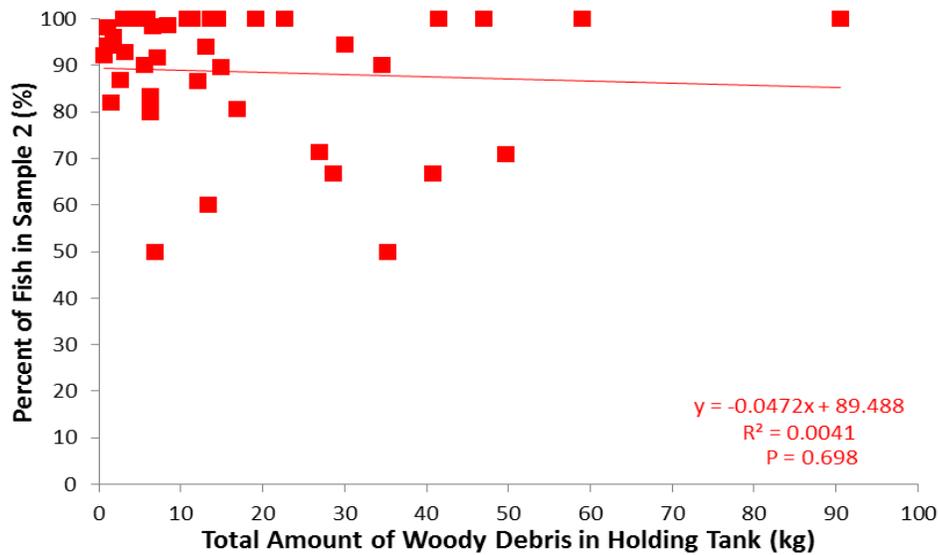
Figure 14.—Percentage of fish recovered in Sample #2 relative to the total amount of woody debris in the holding tank.

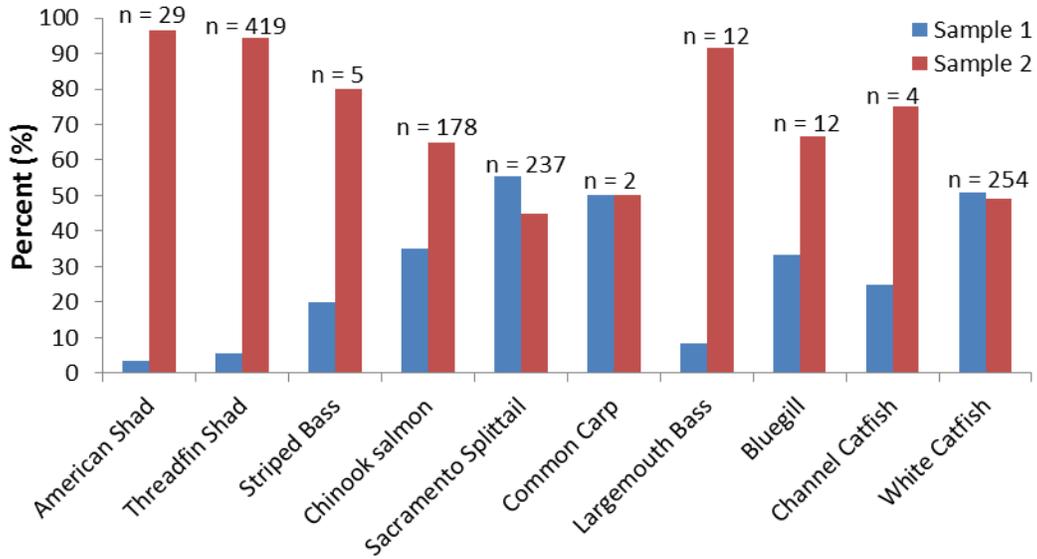
Figure 15.—Percentage of each fish species in Sample #1 and #2 for green debris samples. The total number of each species of fish observed during sampling is represented by “n”.

While the majority of fish remained in the holding tank after the HTSL was completed, variation in percent fish loss in Sample #1 was high between fish species and debris type (Figures 15 and 16). This suggests the loss of fish may be dependent on species, as well as type of debris in the holding tank, when using the HTSL. The relatively high loss of Chinook salmon with both debris types (approximately 45–56 percent) further supports that the immediate disposal of Sample #1, and fish contained therein, would not be appropriate due to the possible loss of fish, including threatened or endangered species.

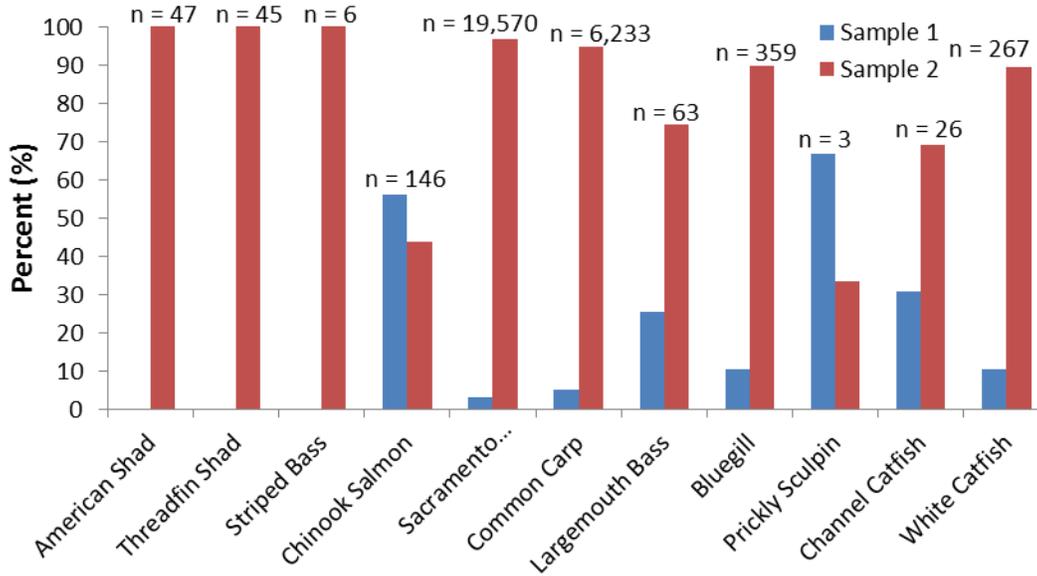
Figure 16.—Percentage of each fish species in Sample #1 and #2 for woody debris samples. The total number of each species of fish observed during sampling is represented by “n”.
