April 2012 Construction Photos

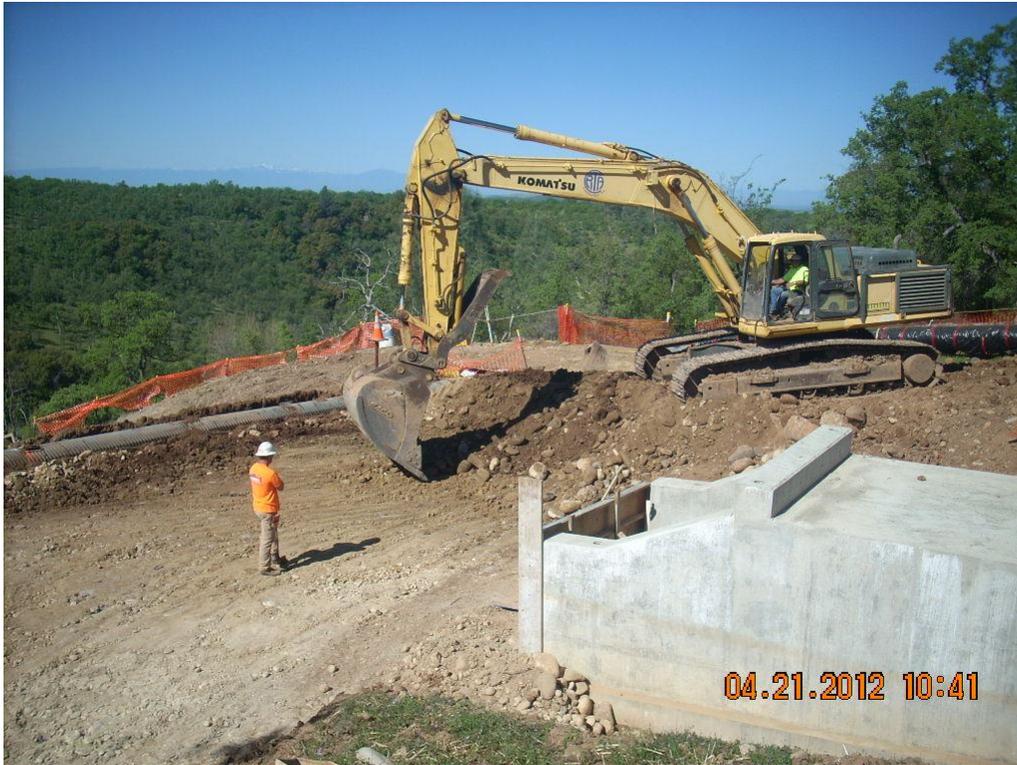
Coleman Diversion Dam/Inskip Powerhouse: The contractor is excavating for the Mouth Lassen Trout Farm water pipeline bypass.

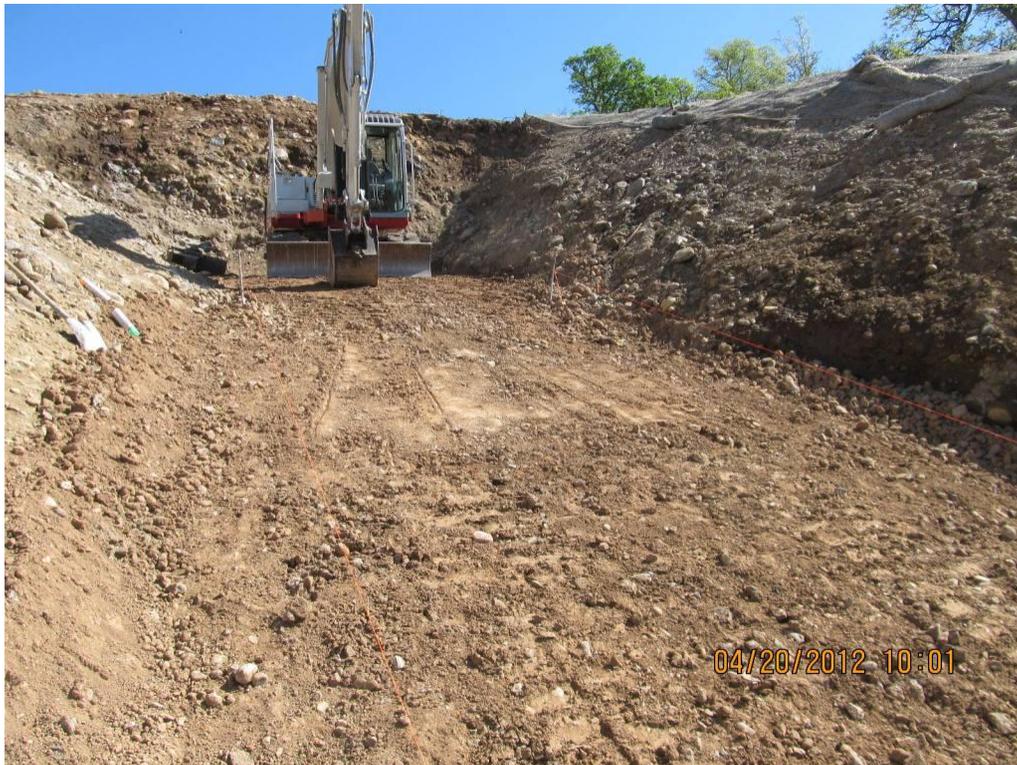
Coleman Diversion Dam/Inskip Powerhouse: The contractor is compacting backfill for the penstock bypass chute slabs # 15 and #16.

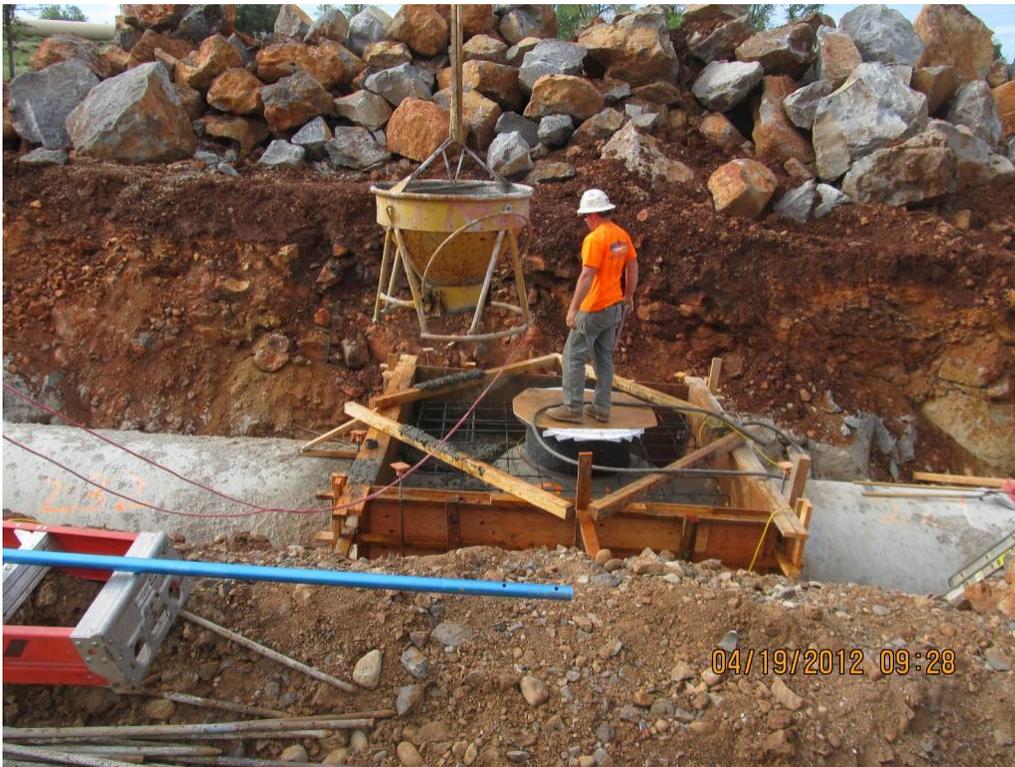
Coleman Diversion Dam/Inskip Powerhouse: The contractor is placing concrete for the 66-inch reinforced concrete pipe manhole at Sta. 19+33.

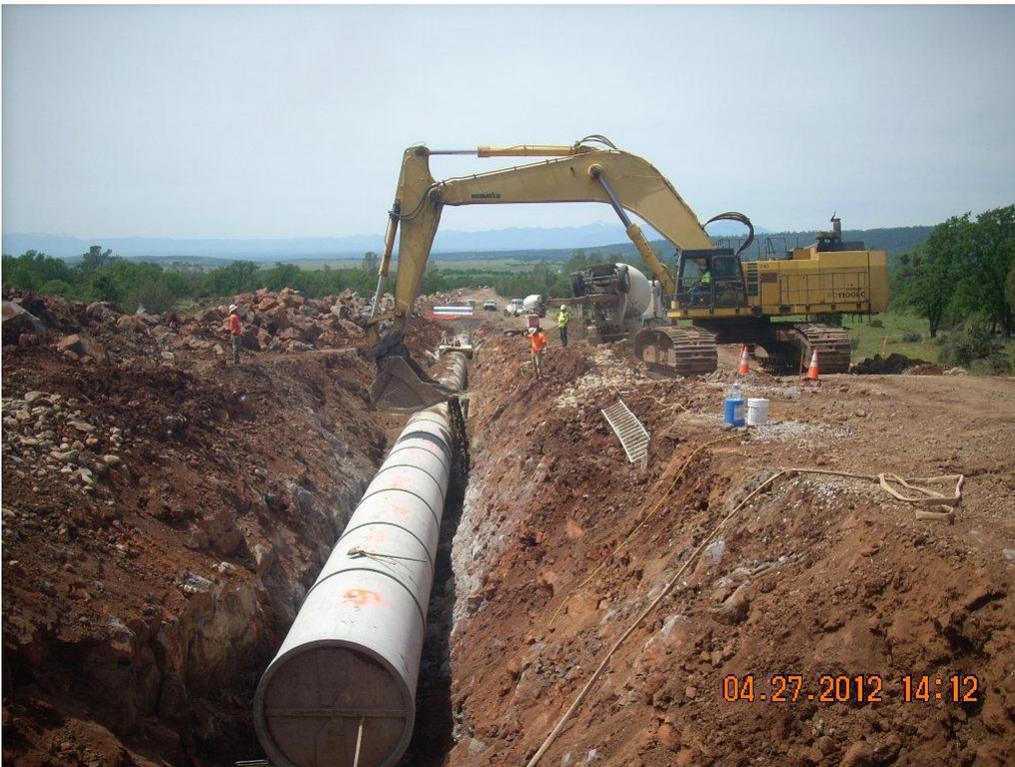
Coleman Diversion Dam/Inskip Powerhouse: The contractor is placing controlled-low strength material for backfill of the the 66-inch reinforced concrete pipe.

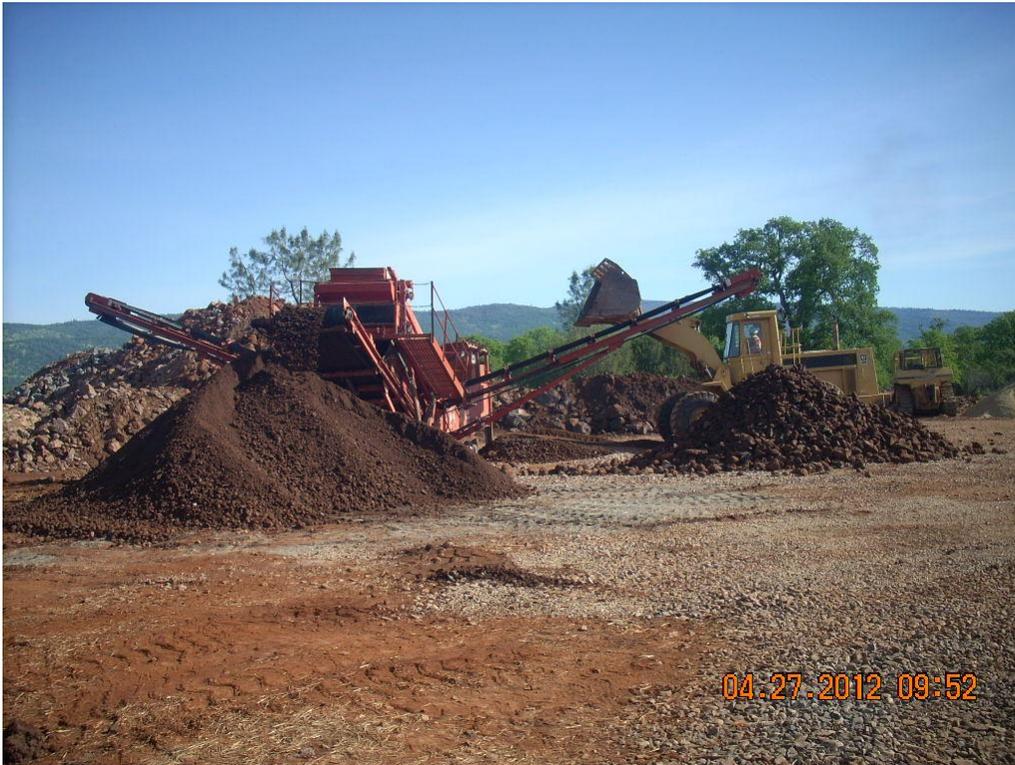
Coleman Diversion Dam/Inskip Powerhouse: The contractor working on screening 3-inch minus materials from excavated stockpiles.

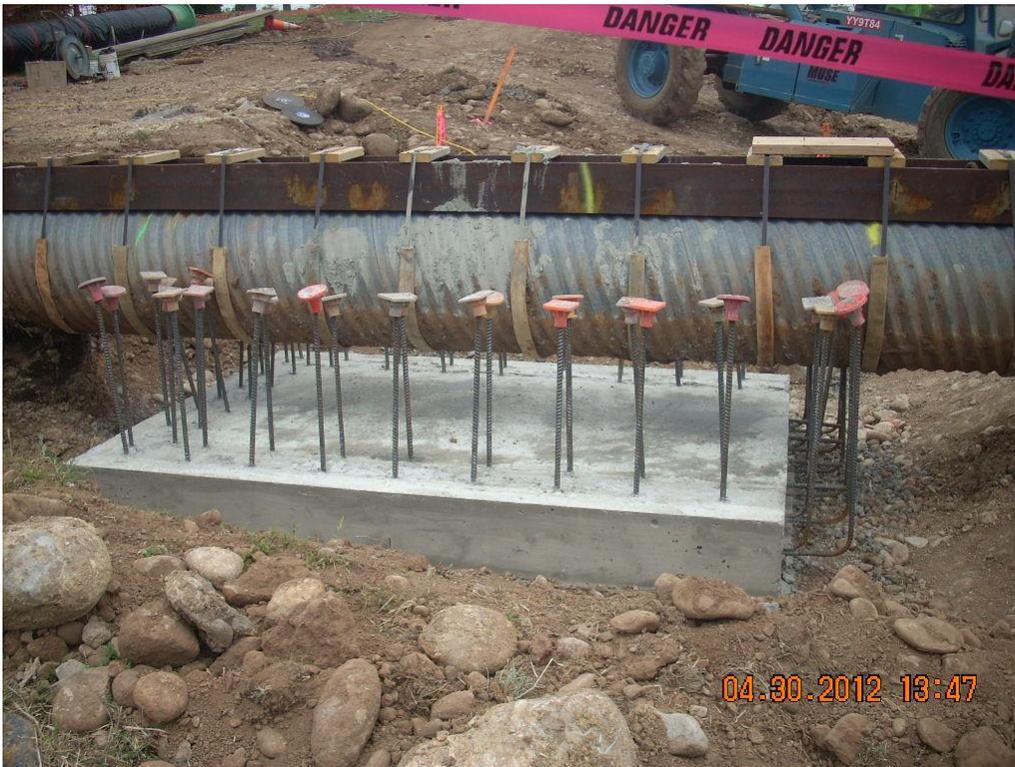
Coleman Diversion Dam/Inskip Powerhouse: Concrete placement of Mount Lassen Trout Farm water diversion box slab.

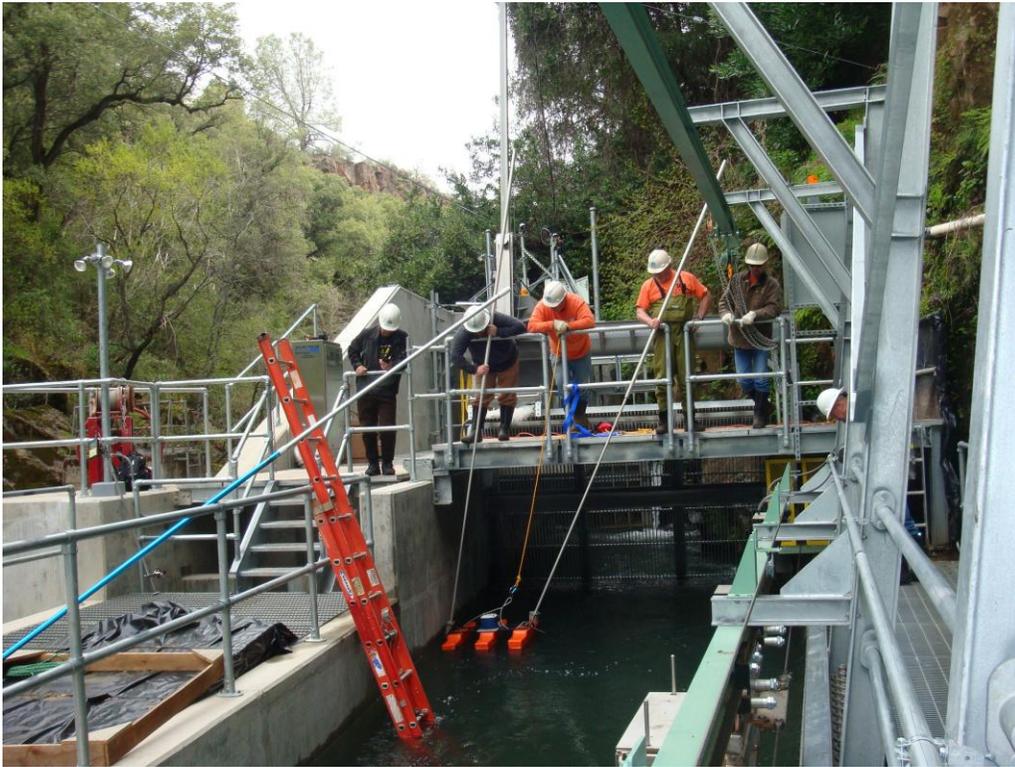
Eagle Canyon Diversion Dam: Hydraulic engineers and Pacific Gas and Electric (PG&E) staff using a tethered boat mount-River Surveyor Acoustic Doppler Current Profiler to measure flow in the canal headwork structure.

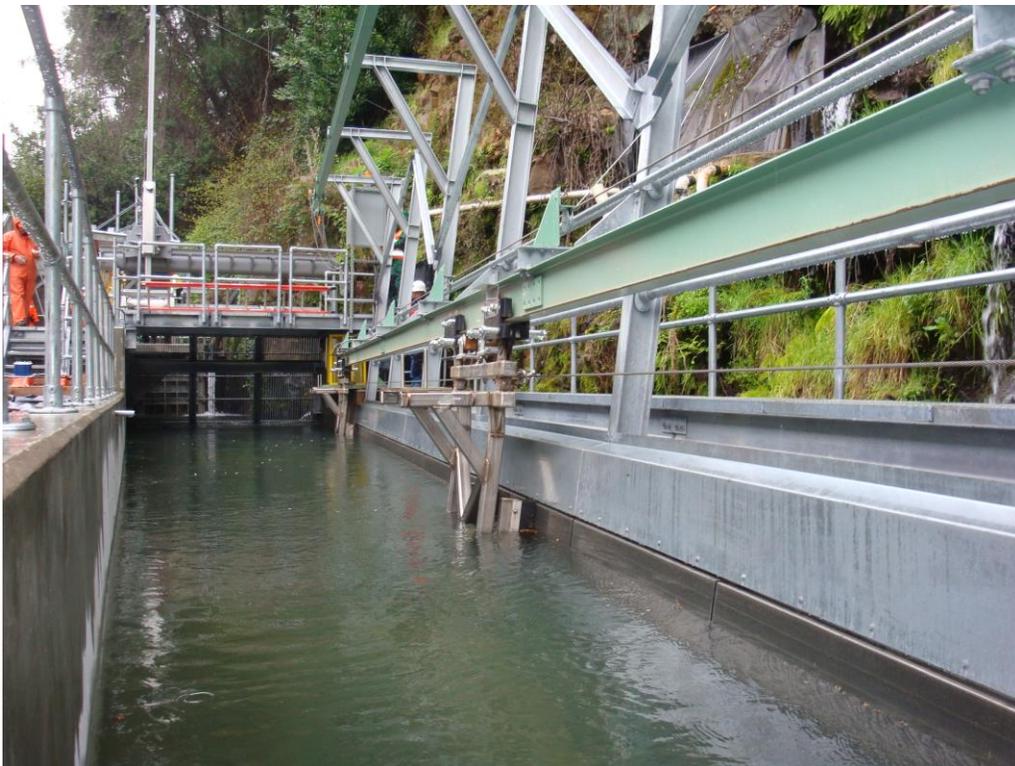
Eagle Canyon Diversion Dam: View of the fish screen and automatic brush cleaners (looking upstream).

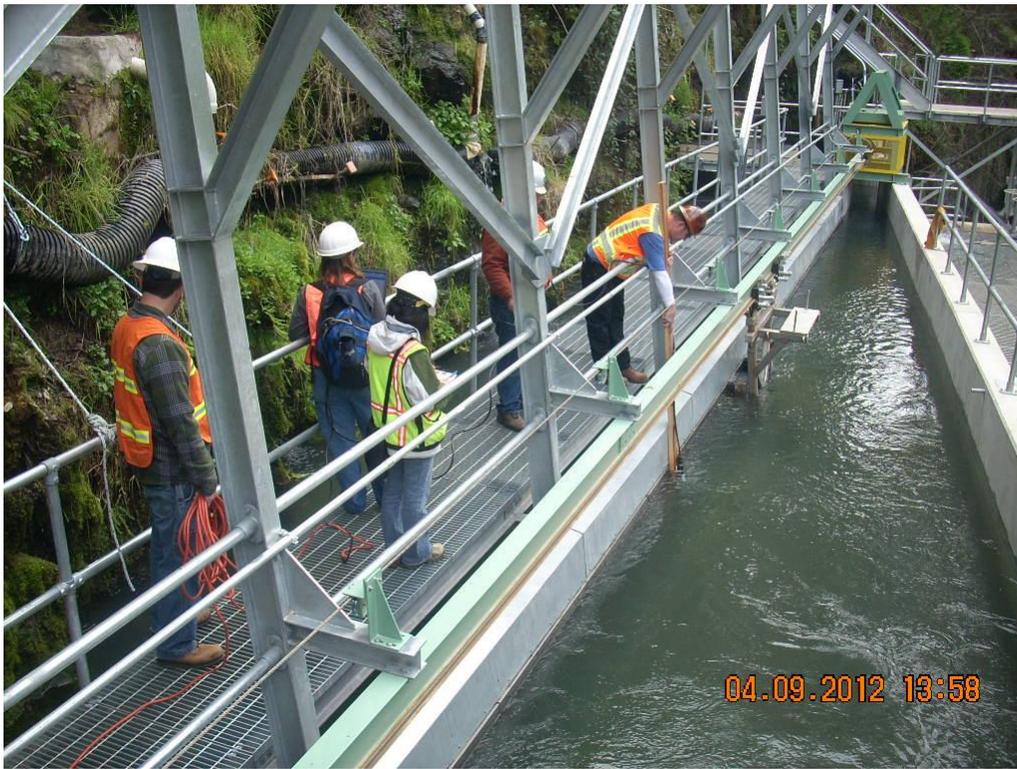
Eagle Canyon Diversion Dam: Engineers and biologists performing hydraulic evaluation on the newly installed fish screen panels (looking downstream).

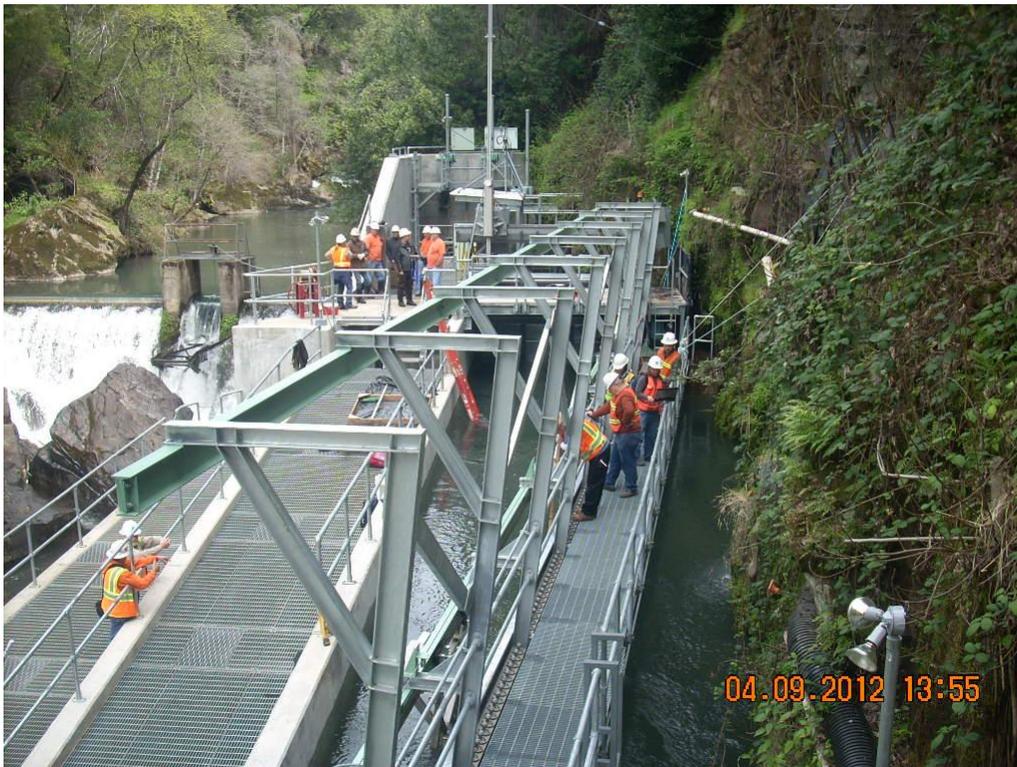
Eagle Canyon Diversion Dam: Engineers and biologists performing hydraulic evaluation on the newly installed fish screen panels (looking upstream).

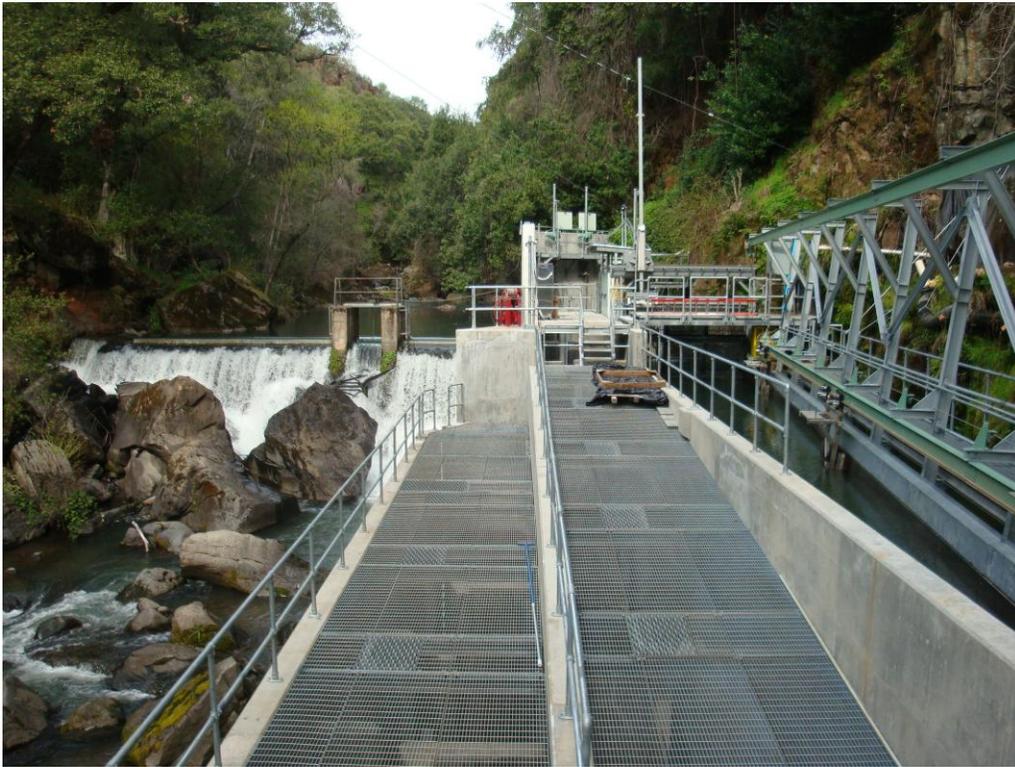
Eagle Canyon Diversion Dam: Looking upstream of the vertical slot fish ladder prior to the hydraulic testing.

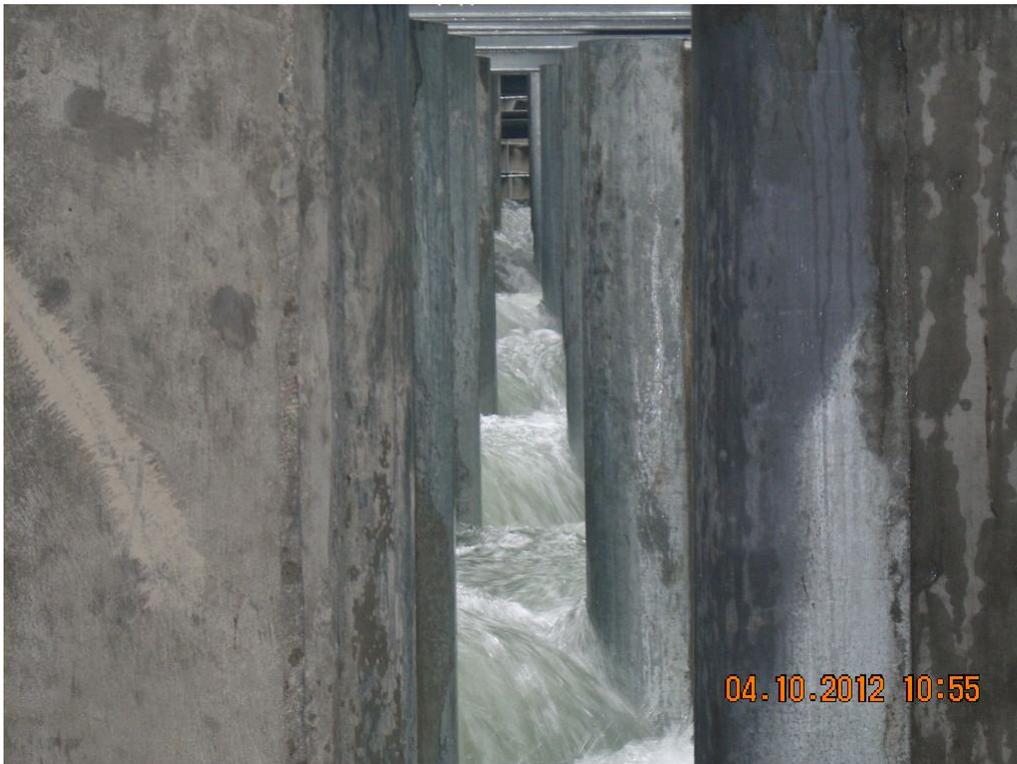
Eagle Canyon Diversion Dam: View of the water surface profile inside of the vertical slot fish ladder (looking upstream).

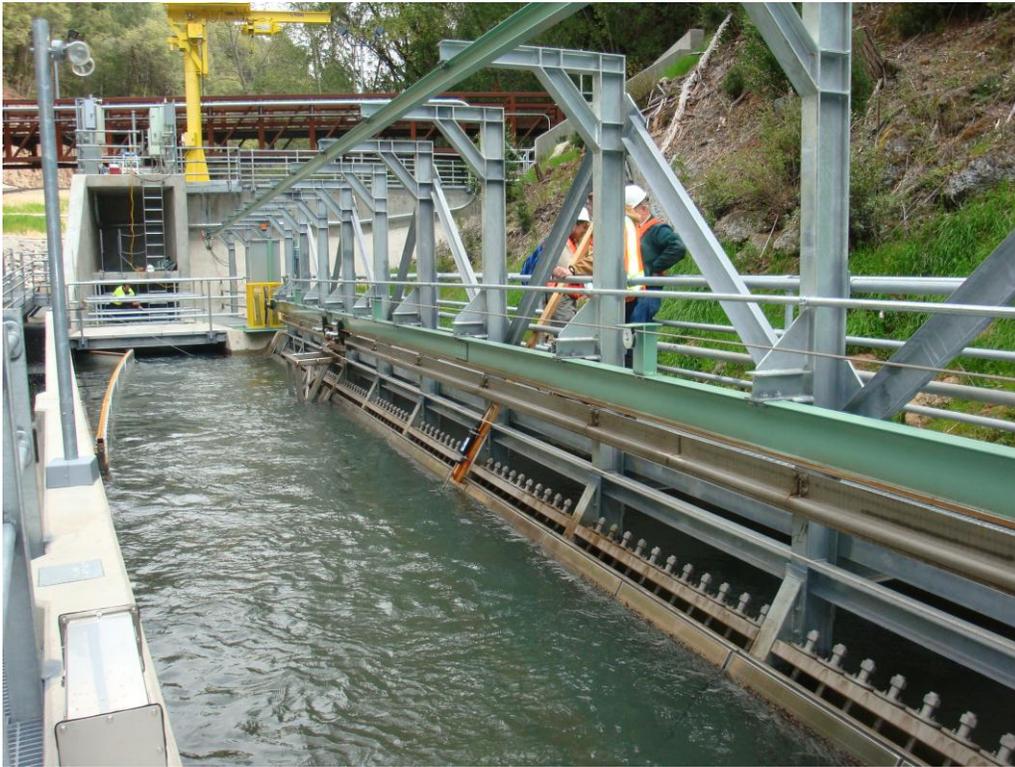
North Battle Creek Feeder Diversion Dam: Engineers and biologists using the Sontek Acoustic Doppler Velocimeter to measure approach and sweeping velocity of each fish screen panel (looking upstream).

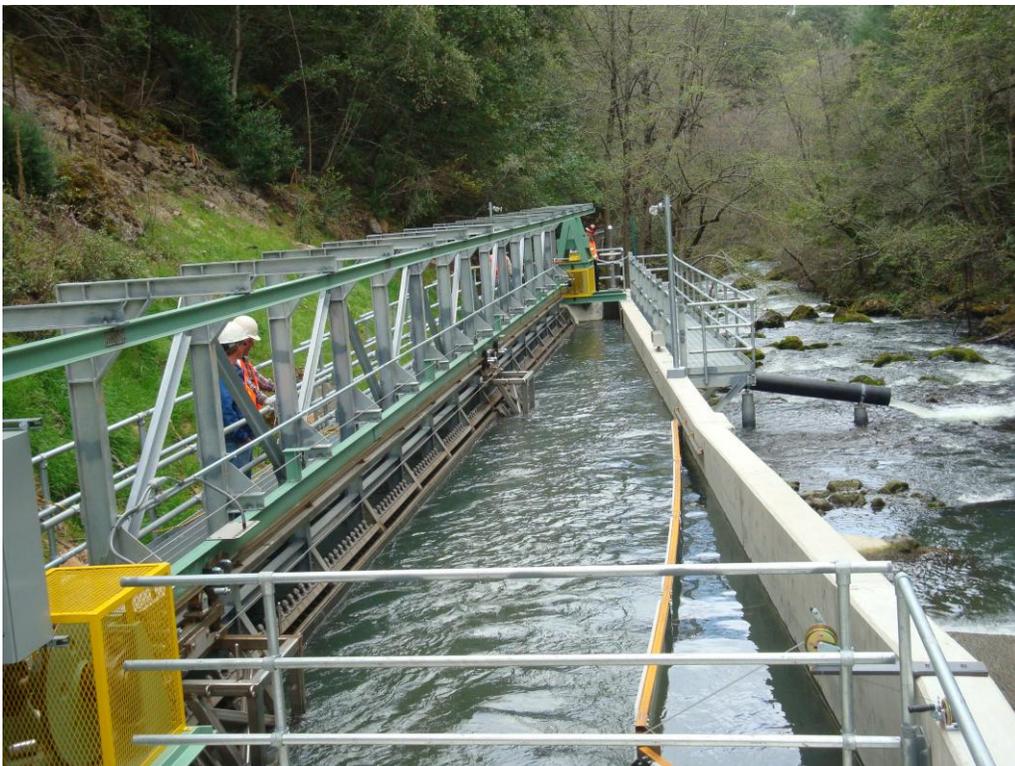
North Battle Creek Feeder Diversion Dam: Downstream view of the fish screen with temporary diverter wall (right center) installed.

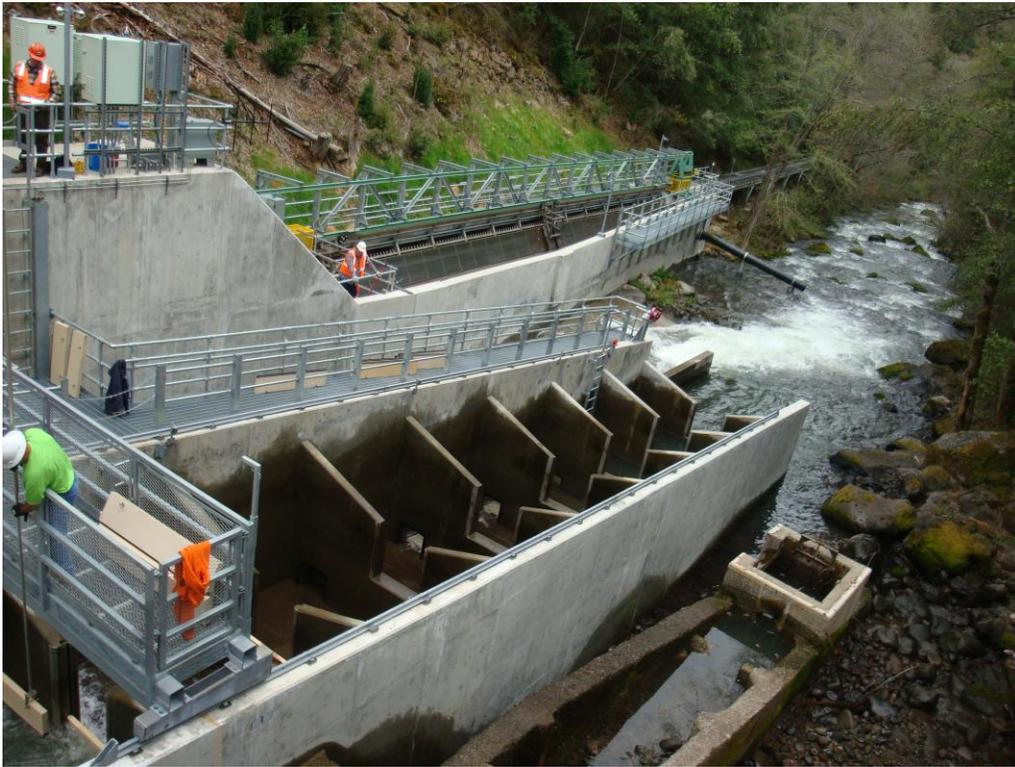
North Battle Creek Feeder Diversion Dam: View of the unwater pool and chute fish ladder as PG&E staff adjusted the entrance flashboards and orifice gates (looking downstream).

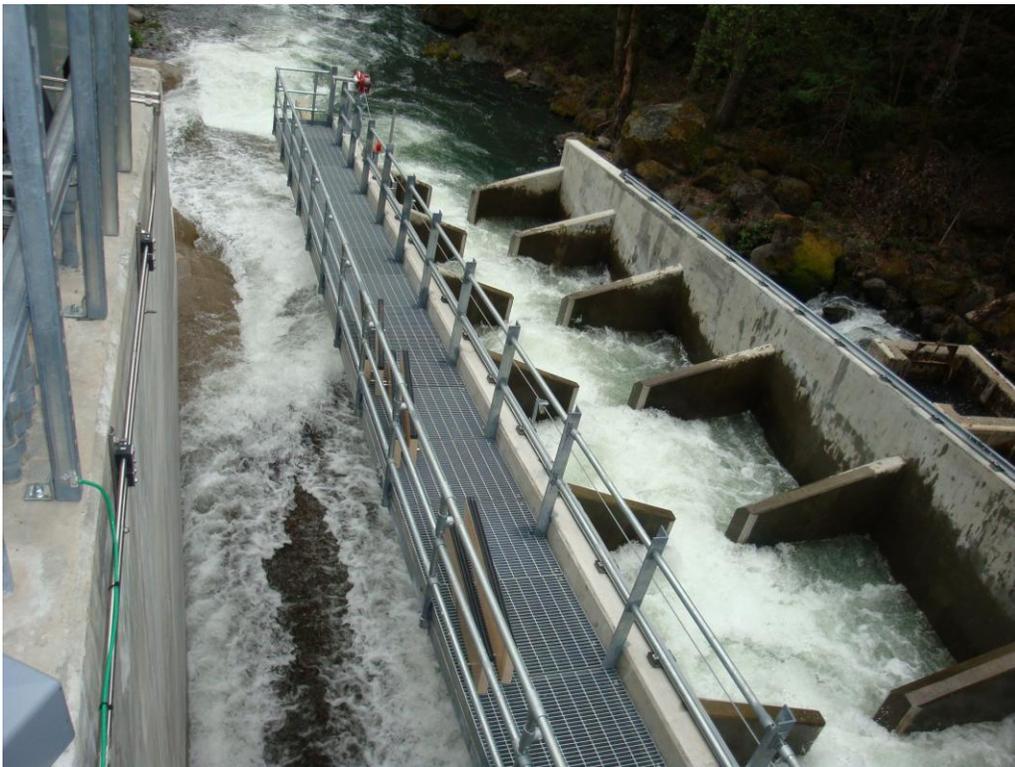
North Battle Creek Feeder Diversion Dam: View of the pool and chute fish ladder (looking downstream).
