August 2012 Construction Photos

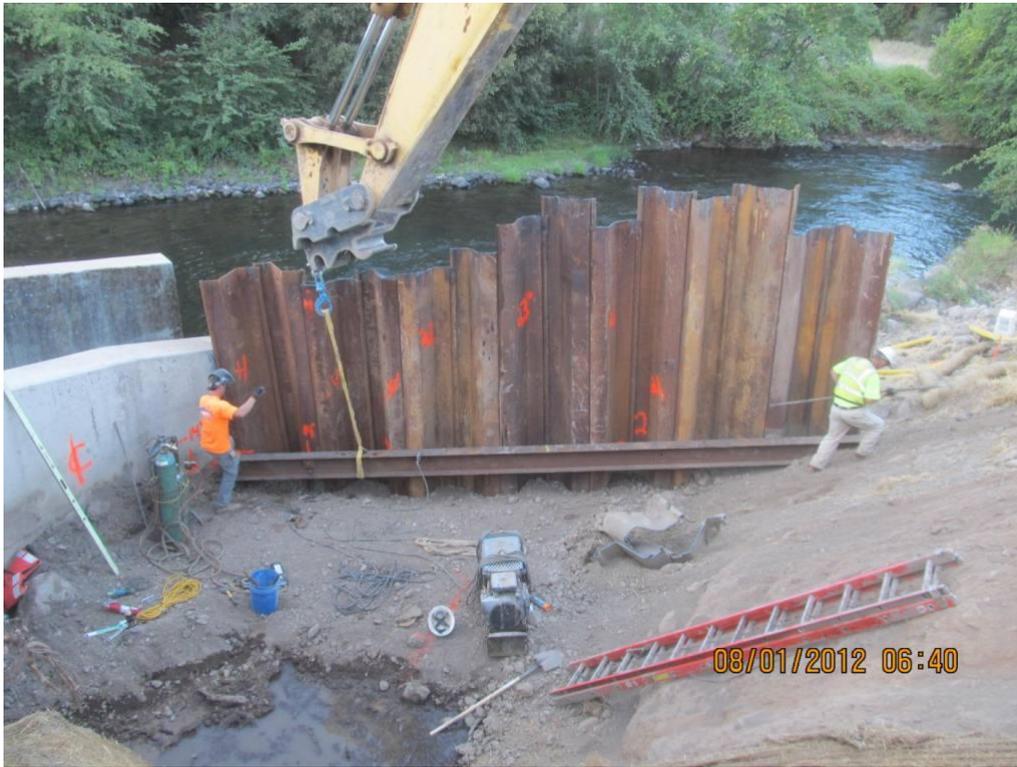
Coleman Diversion Dam/Inskip Powerhouse: The contractor is installing beam to sheet piles for the temporary cofferdam to construct the tailrace connector inlet structure.

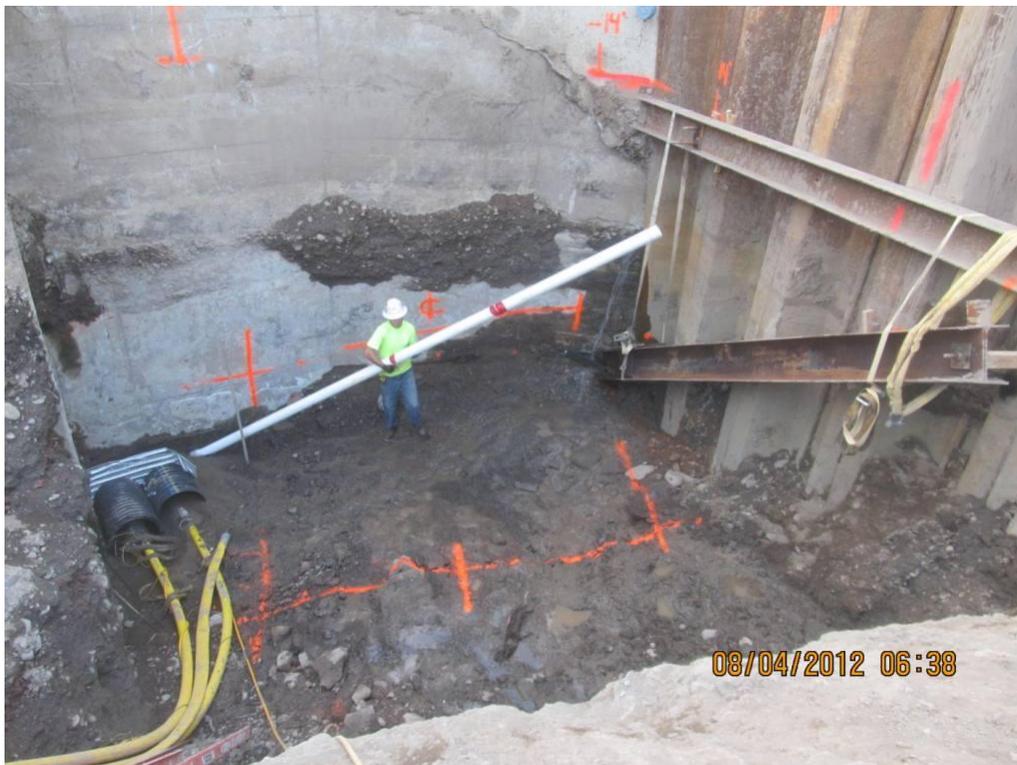
Coleman Diversion Dam/Inskip Powerhouse: The contractor is dewatering for the tailrace connector inlet structure.

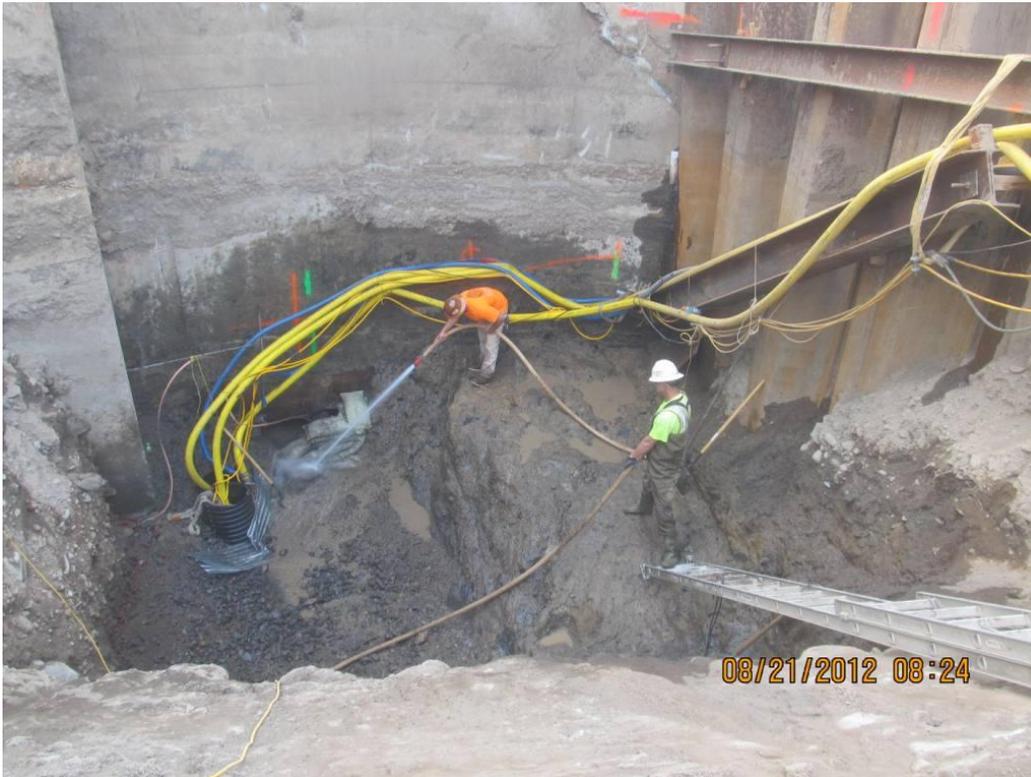
Coleman Diversion Dam/Inskip Powerhouse: The contractor is cleaning the excavated foundation of the tailrace connector inlet structure.

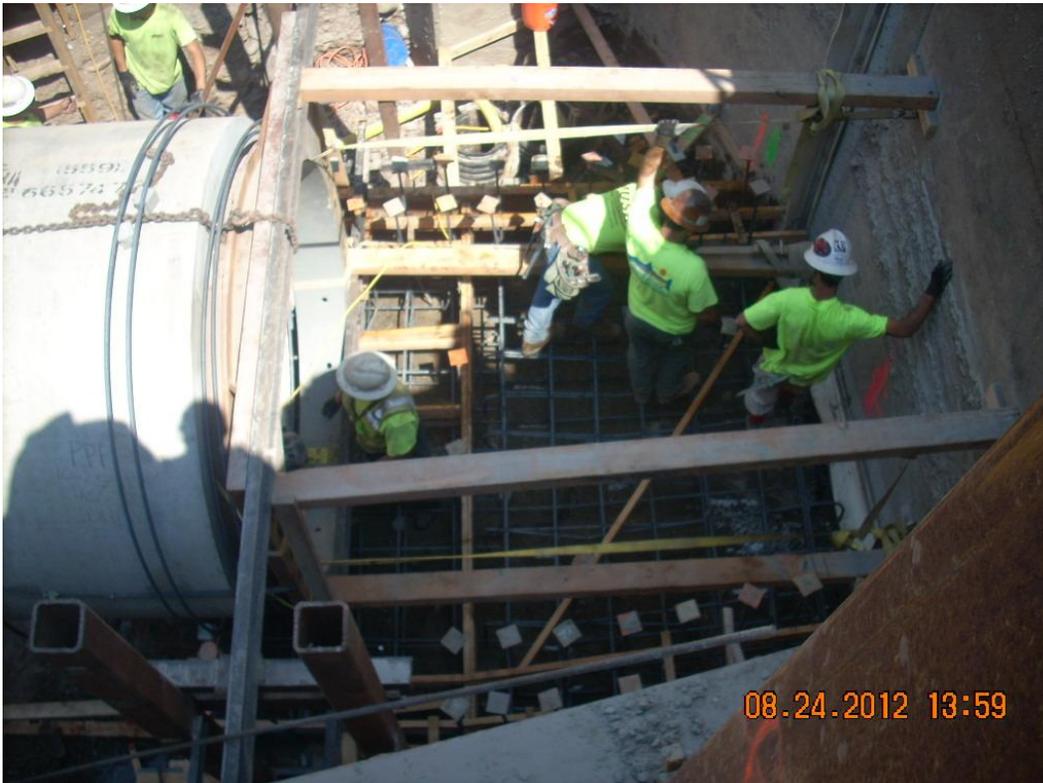
Coleman Diversion Dam/Inskip Powerhouse: The contractor is preparing to place concrete for the tailrace connector inlet slab.

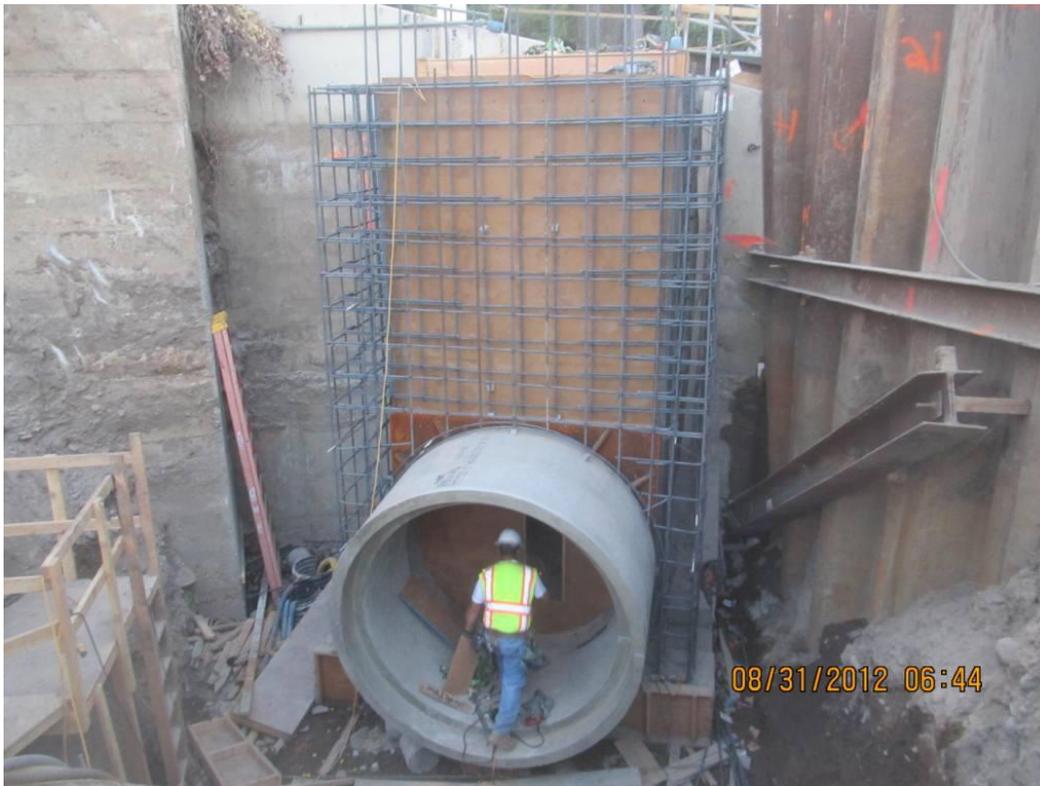
Coleman Diversion Dam/Inskip Powerhouse: The contractor is placing rebars and interior forms for the tailrace connector inlet wall.

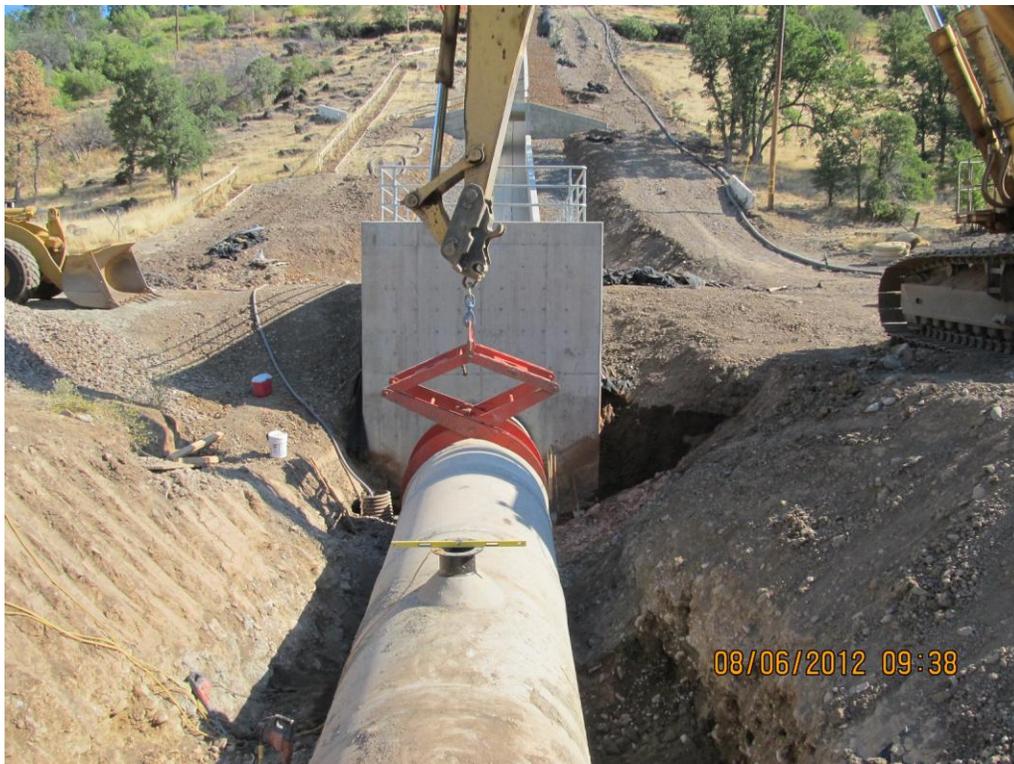
Coleman Diversion Dam/Inskip Powerhouse: The contractor is placing the last section of the 72-inch reinforced concrete pipe (RCP), looking up hill at the penstock bypass chute.

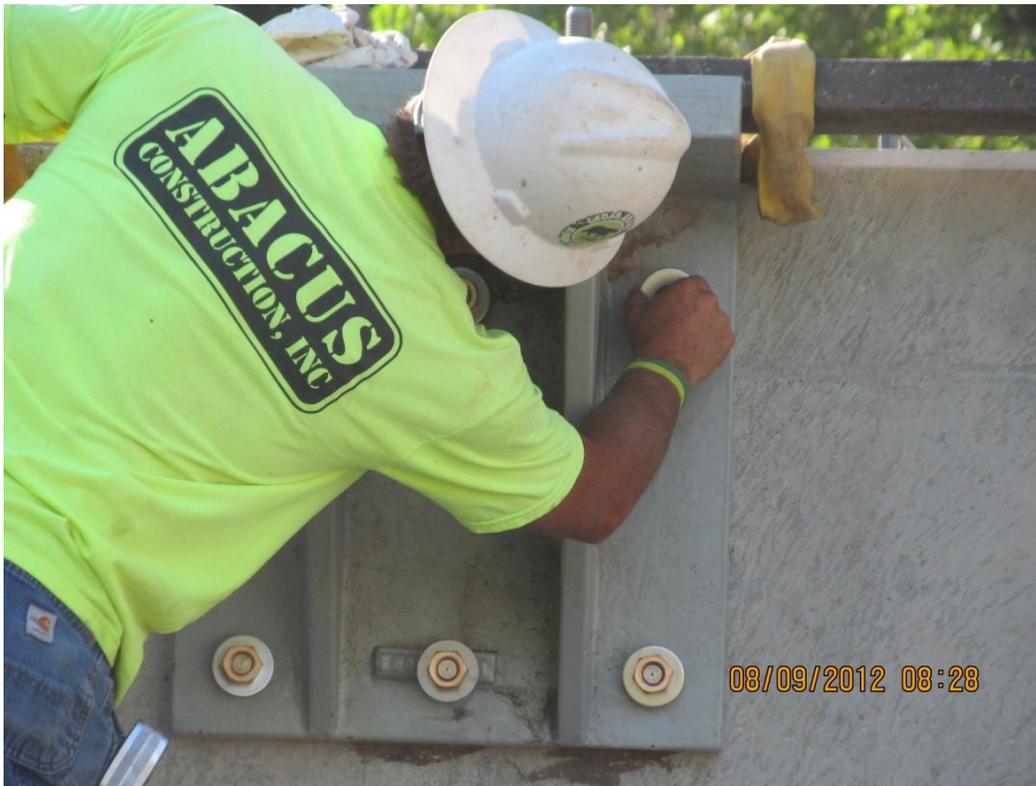
Coleman Diversion Dam/Inskip Powerhouse: The contractor is installing support for the new tailrace connector pipeline outlet gate actuator.

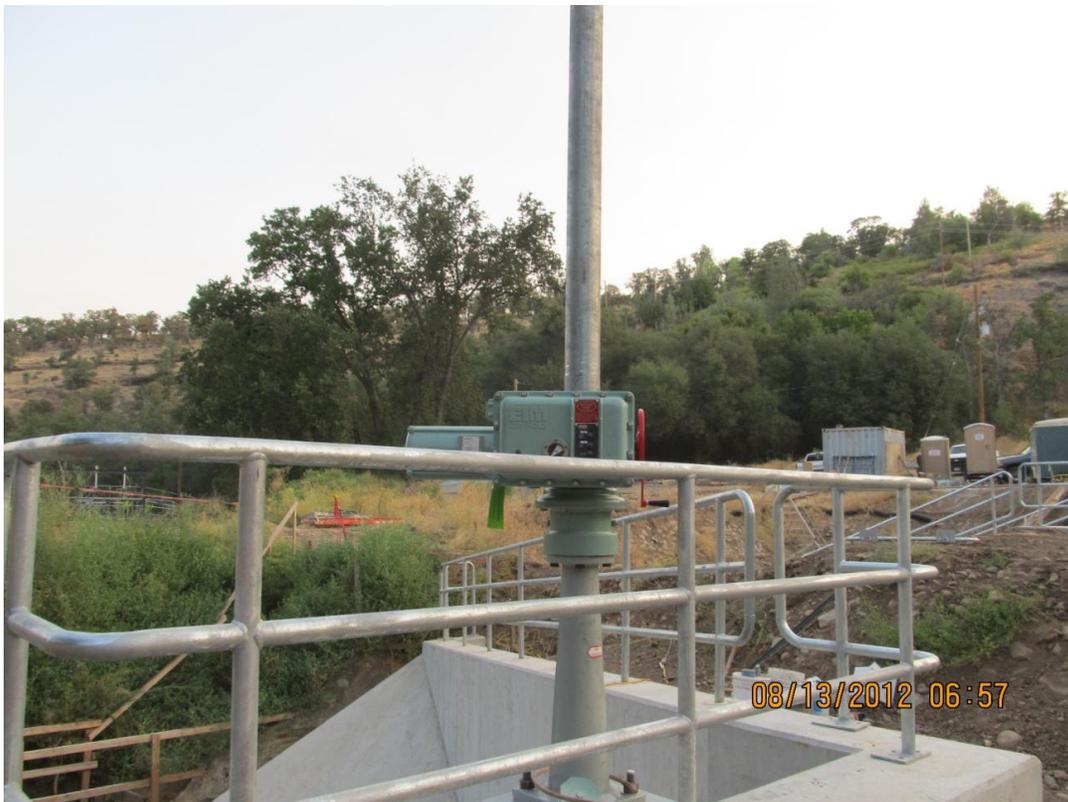
Coleman Diversion Dam/Inskip Powerhouse: The contractor completed installation of the gate actuator at the tailrace connector outlet.

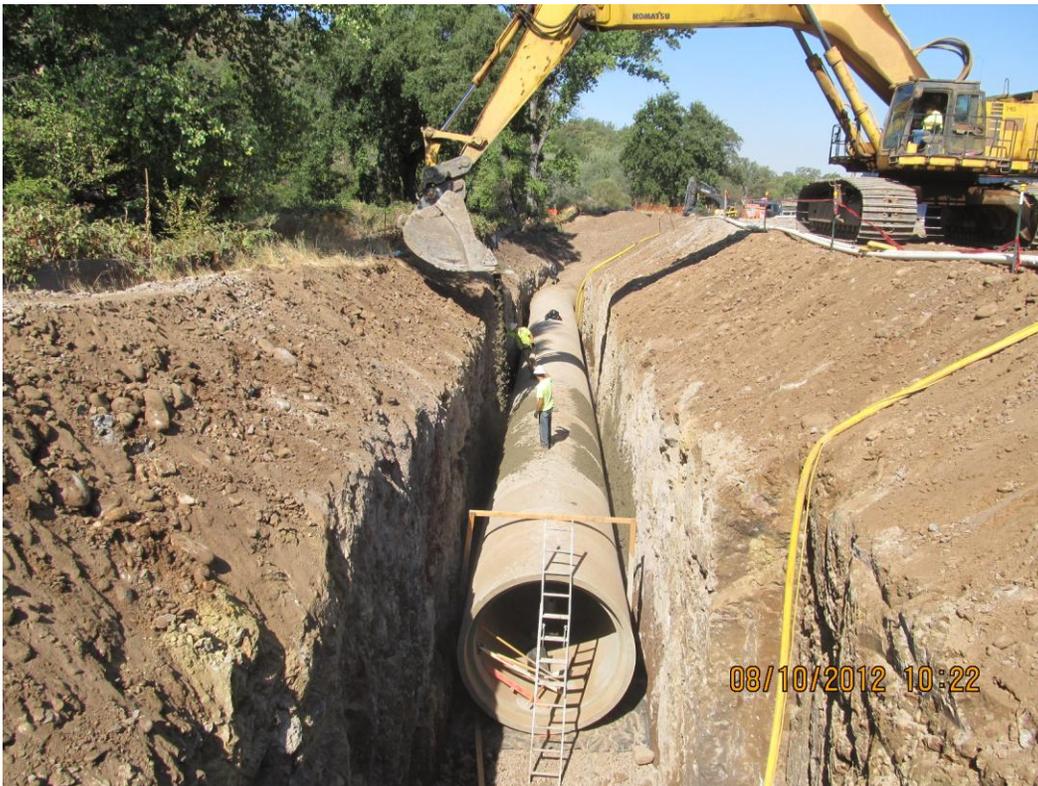
Coleman Diversion Dam/Inskip Powerhouse: The contractor is placing controlled low strength materials around the bottom of the tailrace connector 84-inch RCP.

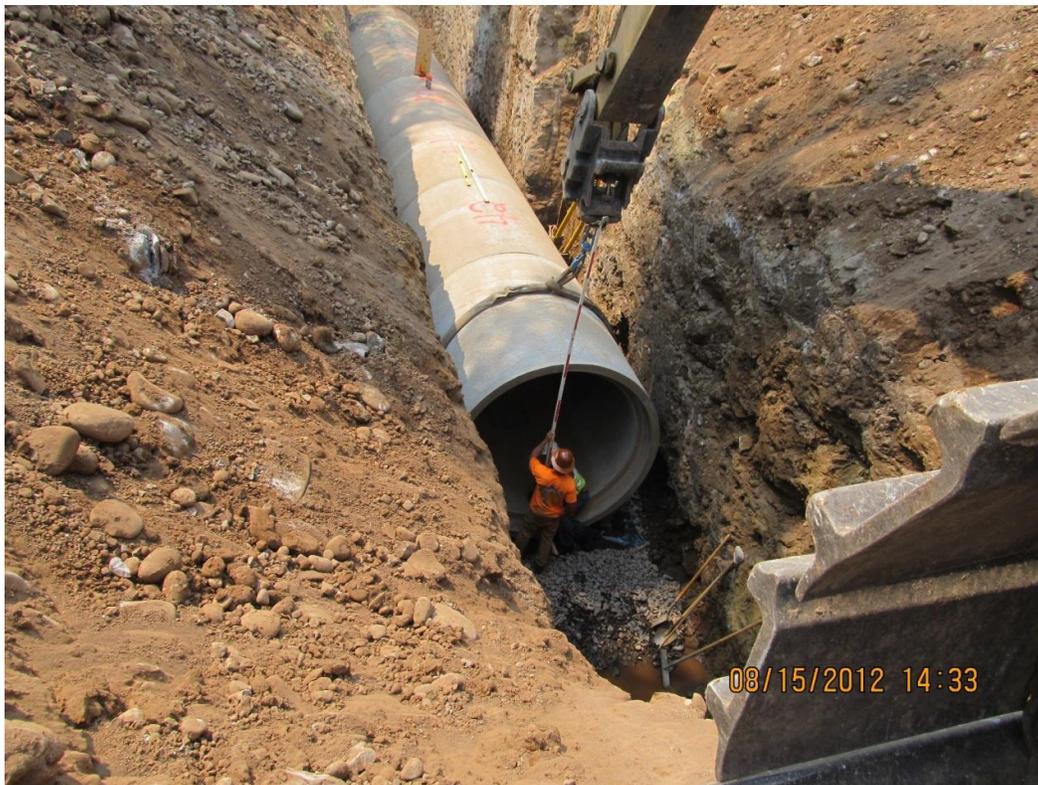
Coleman Diversion Dam/Inskip Powerhouse: The contractor is placing a section of the 84-inch RCP for the tailrace connector.

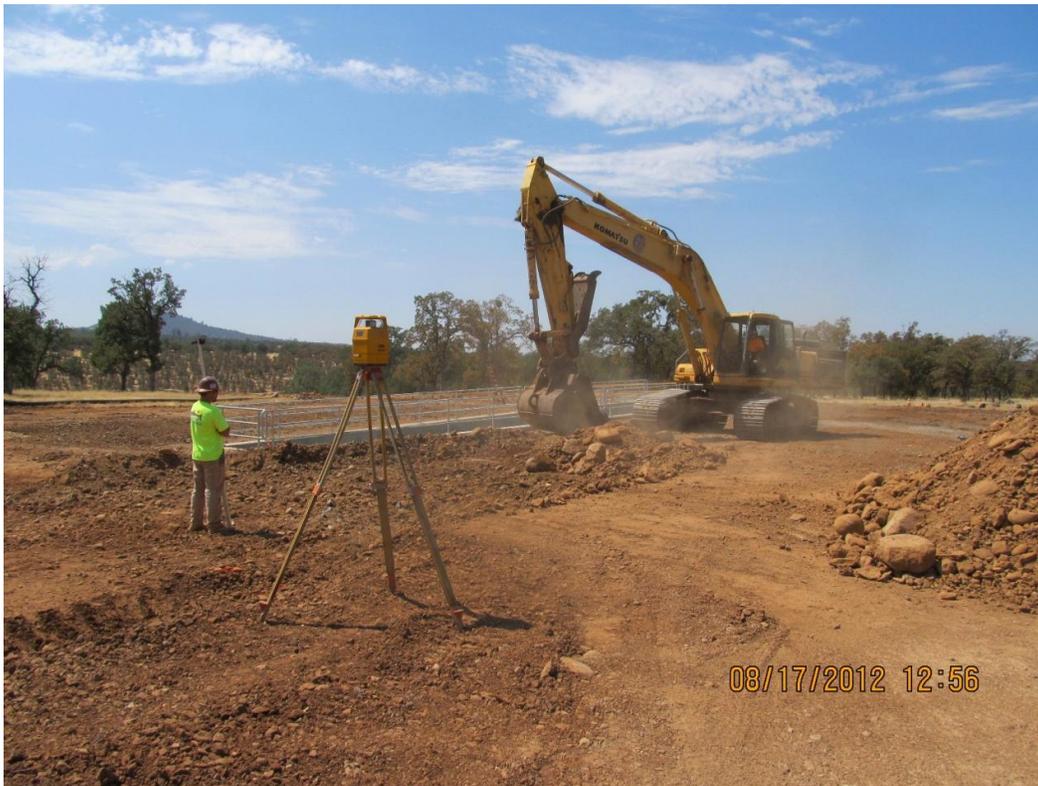
Coleman Diversion Dam/Inskip Powerhouse: The contractor is excavating the downstream end of the access road "A".

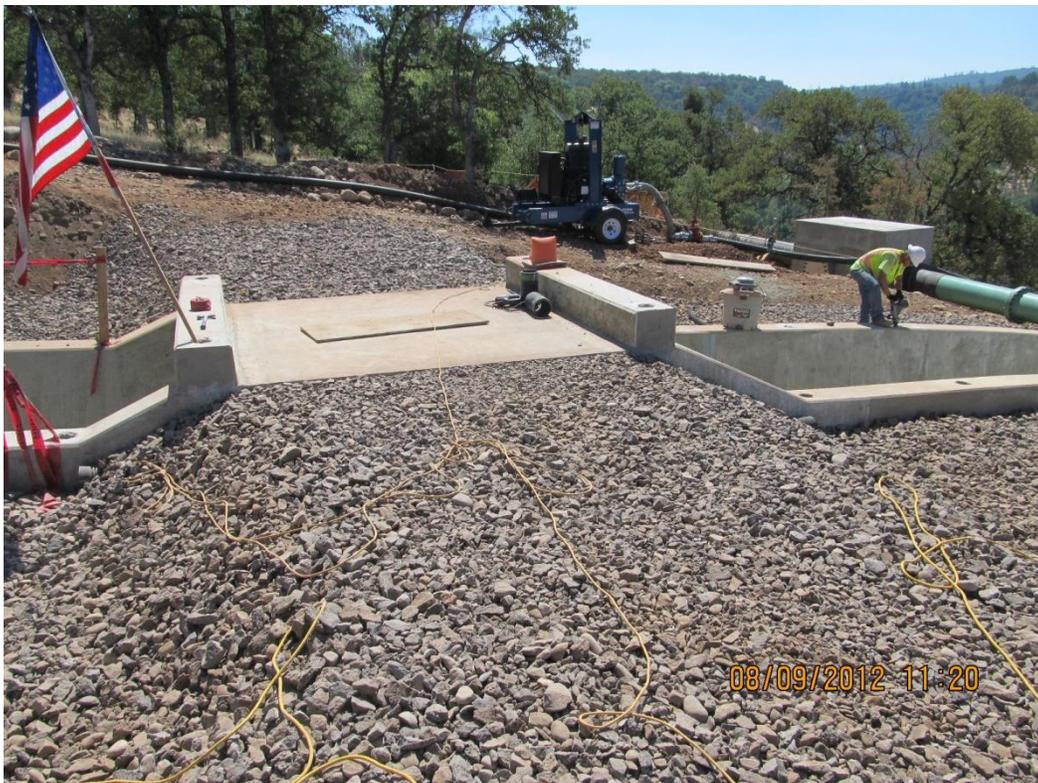
Coleman Diversion Dam/Inskip Powerhouse: The contractor is working on drilling holes for the fence posts along the penstock bypass chute near the animal crossing #1.

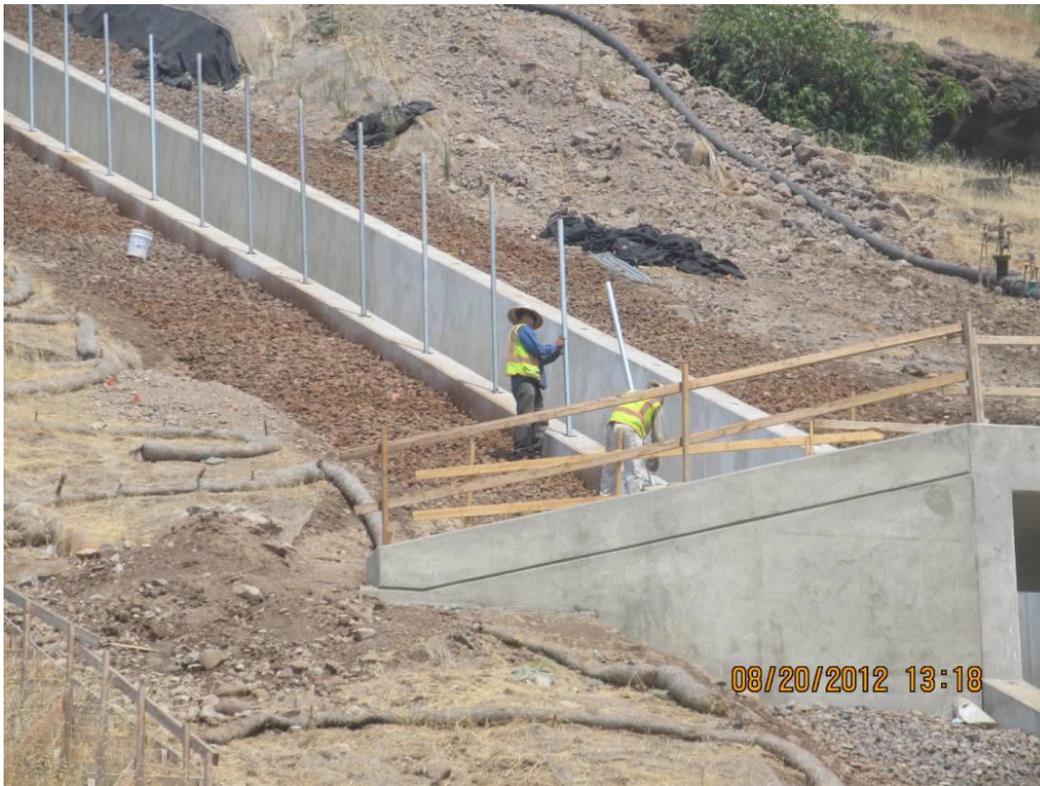
Coleman Diversion Dam/Inskip Powerhouse: The contractor is installing fence posts for the penstock bypass chute.

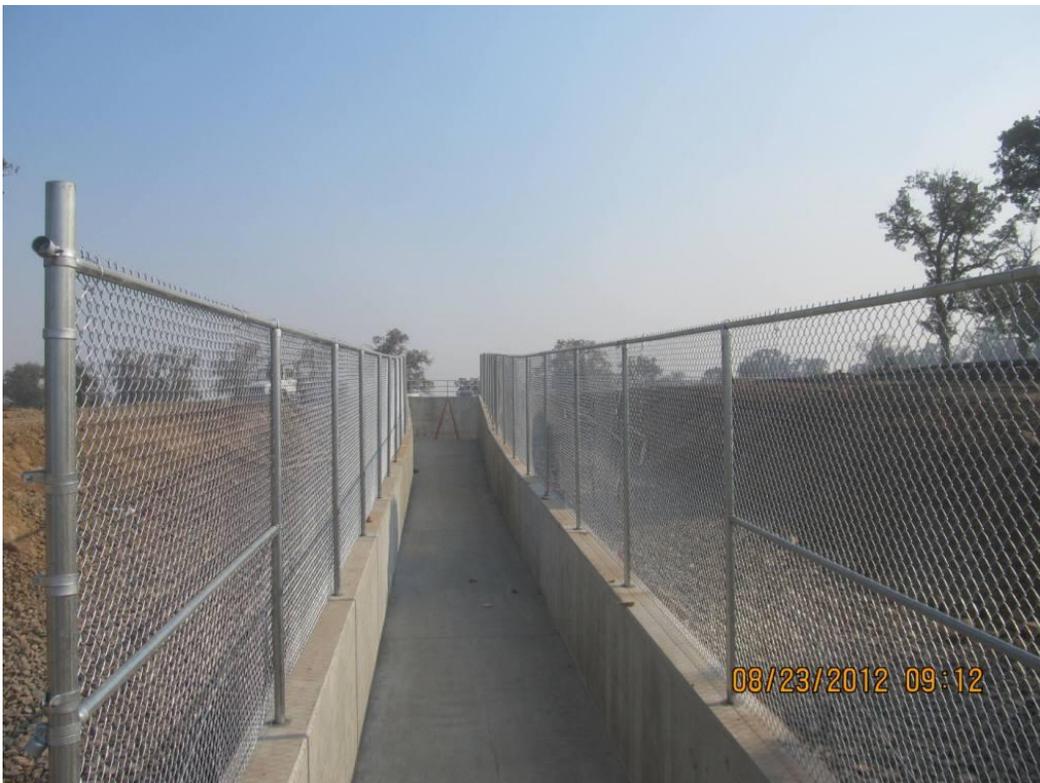
Coleman Diversion Dam/Inskip Powerhouse: The contractor is installing 8-foot chain link fence, looking upstream of the penstock bypass chute.

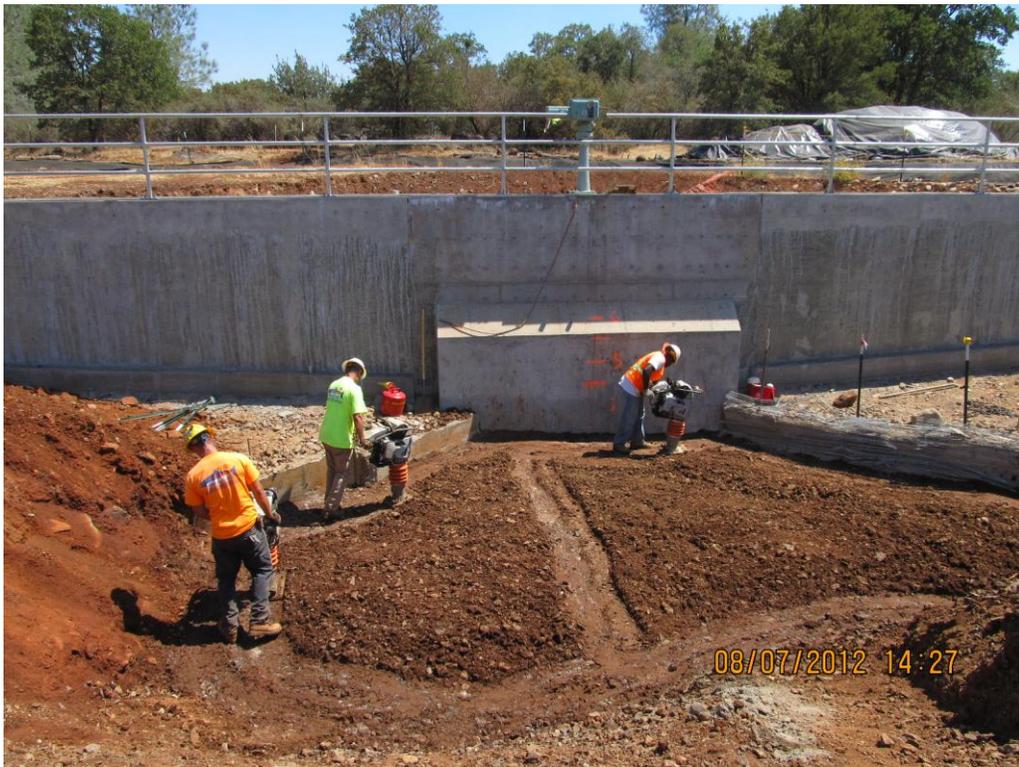
Coleman Diversion Dam/Inskip Powerhouse: The contractor is compacting backfill material around the penstock bypass 66-inch RCP and new wasteway structure.

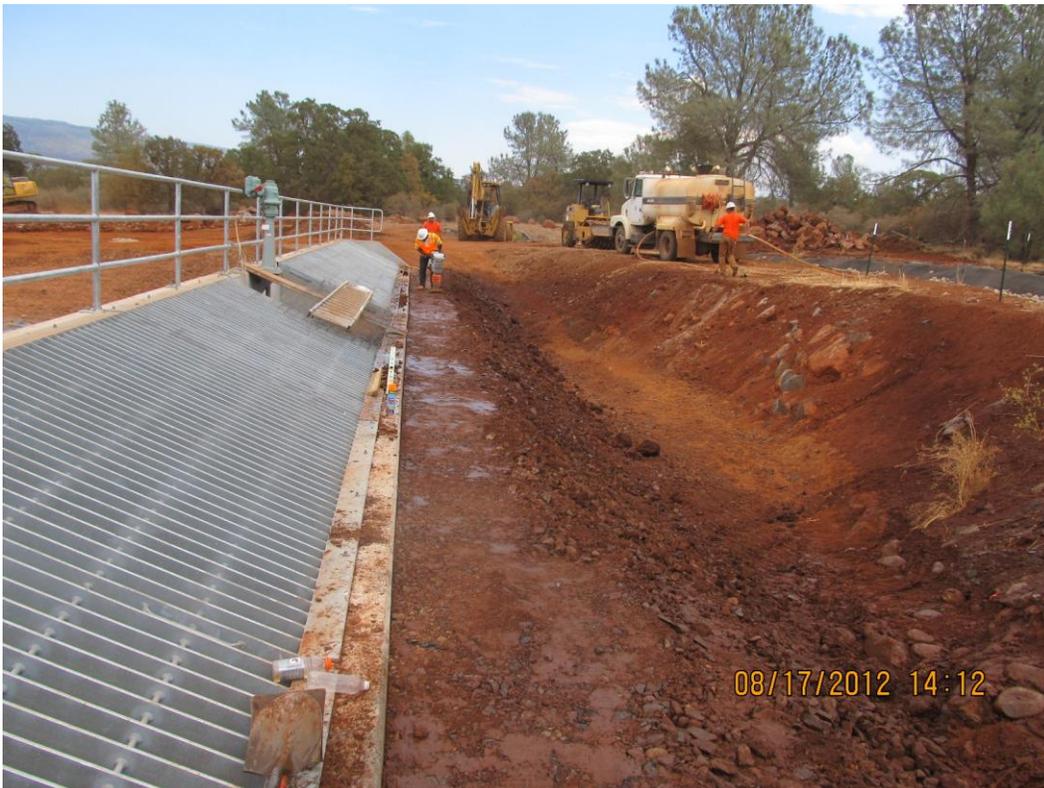
Coleman Diversion Dam/Inskip Powerhouse: The contractor is compacting backfill on the upstream edge of the new penstock bypass wasteway at Eagle Canyon Canal.

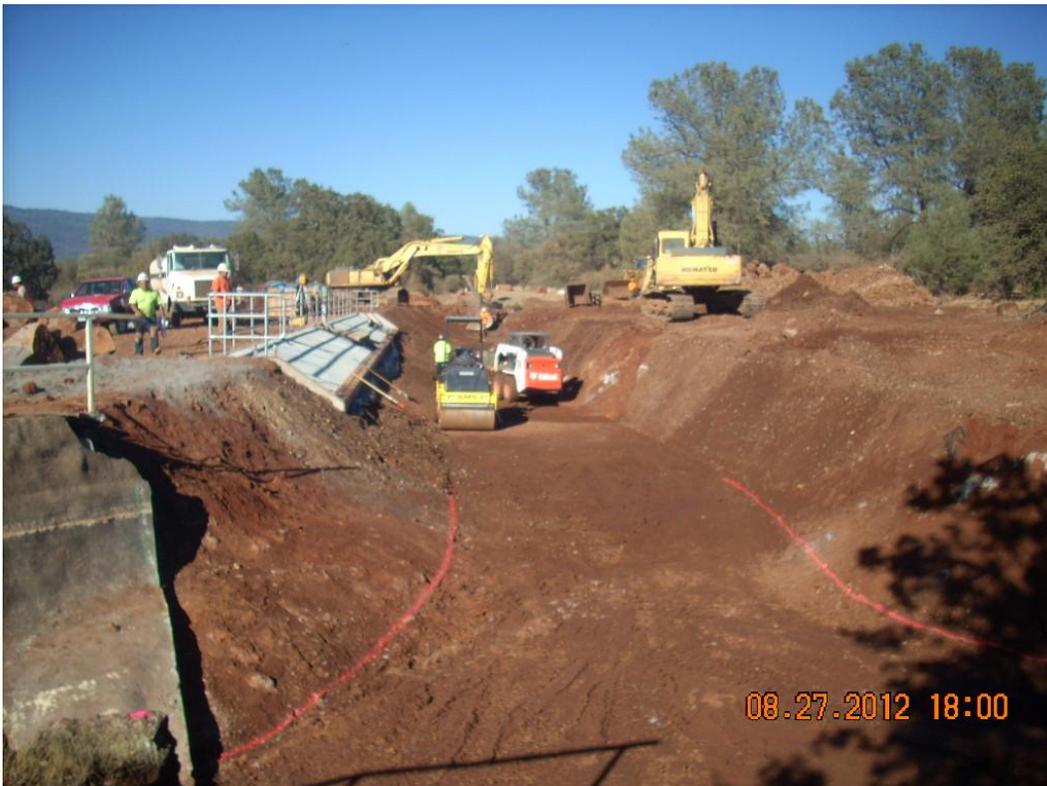
Coleman Diversion Dam/Inskip Powerhouse: The contractor is reshaping Eagle Canyon Canal in preparation for the canal shotcrete lining.

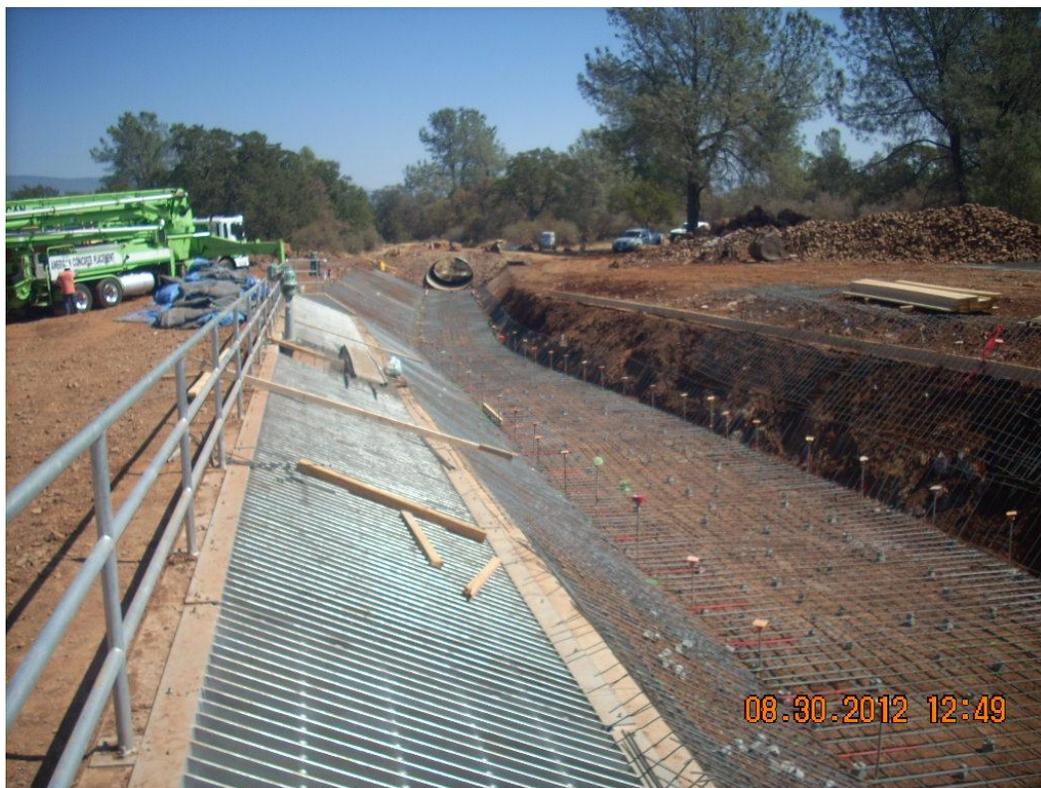
Coleman Diversion Dam/Inskip Powerhouse: The contractor is preparing to place shotcrete for Eagle Canyon Canal slab.

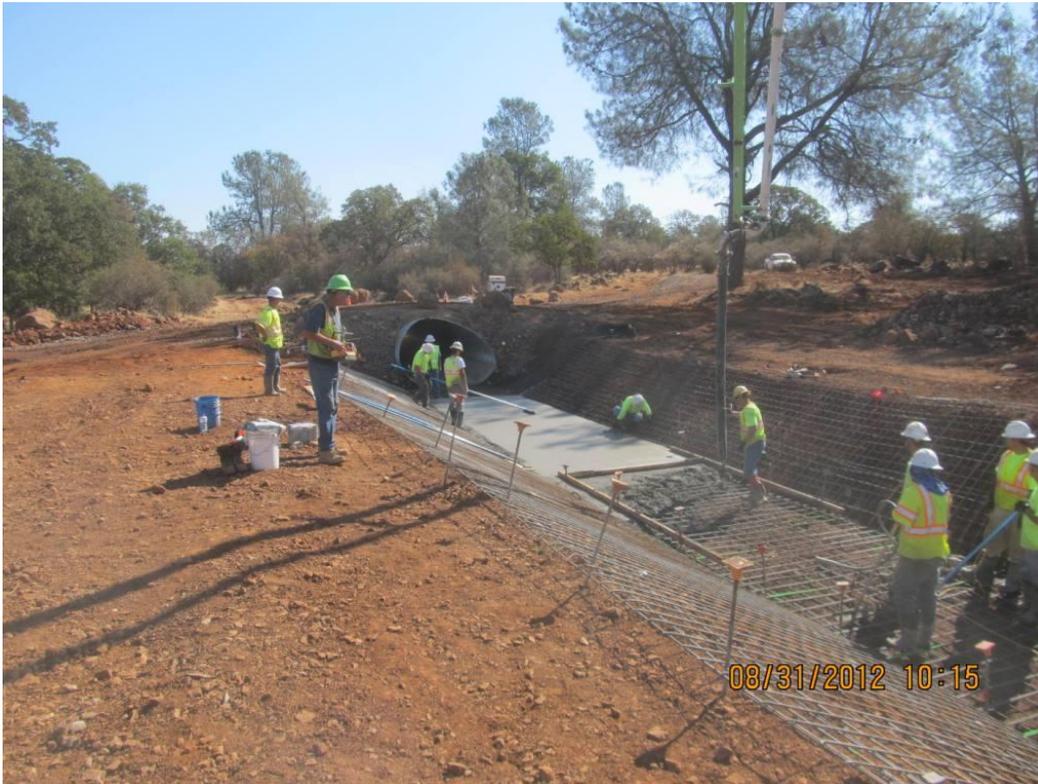
Coleman Diversion Dam/Inskip Powerhouse: The contractor is placing shotcrete slab for the new Eagle Canyon Canal, looking upstream at the arch culvert crossing.

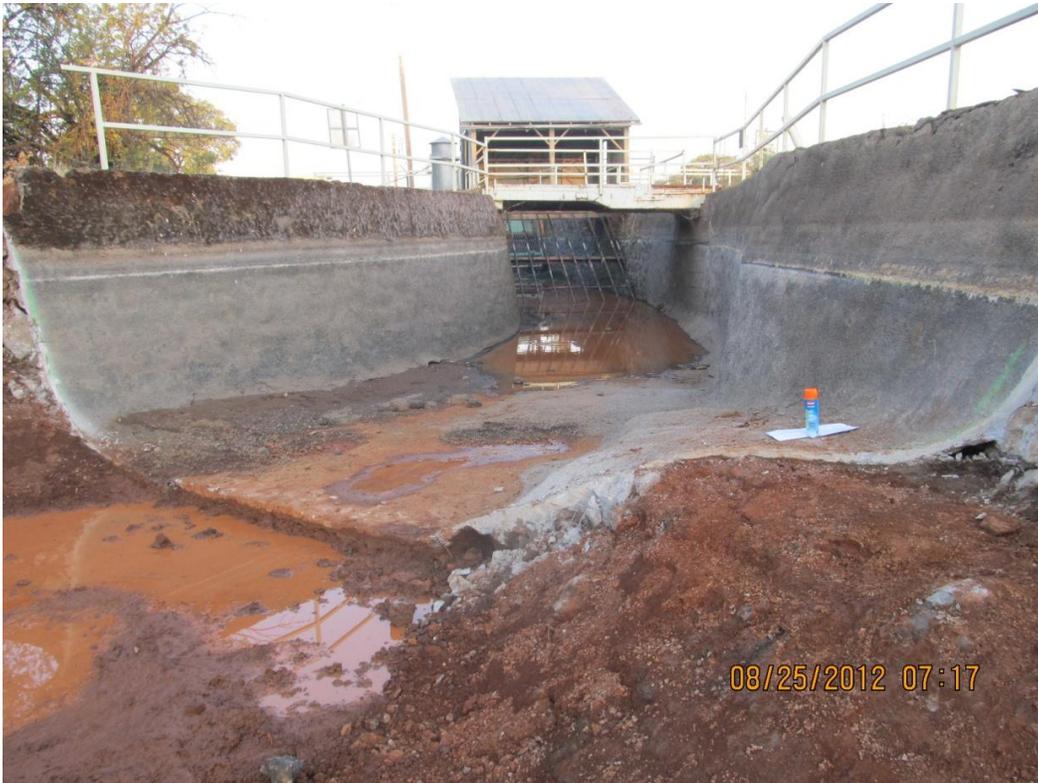
Coleman Diversion Dam/Inskip Powerhouse: Looking downstream into the Inskip Powerhouse forebay at the confluence of Inskip Canal and Eagle Canyon Canal.

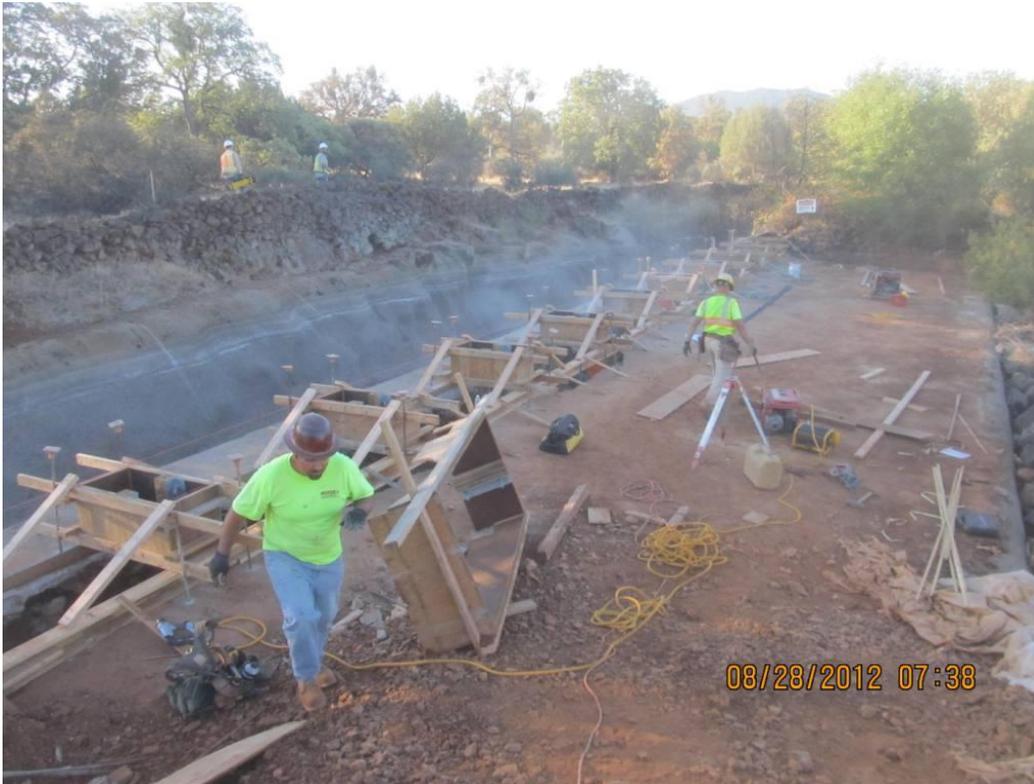
Coleman Diversion Dam/Inskip Powerhouse: The contractor is placing forms for the new flashboards at the existing Inskip Canal overflow wasteway.

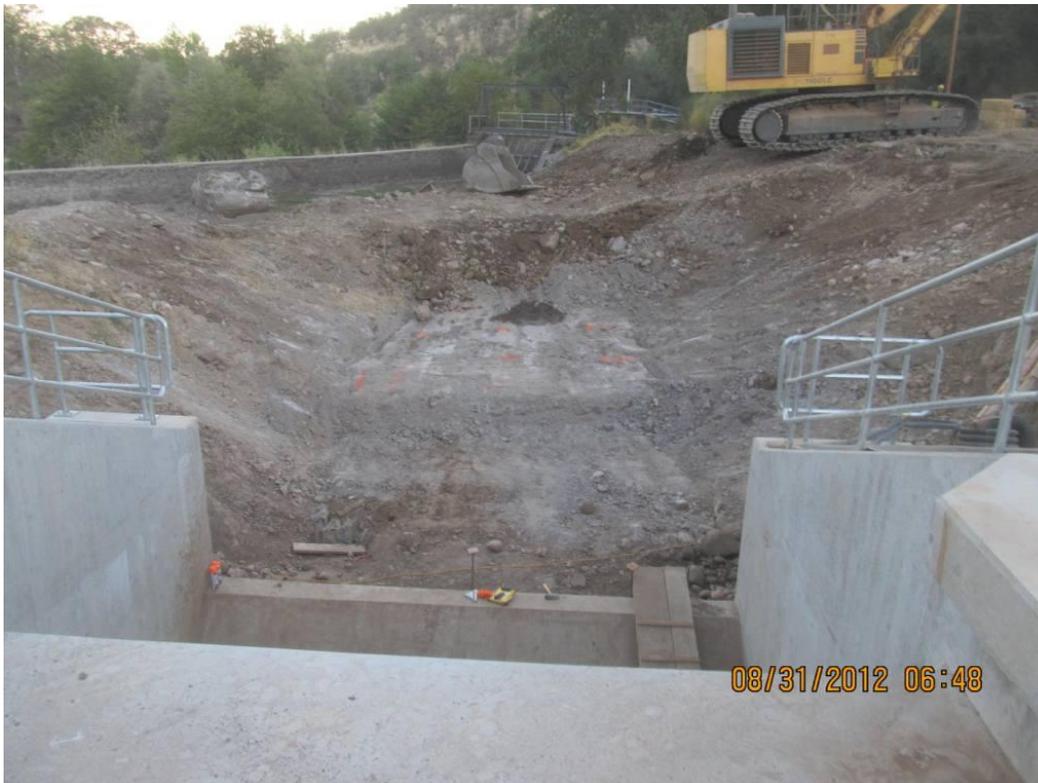
Coleman Diversion Dam/Inskip Powerhouse: The contractor is excavating for the penstock bypass baffled outlet that discharges into Coleman Canal.

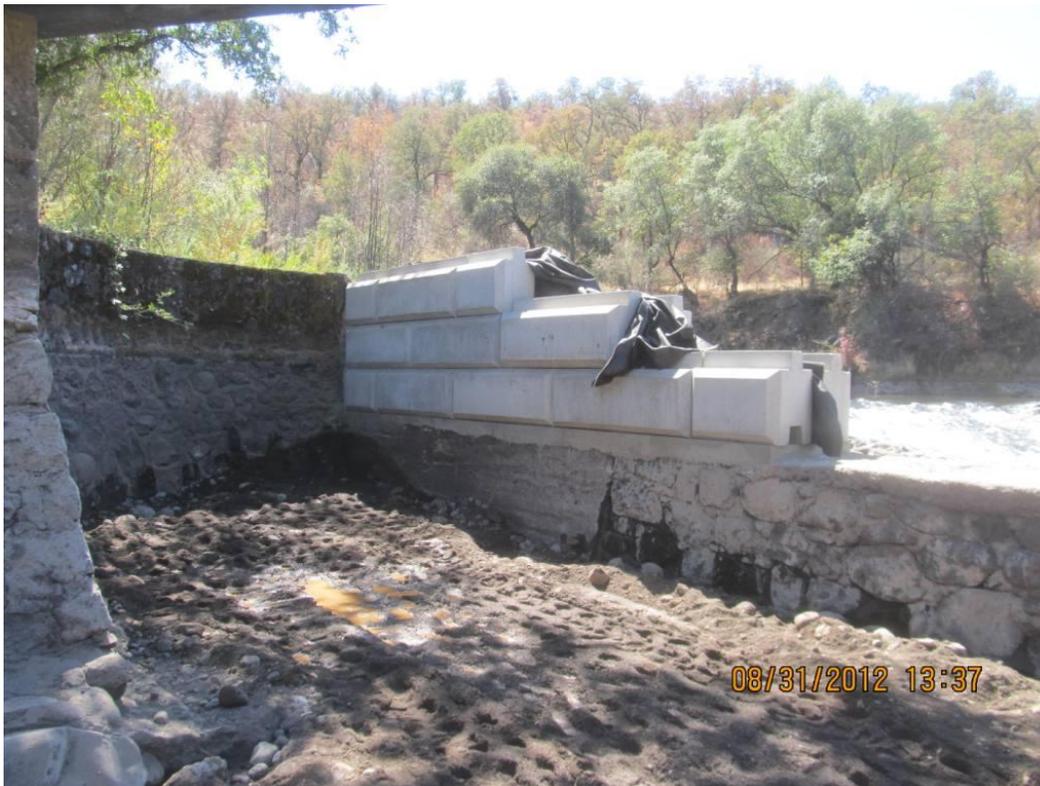
Coleman Diversion Dam/Inskip Powerhouse: The contractor is installing pre-cast concrete wall in Coleman Canal.
