November 2012 Construction Photos

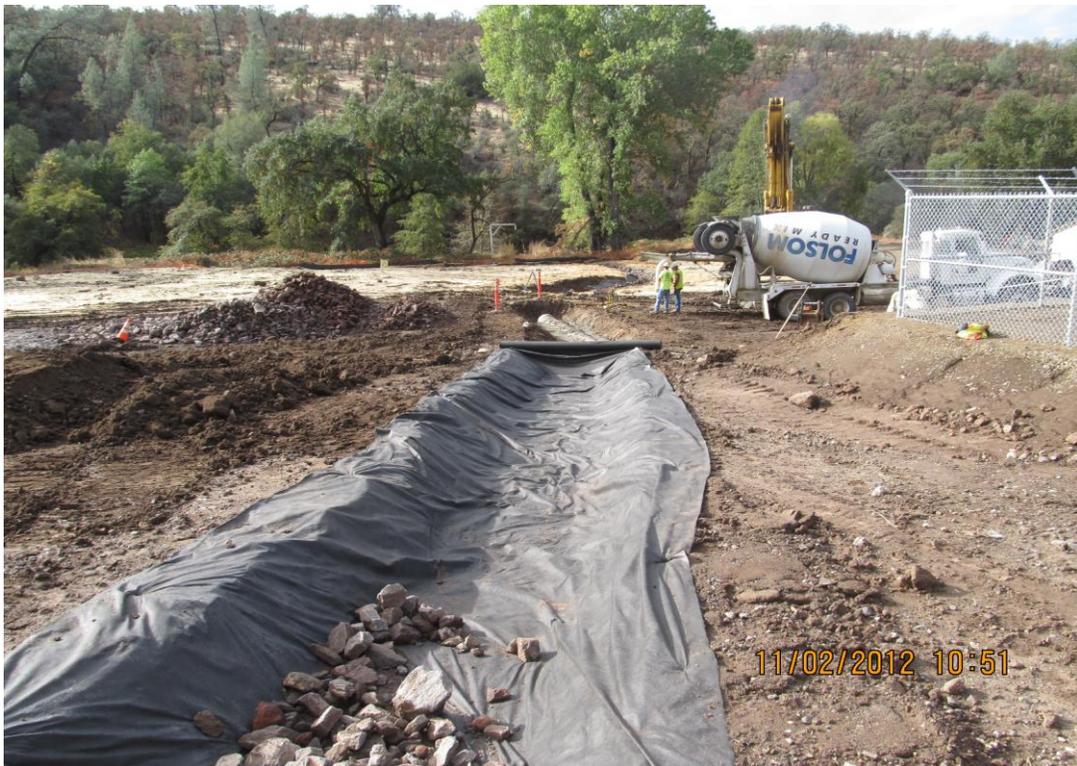
Coleman Diversion Dam/Inskip Powerhouse: The contractor is rock lining the trapezoidal ditch and installing three 18-inch reinforced concrete pipe culverts under Inskip Powerhouse access road.

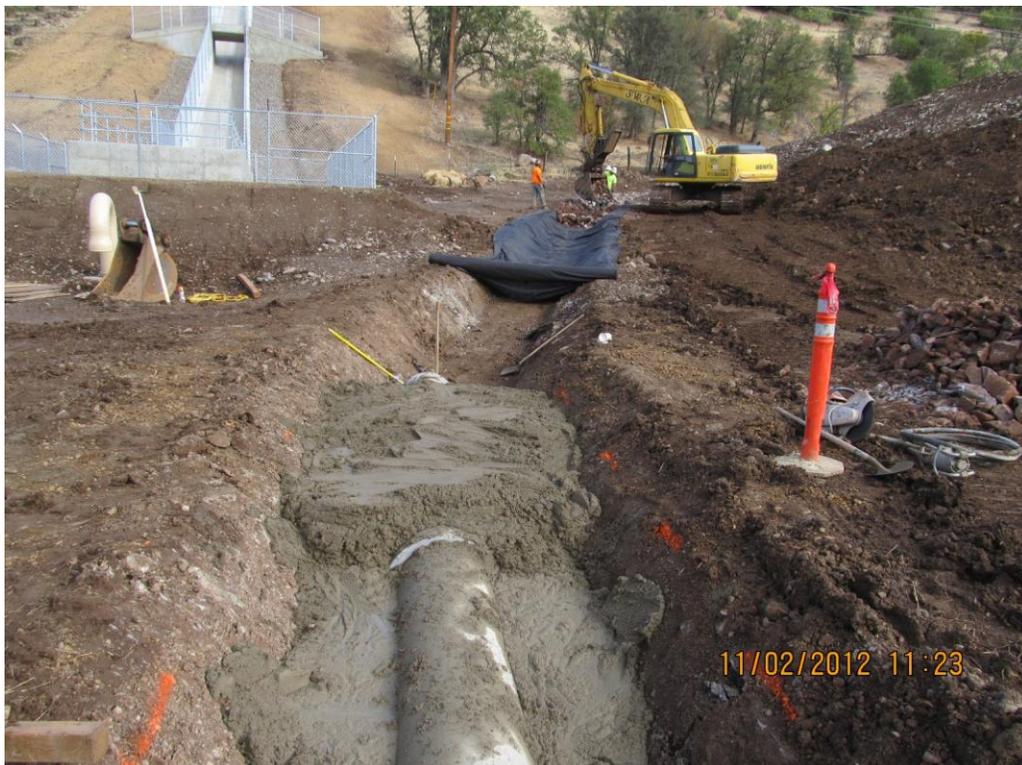
Coleman Diversion Dam/Inskip Powerhouse: The contractor is placing controlled-low strength materials (CLSM) around the new 18-inch RCP culvert.

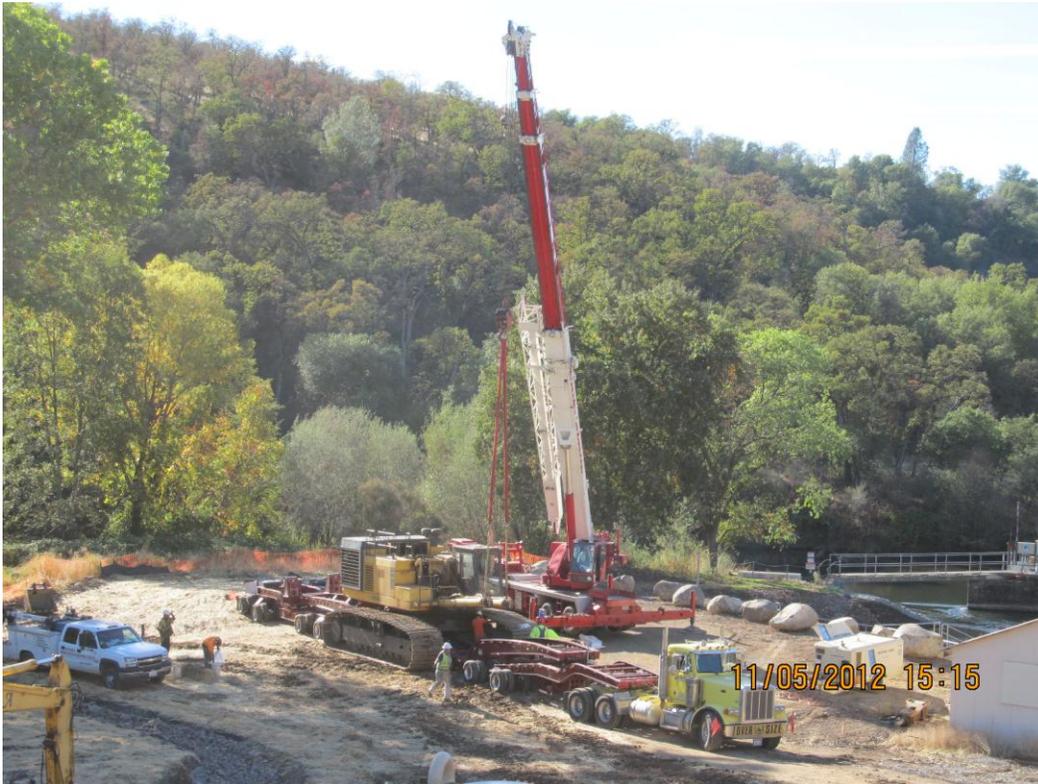
Coleman Diversion Dam/Inskip Powerhouse: The contractor is disassembling the 1100 Komatsu excavator; an equipment that performed most of the project excavation.

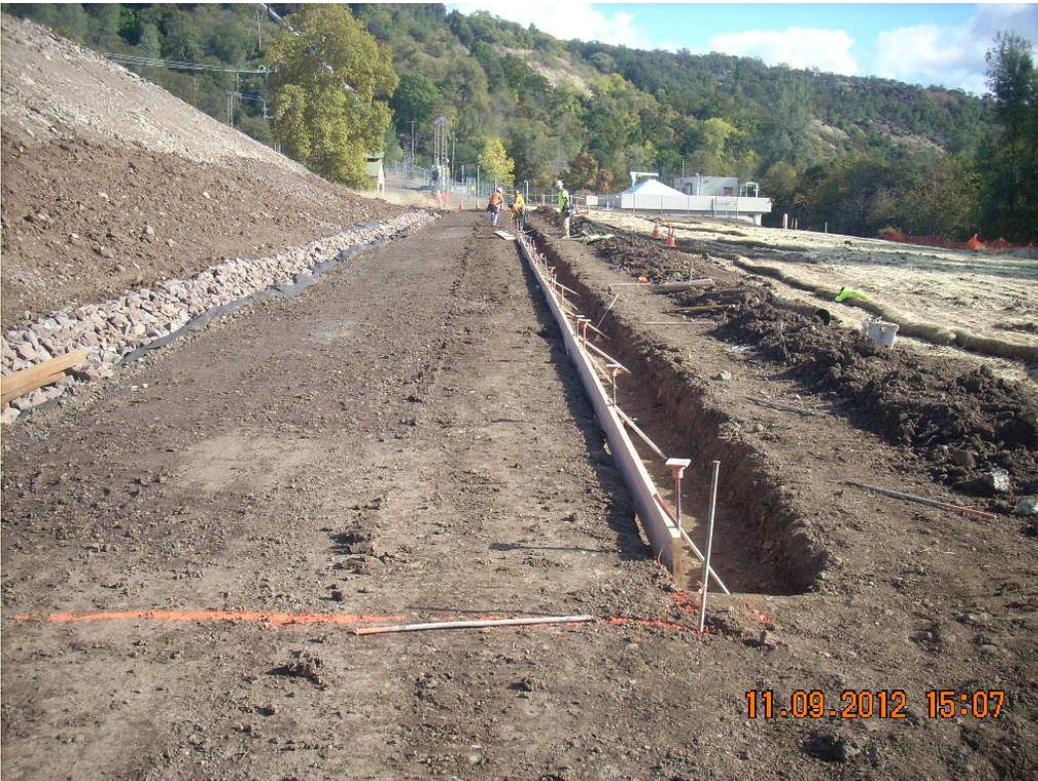
Coleman Diversion Dam/Inskip Powerhouse: The contractor is preparing the subsurface prior to laying asphalt for the Inskip Powerhouse access road repair.

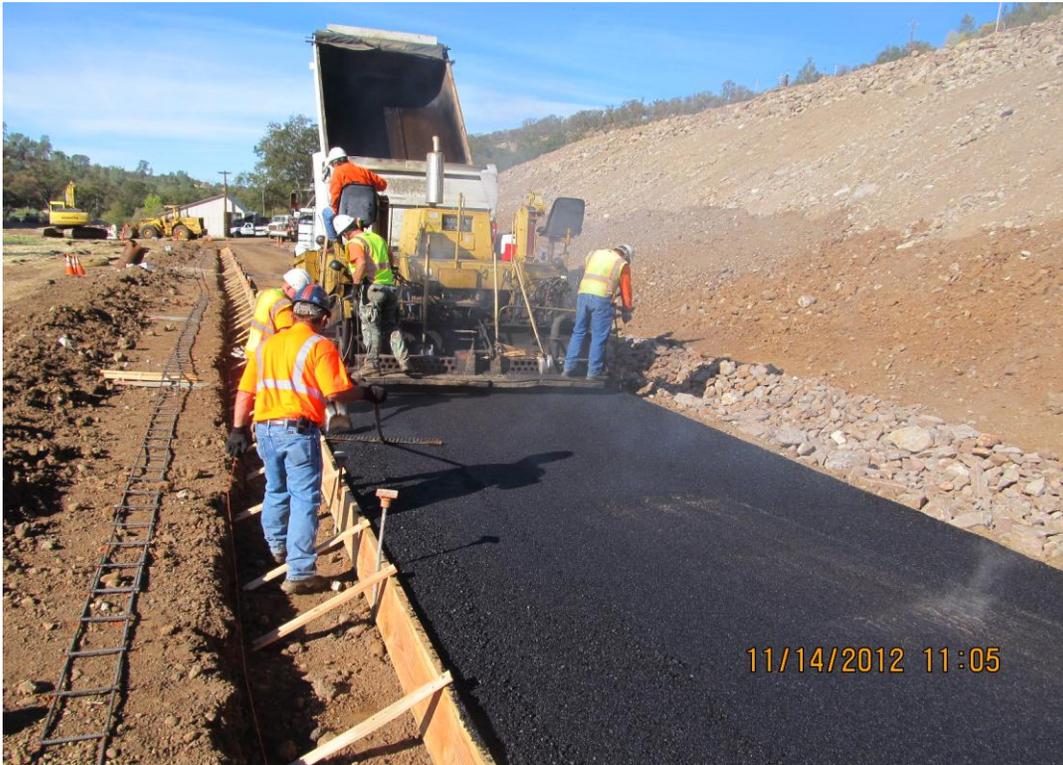
Coleman Diversion Dam/Inskip Powerhouse: The contractor is laying asphalt for the Inskip Powerhouse access road.

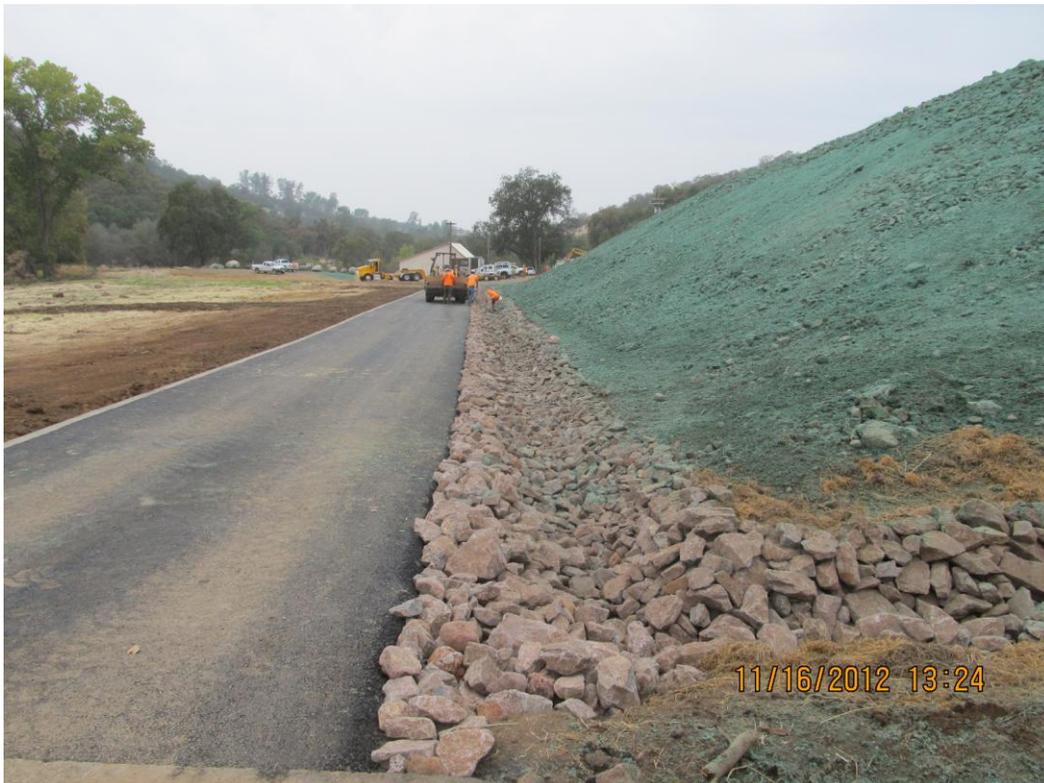
Coleman Diversion Dam/Inskip Powerhouse: The contractor is rock lining the v-ditch adjacent to the Inskip Powerhouse access road.

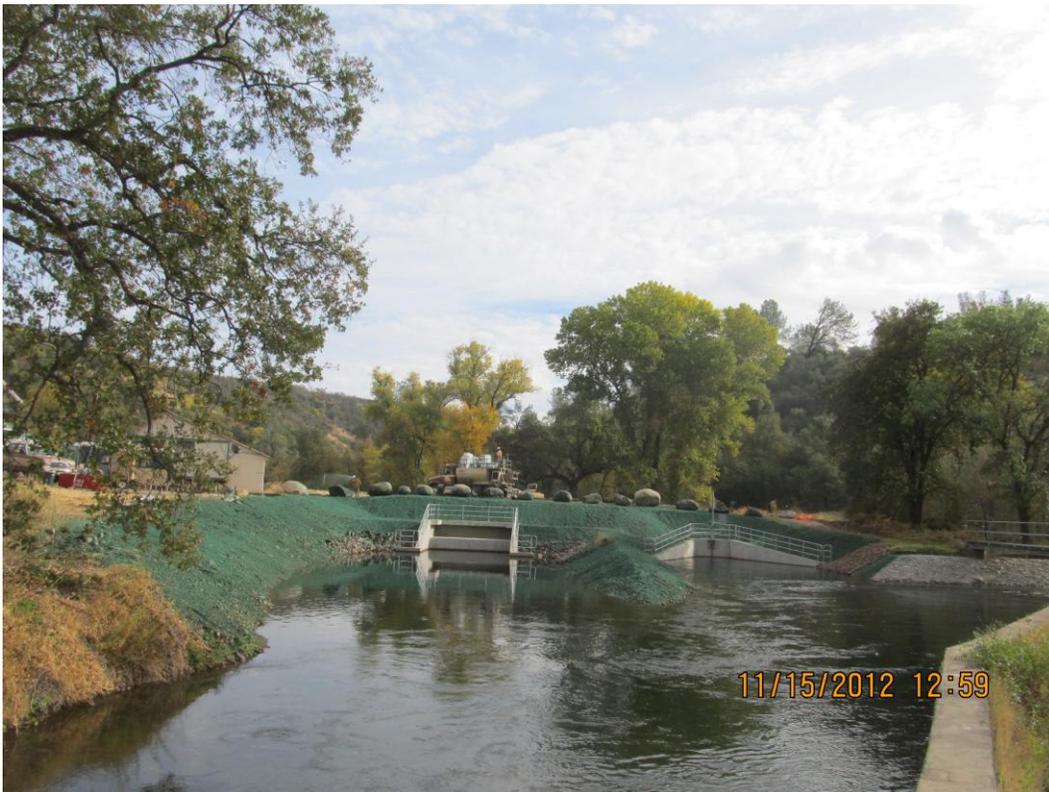
Coleman Diversion Dam/Inskip Powerhouse: The contractor is hydro-seeding and mulching at the penstock bypass (center left) and tailrace connector (center right) outlet structures.

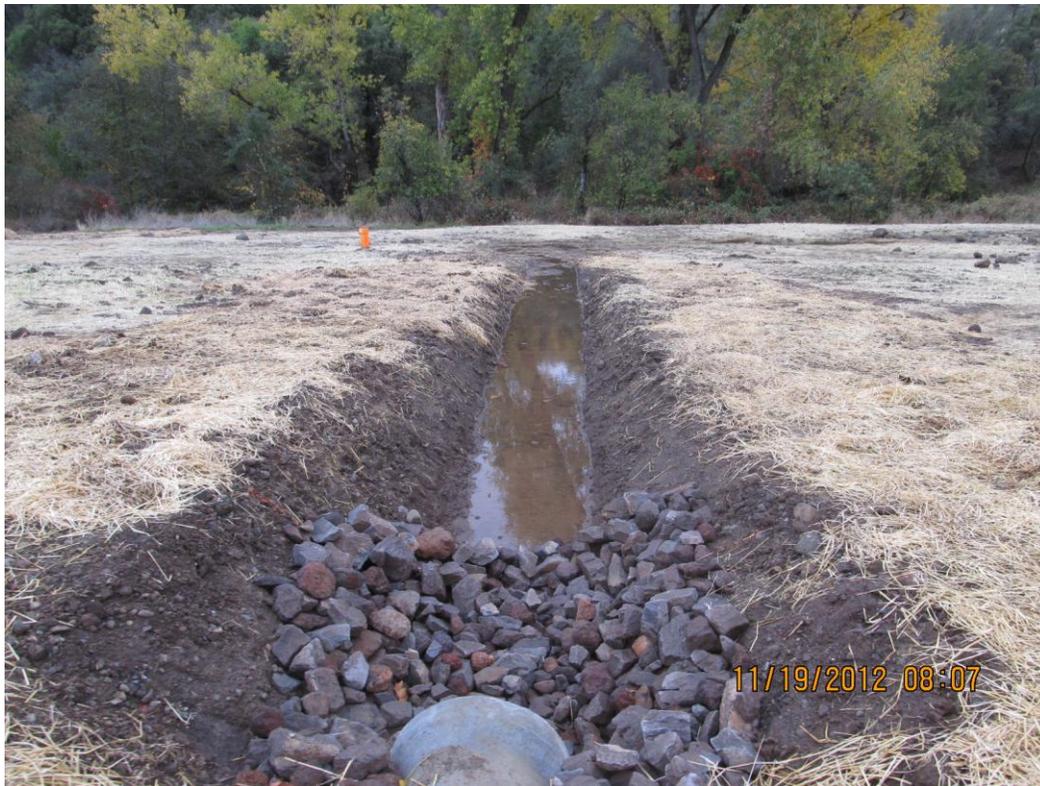
Coleman Diversion Dam/Inskip Powerhouse: View of the newly installed cross drainage culvert under the Inskip Powerhouse access road.
